MINERALS PROGRAM INSPECTION REPORT
PHONE: (303) 866-3567

MINE NAME: Morton Lakes	MINE/PROSPECTING ID#: M-2008-082	MINERAL: Sand and gravel	COUNTY: Weld
INSPECTION TYPE: Monitoring	WEATHER: Clear	INSP. DATE: May 23, 2023	INSP. TIME: 12:00
OPERATOR: Ready Mixed Concrete Company, LLC	OPERATOR REPRESENTATIVE: Stuart Ernst	TYPE OF OPERATION: 112c - Construction Regular Operation	
REASON FOR INSPECTION: High Priority	BOND CALCULATION TYPE:	BOND AMOUNT: \$10,521,378.00	
DATE OF COMPLAINT: NA	POST INSP. CONTACTS: None	JOINT INSP. AGENCY: None	
INSPECTOR(S): Eric Scott Michael Cunningham	INSPECTOR'S SIGNATURE:

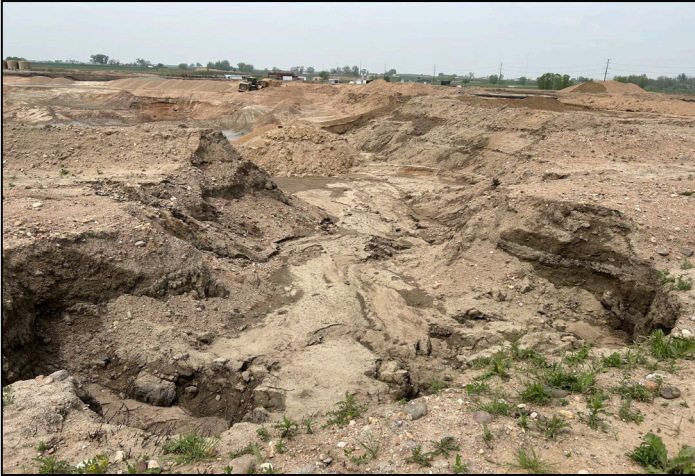
Photo 1 – Inlet breach in SE corner of Cell 7A

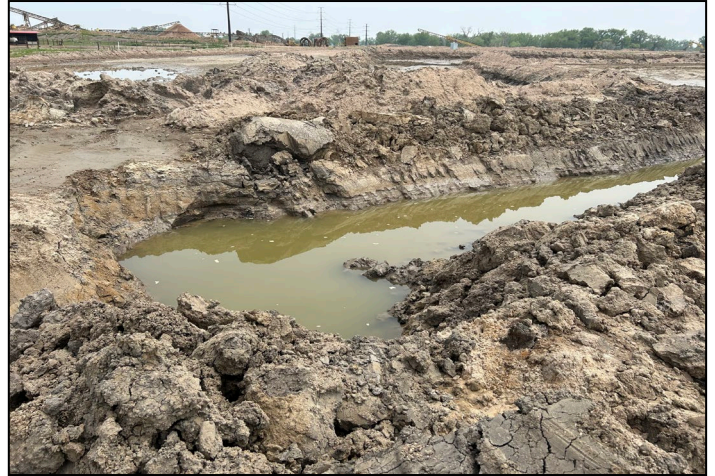
Photo 2 –Outlet breach in NW corner of Cell 7A

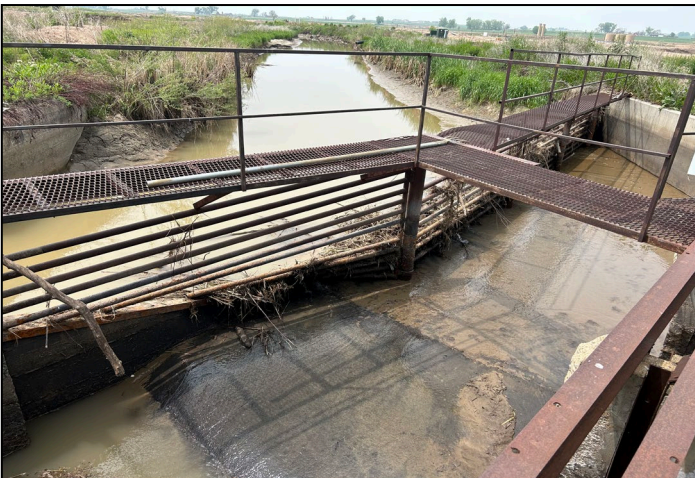
This was a high-priority monitoring inspection conducted by Eric Scott and Michael Cunningham of DRMS for the Morton Lakes 112c sand and gravel site. On May 23, 2023 DRMS was informed by Jorge Vidal of the Division of Water Resources that flooding of Big Dry Creek earlier in the month had resulted in a breach of the south side of Cell 5 of the Morton Lakes site and subsequent pit capture of the creek. Mr. Vidal was concerned that, due to the creek flowing through Cell 5 to reach the South Platte River instead of around it, the head-gate of the Lupton Meadows irrigation ditch was bypassed and not receiving water (photo 3).

Photo 3 – No flow entering headgate of Lupton Meadows ditch at time of inspection due to stream capture.

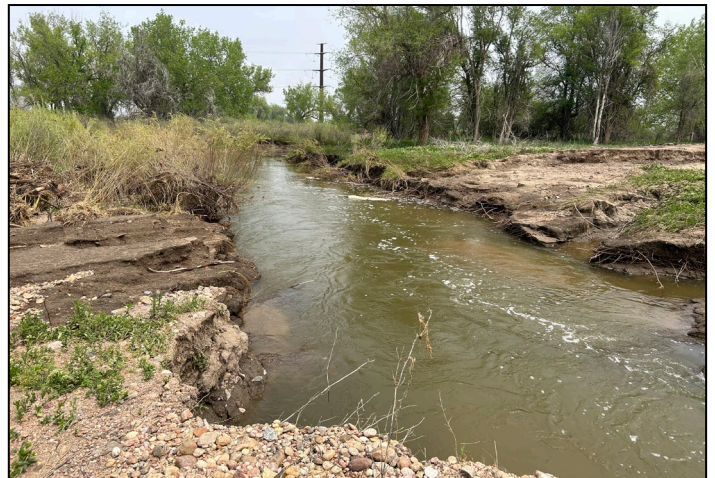
DRMS proceeded to the north end of Cell 5 where the flow of Big Dry Creek was exiting that cell back to its channel and then to the South Platte River. Because the north portion Cell 5 was in the process of being backfilled, damage in this area was not severe, although repairs here will certainly be needed once Big Dry Creek has been returned to its channel (photo 4).

Photo 4 – Flow of Big Dry Creek leaving north end of Cell 5 at time of inspection.

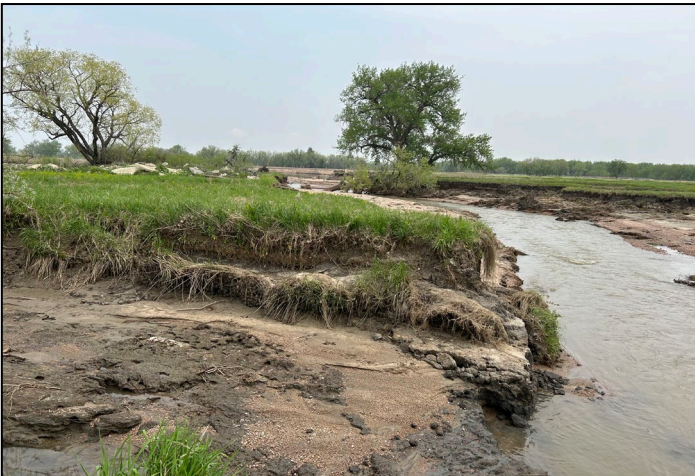
DRMS proceeded to the site of the breach of Big Dry Creek south of Cell 5 and noted the damage in the area where the creek is now flowing through Cell 5 instead of its previous channel (photos 5,6). The majority of the damage to the site is located along the south side of Cell 5 where approximately 1000' of the south cell wall and slurry wall will need to be repaired/replaced. The Cell 5 slurry wall will need to be recertified by SEO when these repairs are complete. DRMS left the site at approximately 14:30. On May 30, DRMS was been informed that the breach located on the City of Aurora property has been repaired and the flow of Big Dry Creek has been returned to its channel. This should restore proper flow at the inlet of the Lupton Meadows irrigation ditch.

Photo 5 – Breach of creek bank on Aurora property. Dry ground in lower photo is the proper creek bed, but Big Dry Creek now flowing through breach into south side of Cell 5.

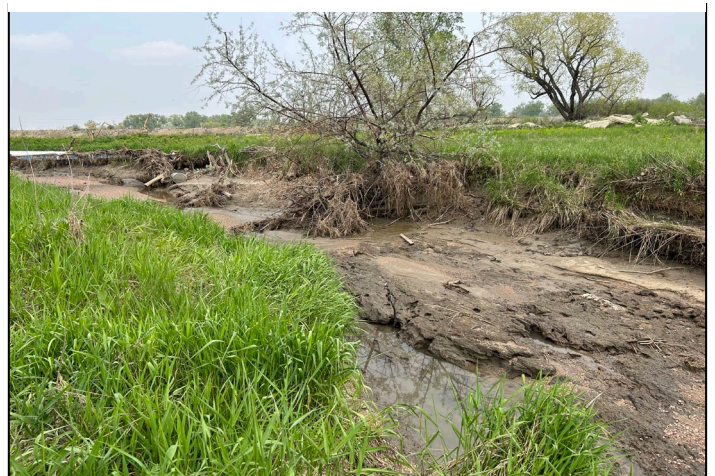
Photo 6 – Dry channel of Big Dry Creek leading into south side of Morton Lakes site after stream capture by Cell 5.
