MINERALS PROGRAM INSPECTION REPORT

MINE NAME: Navajo Clay Pit	MINE/PROSPECTING ID#: M-1993-004	MINERAL: Clay (general)	COUNTY: Elbert
INSPECTION TYPE: Monitoring	WEATHER: Clear	INSP. DATE: May 3, 2023	INSP. TIME: 10:00
OPERATOR: General Shale Brick, Inc.	OPERATOR REPRESENTATIVE: Jason McGraw	TYPE OF OPERATION: 112c - Construction Regular Operation

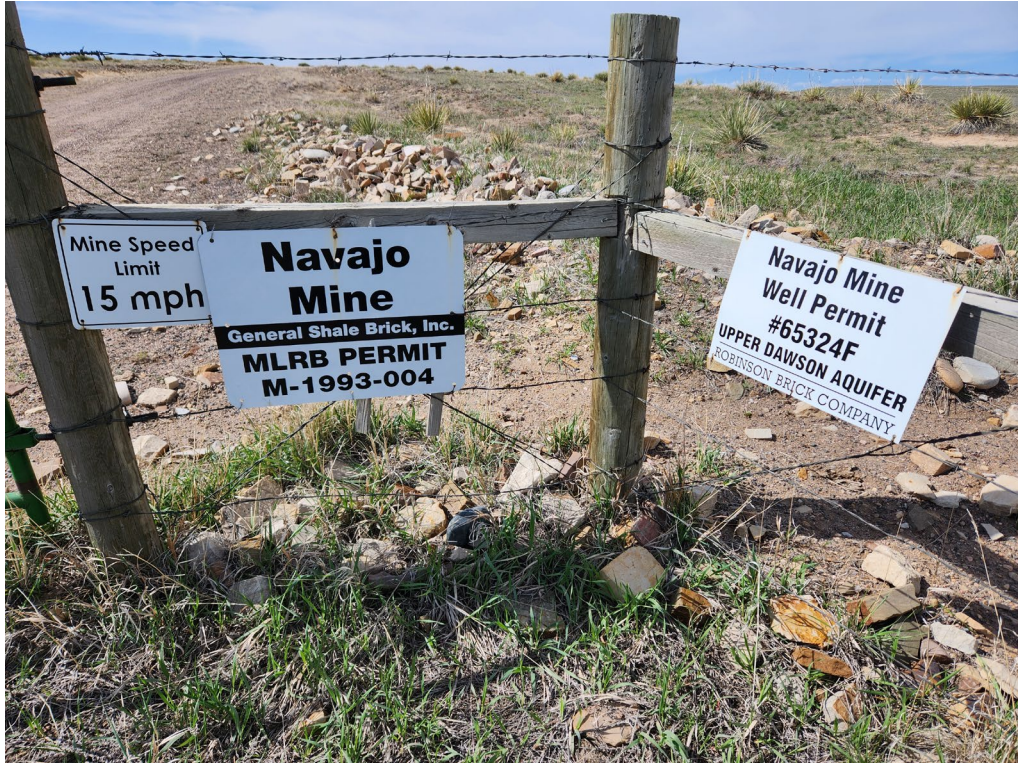
Photo 1. Navajo Clay Pit permit sign.

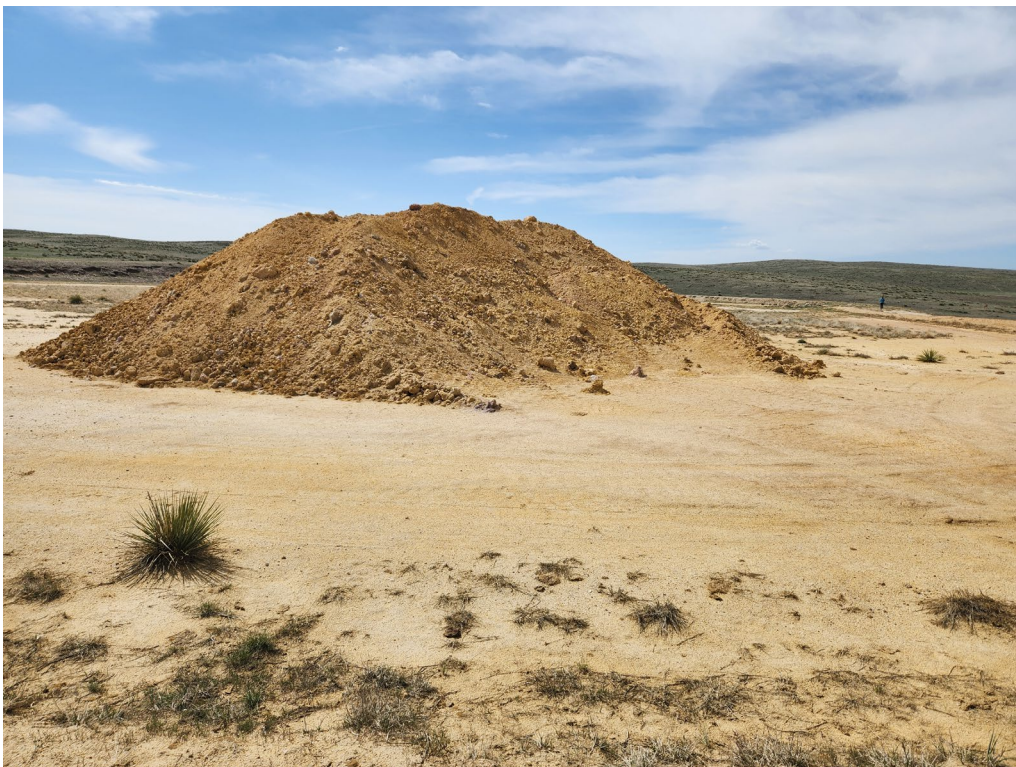
Photo 2. Clay product stockpile on pad, looking south.

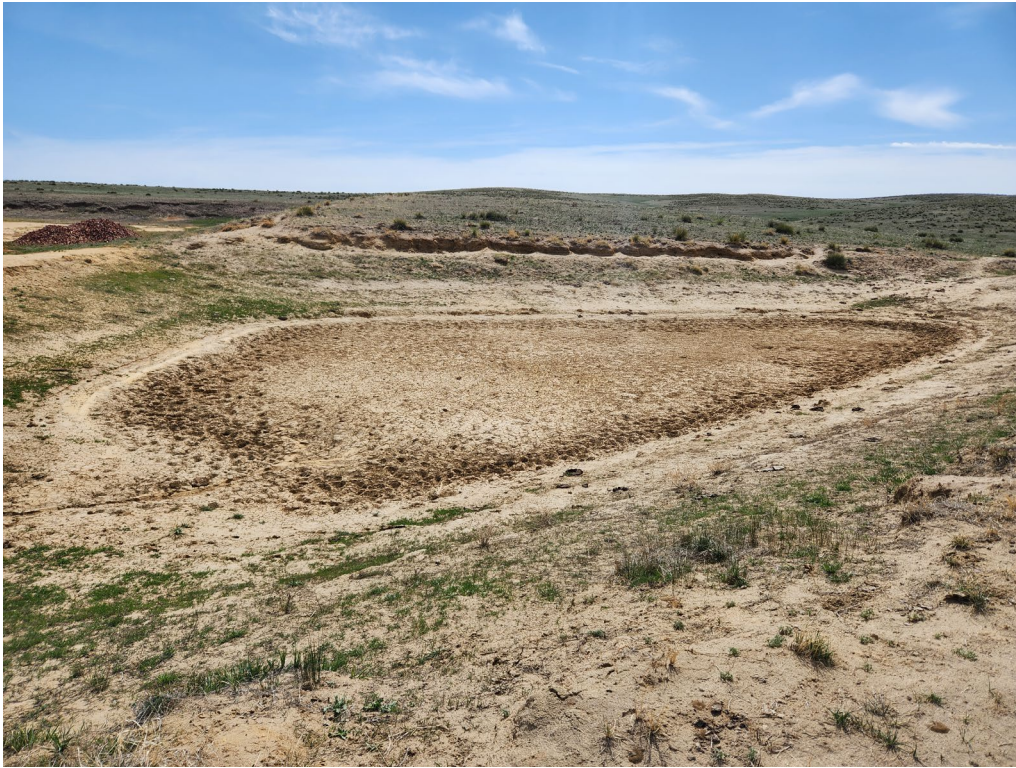
Photo 3. Stormwater pond south of stockpile pad, looking east.

with Rule 6.4.5 to reflect existing and proposed activities. Specifically, the reclamation plan needs to be updated to describe how stormwater management structures at the site (e.g., ditches, rock check dams, pond) will be reclaimed. If any of the stormwater management structures are proposed to remain for reclamation, or any other changes are proposed in the updated reclamation plan, the revision must also include an updated reclamation plan map that meets the requirements of Rules 6.2.1(2) and 6.4.6. The operator should be advised, any proposal to leave a structure for reclamation must include a notarized letter from the landowner acknowledging their desire to leave such structure. This corrective action may be submitted with the same Technical Revision required for Problem #1 above.

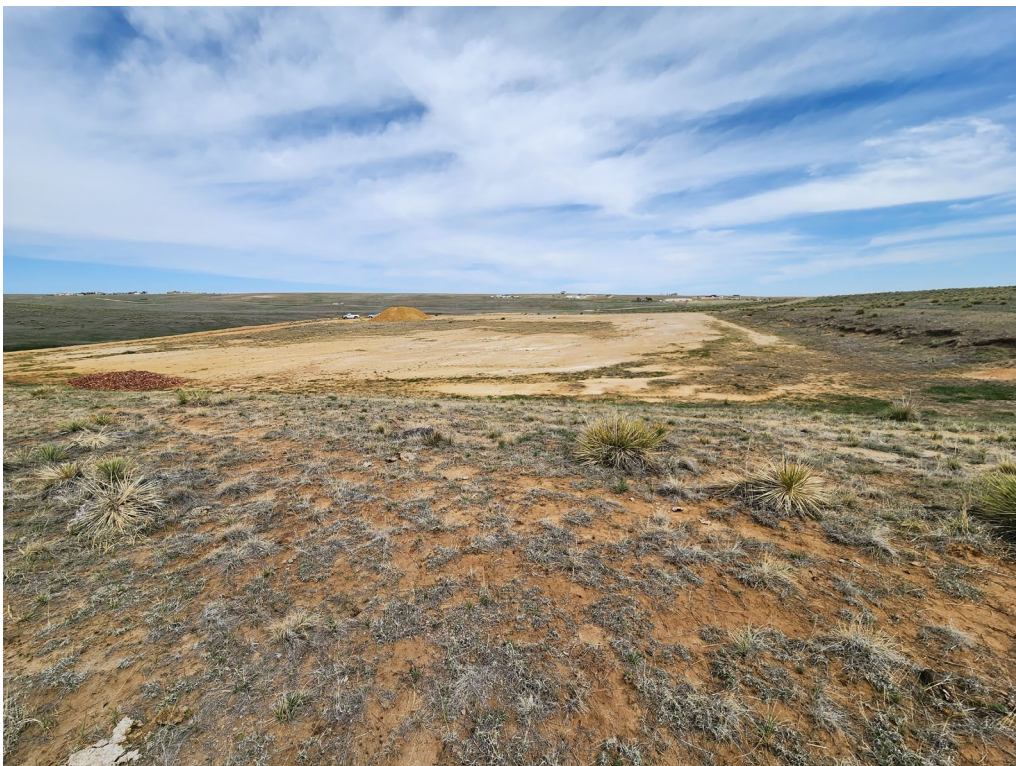
Photo 4. Clay stockpile pad, looking north.

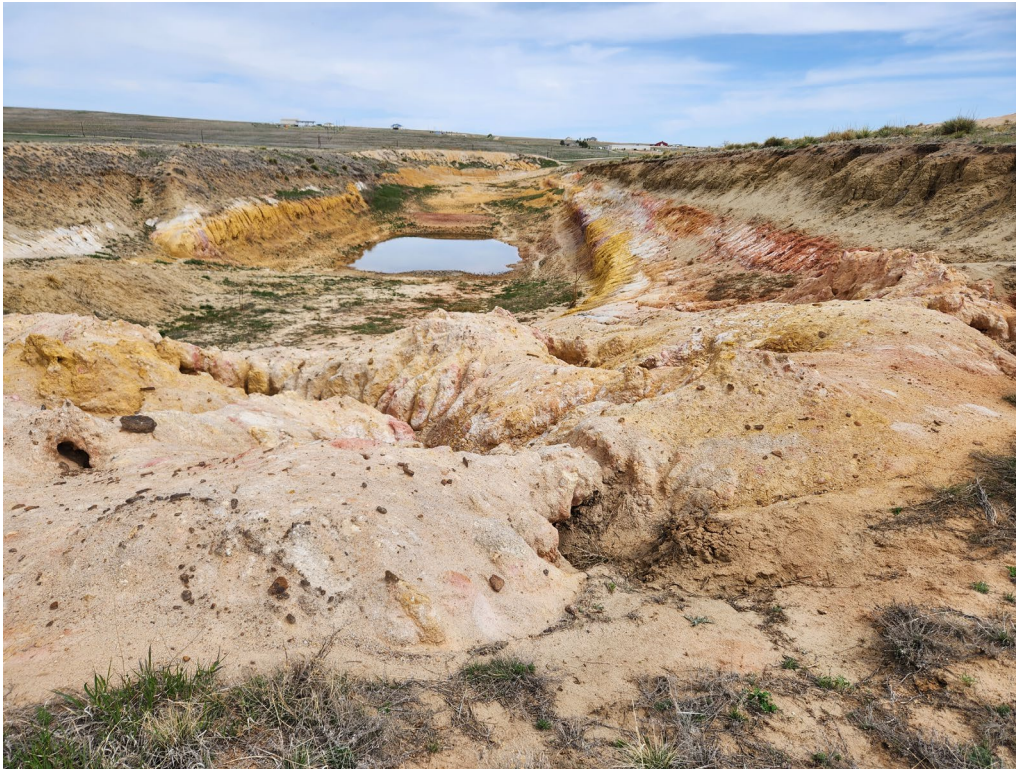
The pit is approximately 6.3 acres in size and 35-40 feet deep. The highwall slope gradients are estimated to be 1H:1V to 2H:1V. There was water present in the pit at the time of inspection. It appears that the operator has a valid well permit (Division of Water Resources Well Permit No. 65324-F) and water rights (Colorado Ground Water Commission Determination No. 1029-BD) to account for the exposed groundwater in the pit. There were several turtles using the water at the time of inspection. These turtles appeared to be Ornate Box Turtles, which Colorado Parks and Wildlife does not recognize as endangered or threatened.

Photo 5. Excavated pit, looking north.

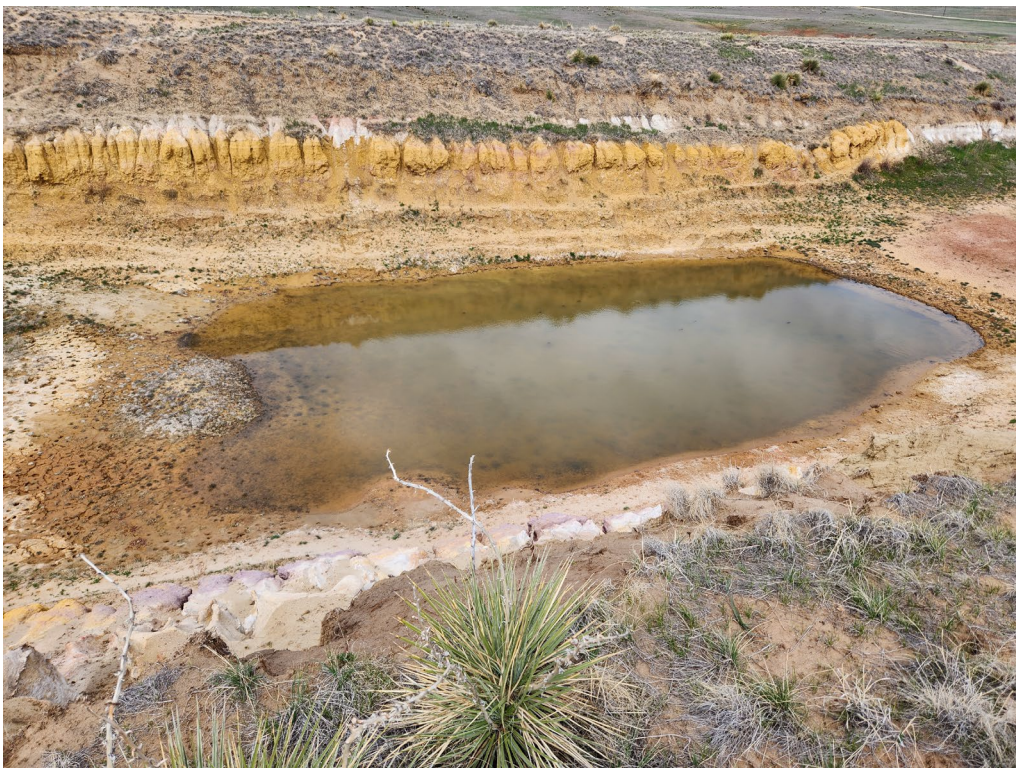
Photo 6. Standing water in pit, looking west.

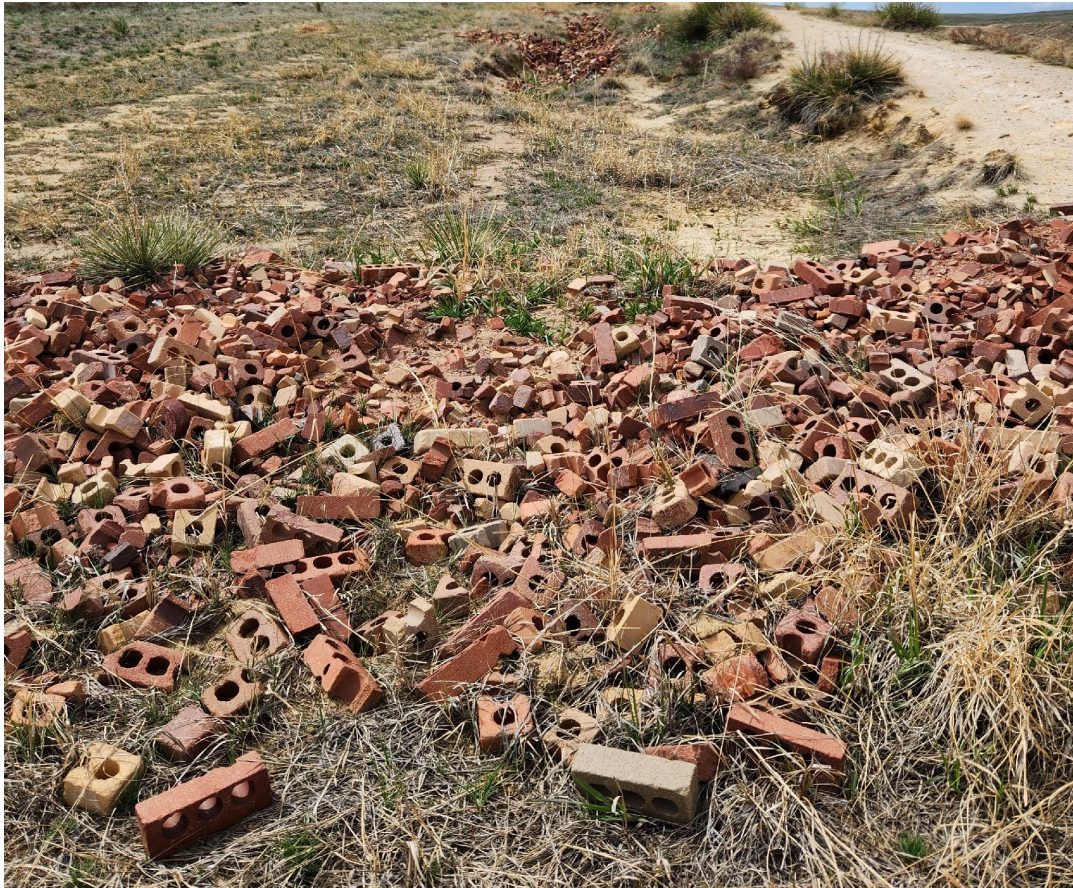
The operator has constructed check dams in two areas within the affected area boundary, along the eastern edge of the haul road running between the clay stockpile pad and the pit, and along the eastern edge of the access road leading from Co Rd 174 to the clay stockpile pad. These check dams have been constructed with scrap bricks imported to the site from the operator's Denver brick manufacturing plant. The operator indicated the check dams were constructed for stormwater management to prevent further erosion of the pit. A small stockpile of scrap bricks was stored in the clay pad area for use in maintenance of the check dams. The approved mining and reclamation plans do not address the stormwater management structures at the site. Specifically, the mining plan does not address the importation of scrap bricks, the use of this material to construct check dams, or the stormwater pond construction. The reclamation plan does not address how the stormwater management structures will be reclaimed. Accordingly, two problems are cited in this report (see Problems #1 and #2) which require the operator to submit a Technical Revision (see enclosed form) to update the mining and reclamation plans and maps for the site to address the existing and planned stormwater management structures.

Photo 7. Check dams made with scrap brick, east of access road. Looking south.

CORRECTIVE ACTIONS: By the corrective action due date, the operator shall submit a Technical Revision, with the required \$216 revision fee, to update and clarify the current approved mining plan in accordance with Rule 6.4.4 to reflect existing and proposed activities. Specifically, the mining plan needs to be updated to describe the stormwater management plan for the site, including all water diversions and impoundments. This revision must also include an updated mining plan map that meets the requirements of Rules 6.2.1(2) and 6.4.3. All stormwater management structures must be shown on the updated map.

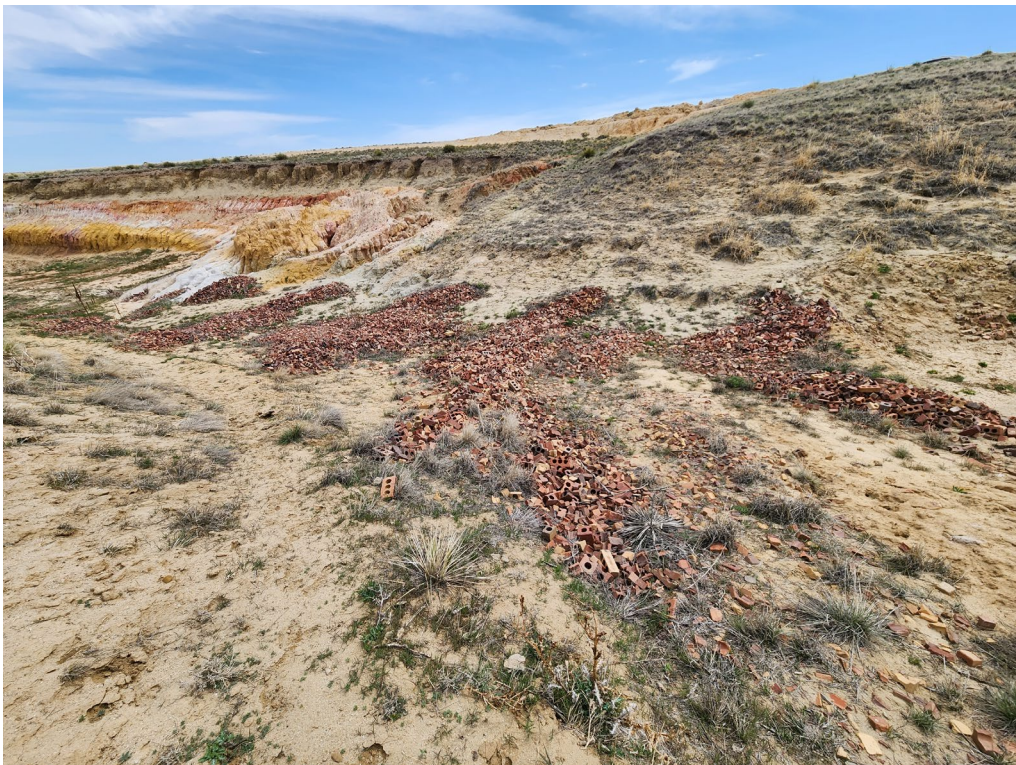
Photo 8. Check dams made with scrap brick in between stockpile pad and mining pit. Looking north.

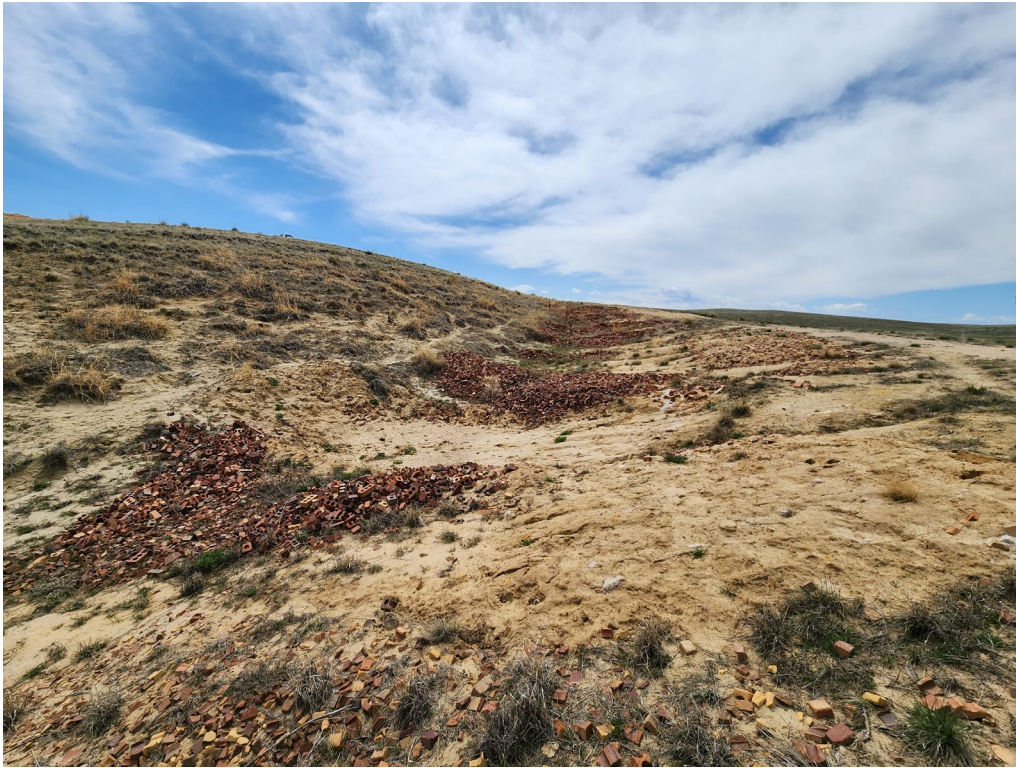
Photo 9. Check dams made with scrap brick in between stockpile pad and mining pit. Looking south.
