**MINERALS PROGRAM INSPECTION REPORT**  
**PHONE: (303) 866-3567**

<b>MINE NAME:</b> DDD	<b>MINE/PROSPECTING ID#:</b> M-1984-076	<b>MINERAL:</b> Clay (general)	<b>COUNTY:</b> Elbert
<b>INSPECTION TYPE:</b> Monitoring	<b>WEATHER:</b> Clear	<b>INSP. DATE:</b> May 3, 2023	<b>INSP. TIME:</b> 11:15
<b>OPERATOR:</b> General Shale Brick, Inc.	<b>OPERATOR REPRESENTATIVE:</b> Jason McGraw	<b>TYPE OF OPERATION:</b> 112c - Construction Regular Operation	
<b>REASON FOR INSPECTION:</b> Normal I&E Program	<b>BOND CALCULATION TYPE:</b> Complete Bond	<b>BOND AMOUNT:</b> \$305,289.00	
<b>DATE OF COMPLAINT:</b> NA	<b>POST INSP. CONTACTS:</b> None	<b>JOINT INSP. AGENCY:</b> None	
<b>INSPECTOR(S):</b> Joel Renfro Amy Eschberger	<b>INSPECTOR'S SIGNATURE:</b>

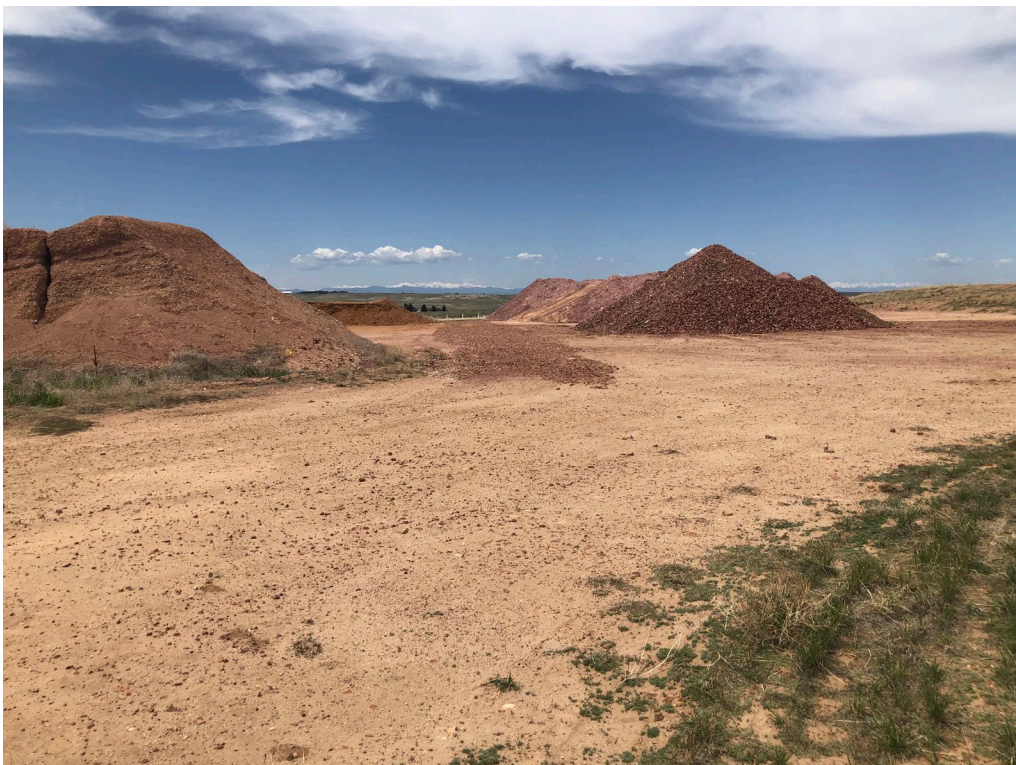
**Photo 2.** Clay and scrap brick stockpiles stored in southeast area, looking northwest at DWR.

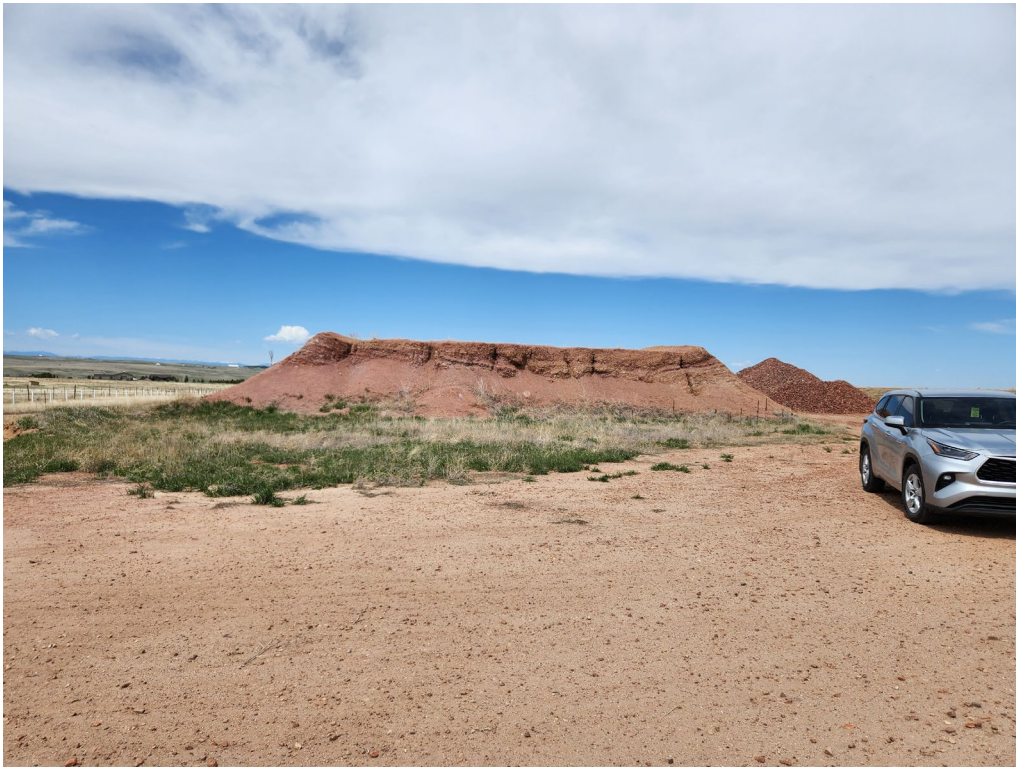
**Photo 3.** Clay and scrap brick stockpiles stored in southeast area, looking north at DWR.

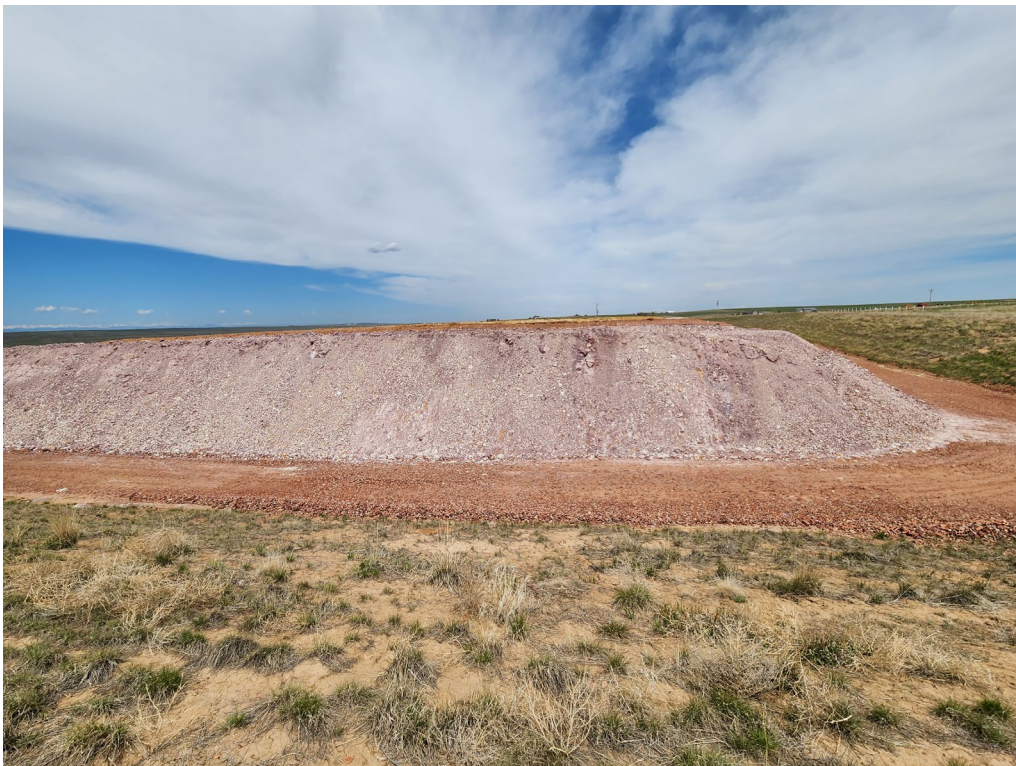
**Photo 4.** Clay stockpiles in northwest area, looking north at DWR. Access road on the right. Picture taken on top of topsoil stockpile.

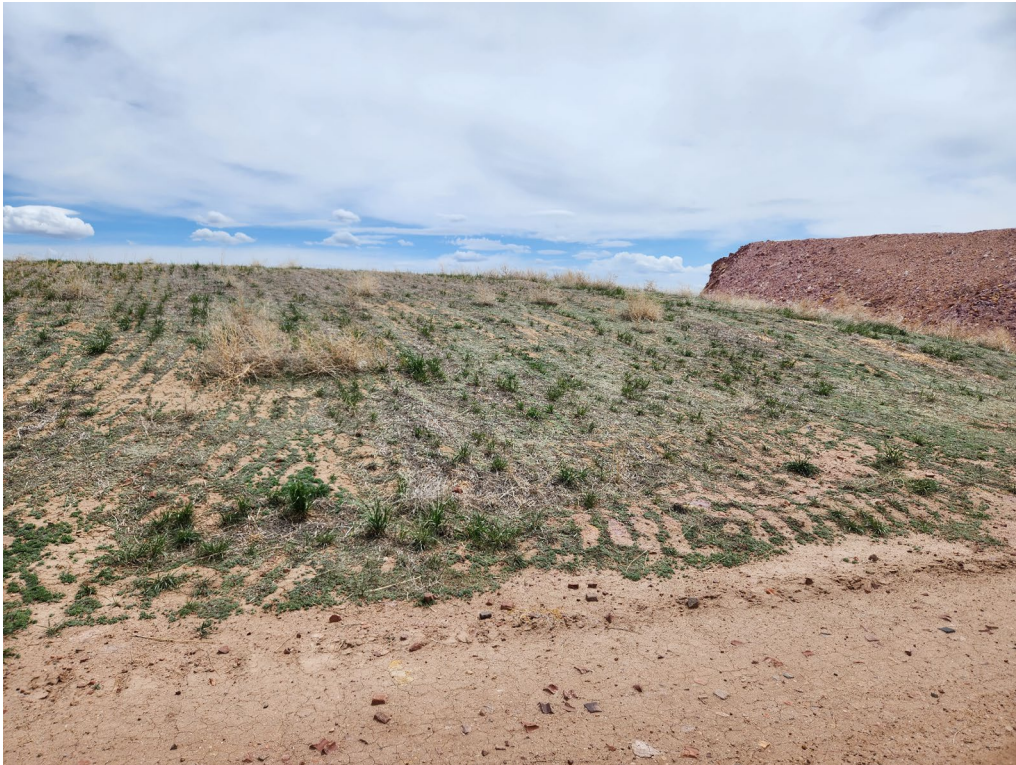
**Photo 5.** Topsoil stockpile in southeast area, looking east at DWR.

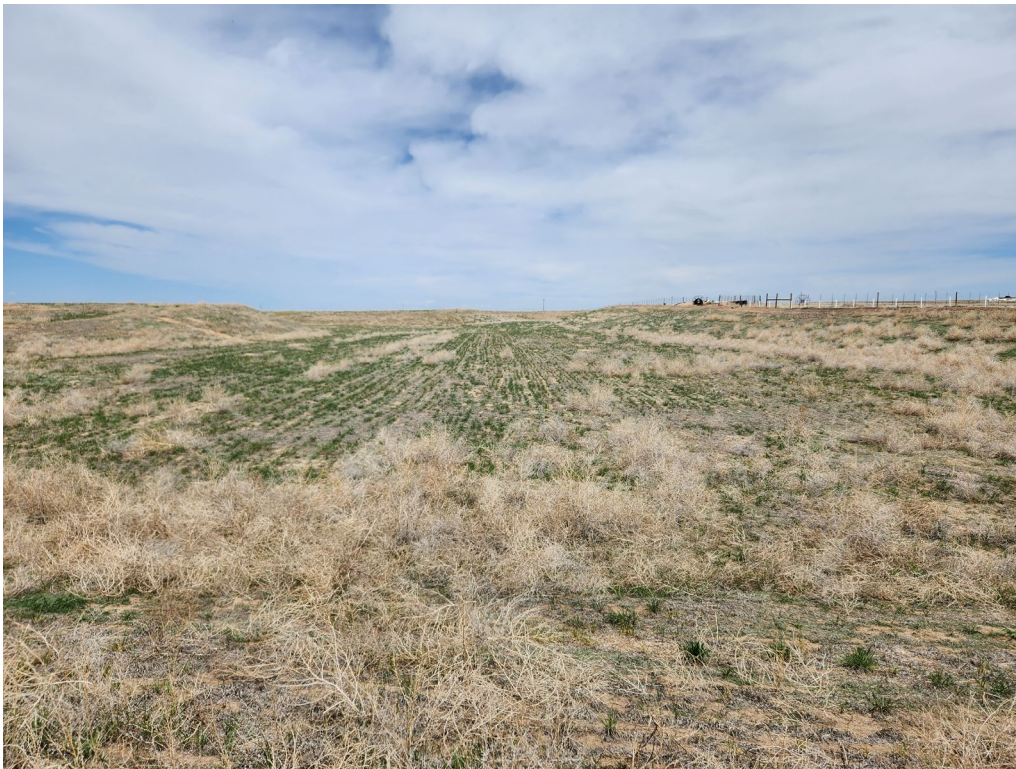
The Operator has begun reclamation on their affected mined pits located in the eastern portion of the DWR Mine permit area. The two pits observed during the Division's April 13, 2021 inspection were later mined through to create one single pit, elongated in a north-south direction. This pit was backfilled, with the slopes graded to 3H:1V, and the approximate 5 acre area drill seeded in May 2022. It appears the seed is establishing well so far. Dead kochia surrounded the slopes of the reclamation site, which is typical in this early stage of reclamation. The Division recommends the Operator continue to monitor revegetation success in the reclaimed pit area, implementing the approved weed control plan and interseeding, as necessary. Common mullein was found throughout the site, most concentrated in the undisturbed southwestern area of the permit. While common mullein is considered a noxious weed species, the Colorado Department of Agriculture identifies it as a List C Species, meaning it must be managed, but does not require eradication. It is apparent that the Operator has been actively treating the mullein and keeping it from spreading to their affected areas.

**Photo 6.** Pit in reclamation, looking north at DWR.

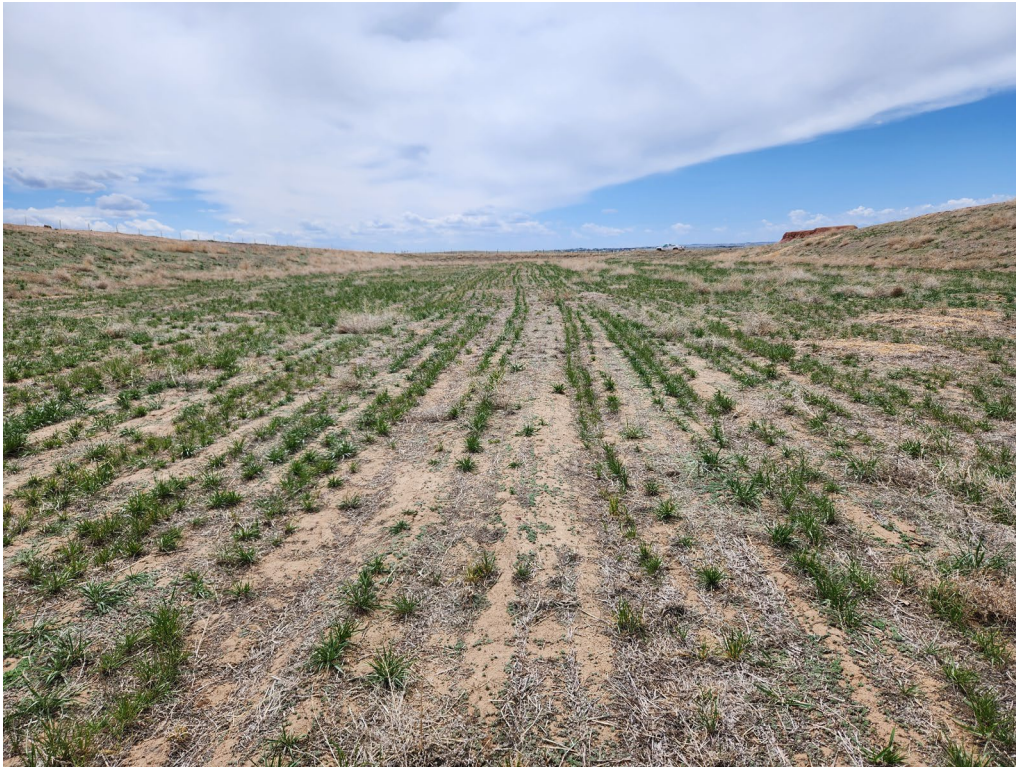
**Photo 7.** Pit in reclamation, looking south at DWR.

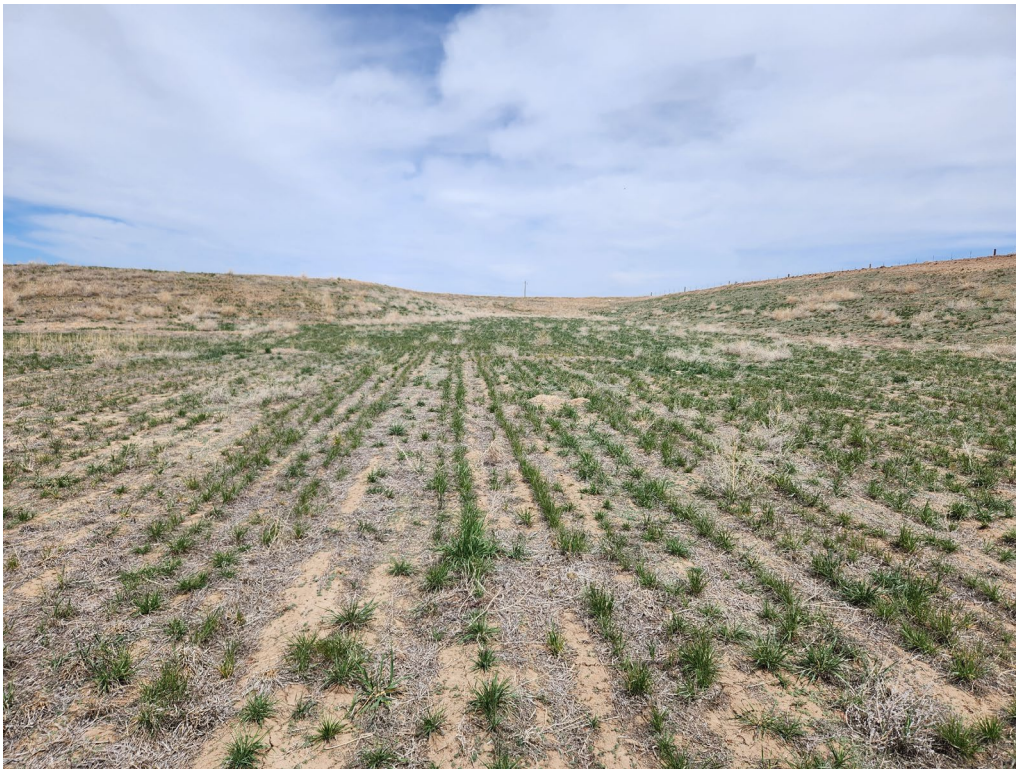
**Photo 8.** Pit in reclamation, looking north at DWR.

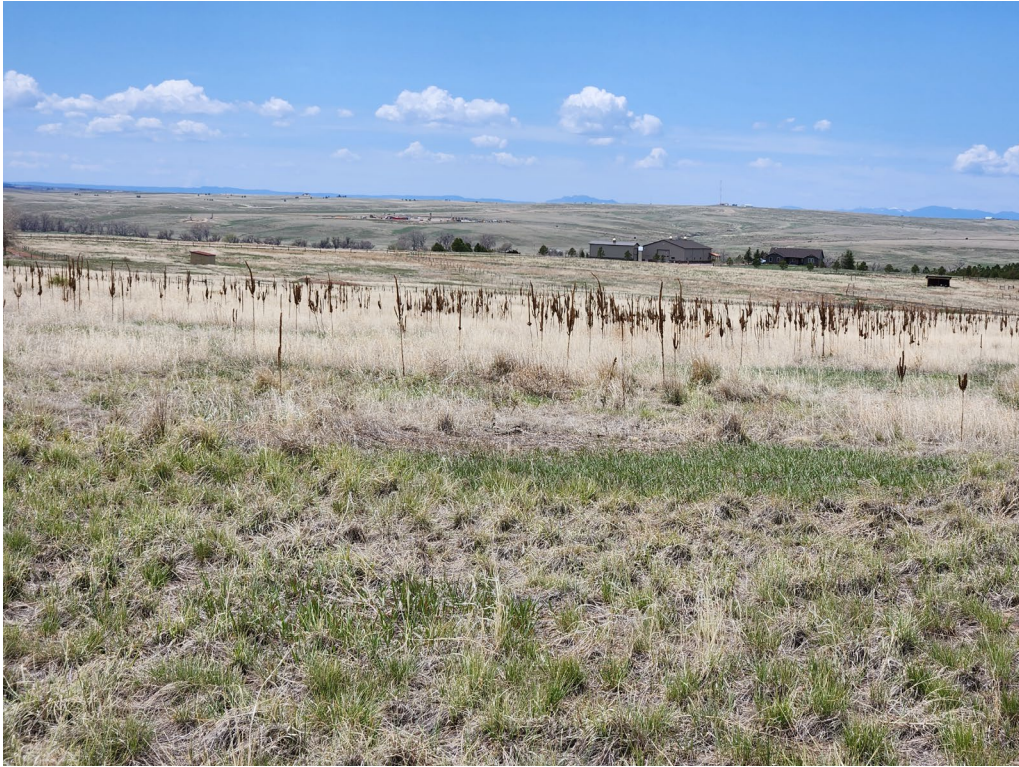
**Photo 9.** Common Mullein in southwest undisturbed permit area. Looking west at DWR. Mullein is actively being treated.

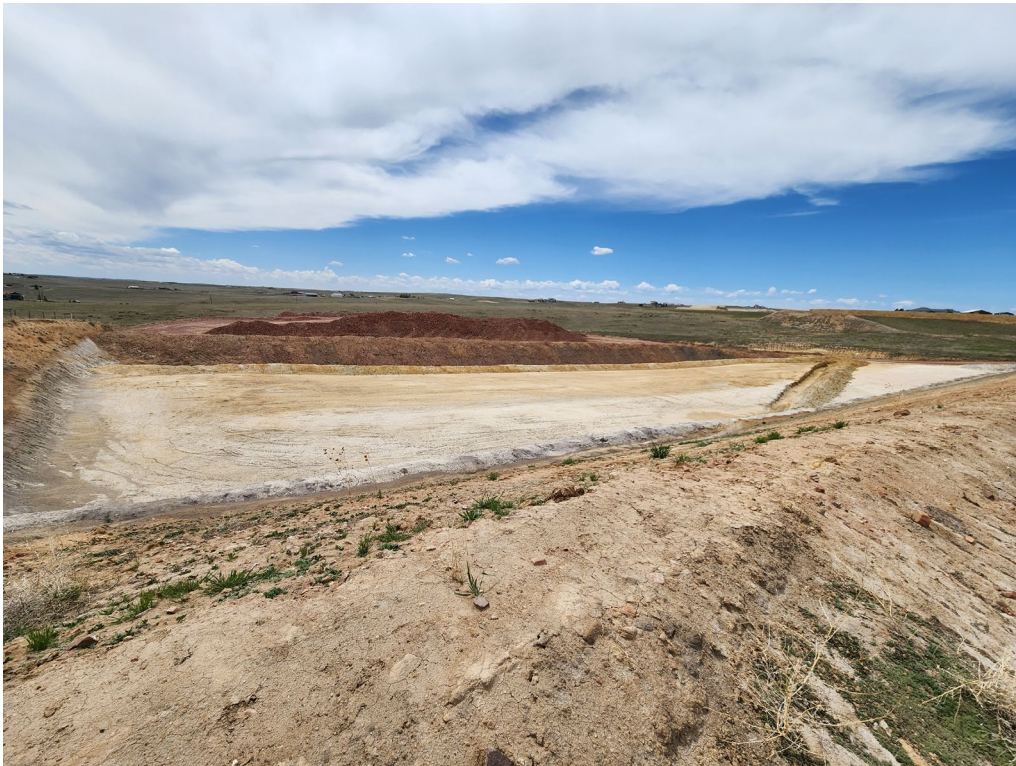
**Photo 12.** East pit and scrap brick stockpile, looking south at DEB. Note temporary channel on the right, this will be mined out.

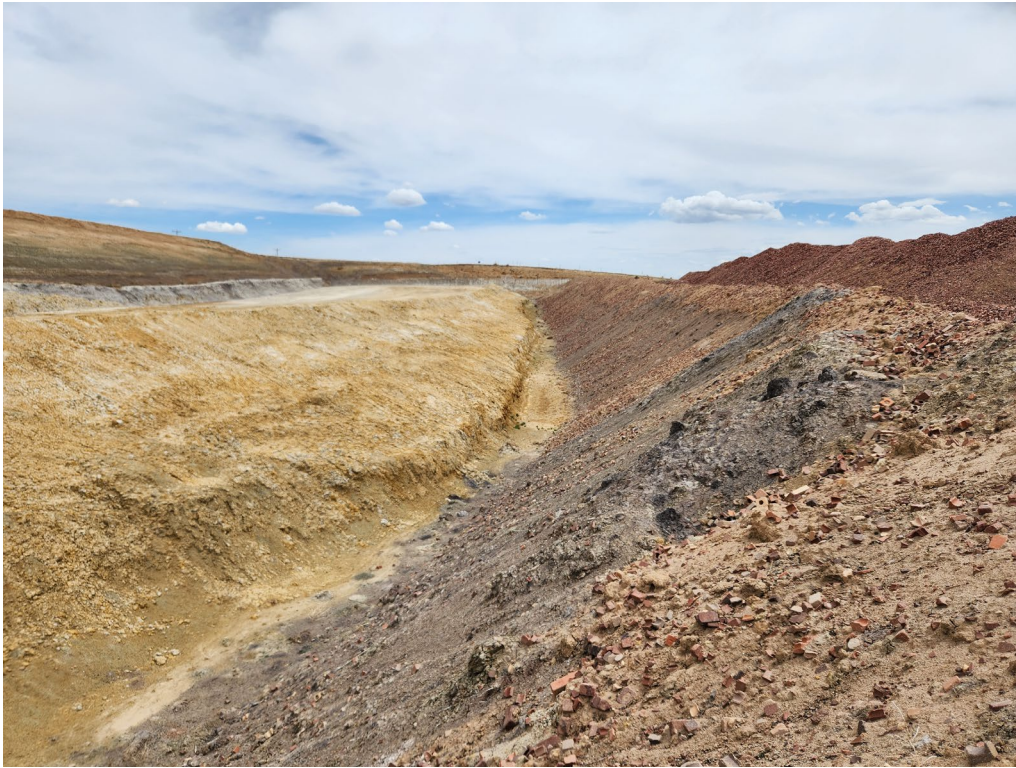
**Photo 13.** Southern edge of east pit, looking east at DEB.

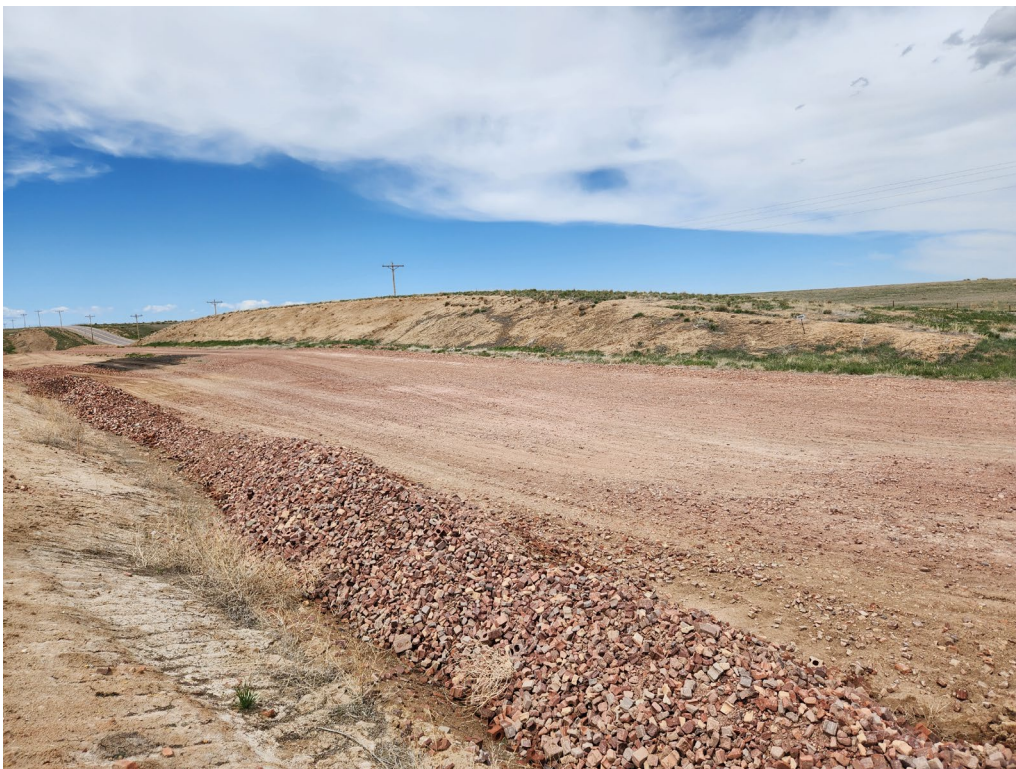
ponds have been constructed at the DEB Mine, one at the western edge of the mining area (approximately 0.95 acre in size) and the other at the southern edge of the clay stockpile area to the west (approximately 0.35 acre in size). The ponds were dry at the time of inspection. Topsoil is stockpiled along the northern edge of the permit boundary; these stockpiles are well-vegetated and stable.

**Photo 14.** Topsoil stockpile stored along northern permit boundary, looking northwest at DEB.

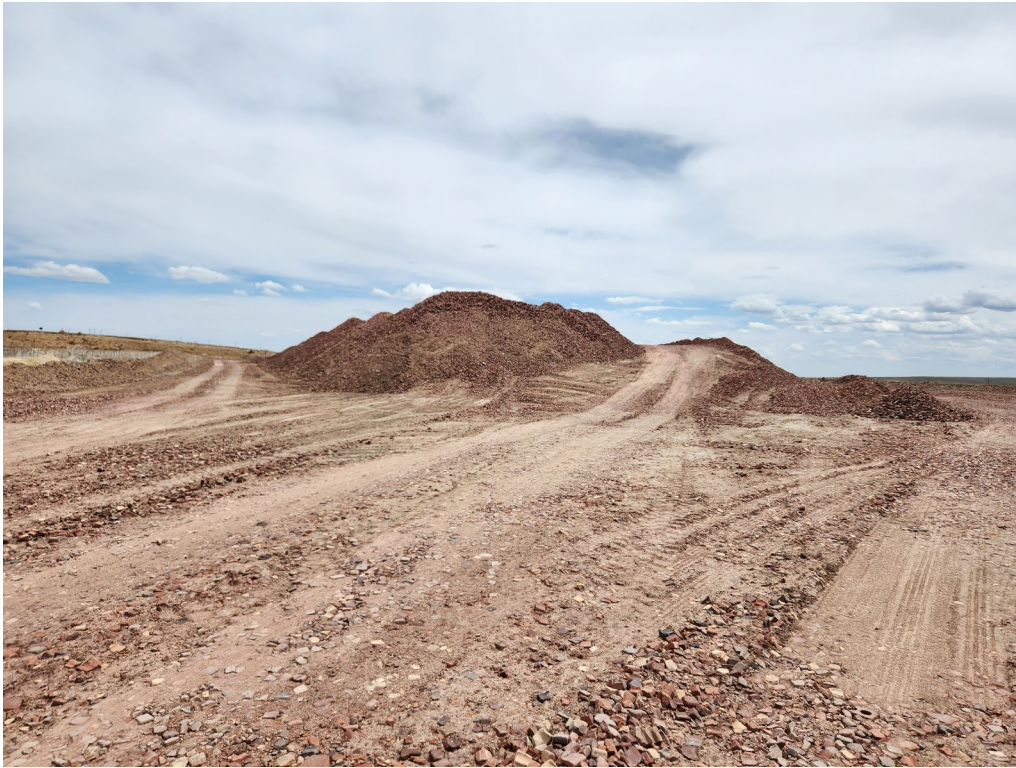
**Photo 15.** Scrap brick pile north of pit, looking east at DEB

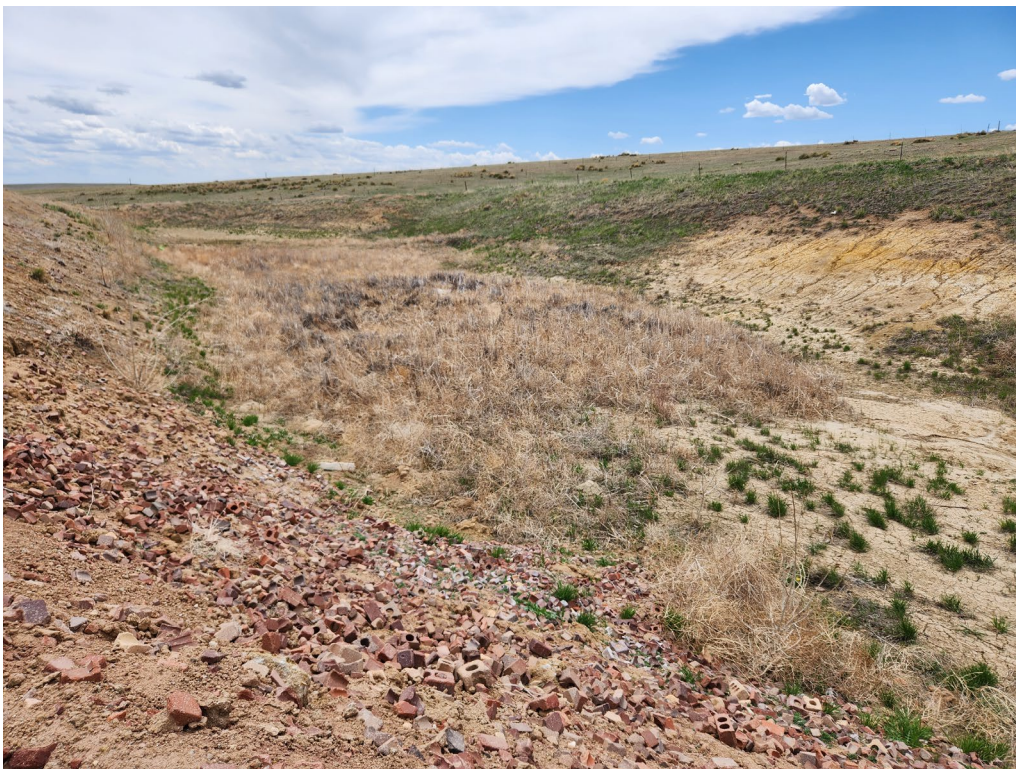
**Photo 16.** Stormwater pond (dry) located west of eastern disturbance area, looking southwest at DEB.

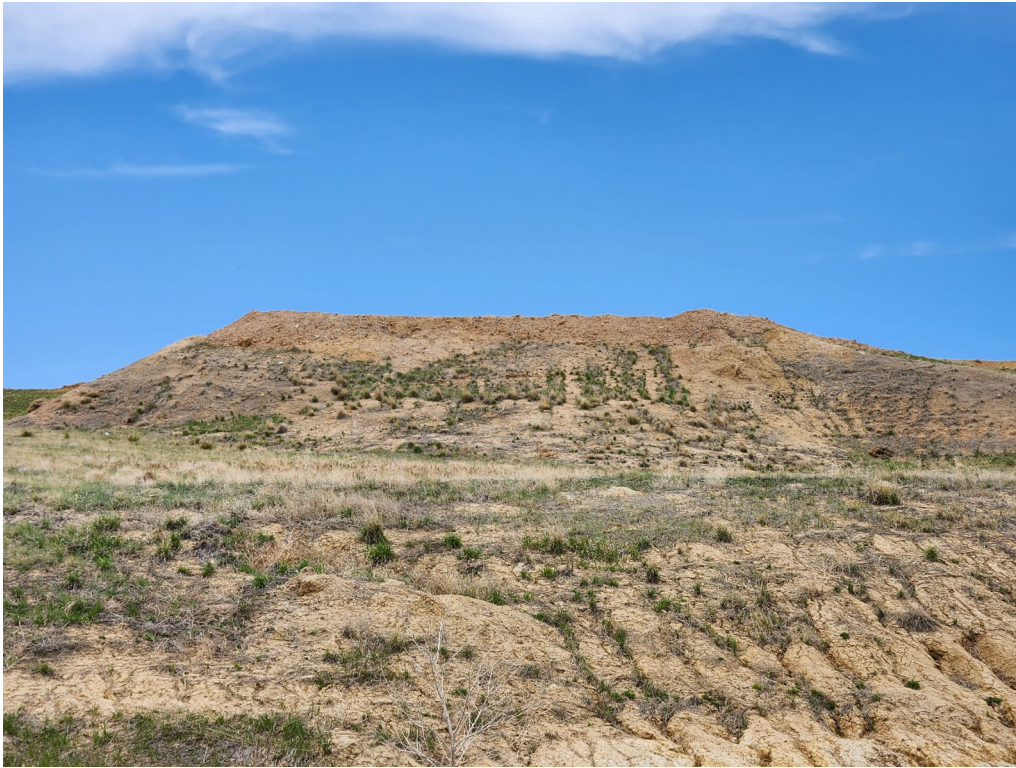
**Photo 17.** Large overburden pile in western disturbance area, looking west at DEB.

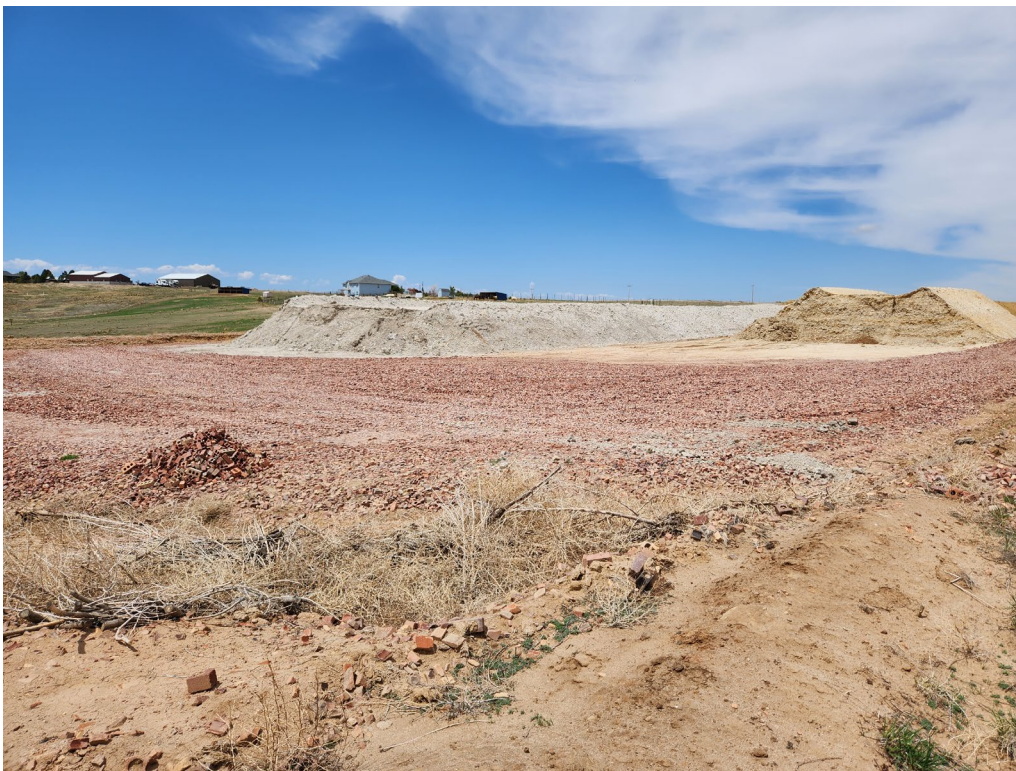
**Photo 18.** Clay stockpiles in western disturbance area, looking north at DEB.

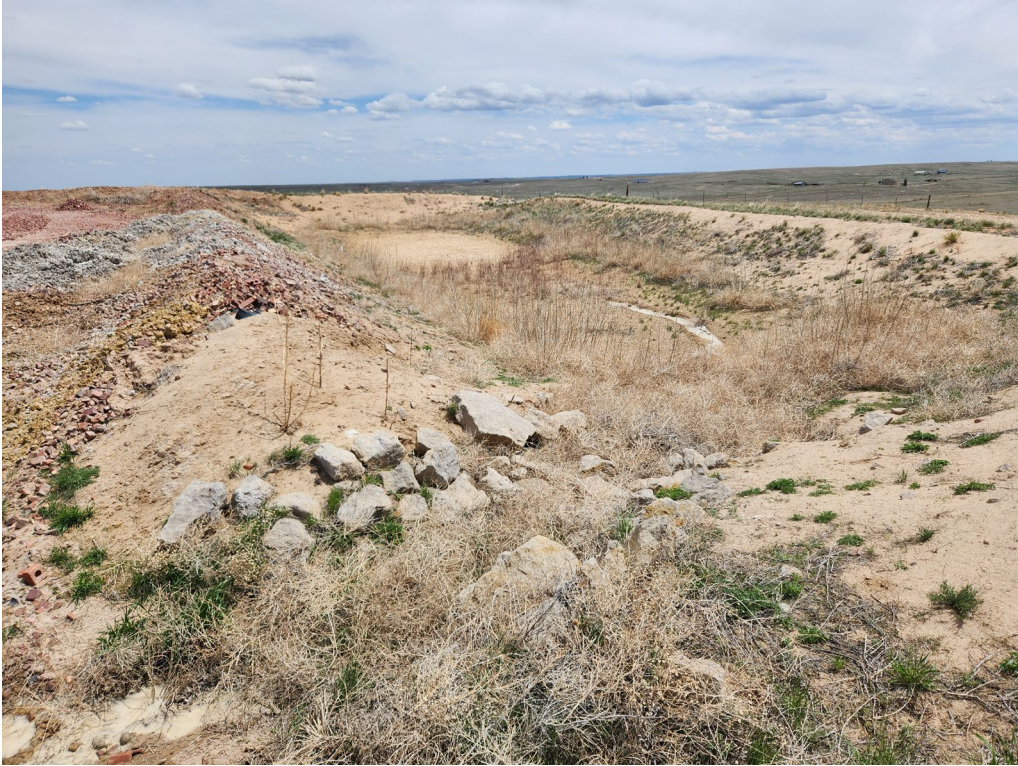
**Photo 19.** Stormwater pond (dry) located south of clay stockpile area in western disturbance, looking southeast at DEB.
