File: April 2023 Monitoring Summary

Date: May 31, 2023

**Reference: April 2023 Geotechnical Monitoring Summary Pikeview Quarry**

PIKEVIEW QUARRY SLOPE  
MONITORING

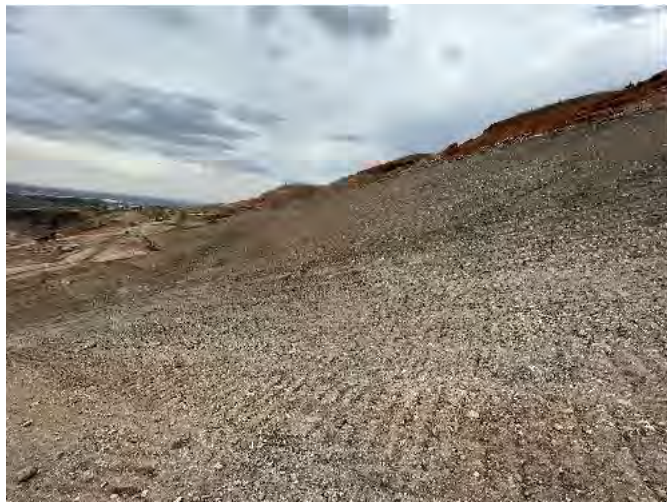
- The slope below the first bench has been placed to the final grade, and this slope was traversed on foot and examined for cracks or signs of instability by Stantec engineers. No cracks or signs of instability were identified.

6. View south on slope of first bench

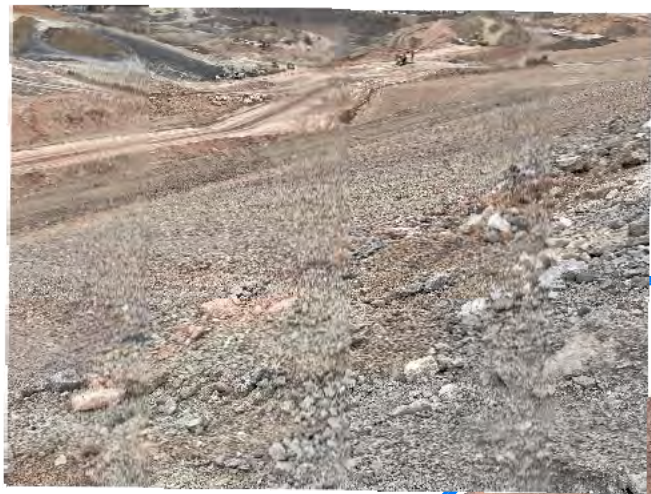
5. View down bench slope to pit floor.

NOTE 1:  
NO CRACKS

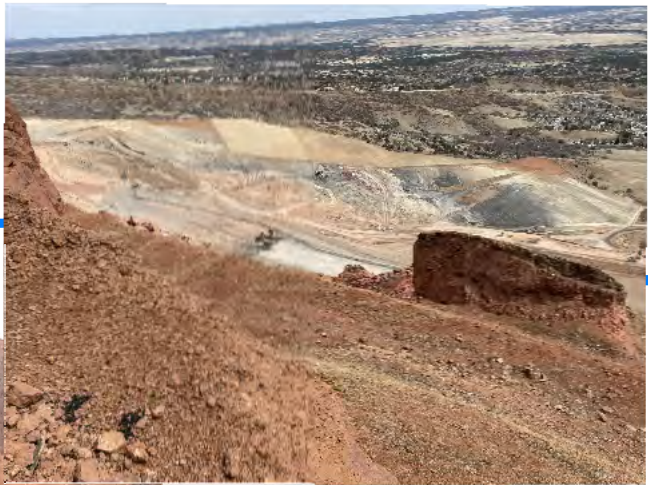
4. NBA as seen from the top of the haul road.

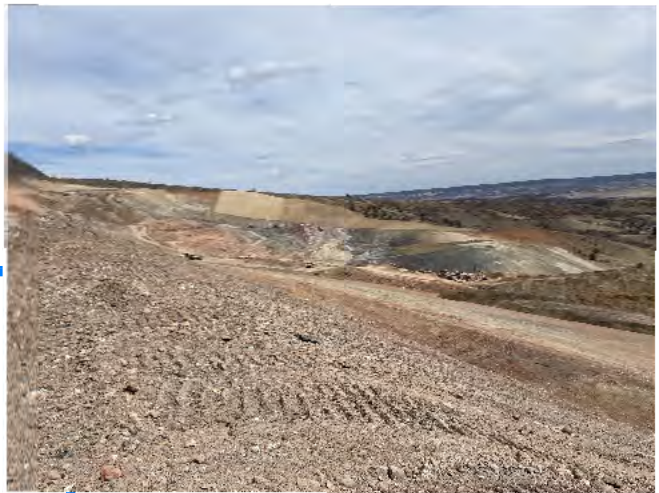
3. North Borrow Area as seen from the pit floor.

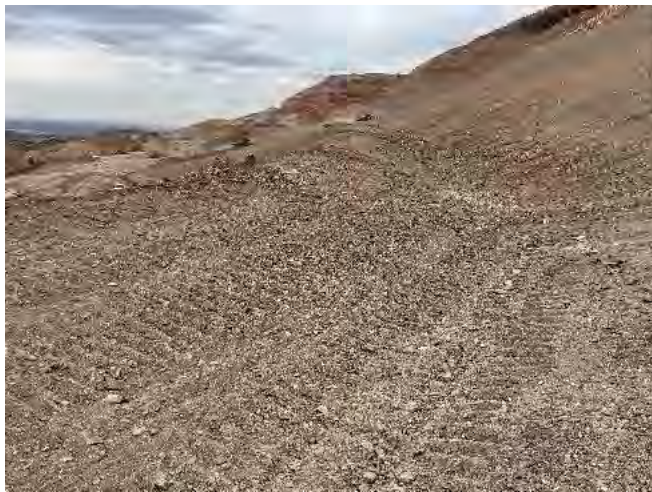
7. View south on slope of first bench.

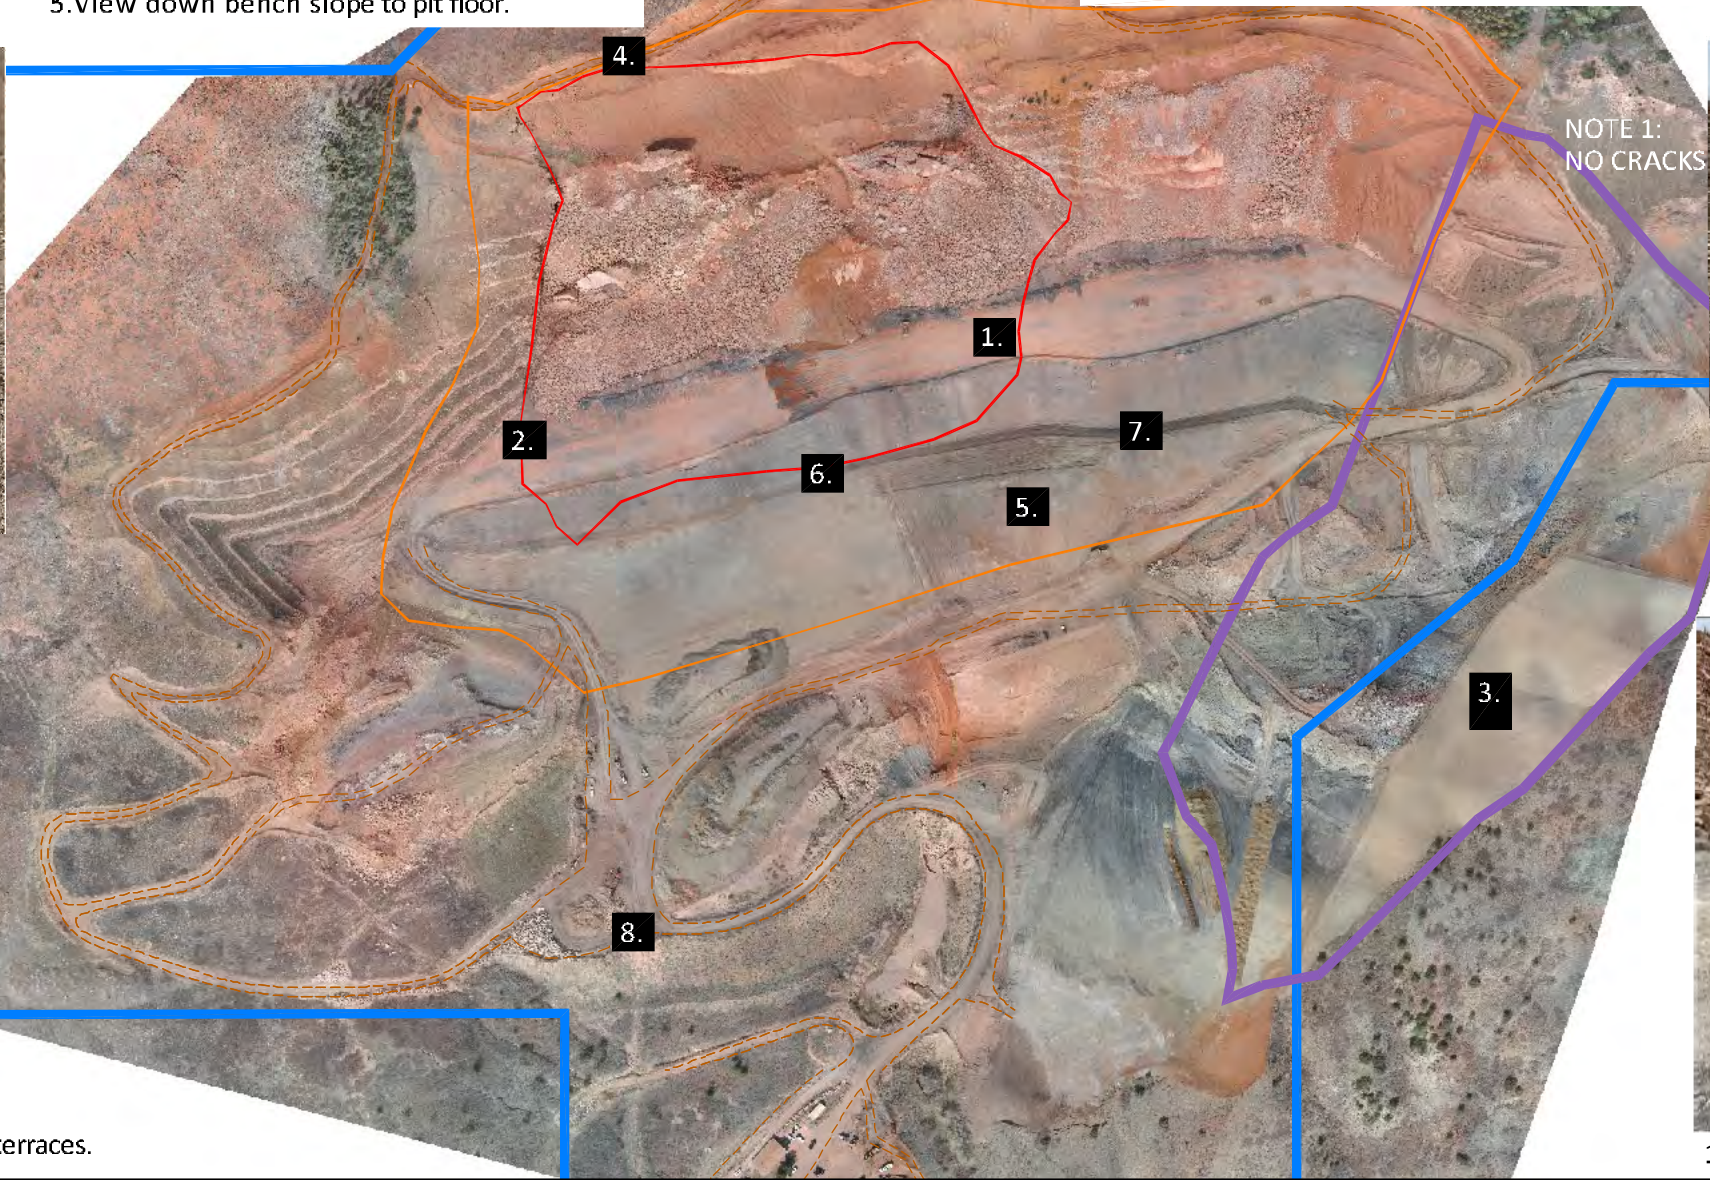
OBSERVATIONS FROM  
APRIL INSPECTION

- Known cracks were monitored for changes. Currently the cracks are not growing in any of the areas on the slopes of the site. The hummocky field in the area immediately above the southern extent of the slide shows evidence of previous cracking, but they are not fresh or active. No new or open cracks were found immediately inside or next to the slide area.

- NO CRACKS OBSERVED IN THIS AREA.
- ALL PHOTOS TAKEN APRIL 13, 2023.

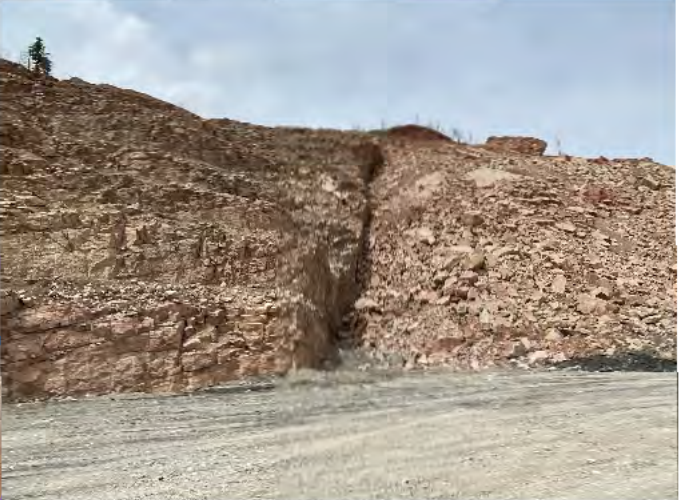
2. Slide area to the west of the pit floor.

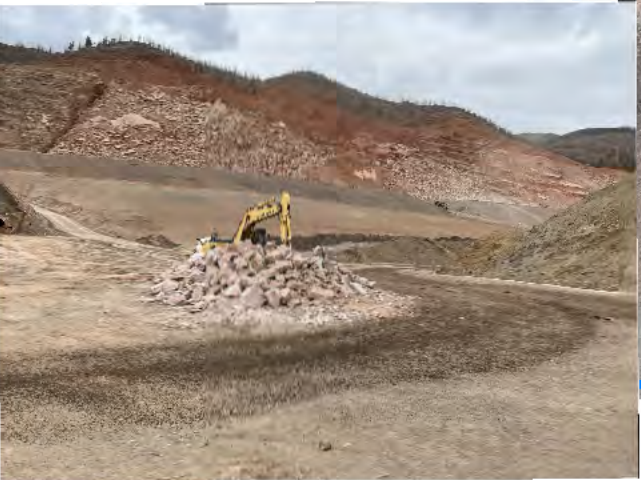
- Rock was being screened, sorted, and stockpiled as riprap for use as erosion protection in the channels.
- The culvert remains cleared but mostly blocked inside. Riverbend has partially cleared the debris, but access limitations and supports within the culvert inhibit clearing all the debris. Riverbend has procured a pump and will begin pumping operations if any water collects behind the culvert. Riverbend inspects the

8. Riprap sorted and stored on site for swales and terraces.

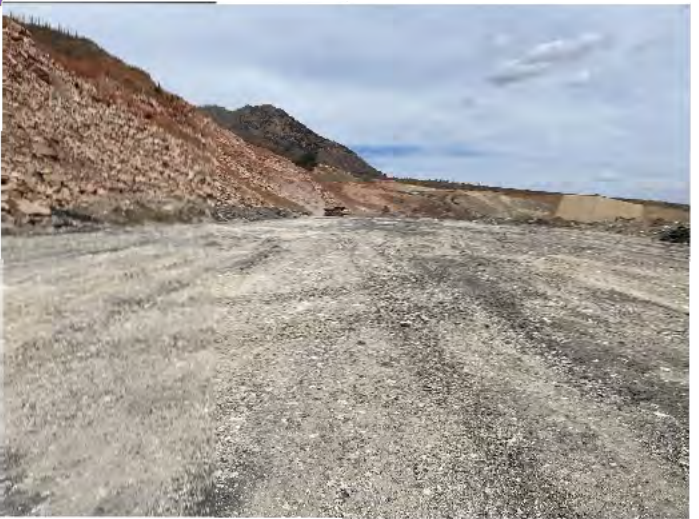
1. View north on compacted pit floor.

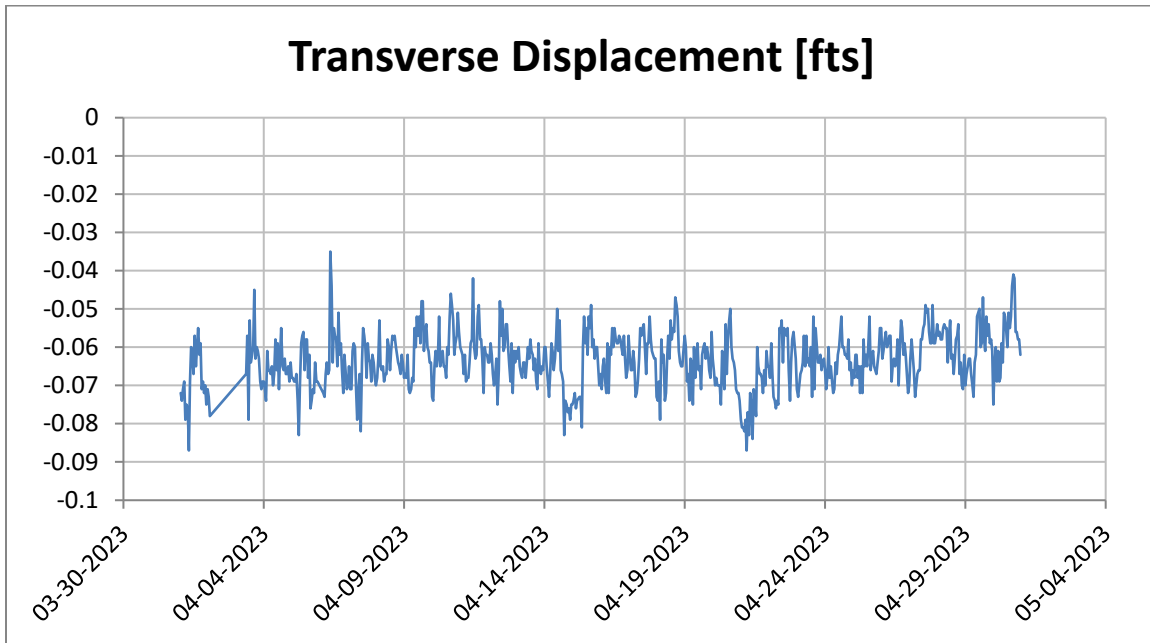
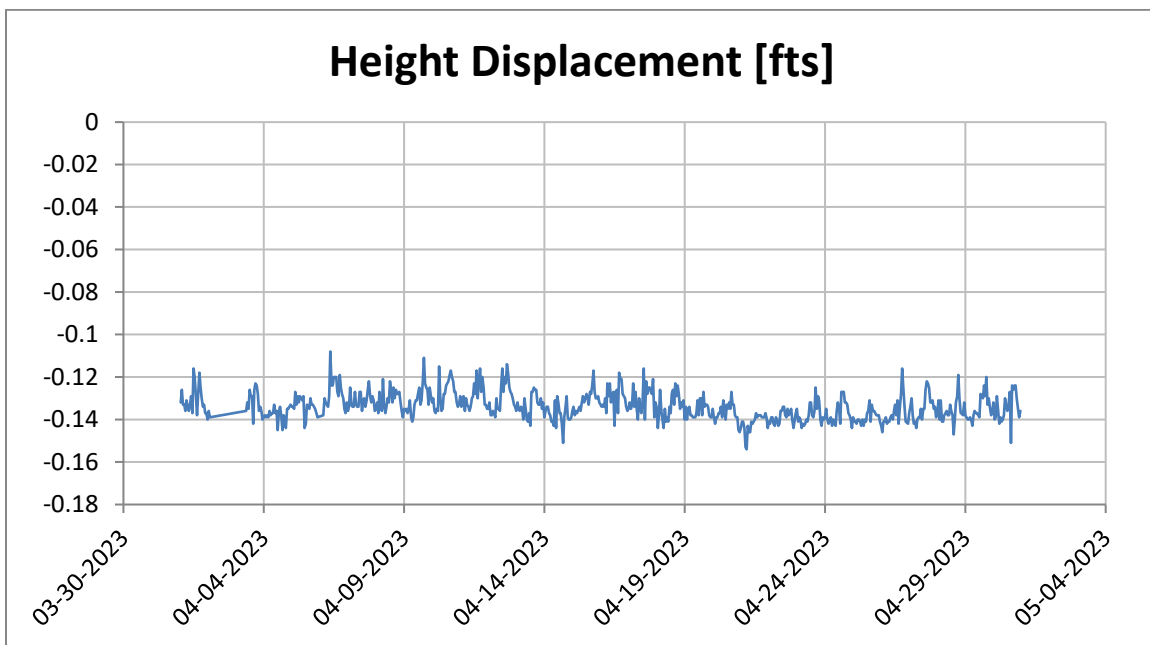
## Prism BR1

The data show stable conditions with no movement for all 15 prisms with recorded displacements limited to data scatter and not actual movements. Prisms BR1, BR2, and NP66 are located above the landslide, and these prisms previously recorded slope creep movements at slow velocity. This settlement was likely related to the landslide material consolidating under its own weight. The data suggest that the creep movements have essentially been halted by the placement of the buttress. New prisms are placed in areas where slope creep movements are likely to be recorded; therefore, slope creep movements being recorded at more locations is expected to occur. Plots of the transverse and height displacements for each prism are included in Appendix B.

1. Survey accuracy is  $\pm 0.016$  feet.
2. Alert threshold is  $\pm 0.35$  feet.
3. Transverse displacement is in the horizontal direction. Positive direction means closer to the robotic station.
4. Height displacement is in the vertical direction. Positive direction means higher in elevation.
5. Prism previously recorded slope creep movements with slow velocity.

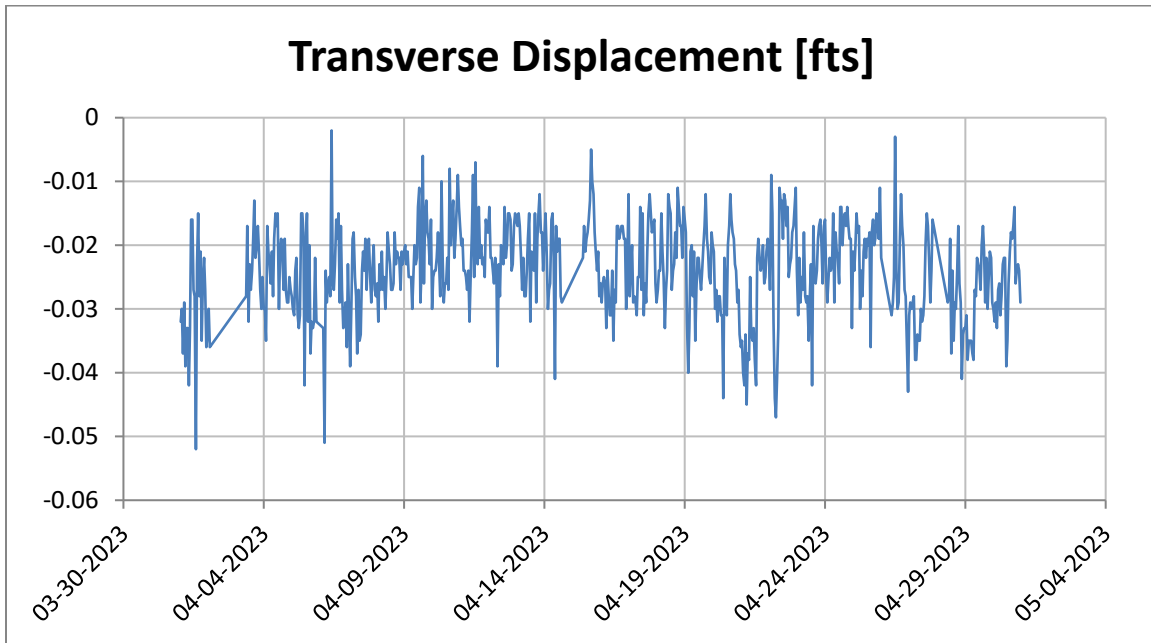
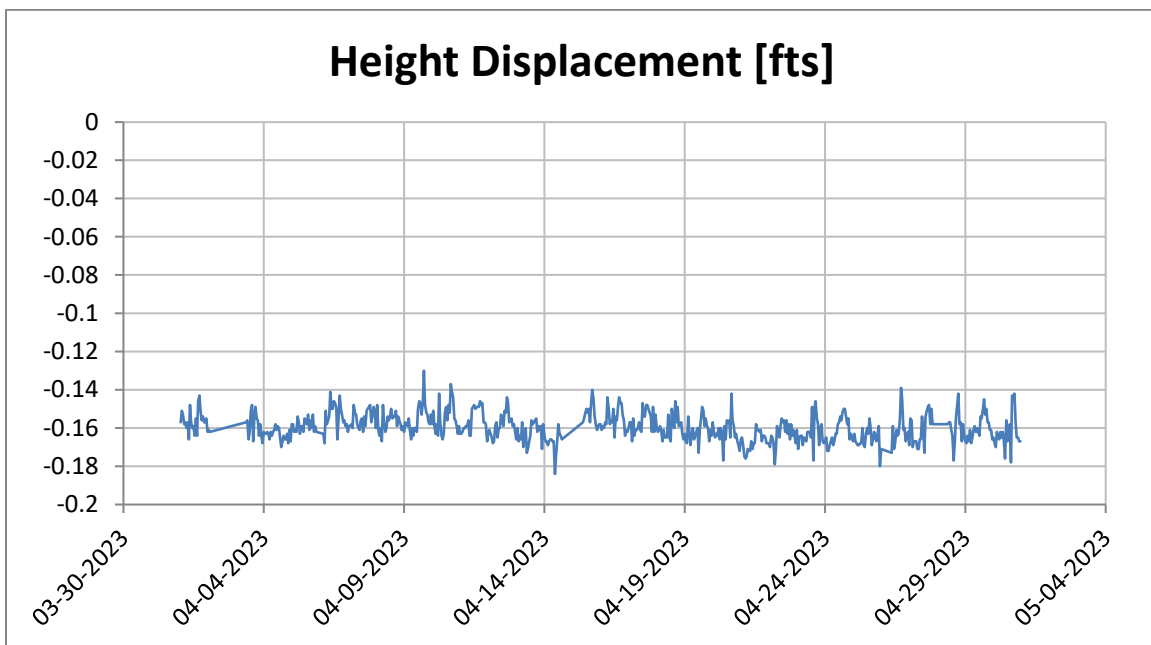
## Prism BR2

1. Survey accuracy is  $\pm 0.016$  feet.
2. Alert threshold is  $\pm 0.35$  feet.
3. Transverse displacement is in the horizontal direction. Positive direction means closer to the robotic station.
4. Height displacement is in the vertical direction. Positive direction means higher in elevation.
5. Prism previously recorded slope creep movements with slow velocity.

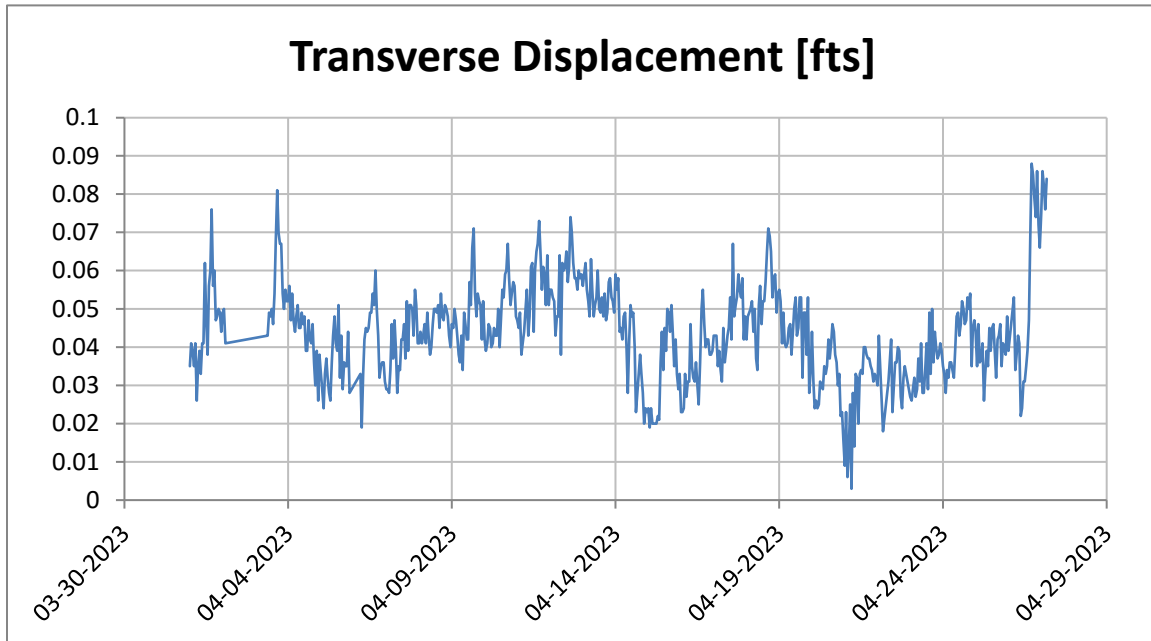
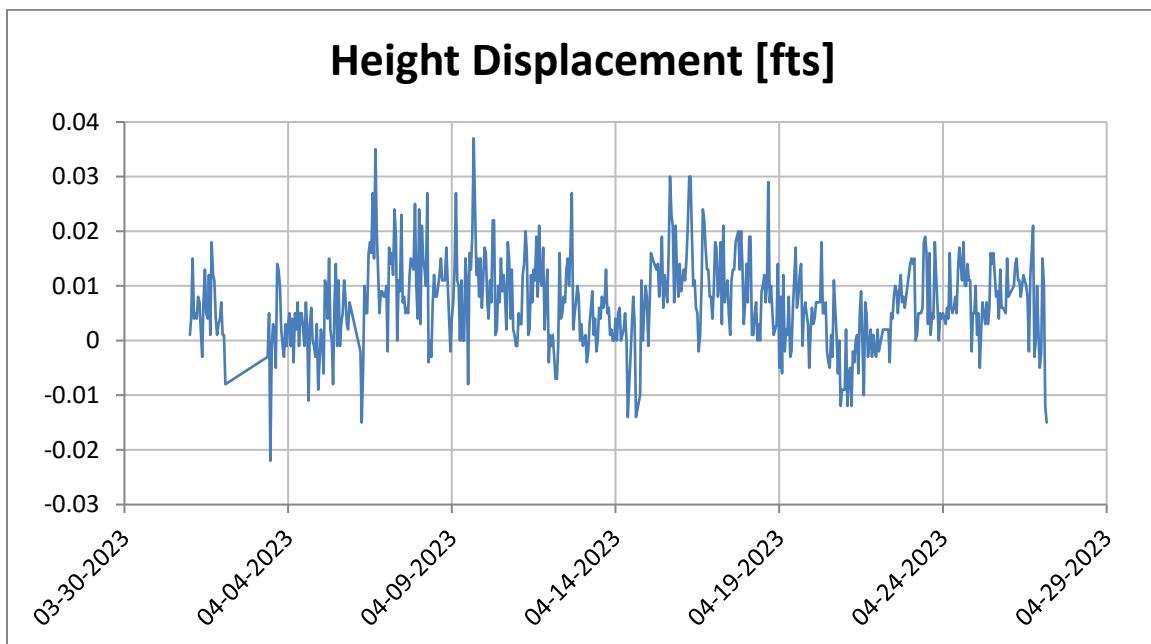
## Prism NP2

Date(s)	Alert	Cause/Actions taken	Alert Resolved
Apr 1	NP2 regression limit received	Single alert. No work during alert. Prism inspected and no signs of movement.	Apr 1
Apr 2 to Apr 3	No communication	Computer shut down automatically. No work being performed during this time.	Apr 3
Apr 4	Points not found	Snow and fog. No work being performed at time of alerts.	Apr 4
Apr 4 to Apr 5	P5 not found	Snow on prism blocking signal.	Apr 4
Apr 4 to Apr 5	P2 not found	Snow on prism blocking signal.	Apr 4
Apr 5 to Apr 6	Points not found	Snow and fog. No work being performed at time of alerts.	Apr 6
Apr 12	P5, CP6, and P70 not found	Equipment movement blocking prism.	Apr 12
Apr 14 to Apr 15	Points not found	Snow, rain, and fog. No work being performed at time of alerts.	Apr 14
Apr 16	CP7 and P70 not found	Single events. Possible animal activity. No work being performed at time of alerts.	Apr 17
Apr 19	P2 not found	Single event. Equipment movement blocking prism. No fill being placed at time of alert.	Apr 19

1. Survey accuracy is  $\pm 0.016$  feet.
2. Alert threshold is  $\pm 0.35$  feet.
3. Transverse displacement is in the horizontal direction. Positive direction means closer to the robotic station.
4. Height displacement is in the vertical direction. Positive direction means higher in elevation.
5. Regression limit alert received on April 1.

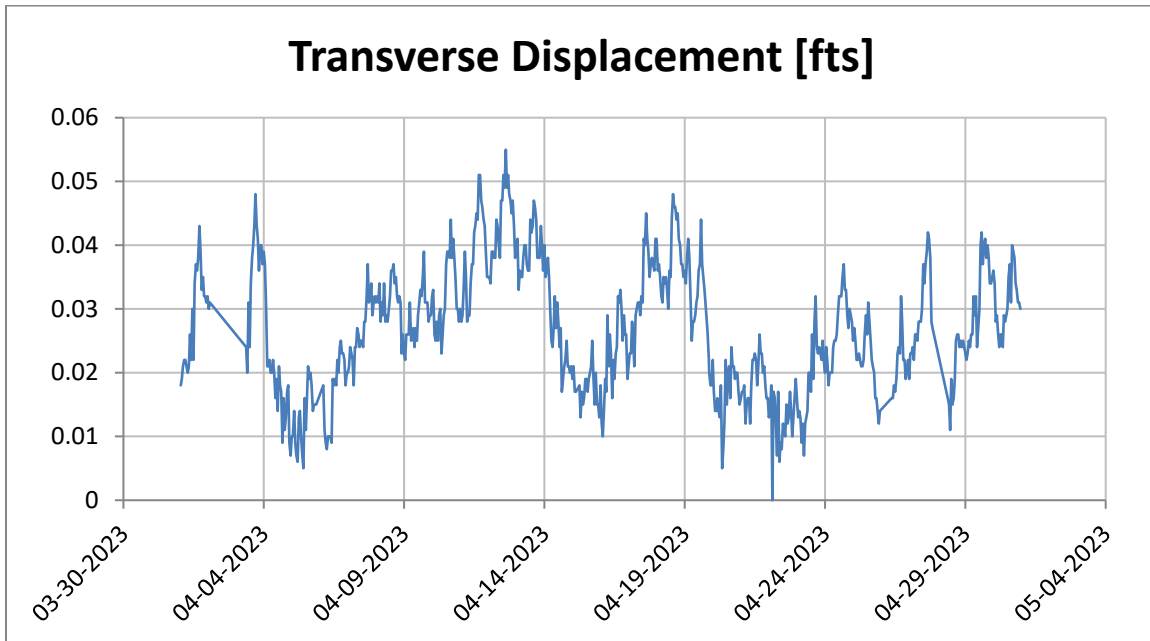
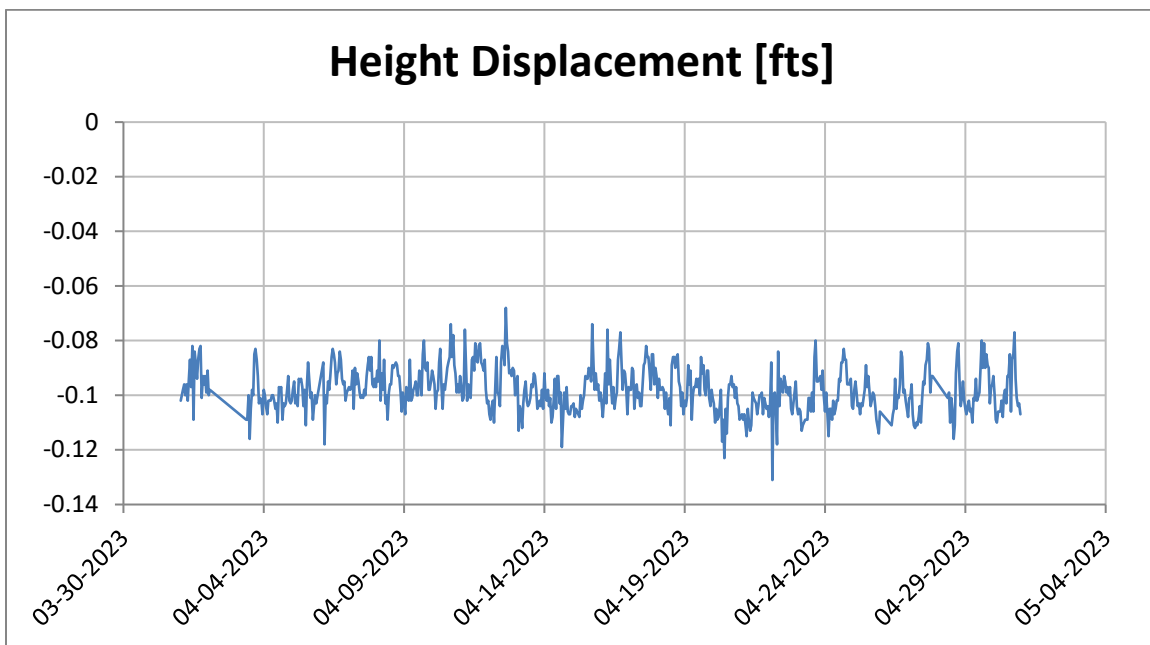
## Prism NP66

1. Survey accuracy is  $\pm 0.016$  feet.
2. Alert threshold is  $\pm 0.35$  feet.
3. Transverse displacement is in the horizontal direction. Positive direction means closer to the robotic station.
4. Height displacement is in the vertical direction. Positive direction means higher in elevation.
5. Prism previously recorded slope creep movements with slow velocity.

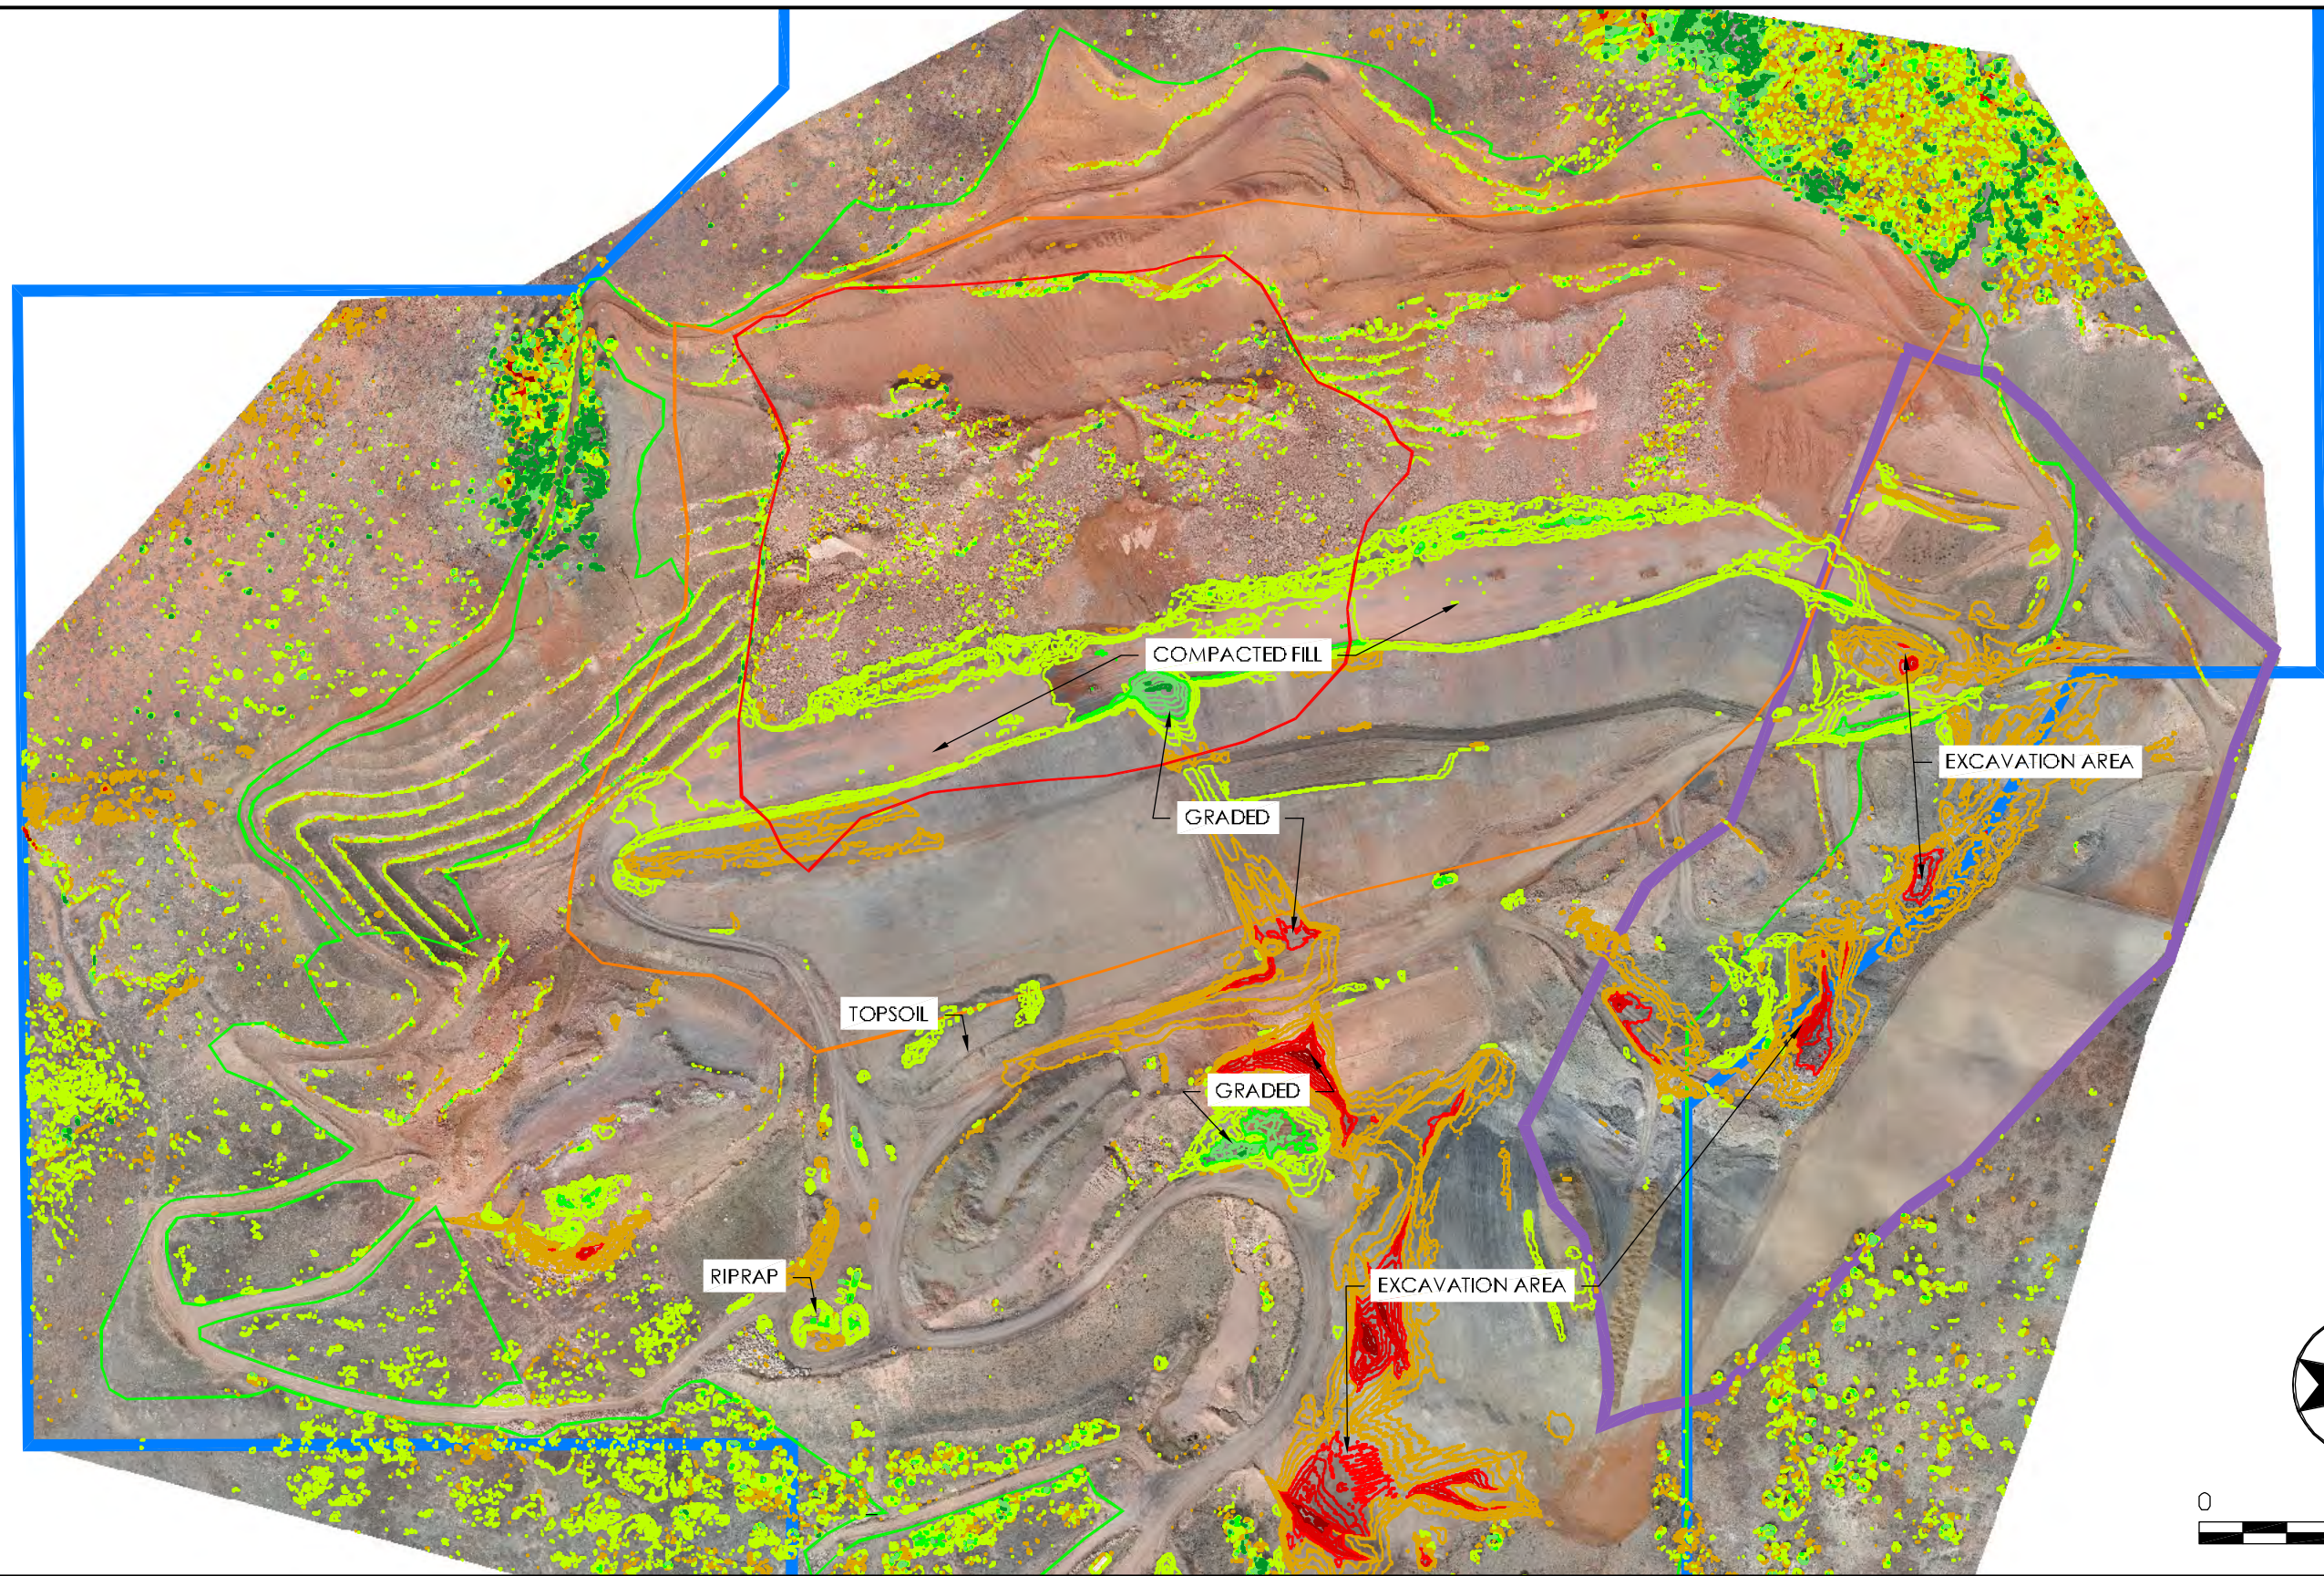
Revision #	Date
	2023.05.31
Drawn By PK	Figure No. 5

The April topography was also compared to the March topography to identify changes in the site topography. Comparison of the two surveys showed the placement of the fill material at the toe of the landslide. Fill material is excavated from the Shop Borrow Area or imported from offsite projects, including the North Borrow Area. No slope movements or other changes in topography were identified. The current imagery and topography are included in Figures 1 and 3, and the comparison surface is included as Figure 5 in Appendix C.

As previously reported in the September 2020 monitoring report, there are limitations with the method of comparing drone surveys from different months. The drone data indicate changes in the slopes along each of the reclamation benches, buildings, and areas with trees or shrubs. These areas are stable, and the changes are the result of survey limitations on or near vertical slopes.
