King Coal Mine, C-1981-035, May 2023 Complete Inspection Report

This report documents the observations taken by the Division during a complete inspection and Office of Surface Mining, Reclamation and Enforcement (OSMRE) complete oversight inspection of the King Coal Mine on May 16, 2023. The inspection was completed by Clayton Wein of the Division. OSMRE was represented by Dan MacKinnon. Wade Wymore represented GCC Energy during the inspection. The weather was clear with a temperature starting at 51 degrees F. The ground was damp from a large precipitation event the evening prior to the inspection.

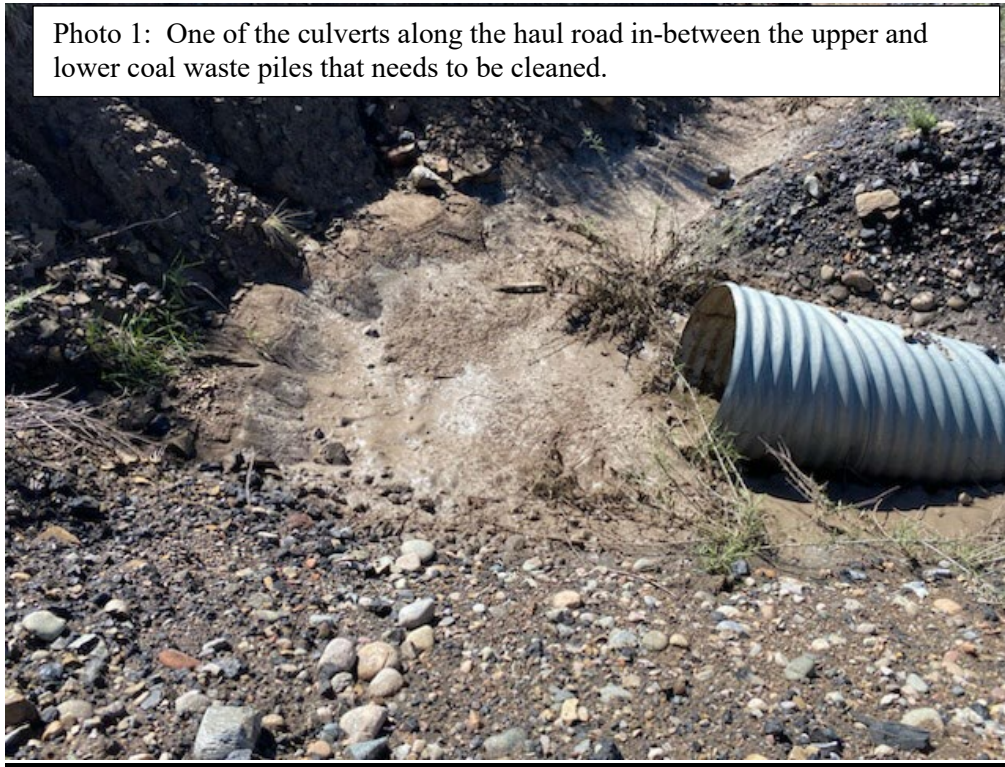
1. Please clean all culvers along the haul road between the upper and Lower refuse disposal piles. Culverts had partly filled with sediment due to the precipitation event the evening prior to the inspection (Photo 1).

Photo 1: One of the culverts along the haul road in-between the upper and lower coal waste piles that needs to be cleaned.

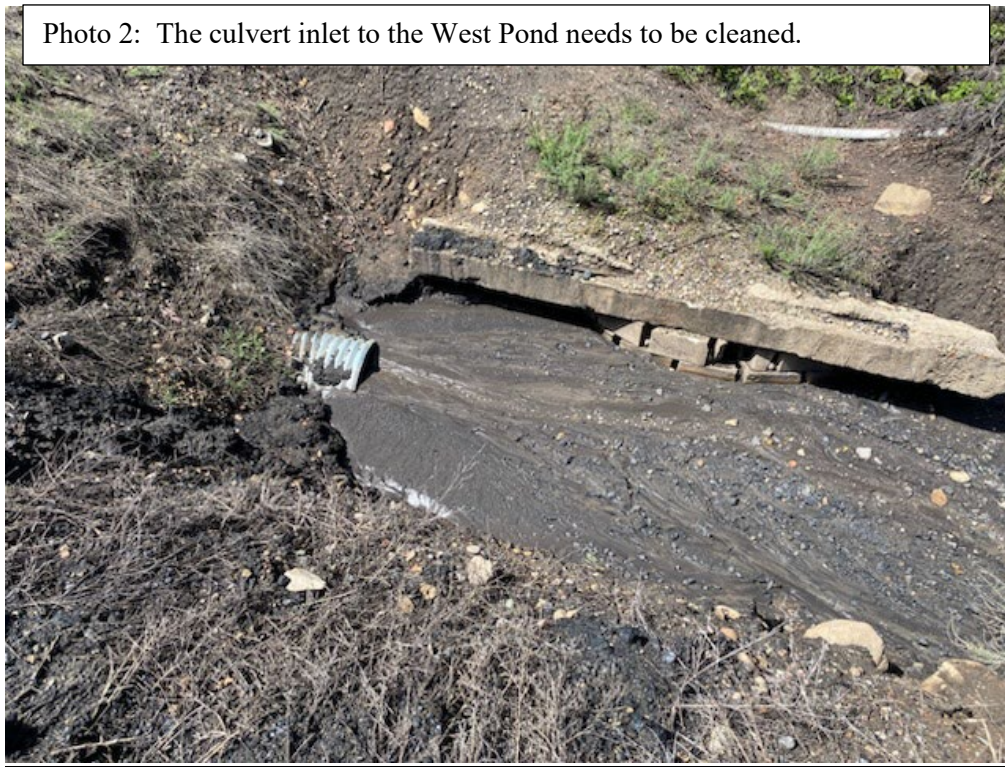
2. Please clean culverts as necessary throughout the mine area below the lower refuse disposal pile including the inlet to the west sediment pond. The culvert at the inlet was about half way full of sediment (Photo 2).

Photo 2: The culvert inlet to the West Pond needs to be cleaned.

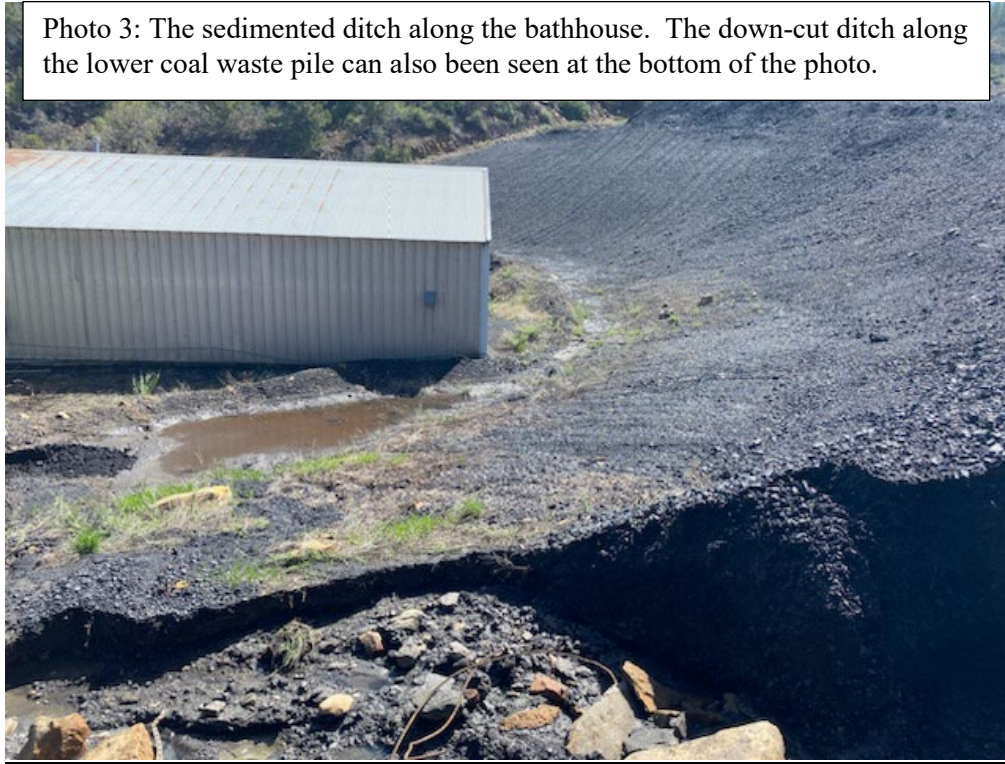
3. Please clean the sediment from the ditch inbetween the bath house and the lower refuse disposal pile. The ditch was mostly full of sediment and had ponded water in the ditch near the southwest corner of the bath house (Photo 3).

Photo 3: The sedimented ditch along the bathhouse. The down-cut ditch along the lower coal waste pile can also be seen at the bottom of the photo.

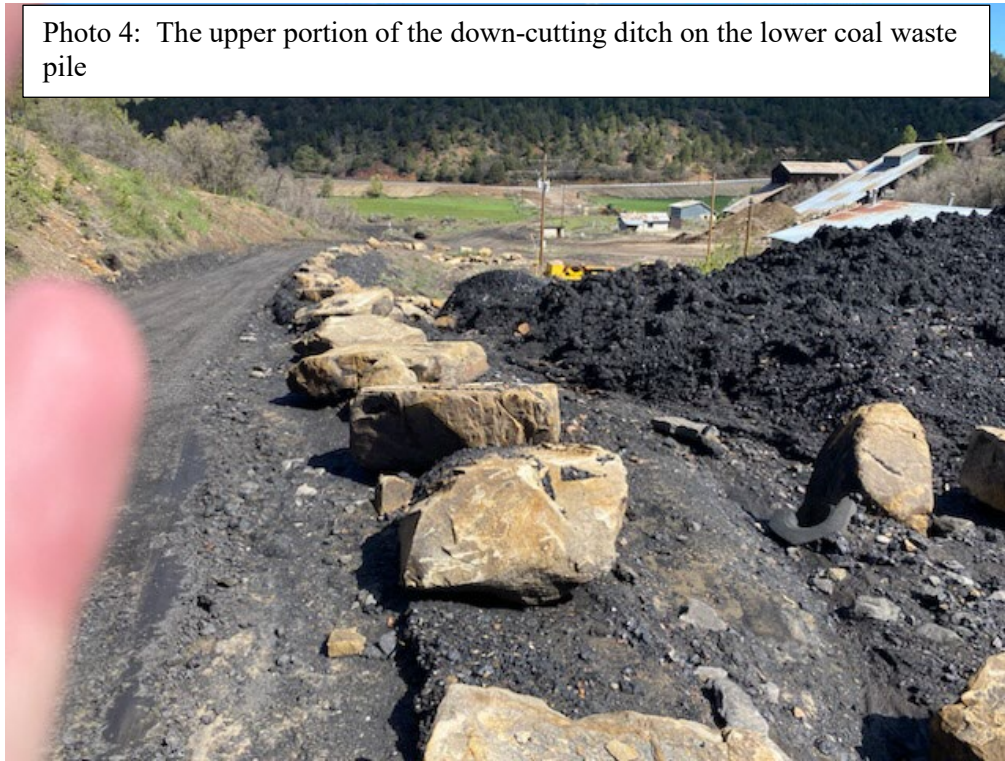
4. Please use rocks to help stabilize the channel leading off of the eastern side of the lower refuse disposal pile next to the access road. The channel has significantly down-cut and needs to be stabilized before the erosion progresses to the point where the slope stability of the pile is affected (Photo 4).

The faces of the upper and lower coal waste piles were stable with no erosional concerns. Some minor rills were observed on the faces of the piles; however, these rills are not deep enough to affect the stability of the piles. Runoff on the Lower coal pile has continued to down-cut along the intersection of the east side of the access road and the northern facing slope of the pile. This section has been noted in previous Division 2023 inspection reports. Rocks have been placed in the ditch to help prevent further down-cutting. Please re-establish the ditch and continue to use rocks to armor the channel. The current ground conditions were too soft to begin work on the ditch repairs. Please start work as soon as conditions will allow.

Photo 4: The upper portion of the down-cutting ditch on the lower coal waste pile

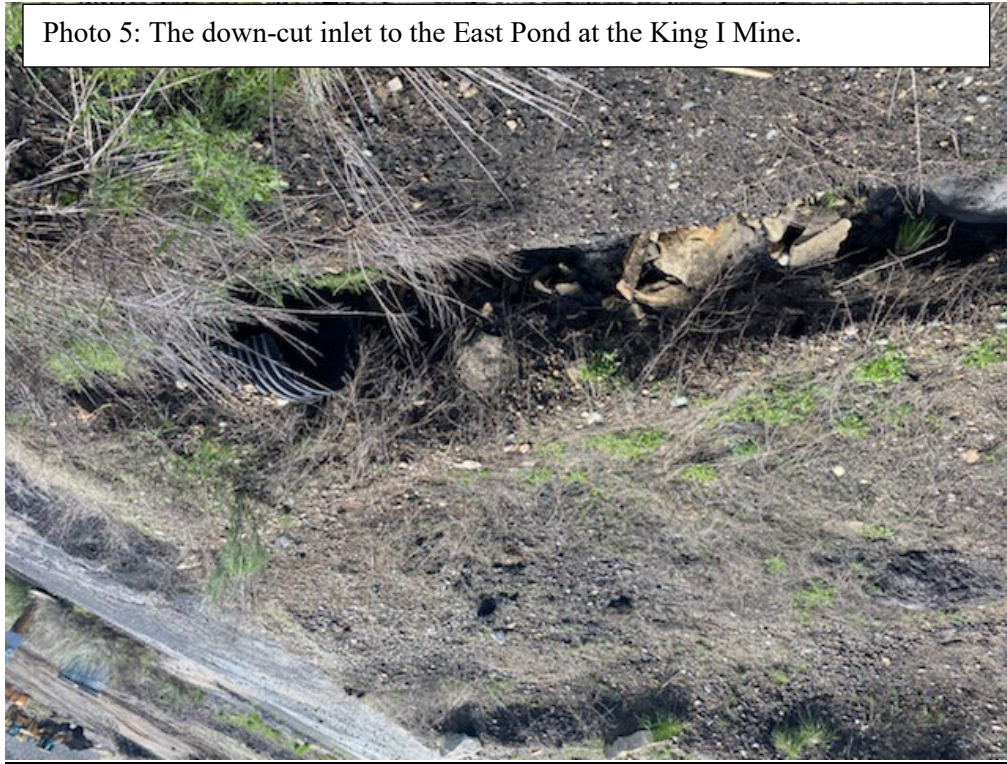
5. The inlet to the east pond has been down-cut below the culvert inlet. Please armor the inlet to the pond with rocks to help prevent future erosion of the pond's inlet (Photo 5).

Photo 5: The down-cut inlet to the East Pond at the King I Mine.

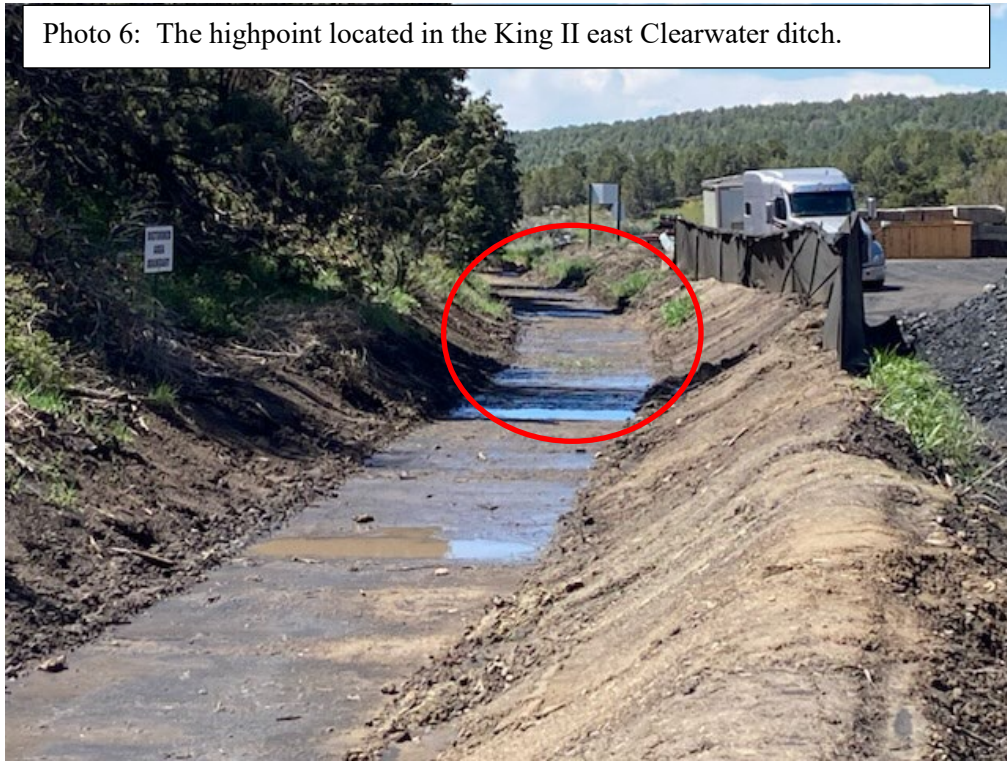
6. The clearwater ditch located on the east side of the King II facilities has been mostly cleaned. Please remove the highpoint in the channel identified adjacent to the silt fence (Photo 6). This high point has the potential to pond some of the water in the clearwater ditch.

Photo 6: The highpoint located in the King II east Clearwater ditch.

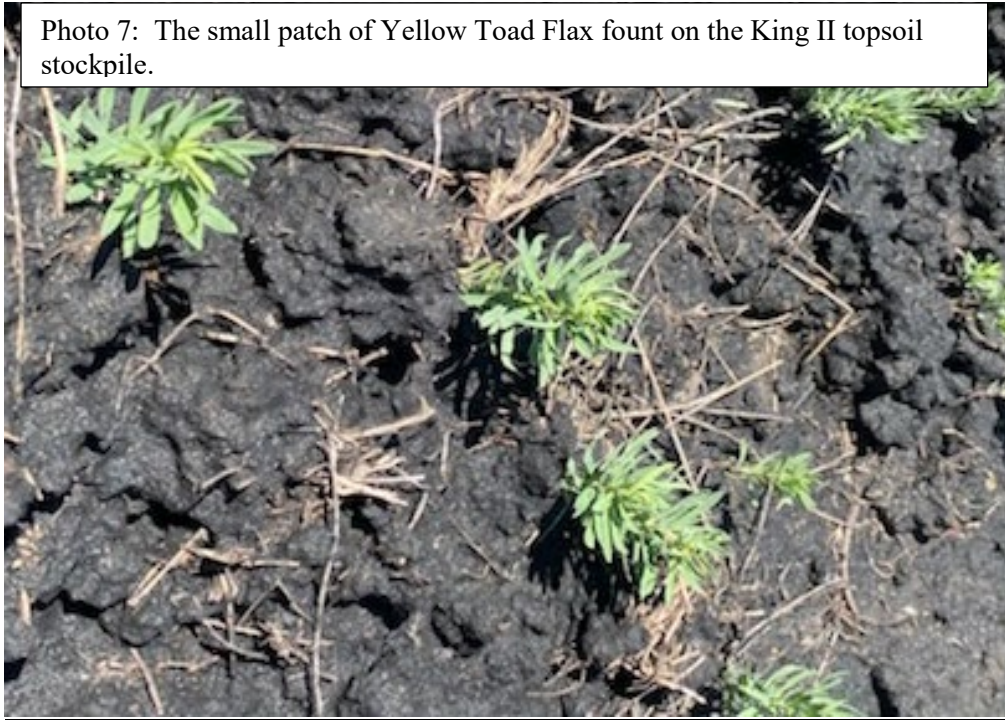
7. Please continue to implement weed control measures. Yellow Toad Flax, Canadian Thistle and Mullen were identified. Yellow Toad Flax was spotted on the southern base of the Topsoil Stockpile (Photo 7). Canadian Thistle and Mullen were identified north and northeast of the topsoil stockpile.

The topsoil pile at the King I Mine was stable with vegetative cover. There were no indications of erosional features or loss of topsoil resource. The topsoil pile located at the King II Mine was also stable and vegetated. Yellow Toad Flax was spotted in a small patch on the southern base of the pile. Please spray these noxious weed as soon as possible to prevent further infestation on the topsoil resource.

Photo 7: The small patch of Yellow Toad Flax found on the King II topsoil stockpile.

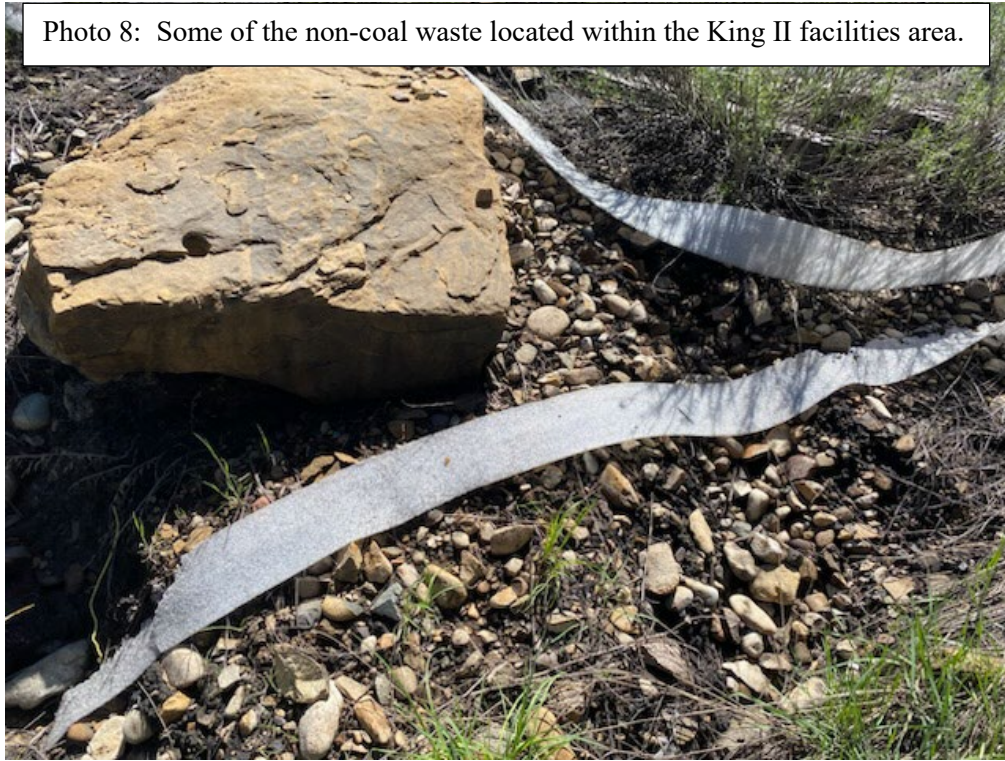
8. Please remove all non-coal waste and dispose of the trash located within the King II facilities area (Photo 8). Work was being conducted to complete this as the Division concluded the inspection.

Photo 8: Some of the non-coal waste located within the King II facilities area.

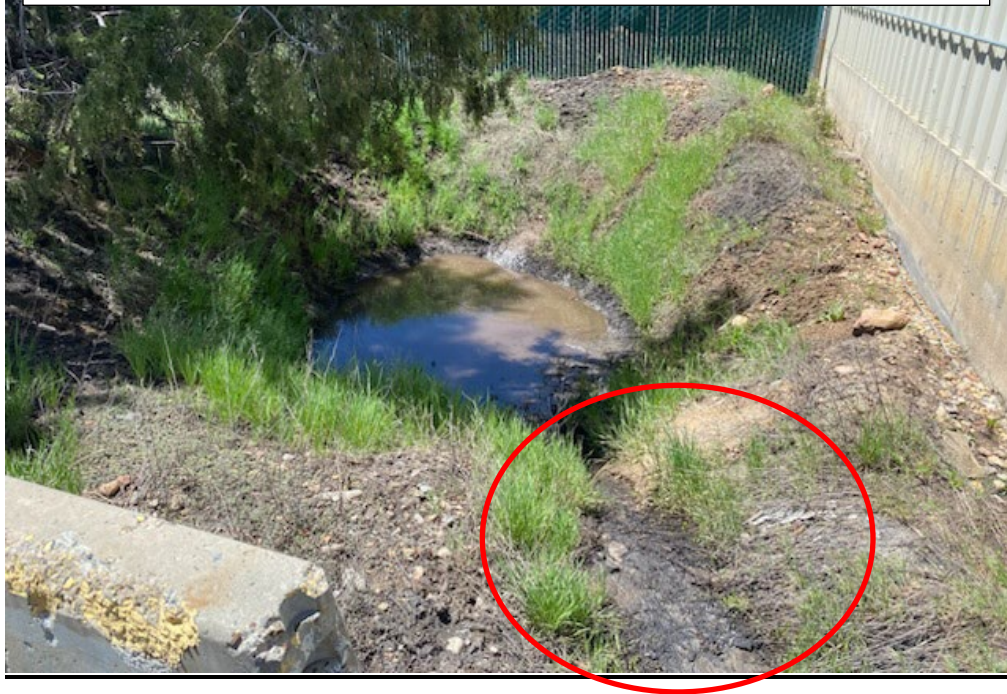
9. Please clean out the ditch entering the sump located behind the fuel storage building. The ditch had filled with sediment due to the precipitation event the day prior to the inspection (Photo 9).

Photo 9: The inlet from the ditch into the sump behind the fuel storage building at the King II Mine

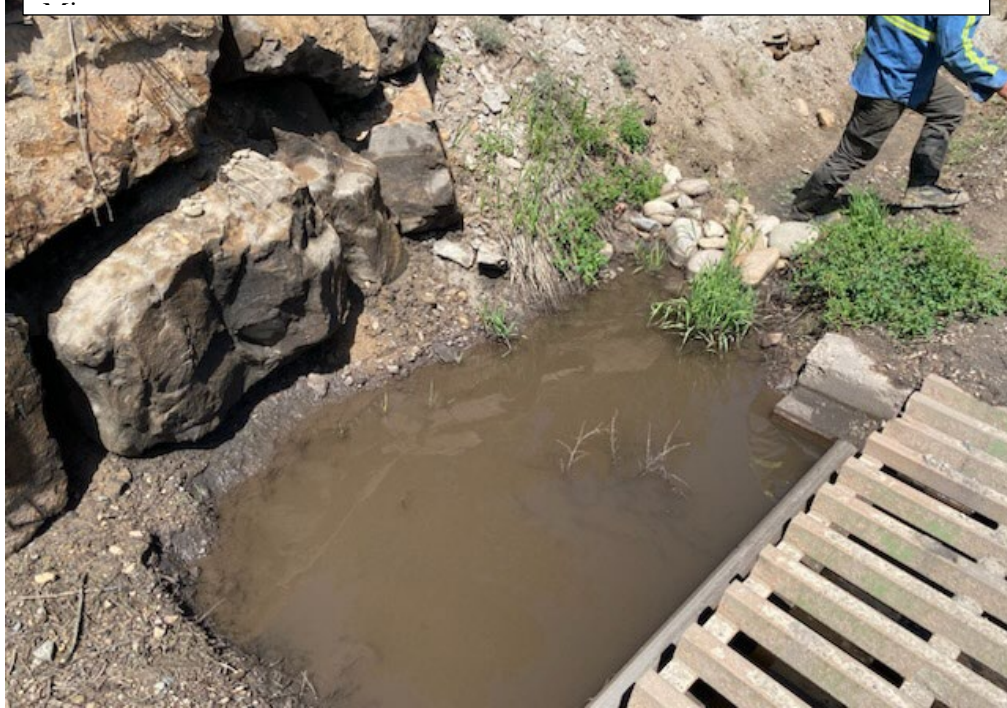
10. The ditch entering the cattle guard at the King II Mine entrance has become partially filled with sediment (Photo 10). Please clean this portion of the ditch when ground conditions allow.

**King II Mine:** Surface drainage control structures along the haul road at the King II Mine were clear from debris and stable. There were no erosional features observed. The portion of the ditch that crosses underneath the cattle guard at the King II entrance was beginning to fill with sediment. Please clean out the sediment when ground conditions allow. The amount of sediment observed in this section had not impeded the ditches functionality. Ditches throughout the King II Mine facilities were observed to be in good condition with no blockages. The ditch leading into the sump behind the fuel storage building was observed to be full of sediment. Please clean out the ditch as soon as possible to prevent water from bypassing the sump. The perimeter ditch around the topsoil stockpile was clear of debris and the culvert underneath the southern access to the pile was clear. In general culverts located throughout the King II Mine were clear of debris. The Sediment pond was holding some water during the inspection. There was no discharge from the pond. The embankments were stable with vegetation, and no erosional concerns were identified. The pond's discharge outlet was clear of blockages. The Clearwater diversion ditch located on the east side of the facilities was clear of debris and had been recently cleaned. One portion of the ditch was observed to have a higher grade than the rest of the ditch. Please remove the highpoint in the channel identified adjacent to the silt fence. This high point has the potential to pond some of the water in the Clearwater ditch. The Clearwater ditch located on the southwestern portion of the facilities was also clear of blockages and functional. There were no erosional concerns identified.

Photo 10: The west side of the cattle guard at the entrance to the King II

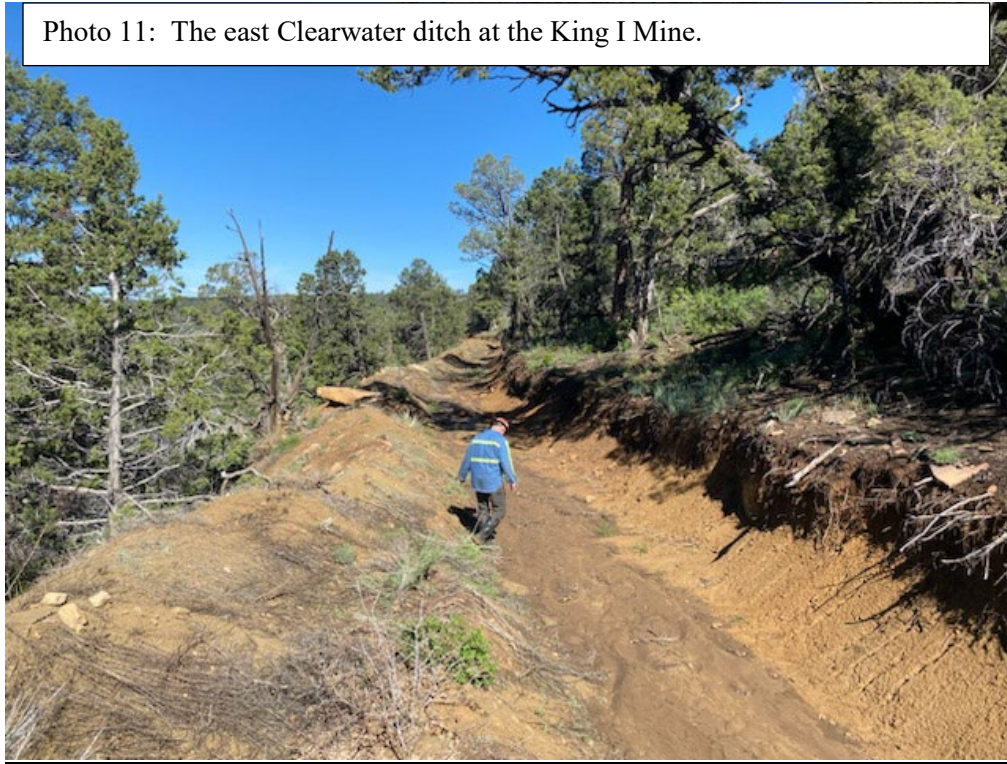
**King I Mine:** The clear water diversion ditches located adjacent to the upper and lower coal waste piles were damp from the precipitation the evening prior to the inspection (Photo 11). The ditches were observed to be stable with no erosional concerns. There were no blockages observed in the ditches. Culverts located along the haul road in-between the upper and lower coal waste piles were observed to have had some sediment deposited in them. Please clean out the culverts as soon as possible to prevent the culverts from plugging. Please clean any culverts as necessary within the facilities area at the King I Mine. The precipitation event that occurred the day prior to the inspection had transported sediment through the facilities area and deposited sediment within the culverts. No culverts were observed to be more than 1/3 full of sediment. Ditches throughout the facilities area at the King I Mine were generally in good condition. There were no indications of off-site impacts. The ditch that runs in-between the bathhouse and the lower refuse pile had become filled with sediment and water was ponded near the portion of the ditch adjacent to the southwest corner of the bathhouse. Please clean this ditch and restore the ditch to the approved design specifications. Two ponds are located at the King I Mine area; the east and the west pond. The east pond was holding water at the time of the inspection (Photo 12). There was no discharge

Photo 11: The east Clearwater ditch at the King I Mine.

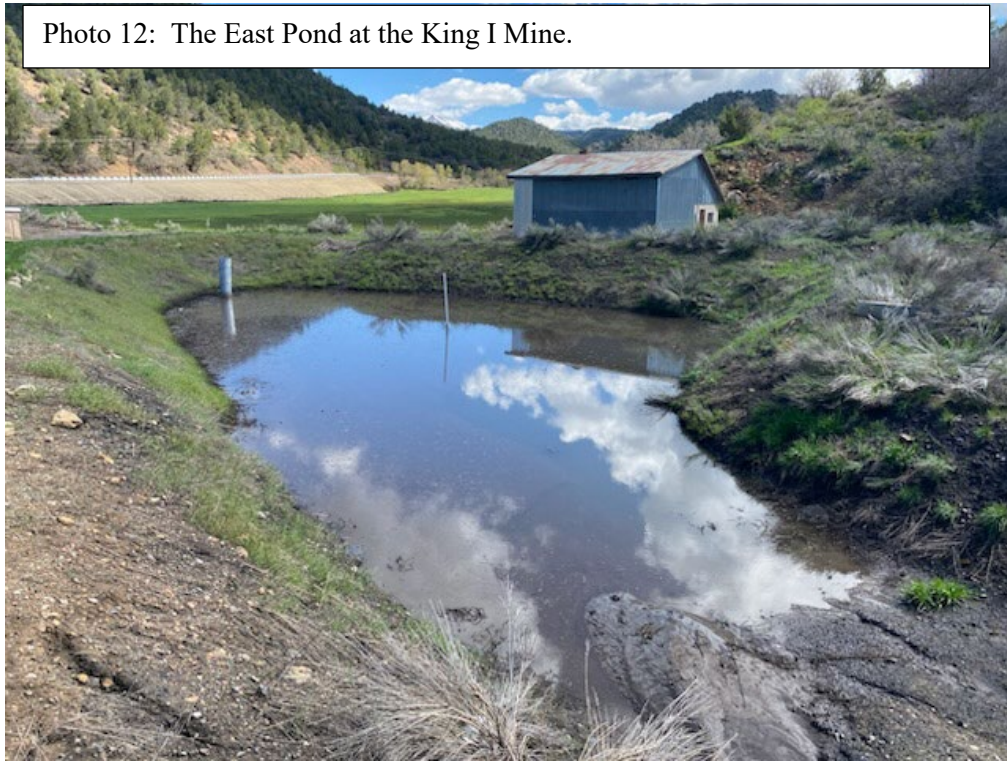
occurring. The inlet to the pond's discharge outlet was clear from debris. The embankment for the pond was stable with vegetative cover. There were no erosional concerns identified on the embankment. The inlet to the east pond is a metal culvert. The inlet was clear of debris. The channel below the culvert inlet has down-cut significantly. Please repair this portion of the pond's inlet. During the inspection the operator discussed with the Division and OSMRE that they will line the inlet channel below the culvert with rocks to help prevent future down-cutting. The west pond was also impounding water during the inspection (Photo 13). There was no discharge from the pond. The pond's outlet pipe was clear of debris. The embankment was observed to be vegetated and stable. No erosional features were noted. The pond still has some material requiring cleaning from winter snow removal operations. Please clean out this material as soon as ground conditions allow. The material in the pond has backed up to the west pond's culvert inlet and partially blocked the exit of the pipe. Please clear out the sediment from the pond's inlet.

Photo 12: The East Pond at the King I Mine.

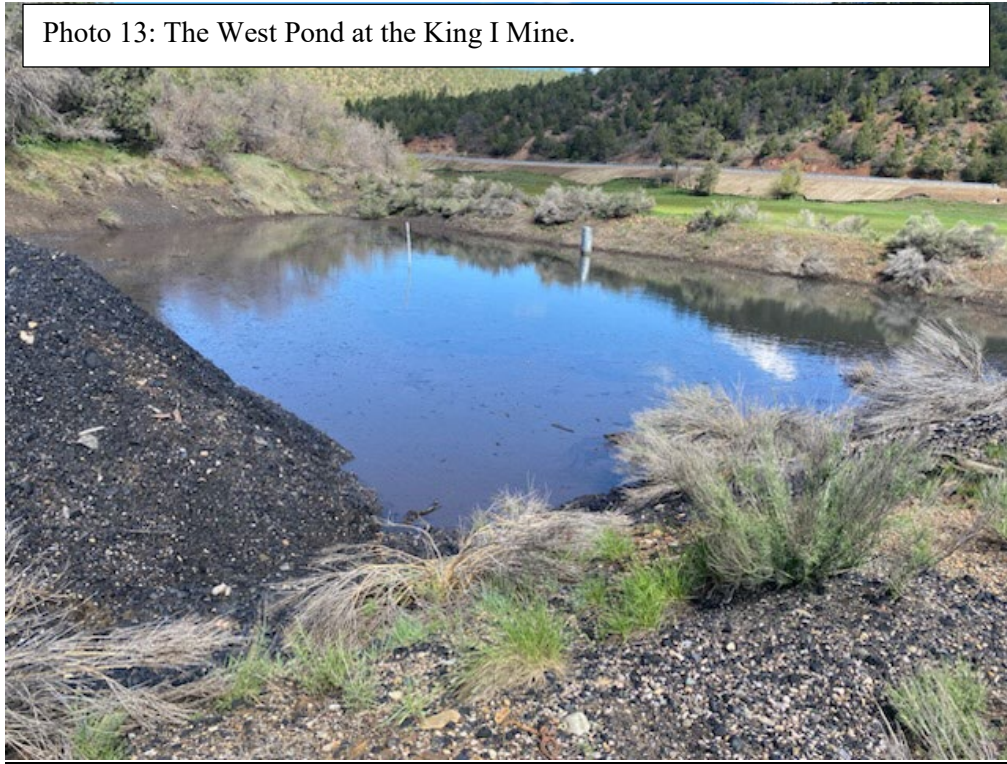
Photo 13: The West Pond at the King I Mine.

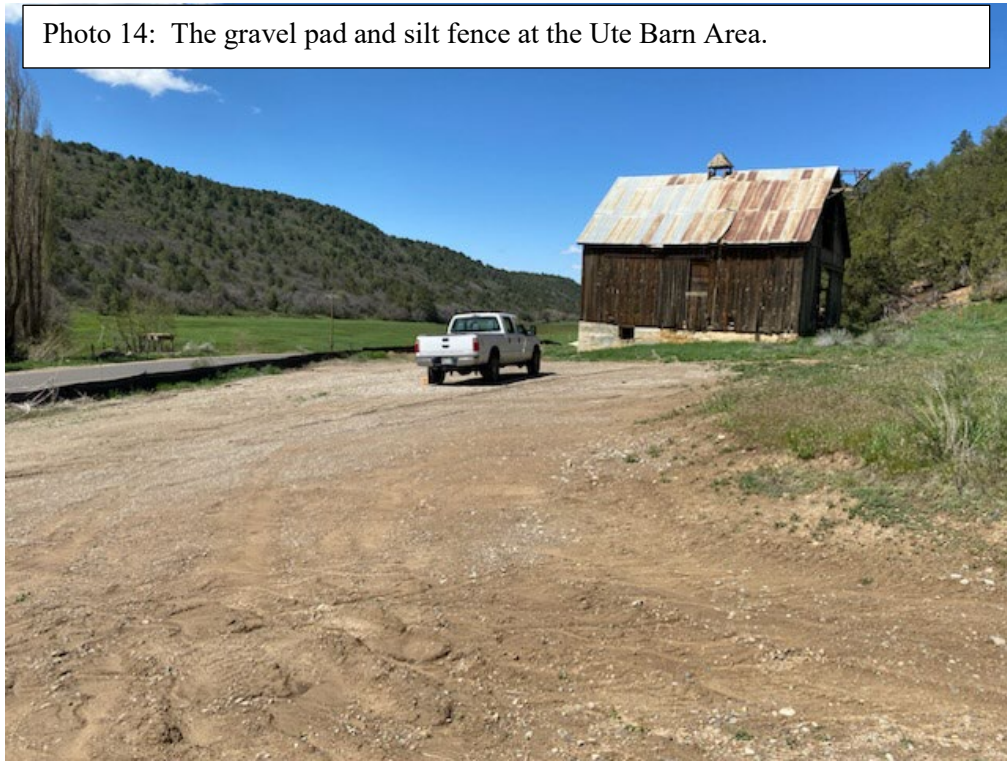
**Ute Barn Area:** The gravel pad located at the Ute barn area was stable with no erosional issues. The silt fences located along the south side of the pad were intact and had recently been repaired (Photo 14). There were no off site impacts observed.

Photo 14: The gravel pad and silt fence at the Ute Barn Area.

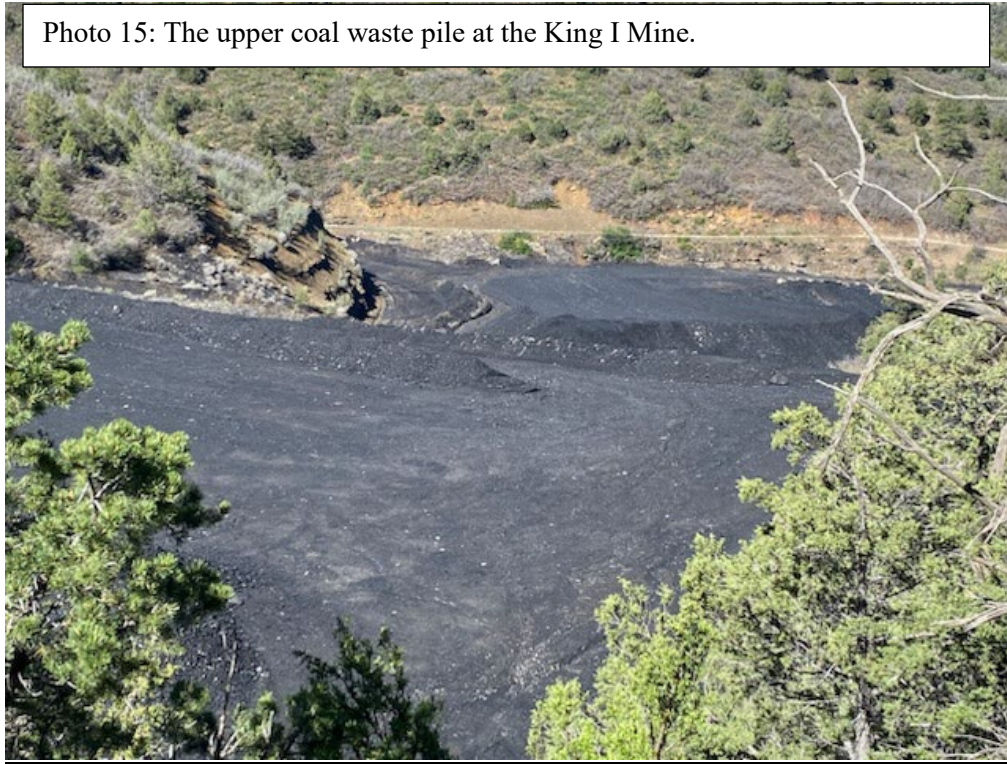
Coal waste from the mining operations is transported and stored at the King I Mine. The coal refuse is placed onto two stockpiles, the upper (Photo 15) and the lower coal waste pile. At the time of the inspection coal stored on the winter stockpile had been transported from the lower pile to the upper pile. Coal refuse from the winter stockpile will continue to be transported to the upper pile as conditions continue to dry up. Coal had been placed on the upper pile and was waiting to finish drying before the material will be spread out and compacted.

Photo 15: The upper coal waste pile at the King I Mine.

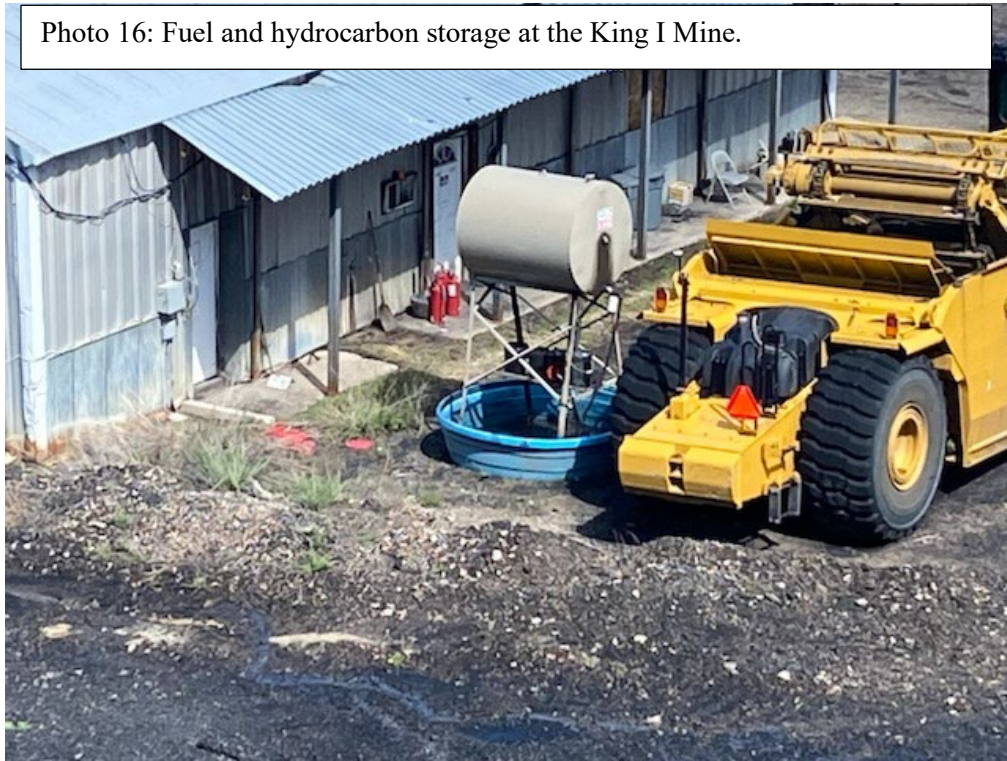
Support facilities at the King I Mine were well kept. There was no no-coal waste identified. Fuel stored on the site was located within secondary containment (Photo 16). A container of DEF was found outside the secondary containment. The operator's representative promptly moved the container to the secondary containment. There was no leakages from the container and no contamination was observed. Fuels and hydrocarbons stored at the King II Mine are located in a covered building to the east of the mine office. All fuels and hydrocarbons were stored properly in designed containment structures or on spill pallets (Photos 17 and 18). There were no spills observed.

Photo 16: Fuel and hydrocarbon storage at the King I Mine.

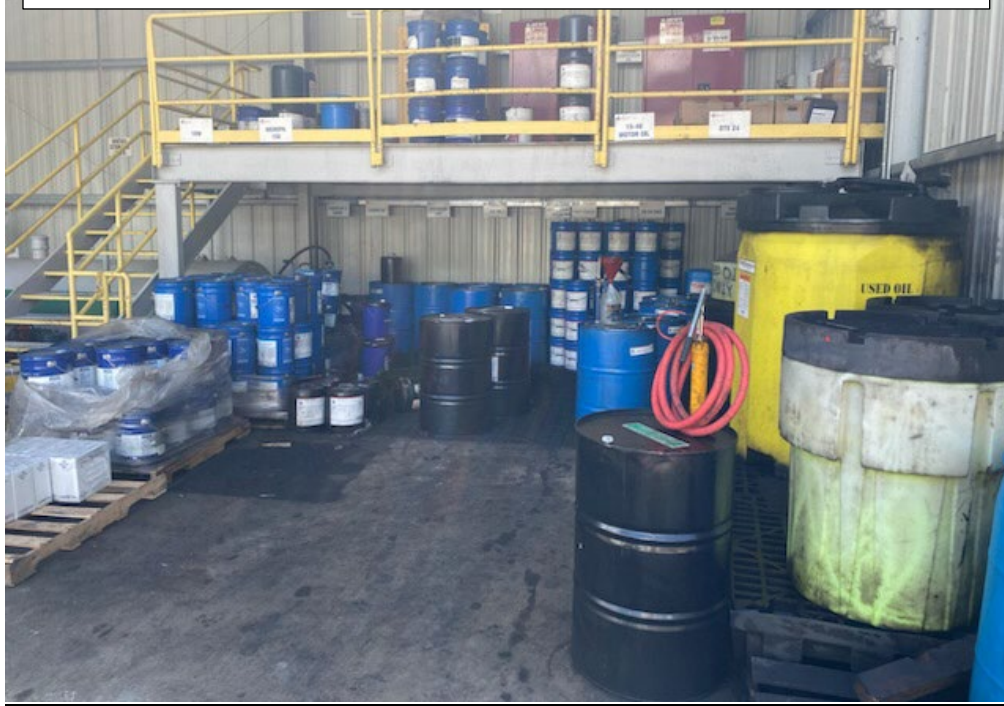
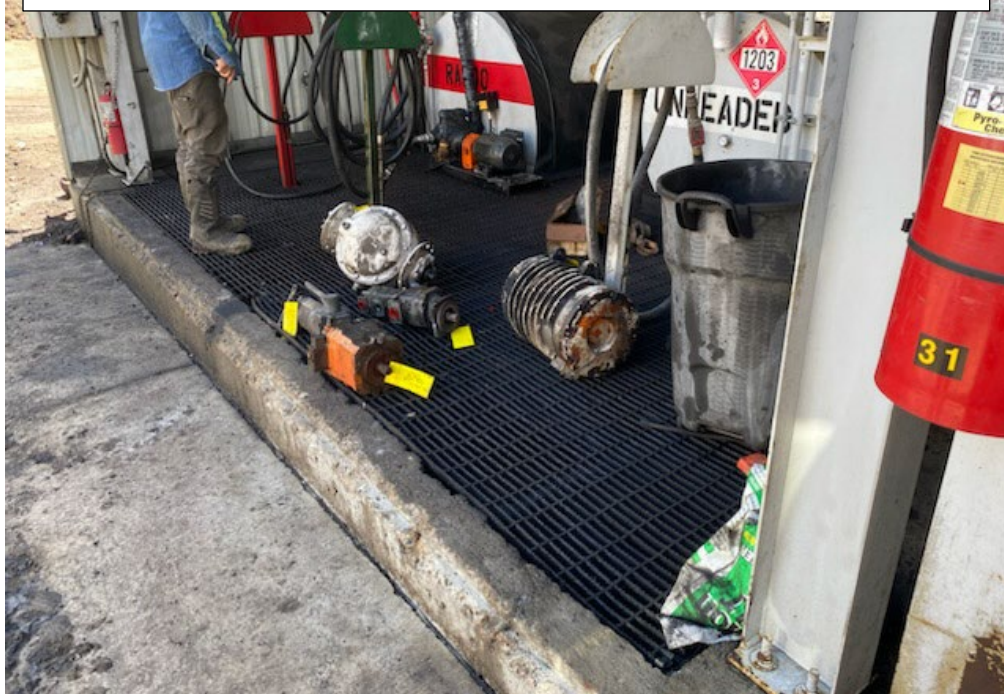
Photo 17: Fuel and hydrocarbon storage at the King II Mine.

Photo 18: Fuel and hydrocarbon storage at the King II Mine.
