Deserado Mine, C-1981-018, May 23, 2023 Partial Inspection Report

Division of Reclamation,
Mining and Safety

PERMIT INFORMATION

INSPECTION INFORMATION

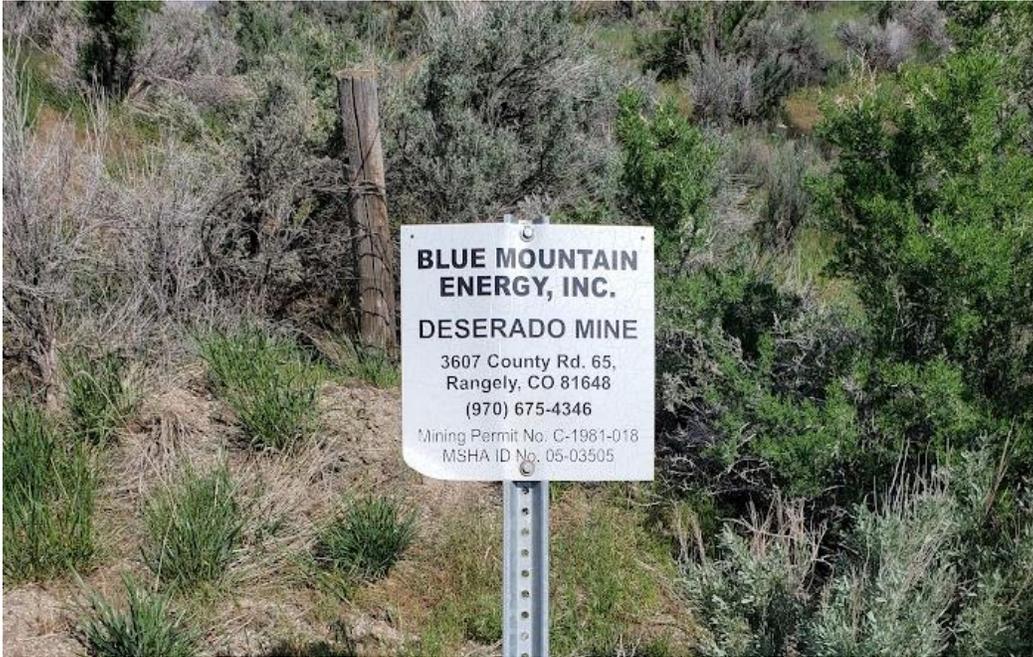
Photo 1: Mine identification sign at entrance to permit

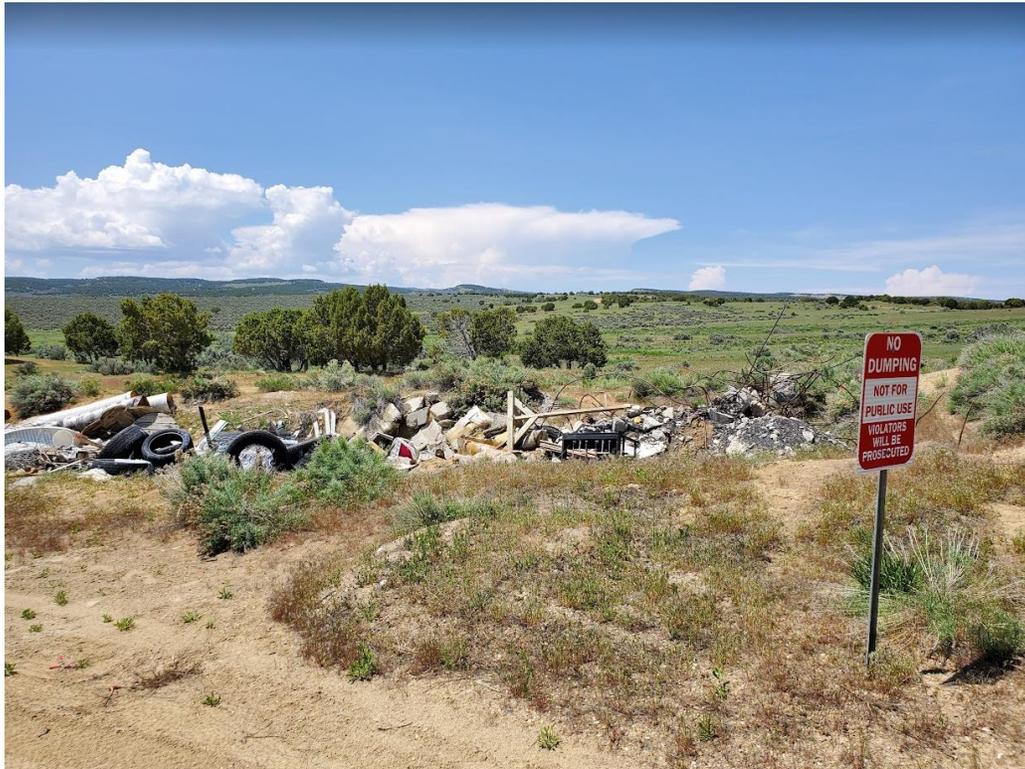
The Halandras Landfill (Photo 2) is located on the west side of County Road 65 (CR-65), north of the main facilities area. The debris outside of the pit that was noted in the April inspection was returned to the pit. There were no indications of offsite impacts of erosional features in the landfill area.

Photo 2: View to the southwest of landfill area. Waste is contained in the pit.

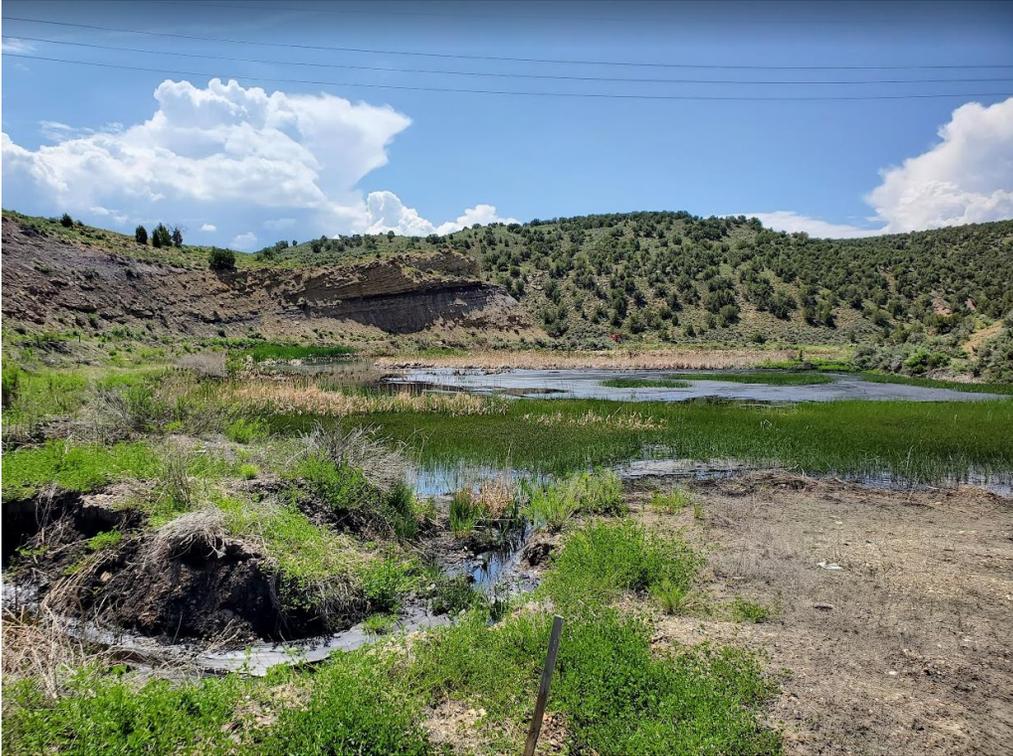
The DP-1 pond (Photo 3) is within the facilities area of the mine site. DP-1 was discharging at the time of the inspection. The embankments of the pond have established vegetation and there was no evidence of instability of erosion. The outfall was free of obstructions. The pond is designed to be 6 feet deep, but is filling with sediment. The mine anticipates being able to muck out pond DP-1 in the summer months (likely August) to regain

Photo 3: View to the south of inlet to Pond DP-1.

storage capacity in the pond. Mine staff expects to remove approximately 650 cubic yards of sediment from DP-1 that will be impounded in waste storage facilities on site.

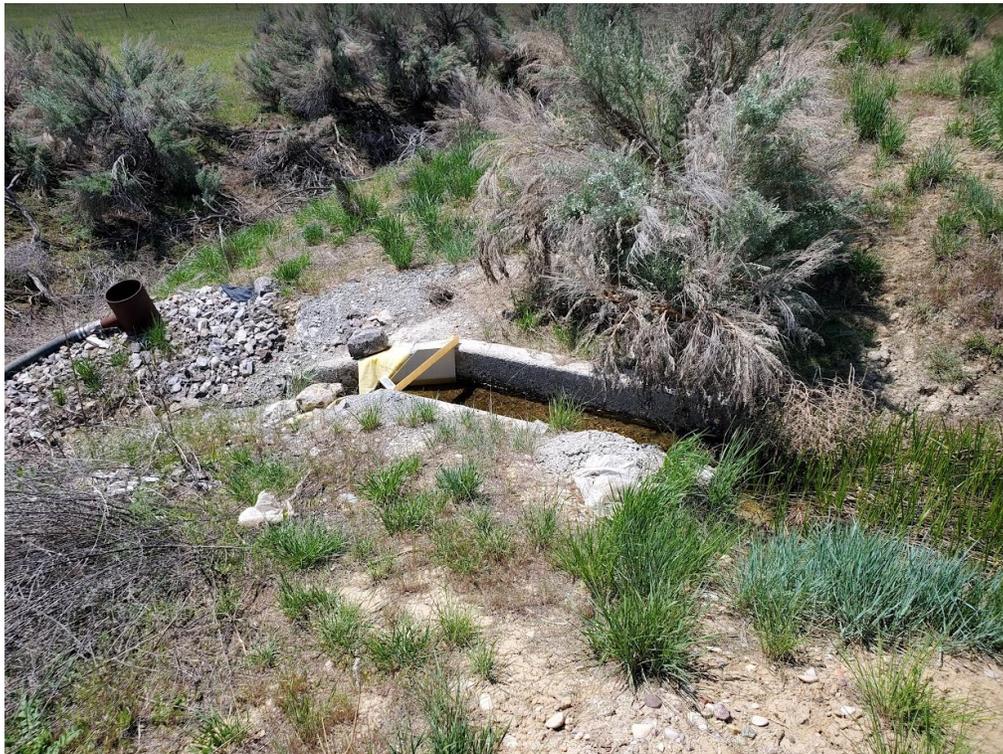
The Last Chance Pond is part of the dewatering system that allows miners to work underground. The pond is part of a passive water treatment system that improves water quality before it is discharged into the environment. At the time of the inspection the pond was discharging water (Photo 4). The embankment of the pond is stable with no burrows or erosional concerns (Photo 5). There were also a large number of song birds around the pond at the time of the inspection.

Photo 4: View to the south of discharge on Last Chance Pond

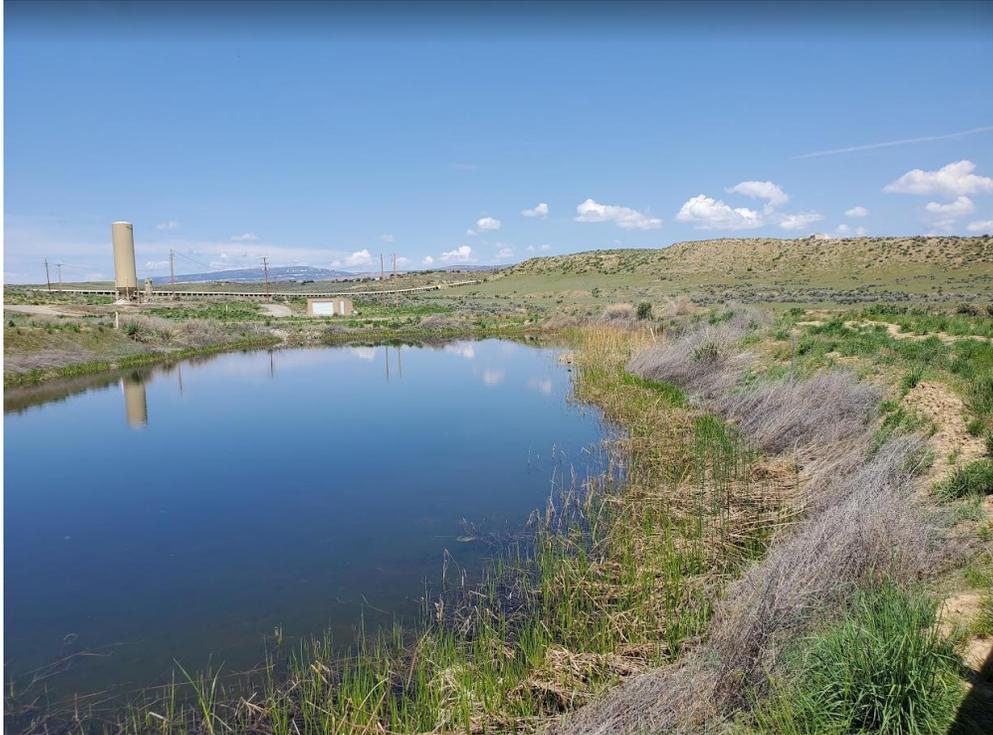
Photo 5: View to the west of embankment of Last Chance Pond

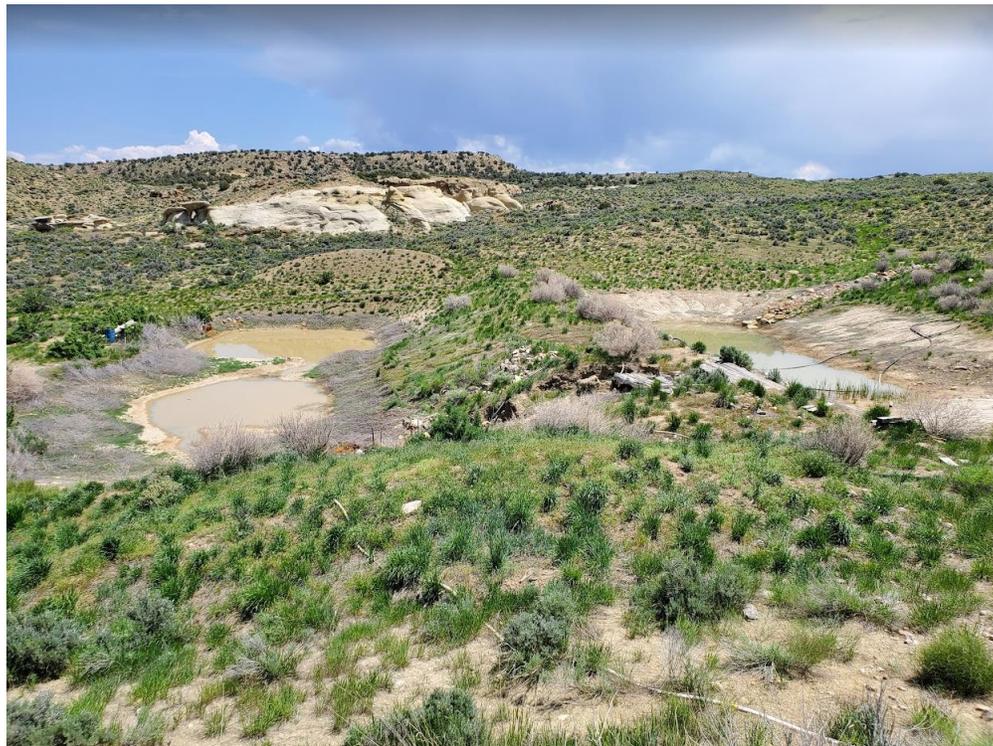
The D-Seam dewatering system was not active during the time of the inspection. The ponds that are part of the treatment process are holding a small amount of meteoric water, but they are expected to dry out in the coming weeks (Photo 6). There was no evidence of animal burrows or erosional concerns identified on the embankments of the ponds. The pumps for this dewatering system have not run since 2022. The pad where the dewatering pump is located does not show signs of settling or erosion.

Photo 6: View to the northeast of D Seam dewatering ponds. Meteoric water present.

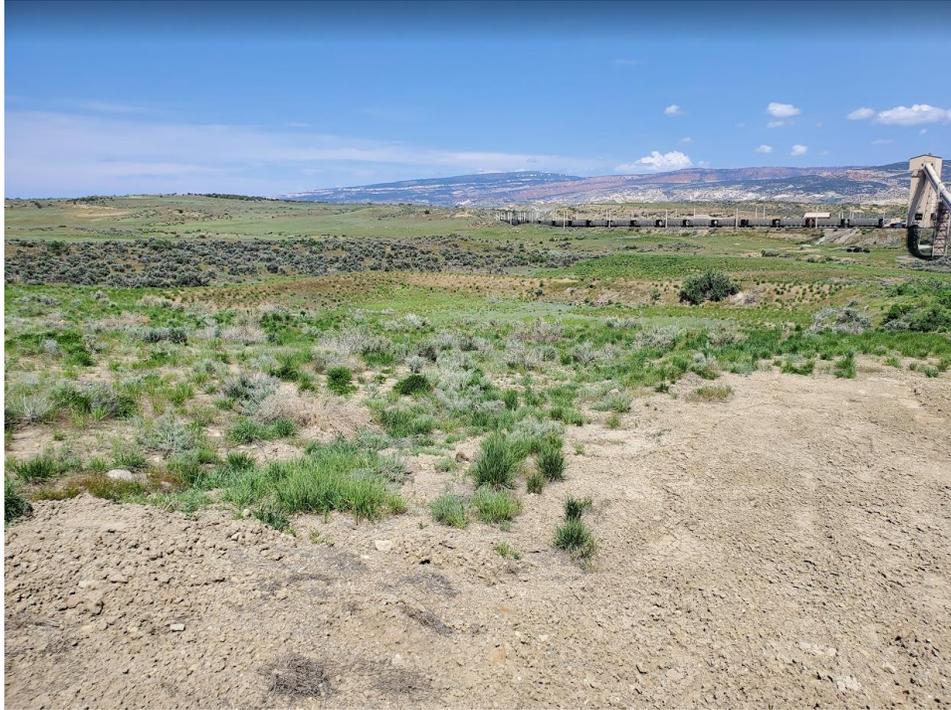
Pond SS-2 in the slot storage area is not holding water (Photo 7). The embankments of the pond are stable with no burrows or erosional concerns identified. Culverts around the slot storage area and nitrogen plant have been cleaned of debris.

Photo 7: View to the north of pond SS-2. No water present.

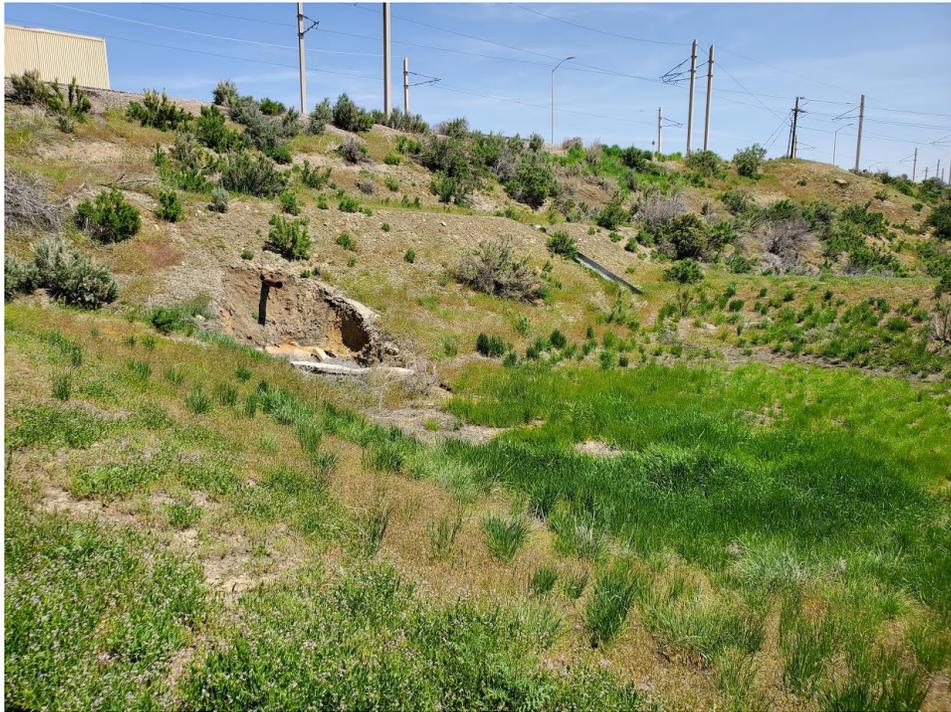
The Rail Loop Sump and Pond are part of the hydrologic controls around the rail loop area. The sump was not holding water, but a small amount of water was seen dripping in and filtering into the ground. No erosion concerns were identified at the sump. The Rail Loop Pond (Photo 8) to the east of the sump was not holding water either. The erosional scar on the north embankment of the pond looks the same size as previous inspections and does not appear to grow.

Photo 8: View to the northeast of erosional scar in Rail Loop Pond.

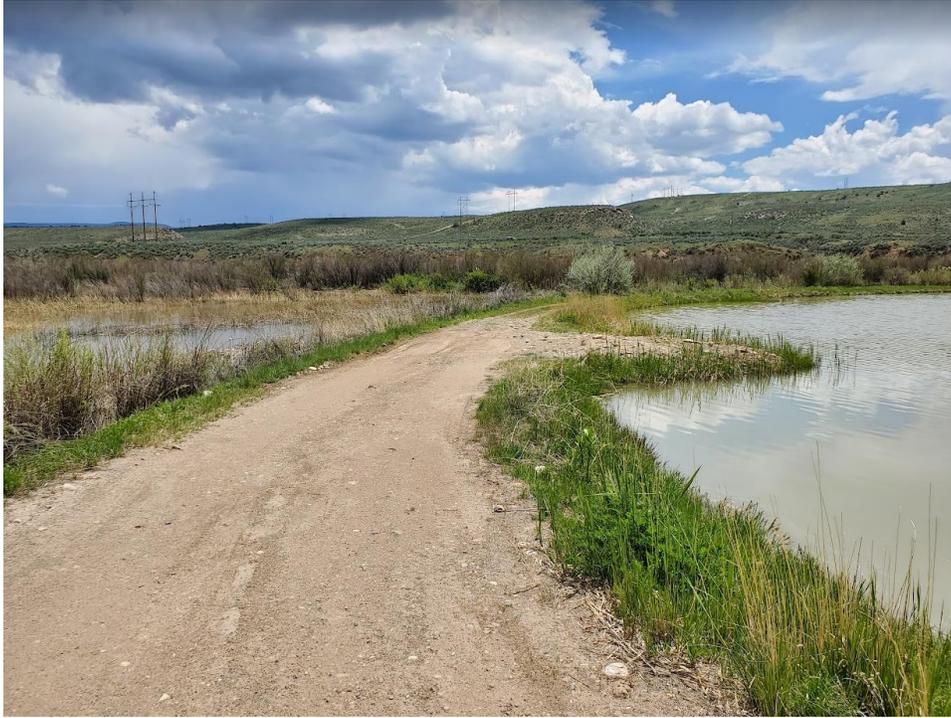
The Process Water Pond (Photo 9) near the entrance to the mine site provide makeup water for the coal operation. With the good snow year, runoff in the adjacent White River is extremely high. The river has entered the flood plain around the pond, but the embankment is maintaining separation between the pond and flooded river.

Photo 9: View to the east of process water pond. Pond is on the right and flooded river on the left.

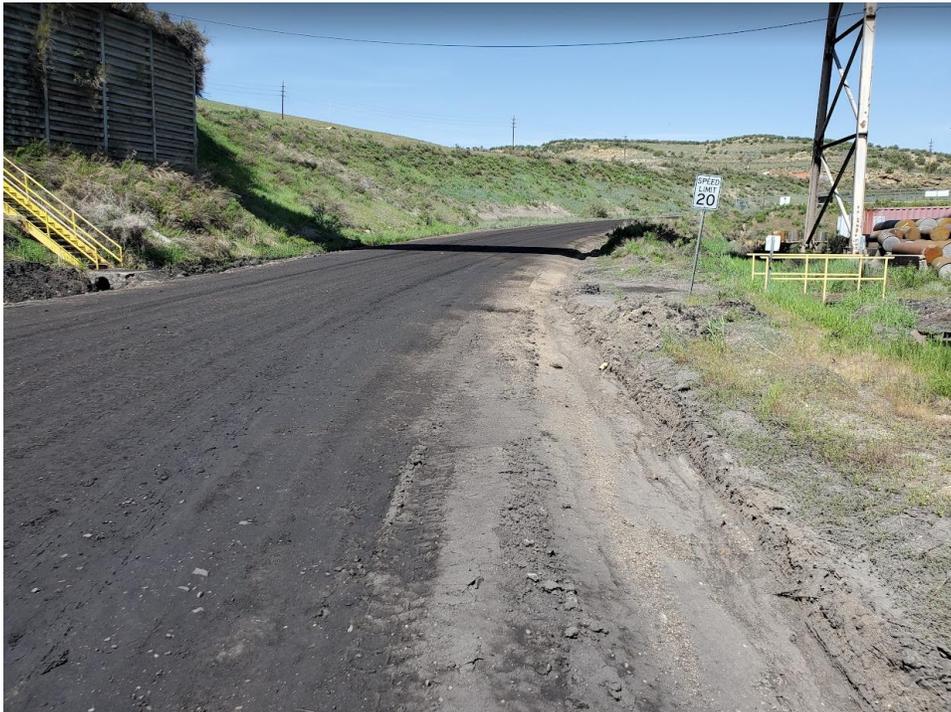
The haul road (Photo 10) at the Deserado Mine was well maintained and being sprayed to suppress dust. For the most part, ditches along the main haulage and support roads have been pulled and are clear. Support roads leading to some of the more remote areas of the mine are rutted, but surface operators are continuing with their spring cleaning and will grade the roads when they are able.

Photo 10: View to the west of haul road. Ditch has been pulled and road was wet from water truck.

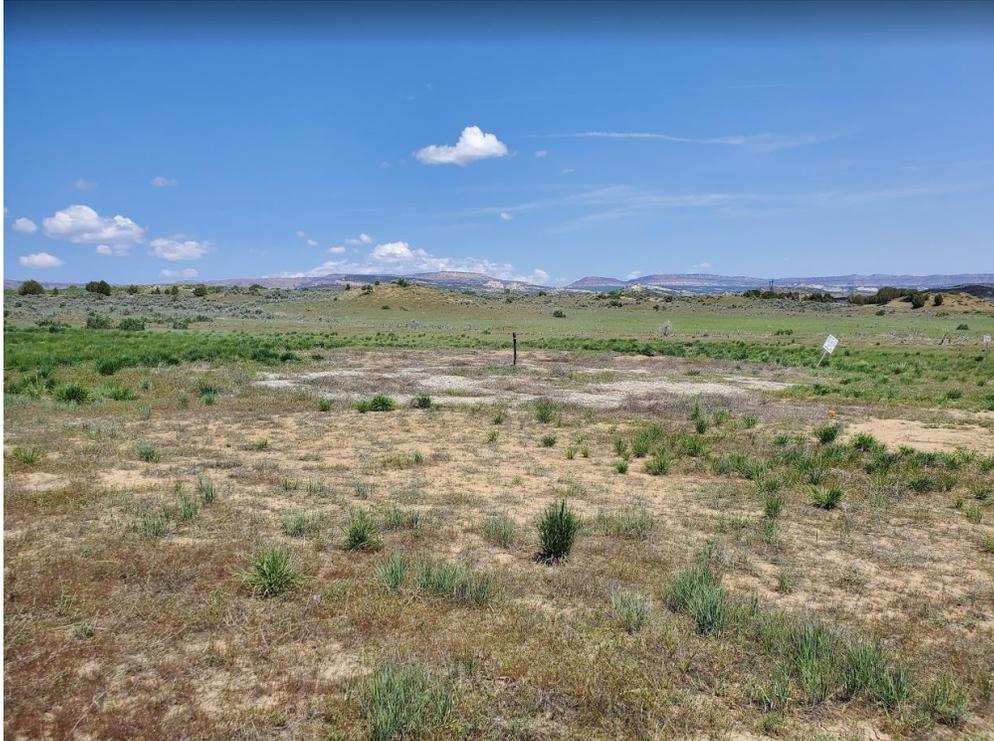
Crews reclaimed boreholes last fall and work on those pads continue this year. The boreholes were used to inject nitrogen into underground workings. Now that the underground crews have moved to a different area the boreholes are being abandoned. Surface crews are grading and revegetating pads while abandoning boreholes by plugging them (Photo 11). This will be an ongoing effort over the summer months for the surface crews.

Photo 11: View to the north of borehole pad revegetated last fall. Crews still need to plug and fill the injection well on this pad.

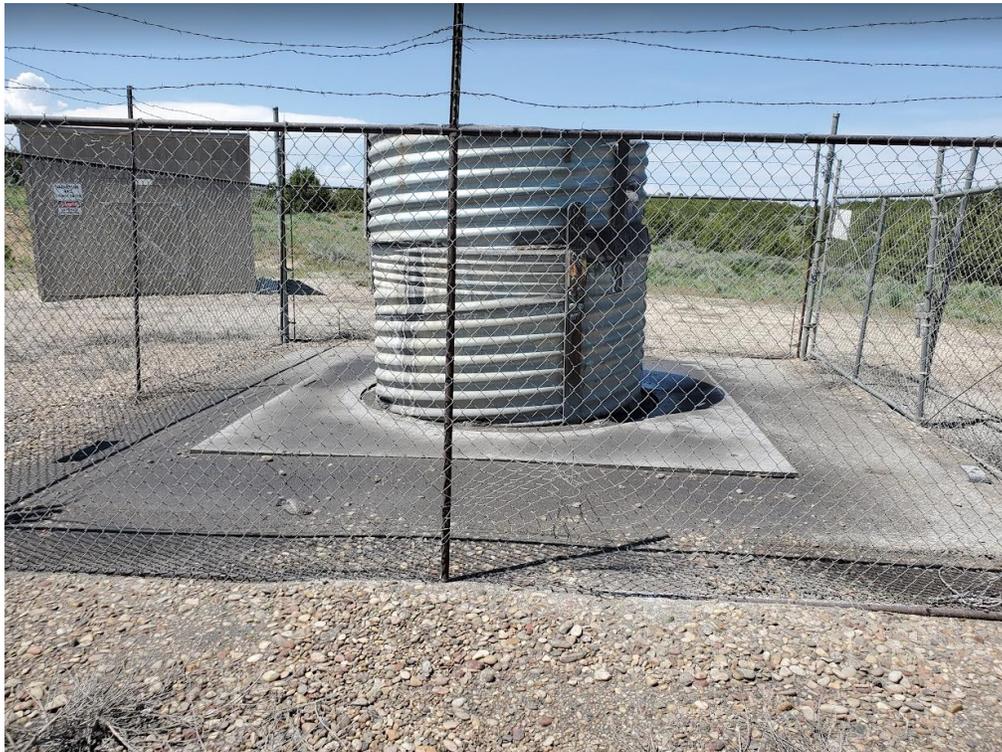
The B Vent Shaft #3 (Photo 12) is a vent shaft designed to improve ventilation in the underground workings. The vent shaft is guarded by a chain-link fence to prevent staff and the general public from approaching an open hole. The shaft is also guarded by corrugated tube that reaches roughly 6 feet above ground level. There were no signs of erosion or slumping around the vent shaft pad

Photo 12: View to the south of B Vent Shaft.

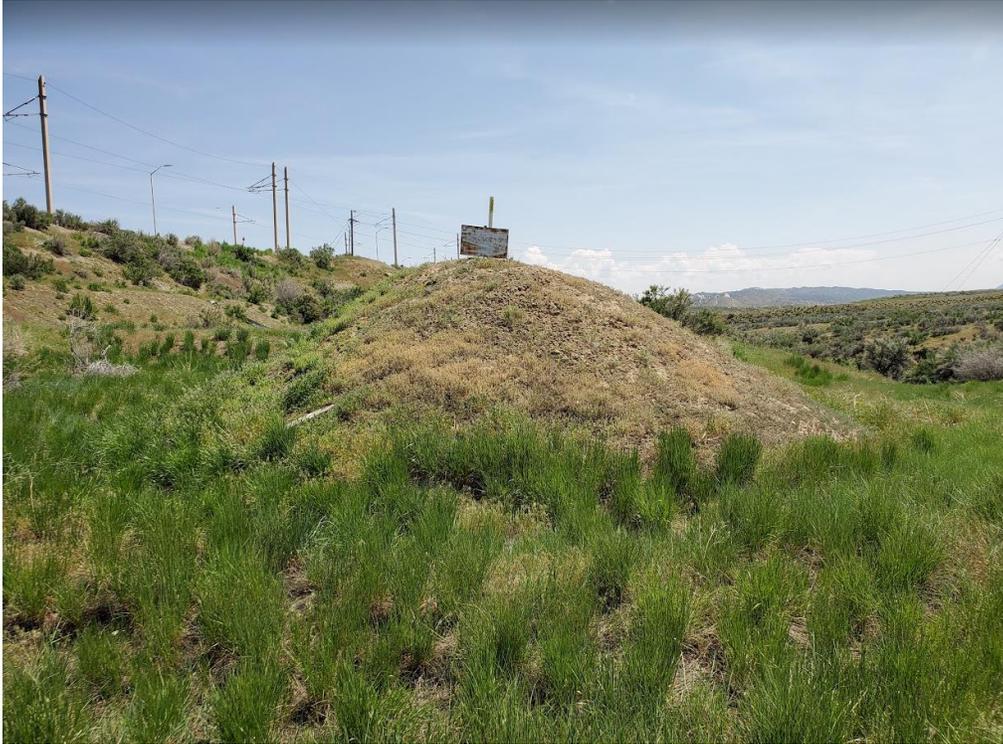
The Rail Loop Topsoil Stockpile (Photo 13) is located between the Rail Loop Sump and Rail Loop Pond. The topsoil stockpile is protected from erosion by vegetative cover and a small berm at the base of the pile. A topsoil marker is placed on top of the pile to mark it as topsoil. There were no indication of erosion or instability observed on the stockpile.

Photo 13: View to the east of topsoil stockpile by the Rail Loop.
