## Colowyo Mine Inspection Report

<b>Permit Number:</b> C-1981-019 <b>Mine Name:</b> Colowyo Coal Mine <b>Operator:</b> Colowyo Coal Company L.P. <b>Operator Address:</b> Mr Tony Tennyson 5731 State Highway 13 Meeker, CO 81641	<b>County:</b> Moffat, Rio Blanco <b>Operation Type:</b> Surface <b>Permit Status:</b> Active <b>Ownership:</b> Private
	<b>Operator Representative Present:</b>  Tom Fry
<b>Operator Representative Signature: (Field Issuance Only)</b>

<b>Inspection Start Date:</b> May 31, 2023 <b>Inspection Start Time:</b> 08:30 <b>Inspection End Date:</b> June 1, 2023 <b>Inspection End Time:</b> 09:30		<b>Inspection Type:</b> Coal Complete Inspection <b>Inspection Reason:</b> Normal I&E Program <b>Weather:</b> Cloudy	
<b>Joint Inspection Agency:</b>  None		<b>Joint Inspection Contacts:</b>  None	
<b>Post Inspection Agency:</b>  None		<b>Post Inspection Contacts:</b>  None	
<b>Inspector(s):</b>  Zach Trujillo	<b>Inspector's Signature:</b>

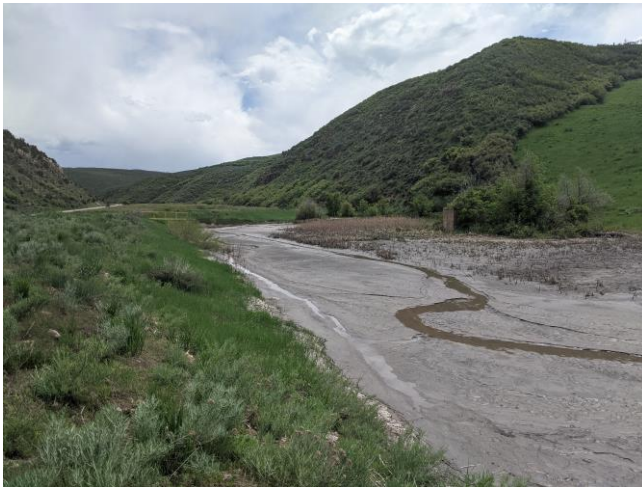
The Streeter and Prospect Pond were inspected. These ponds receive surface runoff associated with the East Pit. Both ponds held water and were discharging at the time of the inspection. Sediment levels in the Streeter Pond are high. The mine representative stated that they were aware of the issue and it is scheduled for clearing. No issues were observed with the Prospect Pond.

Streeter Pond.

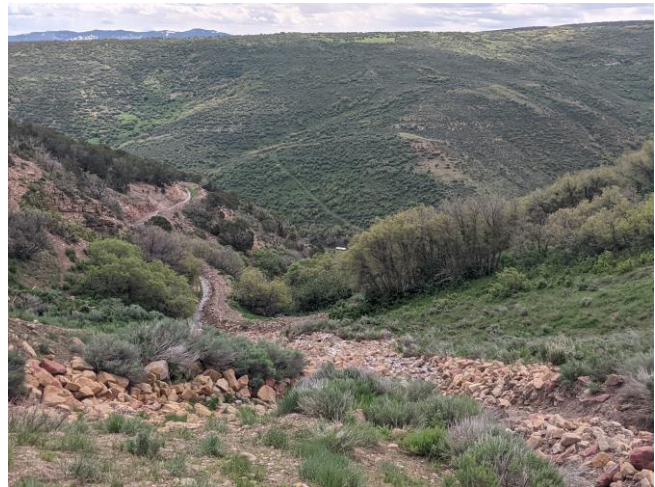
The entirety of the Final East Pit Ditch (FEPD) and North Trib. East Pit Ditch (NTEPD) and Prospect Ditch were inspected. The FEPD was flowing from contributing seeps along the southern slope. The FEPD remains in the same condition from the previous inspection that occurred on May 11, 2023. For more information, please refer to the inspection report dated May 18, 2022. Water flow from the FEPD is directed to the South Collection Ditch before being conveyed to the Prospect Pond. No issues were observed with the Final East Pit Ditch or the South Collection Ditch. The NTEPD and Prospect Ditches were stable and was dry. Stock ponds associated with both the NTEPD and Prospect Ditch held water with no discharge. NTEPD was stable with no issues however cutting was observed in the lower part of the Prospect Ditch.

Intersection of Final East Pit Ditch and South Collection.

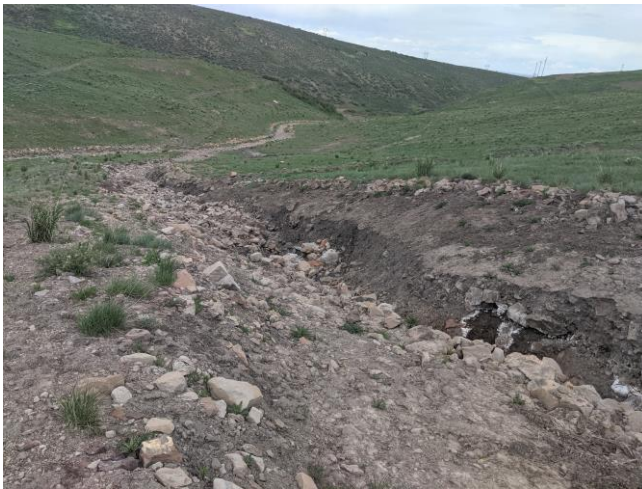
and of that 0.49 inches, 0.41 inches fell in the span of an hour. Due to the relative steepness in this section of the ditch along with the associated surface runoff from the storm event, cutting has occurred within the ditch. It also appeared that the water had breached or “jumped” outside of the ditch at an area where there was a slight bend just prior to the intersection with Taylor Ditch. While the East Taylor Ditch remained stable at the bend, rock, and small sized rip rap and minor riling was observed in the area between the two ditches at the location of where the water jumped. Any water leaving the East Taylor Ditch was immediately captured by the Taylor Ditch before flowing to the East Taylor Pond. Due to the relatively small distance between the ditches where the water breached, the erosion was minimal and based on the experience at the site, it is the Division’s opinion this area will self-heal over time. However, the East Taylor Ditch is in need of repair from the cutting that occurred as well as all noted rip-rap replaced back to the East Taylor Ditch.

Cutting at East Taylor Ditch.

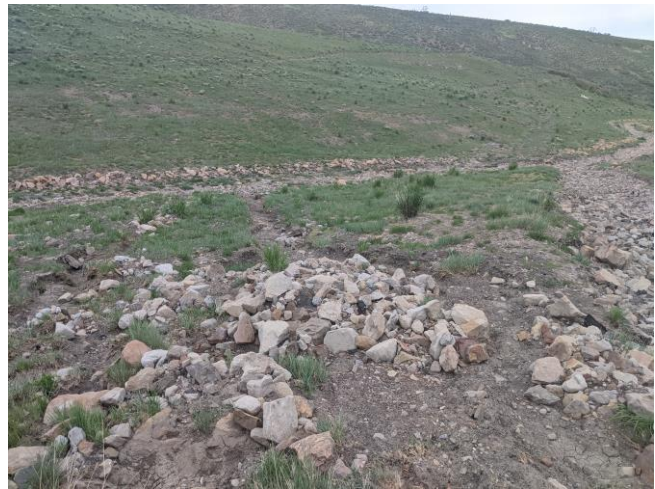
Breached area of East Taylor Ditch.

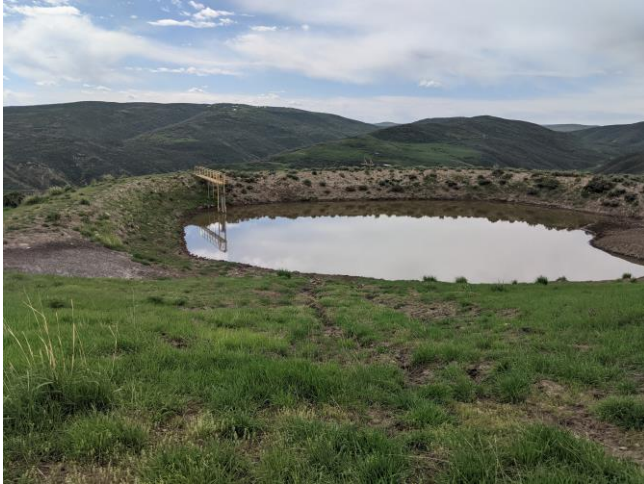
Section 16 Pond which receives disturbed runoff from the eastern crest of the South Taylor Pit was inspected. This pond held water with no discharge. No issues were observed. The West Taylor Pond was also inspected. This pond currently receives discharge for the West Taylor Fill underdrain as well surface runoff from the fill as well. The pond held water and was discharging at the time of the inspection. No issues were observed.

Section 16 Pond.

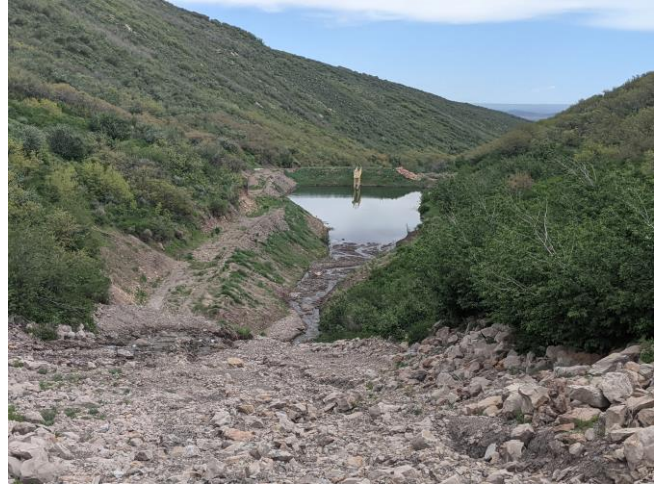
West Taylor Pond.

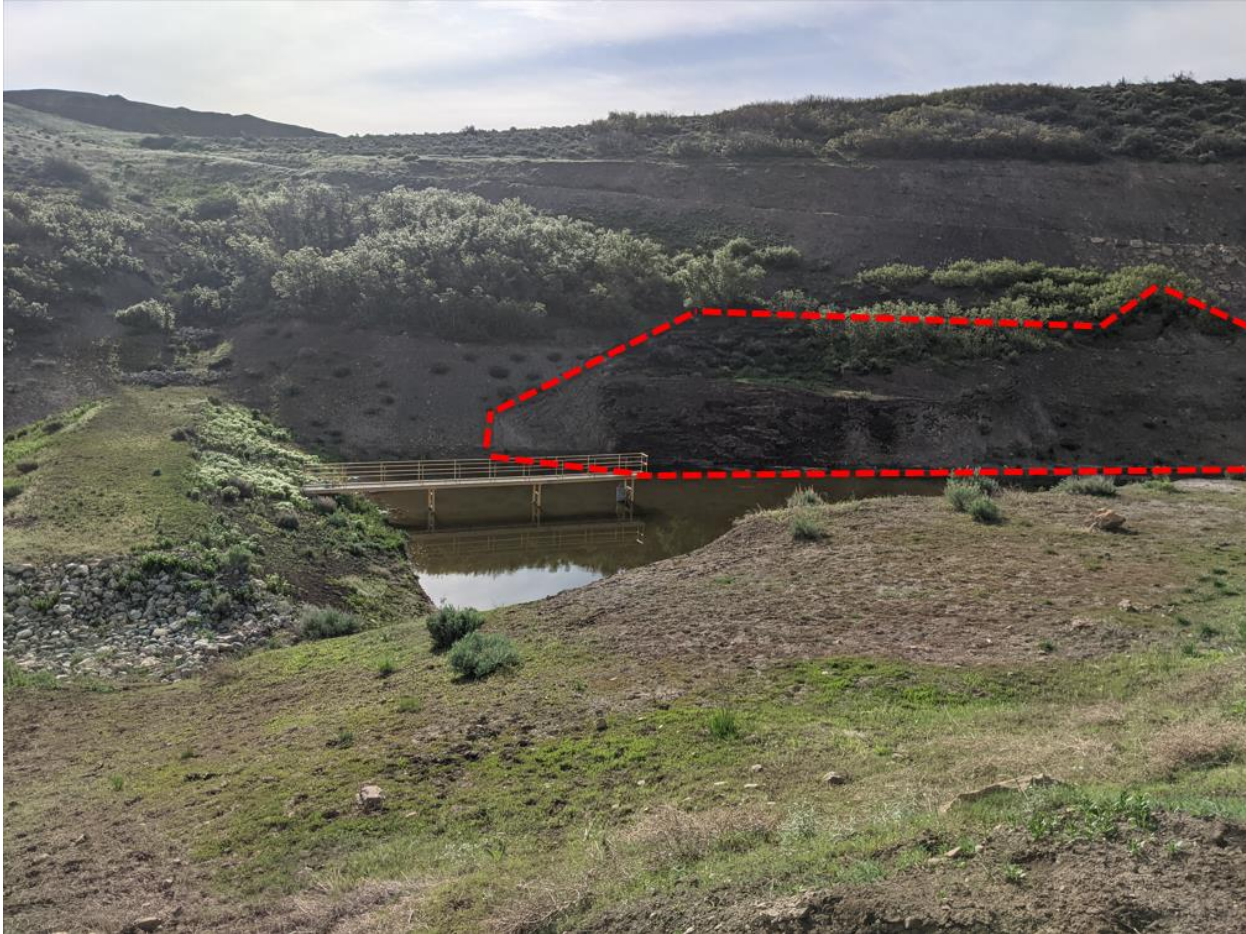
Section 36, Section 25 and Middle Ponds were inspected. These ponds are associated with Collom Pit and run in series with each other. Each of these ponds held water with discharge. Each pond was stable, well vegetated with no issues observed. The Sidehill and Section 26 Ponds were also inspected and associated with the Collom Pit. A slump has begun to occur along the upper slope of the hill in which the Section 26 was built along. Currently the slump is not impacting the pond or the pond's capacity. This area is currently being monitored by Colowyo. Overall, both ponds stable at the time of the inspection.

Approximate outline of slump at Section 26 Pond.

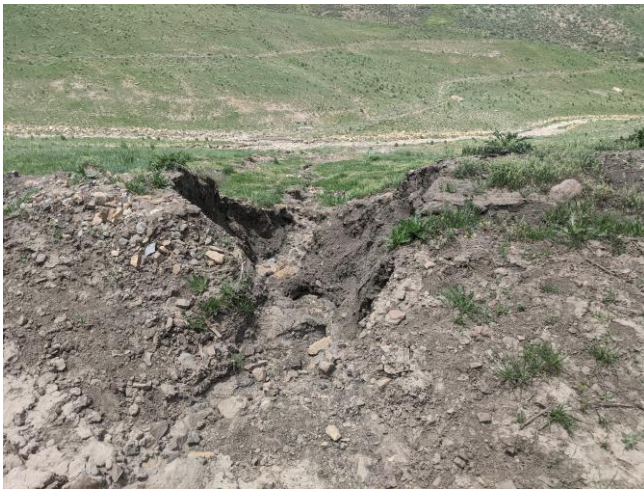
A breached “collection ditch” was observed adjacent to the East Taylor Ditch. These collection ditches are not designed ditches as required by the Rules and Regulations and discussed in the Hydrology Section of this report but a best-management-practice to help break up surface flow along the face of long reclaimed slopes. It appears that surface water flows, potentially related to the precipitation event noted earlier, cut through the collection ditch which allowed water flow to travel down the face of the slope until captured by the lower collection ditch. As a result, riling occurred below the breached collection ditch. In order to prevent additional concentrated flows down the face of the slope resulting in additional riling, maintenance to the collection ditch may be beneficial.

Collection ditch breach.
