MINERALS PROGRAM INSPECTION REPORT
PHONE: (303) 866-3567

MINE NAME: The Rise Above	MINE/PROSPECTING ID#: M-2014-054	MINERAL: Gemstones	COUNTY: El Paso
INSPECTION TYPE: Monitoring	WEATHER: Clear	INSP. DATE: October 12, 2022	INSP. TIME: 15:30
OPERATOR: Amanda Adkins Anderson & Travis Anderson	OPERATOR REPRESENTATIVE: Amanda Adkins	TYPE OF OPERATION: 110(2) - Hard Rock Limited Impact	
REASON FOR INSPECTION: Normal I&E Program	BOND CALCULATION TYPE:	BOND AMOUNT: \$5,900.00	
DATE OF COMPLAINT: NA	POST INSP. CONTACTS: U.S.Forest Service	JOINT INSP. AGENCY: U.S.Forest Service	
INSPECTOR(S): Timothy Cazier, P.E.	INSPECTOR'S SIGNATURE:

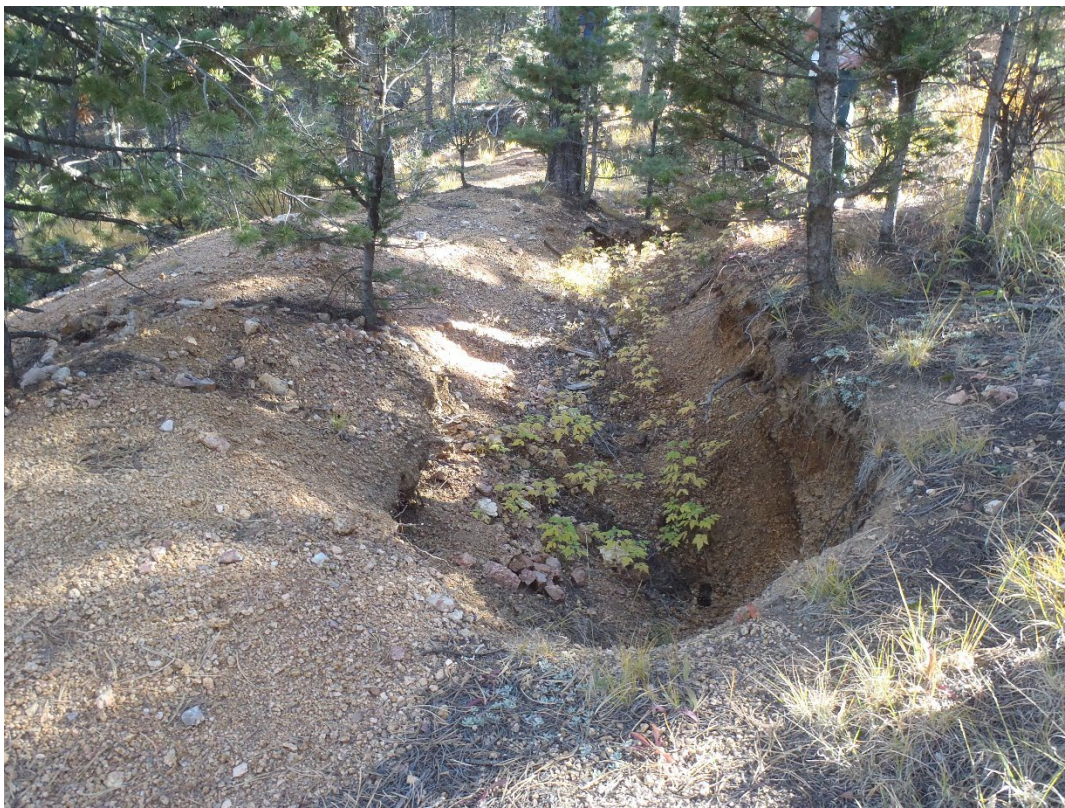
Excess Spoil and Dev. Waste: Overburden piles were observed in the active mine areas (see **Photos 1 and 2**).

Reclamation Success: Ms. Adkins indicated reclamation has been initiated on the Shrew Pocket (see **Photo 3**) and the Middle Pocket (see **Photo 1**). Both need additional backfill. No trash was observed.

Photo 1. Overburden (left/east side) piled next to the Middle Pocket – needs more backfill (looking south).

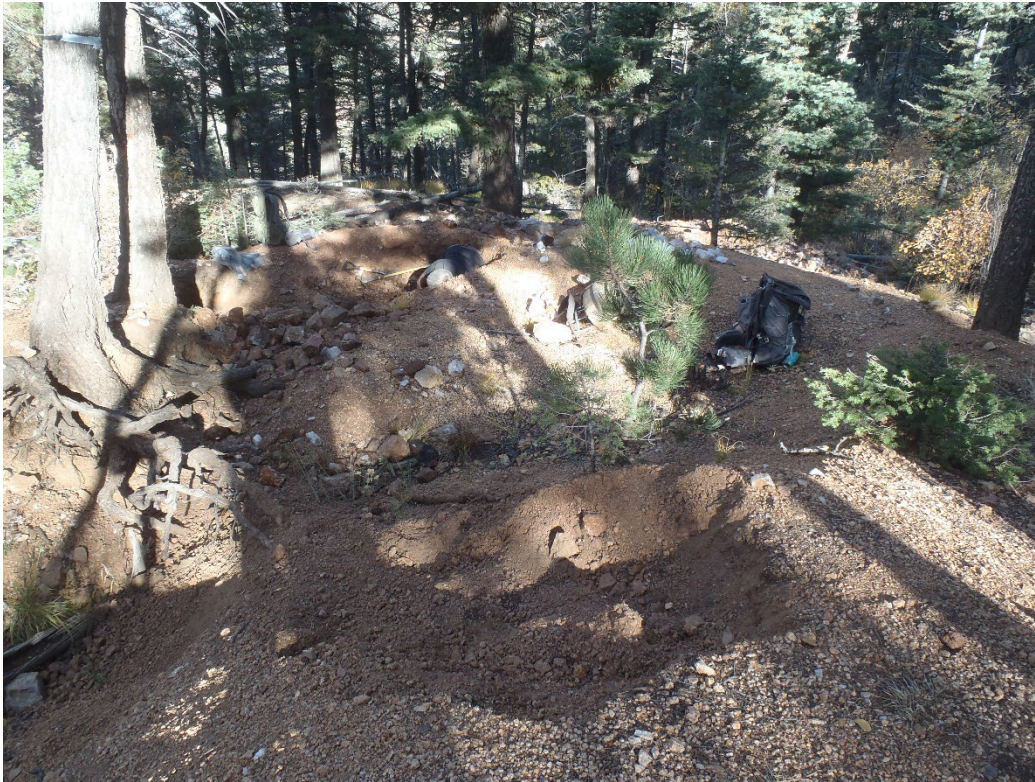
Photo 2. Short Cut and City Lights pits (Active sites) with overburden.

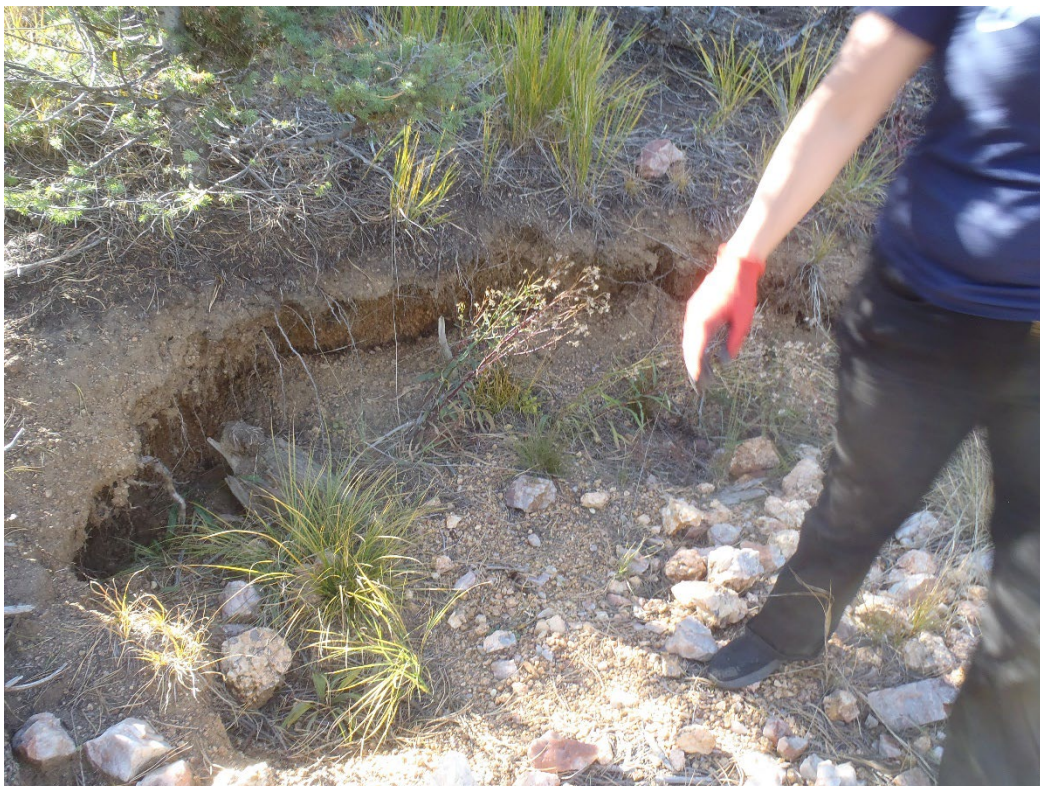
Photo 3. Shrew Pocket reclamation – needs more backfill.

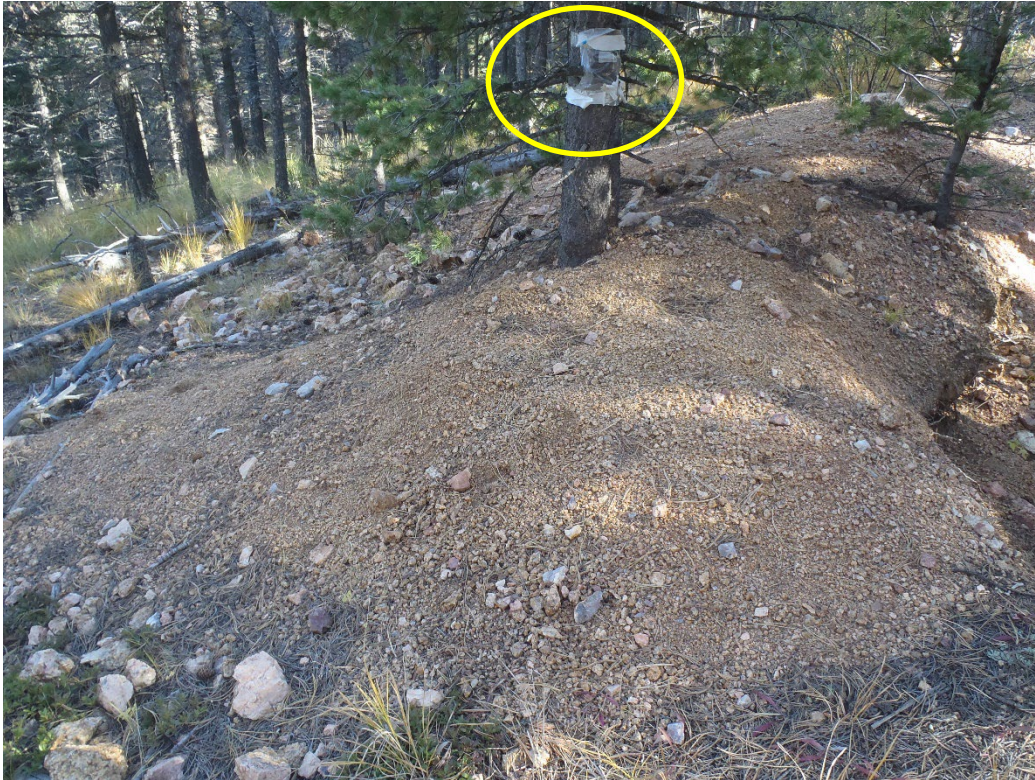
Signs and Markers: The permit sign had been vandalized and removed (see **Photo 4**). Many of the claim signs had also been vandalized. A new claim center post sign was observed (see **Photo 5**). *The DRMS suggests adding*

Photo 4. Vandalized/missing DRMS permit sign (circled).

Post Inspection Meeting: Ms. Adkins agreed to confirm the NOI was current with the USFS and get new permit sign(s) posted.

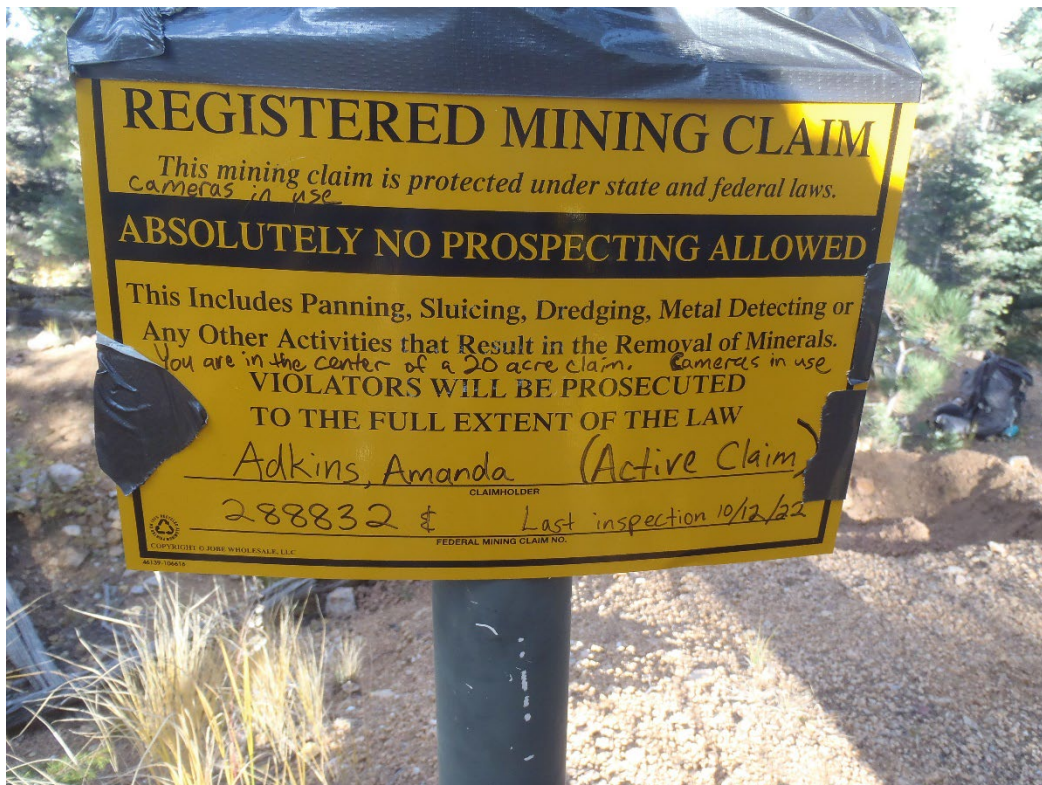
Photo 5. New claim marker on center post.

the DRMS permit number to the claim markers as the metal signs are more durable. Alternatively, the DRMS permit number could be etched or painted on the claim center post.
