**MINERALS PROGRAM INSPECTION REPORT**  
**PHONE: (303) 866-3567**

<b>MINE NAME:</b> Cross Gold Mine	<b>MINE/PROSPECTING ID#:</b> M-1977-410	<b>MINERAL:</b> Gold, copper, silver,	<b>COUNTY:</b> Boulder
<b>INSPECTION TYPE:</b> Monitoring	<b>WEATHER:</b> Cloudy	<b>INSP. DATE:</b> May 18, 2023	<b>INSP. TIME:</b> 10:00
<b>OPERATOR:</b> Grand Island Resources LLC	<b>OPERATOR REPRESENTATIVE:</b> Je'an Paul Brewer	<b>TYPE OF OPERATION:</b> 110(2) - Hard Rock Limited Impact	
<b>REASON FOR INSPECTION:</b> Normal I&E Program	<b>BOND CALCULATION TYPE:</b>	<b>BOND AMOUNT:</b> \$546,751.00	
<b>DATE OF COMPLAINT:</b> NA	<b>POST INSP. CONTACTS:</b> None	<b>JOINT INSP. AGENCY:</b> None	
<b>INSPECTOR(S):</b> Patrick Lennberg	<b>INSPECTOR'S SIGNATURE:</b>

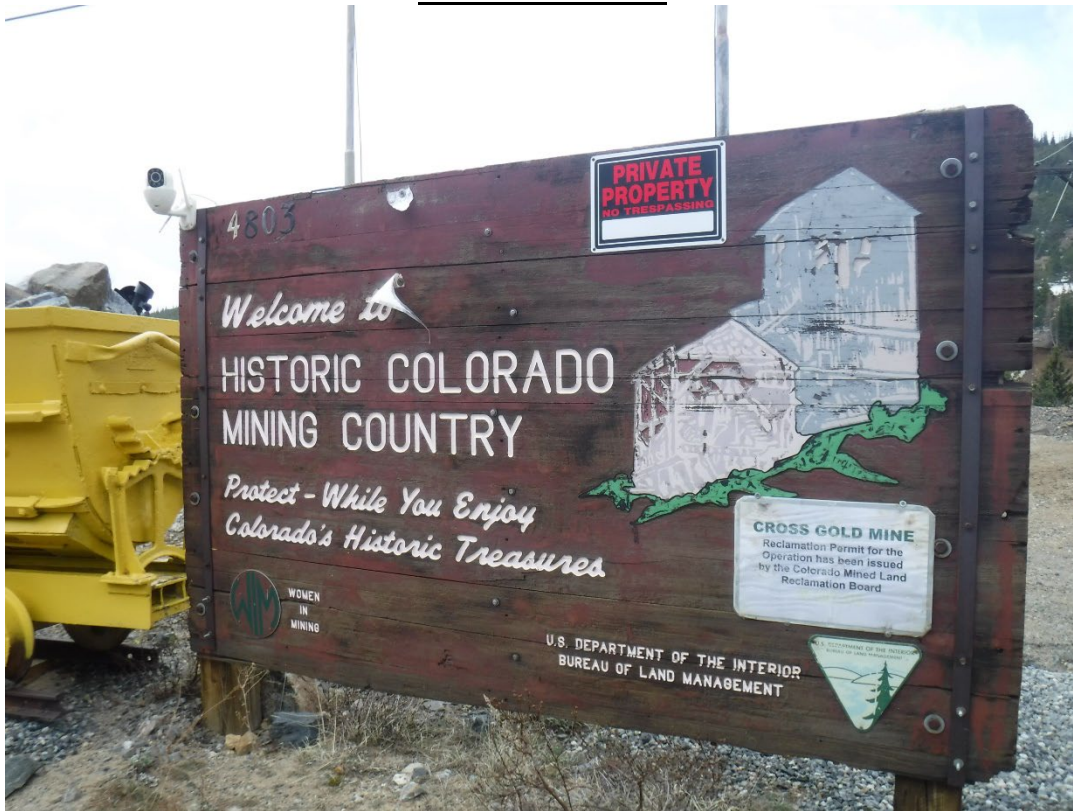
The Cross Gold Mine is a 110(2) underground mine operation permitted for 9.9 acres for the mining of gold, silver, and other minerals. The permit area includes two discharging mine openings: the Cross Mine portal (at the Cross Mine) and the Idaho Tunnel portal (at the Caribou Mine). Discharge from these mines is directed to a series of plastic-lined ponds prior to being treated and discharged into Coon Track Creek at the permitted discharge point (CO0032751). The mine is located on land owned by the permittee. The site is located approximately 4 miles northwest of Nederland, CO in Boulder County, at an elevation of approximately 9,760 feet. Access to the site is off of Caribou Road. A separate entrance exists for each of the two mines at the site, the Cross Mine (to the south) and the Caribou Mine (to the north). The approved post-mining land use is a combination of forestry and residential. A mine sign was observed at the primary mine entrance as required by Rule 3.1.12.

**Photo 1:** Mine sign at the primary mine entrance location

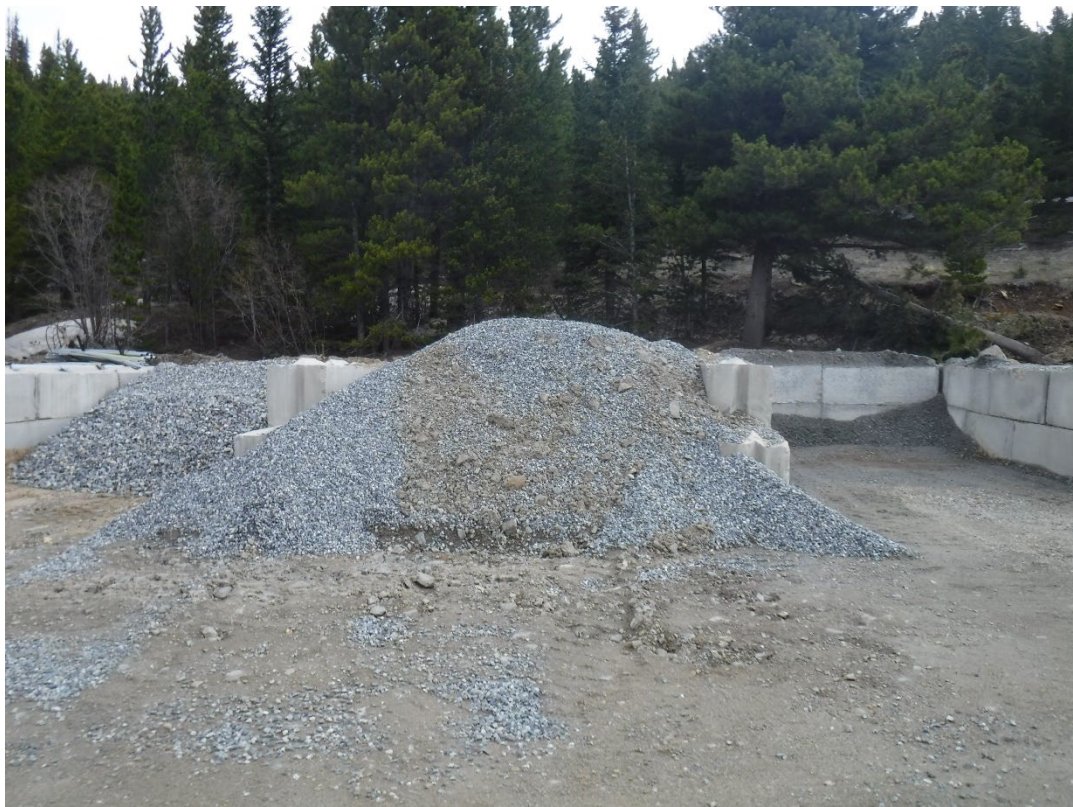
The site was not active at the time of inspection. In recent weeks the site had received around five or so truckloads of gravel material for maintenance of site roads. A similar activity occurred last year around this same time.

**Photo 2:** Imported gravel material used for site road maintenance

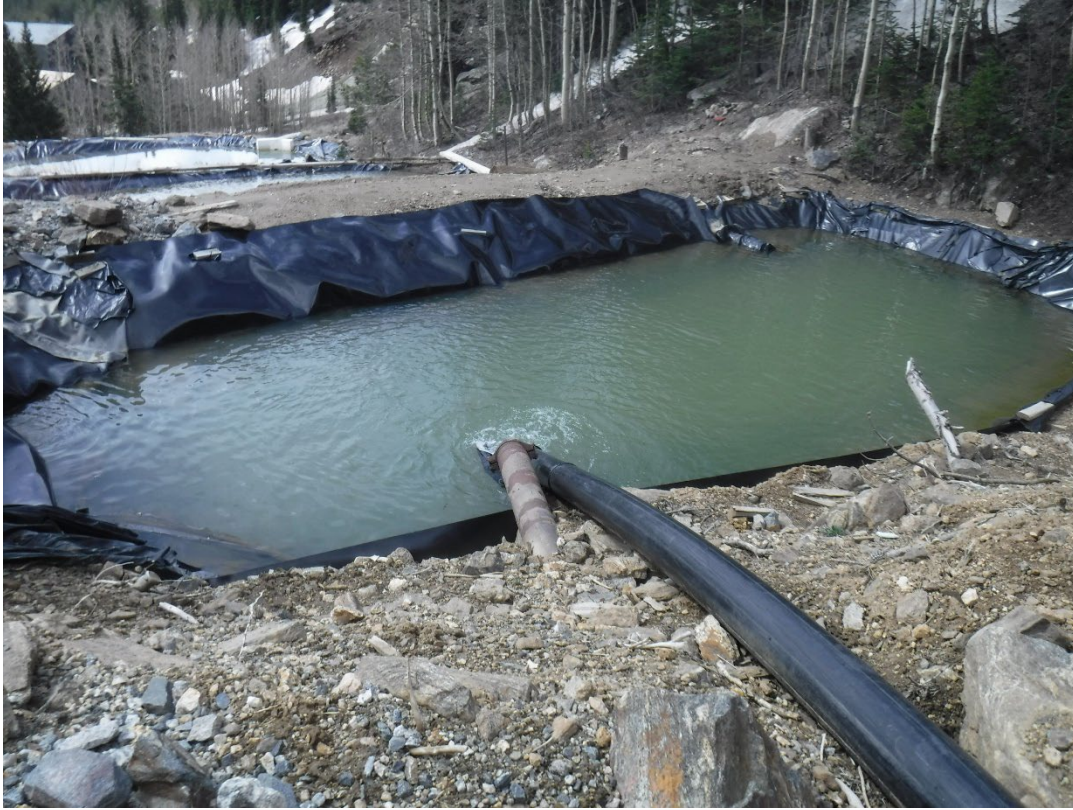
The Division observed water being discharged from the Idaho Tunnel into Ponds 3a, b and c. The water is then conveyed to Pond 1 and then to the Joliet Raise. The Operator stated that the remediation of the Cross Shaft, approved on June 23, 2022, has greatly decreased the amount of runoff water that has to be managed.

**Photo 3:** Idaho Tunnel discharge into Pond 3a

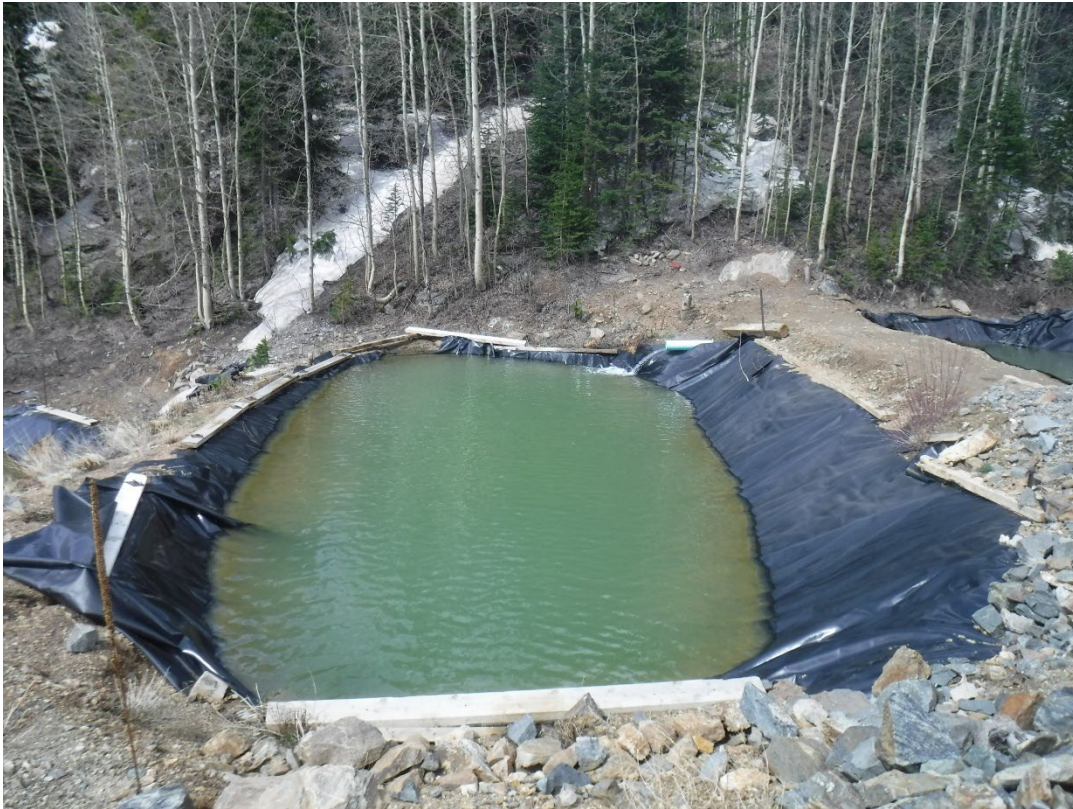
**Photo 4:** Discharge from Pond 3a to 3b

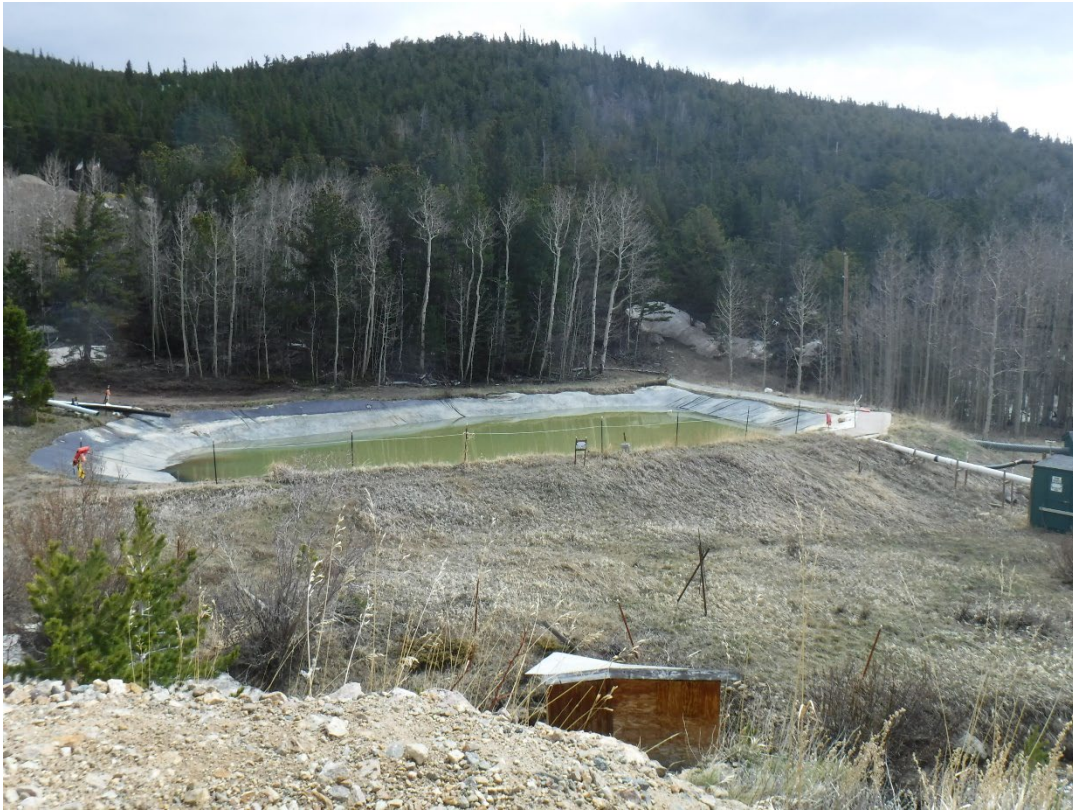
During the winter Pond 2 was utilized to contain the back flush water and sediment from the water treatment plant. The Pond was used because the holding tank previously used was freezing and did not have capacity to make it through the winter. Pond 2 will be cleaned out again in the future. The Division reiterated, from previous inspections, that when the Operator determines a proper disposable facility for the sediment that they provide the Division with the letter of acceptance from the facility along with the analytical results. It was also stated these similar documents were also needed for disposal of the water treatment sludge.

**Photo 7:** Pond 2 also used for emergency over flow if needed

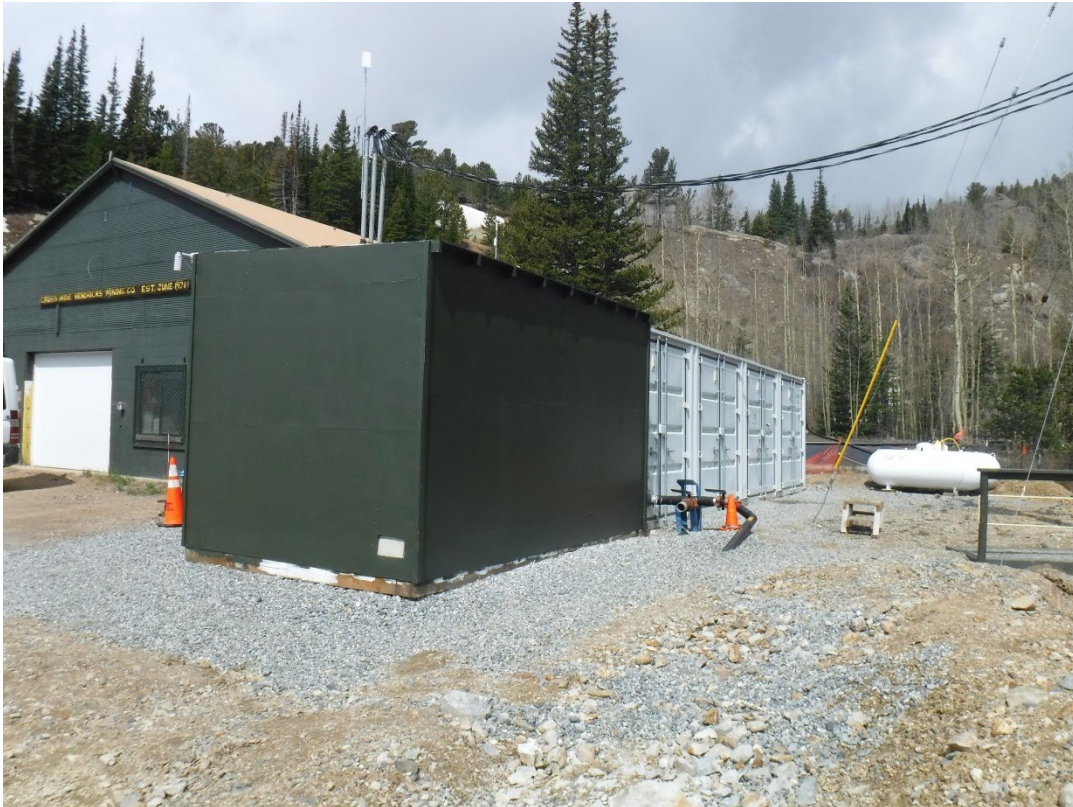
**Photo 8:** Structures used to contain water treatment facility

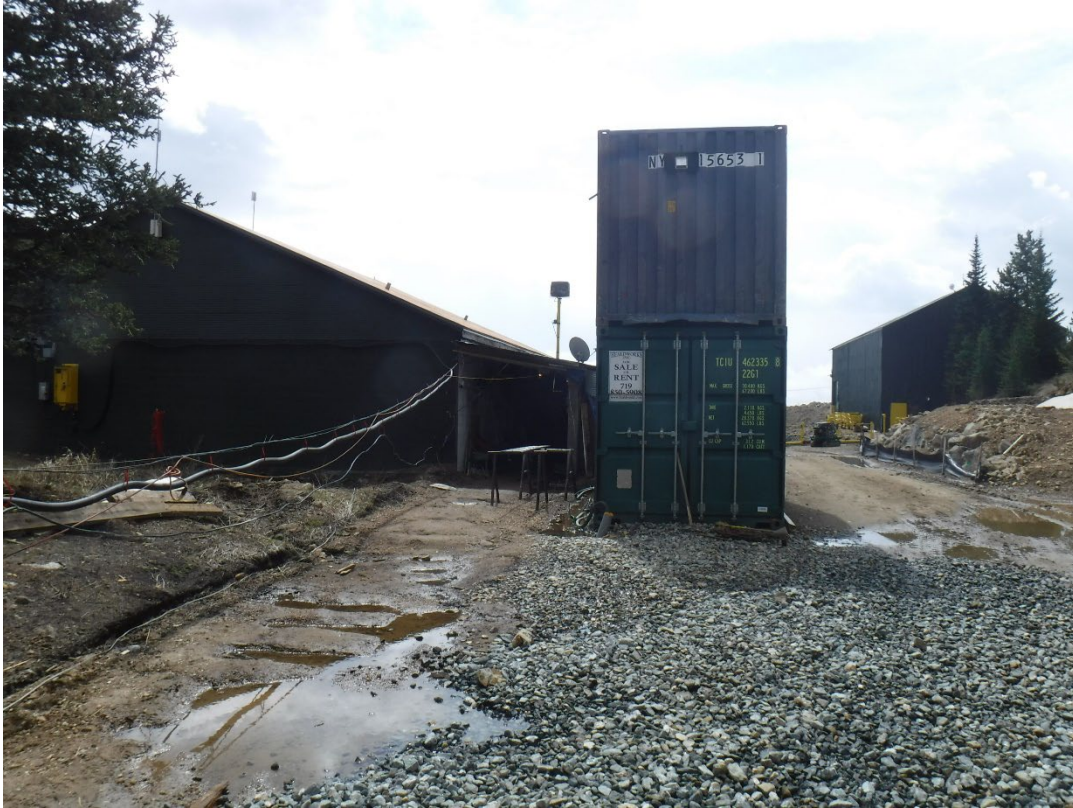
**Photo 9:** Looking south from Cross Mine Portal and where the railroad tracks and snow shed used to be

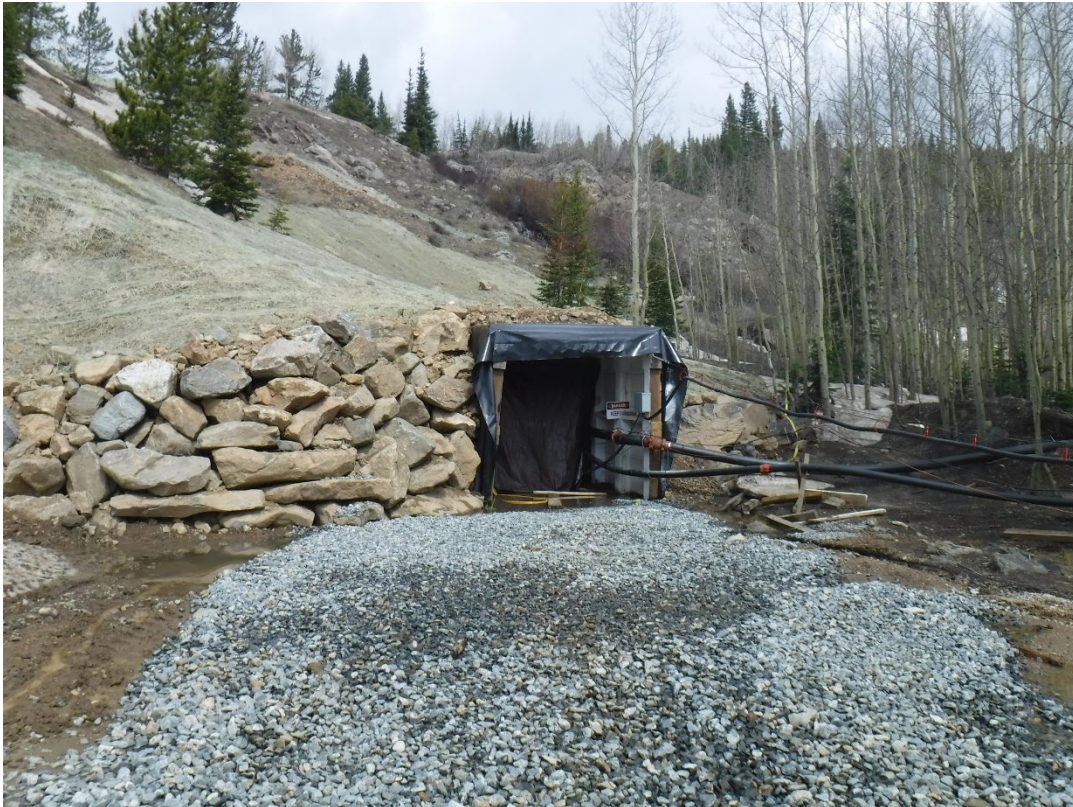
**Photo 10:** Looking at the Cross Mine Portal entrance
