MINERALS PROGRAM INSPECTION REPORT
PHONE: (303) 866-3567

MINE NAME: Daniels Sand Pit 2	MINE/PROSPECTING ID#: M-1973-007-SG	MINERAL: Sand and gravel	COUNTY: El Paso
INSPECTION TYPE: Monitoring	WEATHER: Cloudy	INSP. DATE: May 10, 2023	INSP. TIME: 13:00
OPERATOR: Holcim - WCR, Inc.	OPERATOR REPRESENTATIVE: Wyatt Webster	TYPE OF OPERATION: 112c - Construction Regular Operation	
REASON FOR INSPECTION: Priority	BOND CALCULATION TYPE: None	BOND AMOUNT: \$1,038,500.00	
DATE OF COMPLAINT: NA	POST INSP. CONTACTS: None	JOINT INSP. AGENCY: Other Agency	
INSPECTOR(S): Timothy Cazier, P.E.	INSPECTOR'S SIGNATURE:

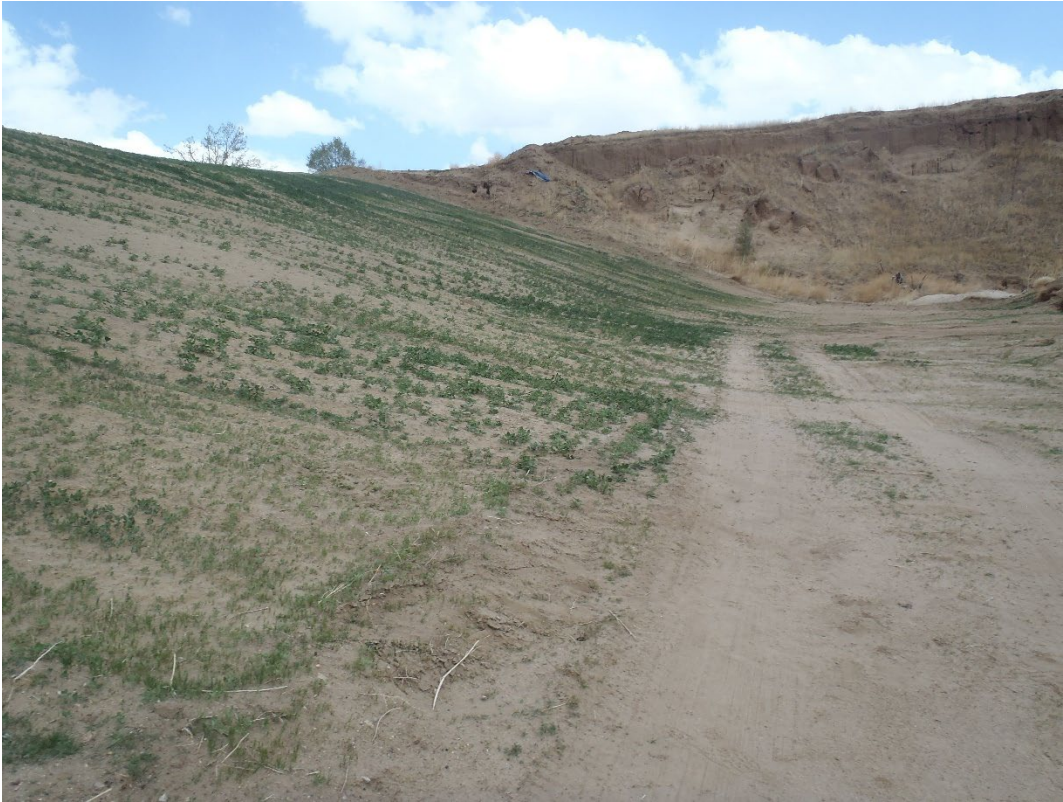
Backfilling and Grading: The slope appears to vary between 3H:1V and 4H:1V (see **Photos 1** and **2**). No signs of erosion/headcutting were observed above the backfill crest and the FMIC irrigation ditch (see **Photo 3**).

Reclamation Success: The east end was recently regraded (see **Photo 1**) and hydromulched (see **Photo 4**). The west end has not been regraded since initial backfill placement, and shows extensive rill erosion (see **Photo 5**).

Photo 1. Regraded and hydromulched east end of buttress fill (looking east).

Post Inspection Meeting: Mr. Webster stated they were waiting to see how successful the hydromulched area would be before they regraded and seeded the west end of the buttress backfill. If it is successful, he anticipated regrading the west end and hydroseeding it this fall.

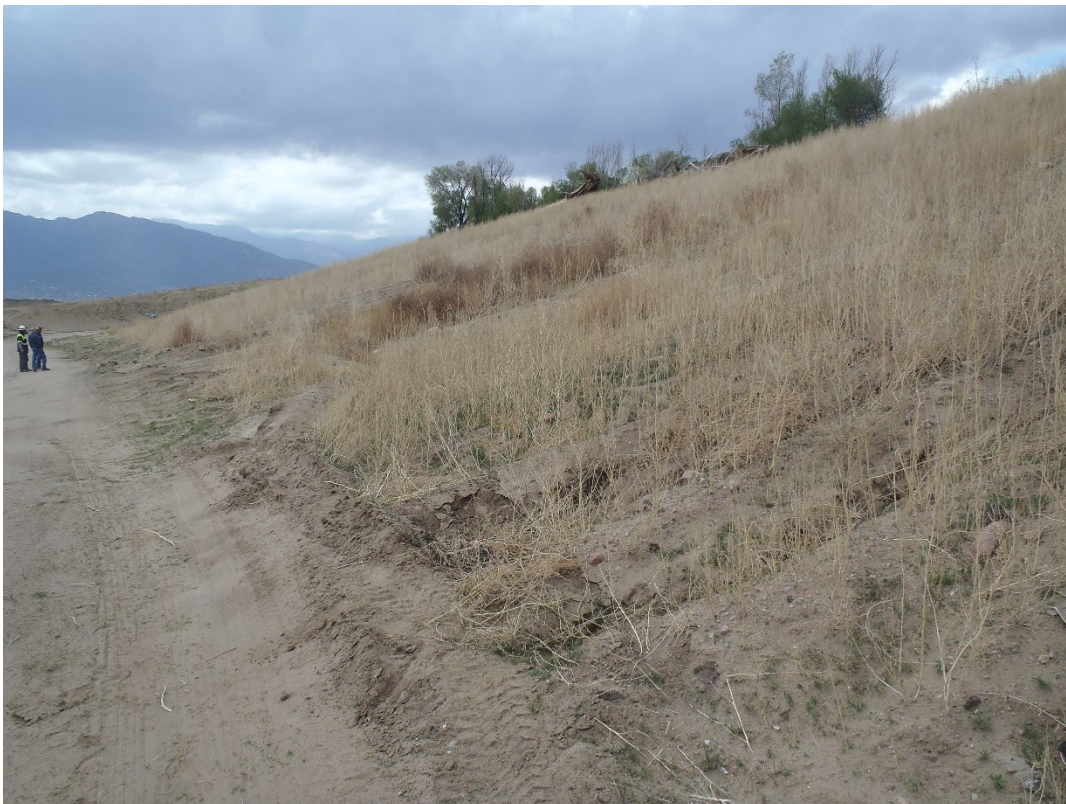
Photo 2. West end of buttress fill (looking west).

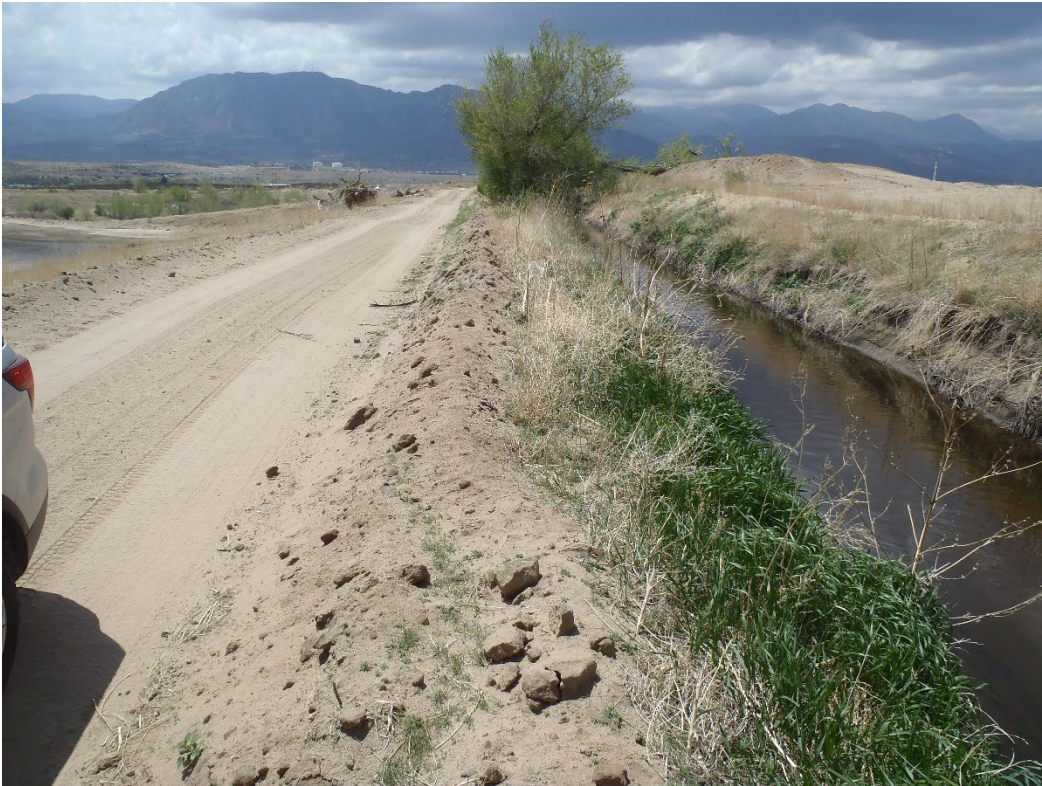
Photo 3. Ditch and access road at crest of buttress fill (looking west, no rill/headcutting at crest on left).

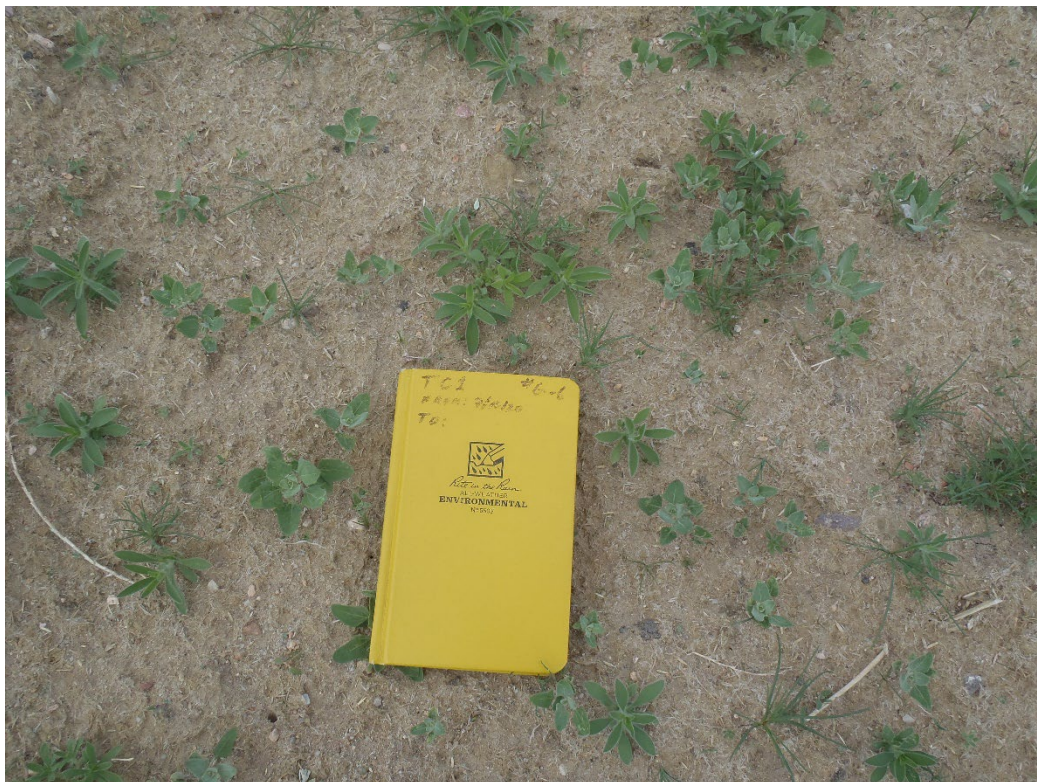
Photo 4. Close-up of hydromulch.

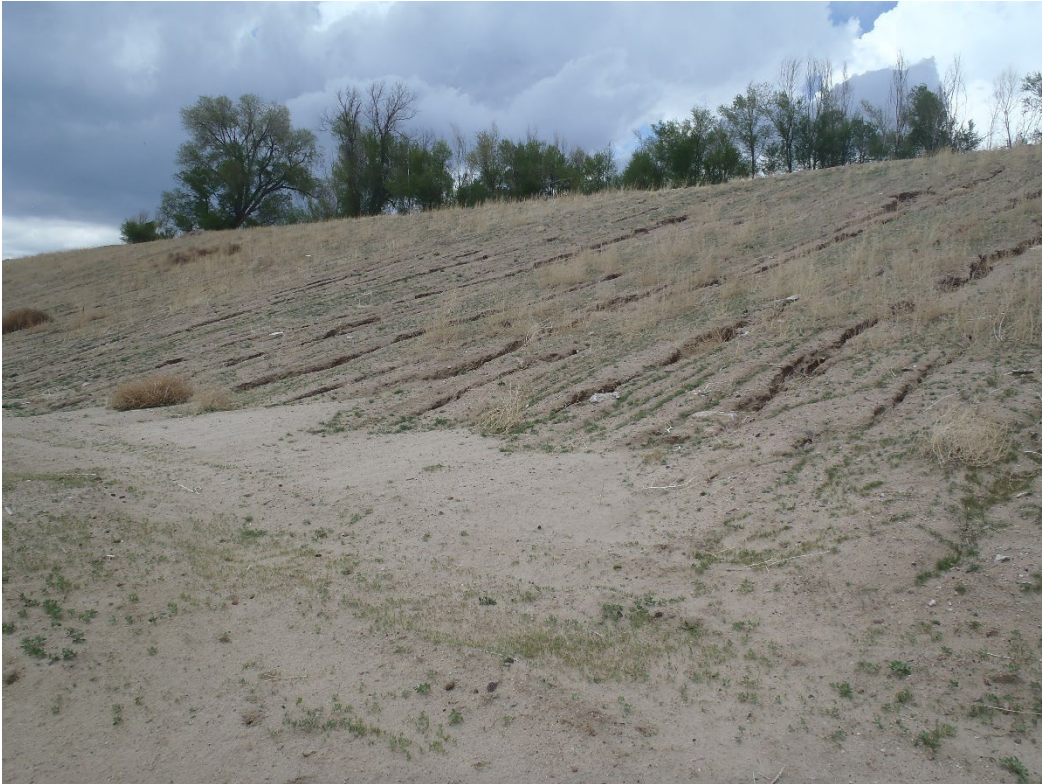
Photo 5. Heavy erosion rilling on west buttress fill (looking NW).

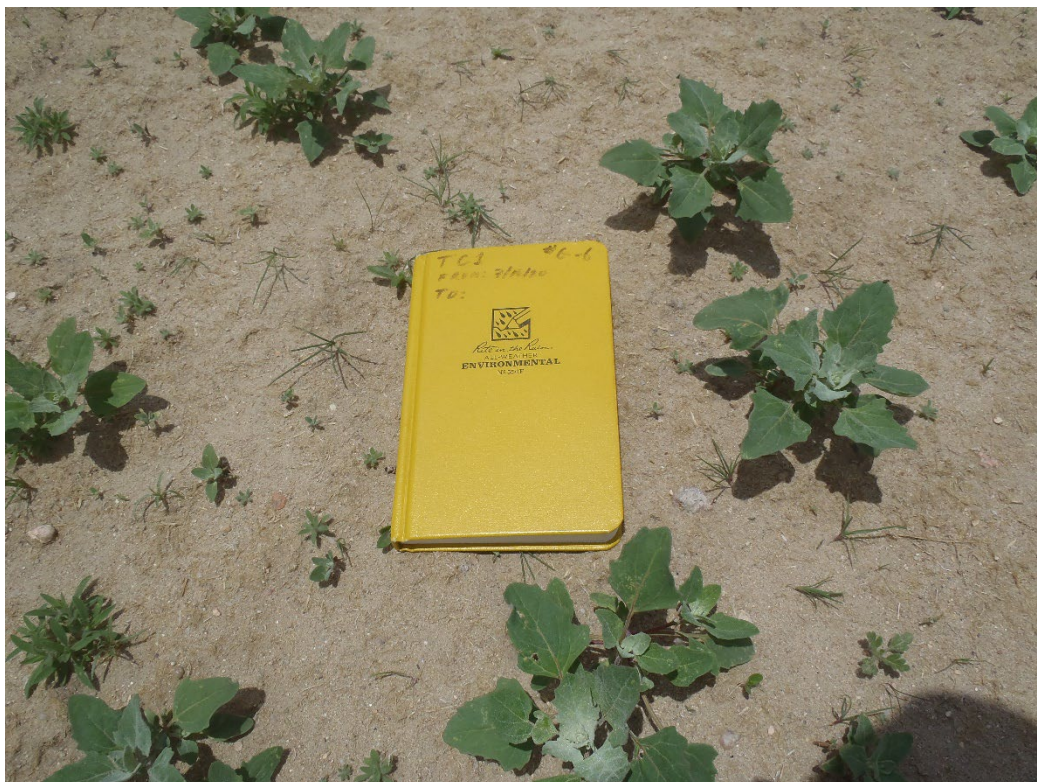
Revegetation: No grasses had emerged from the hydroseeded area at the time of the inspection. The observed emerging vegetation included: lambsquarters (see **Photo 6**), kochia and Russian thistle (see **Photo 7**). None of these three species are included in the Colorado noxious weed list, so their presence was not cited as a problem. Subsequent to the inspection, DRMS vegetation specialists indicated the hydromulch would be expected to retain sufficient moisture in the soil and grasses may yet emerge. No noxious weeds were observed.

Photo 6. Lambsquarters (broadleaf) and kochia (smaller leaves) on hydroseeded east end.

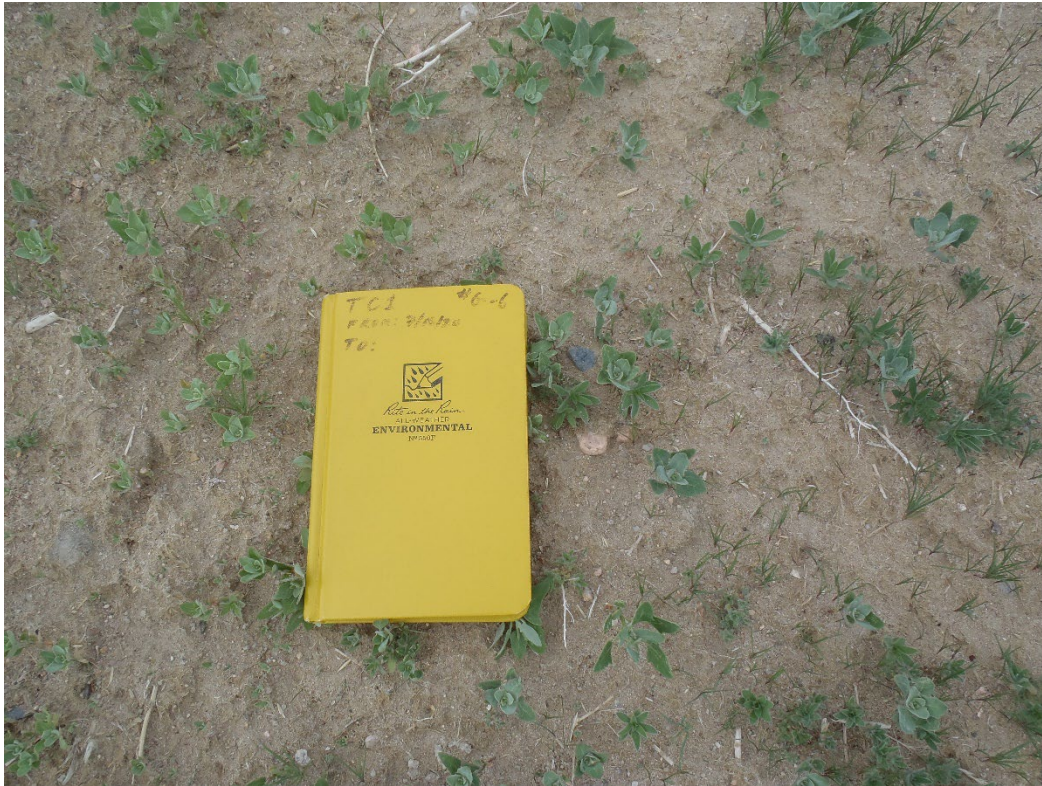
Photo 7. Kochia and Russian thistle on hydroseeded east end.
