MINERALS PROGRAM INSPECTION REPORT
PHONE: (303) 866-3567

MINE NAME: T.H.E. Aggregate Source	MINE/PROSPECTING ID#: M-1977-193	MINERAL: Granite, granite gneiss and gravel	COUNTY: Fremont
INSPECTION TYPE: Preoperation Inspection	WEATHER: Cloudy	INSP. DATE: May 17, 2023	INSP. TIME: 13:00
OPERATOR: Tezak Heavy Equipment Co. Inc.	OPERATOR REPRESENTATIVE: Randy DiLuzio	TYPE OF OPERATION: 112c - Construction Regular Operation	
REASON FOR INSPECTION: Surety Related	BOND CALCULATION TYPE: Complete Bond	BOND AMOUNT: \$913,998.00	
DATE OF COMPLAINT: NA	POST INSP. CONTACTS: None	JOINT INSP. AGENCY: None	
INSPECTOR(S): Timothy Cazier, P.E.	INSPECTOR'S SIGNATURE:

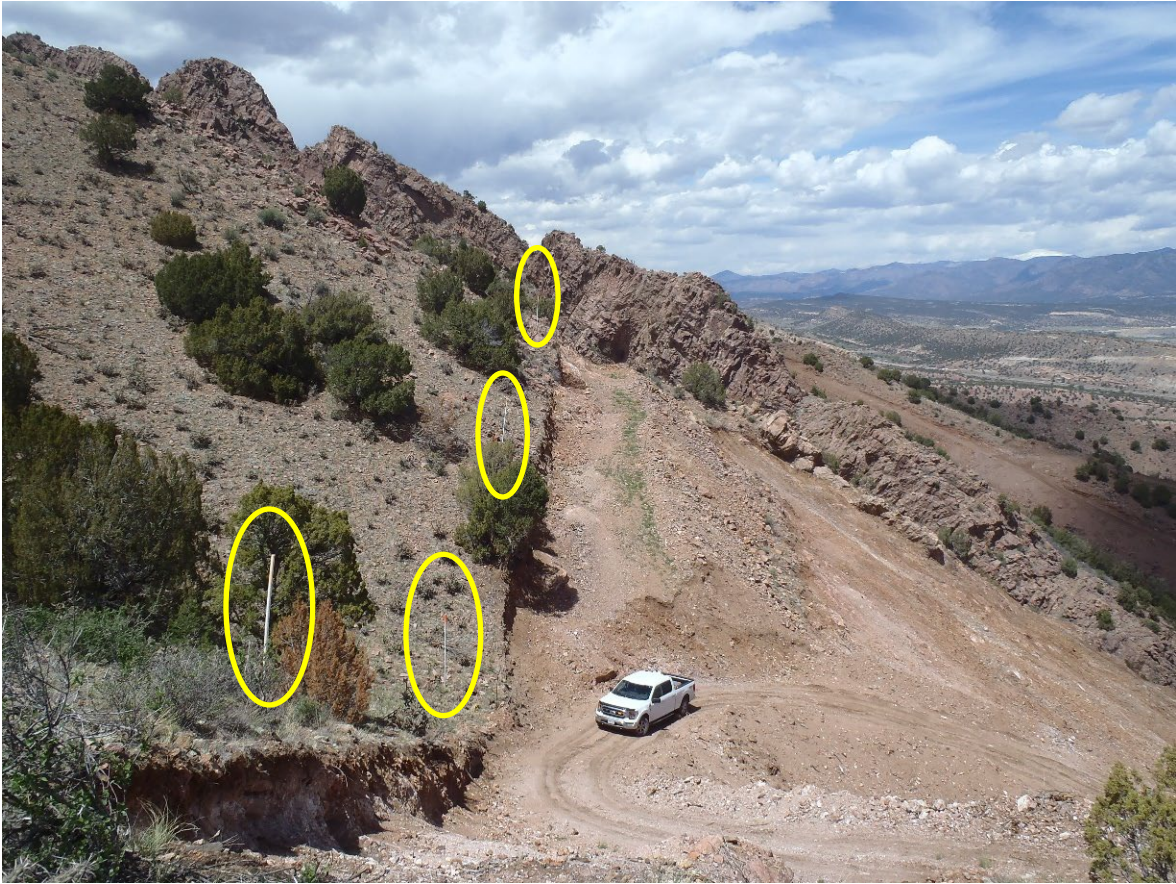
Off-site Damage: All parties went to the ridge of concern to assess the potential for offsite impact, should the ridge be blasted. The west boundary was clearly marked (see **Photo 1**) and the current disturbance was within the boundary. However, given the observed ridge overhang (see **Photo 2**) to the southwest and the extremely steep toe of the ridge (see **Photo 3**), the likelihood of a significant amount of blasted rock ending up offsite to the west was thought to be too high to risk blasting the ridge.

Signs and Markers: The permit sign was properly posted and boundary markers were observed to delineate the permit boundary (see **Photo 1**).

Photo 1. West side boundary markers (circled - looking north from ridge to be blasted).

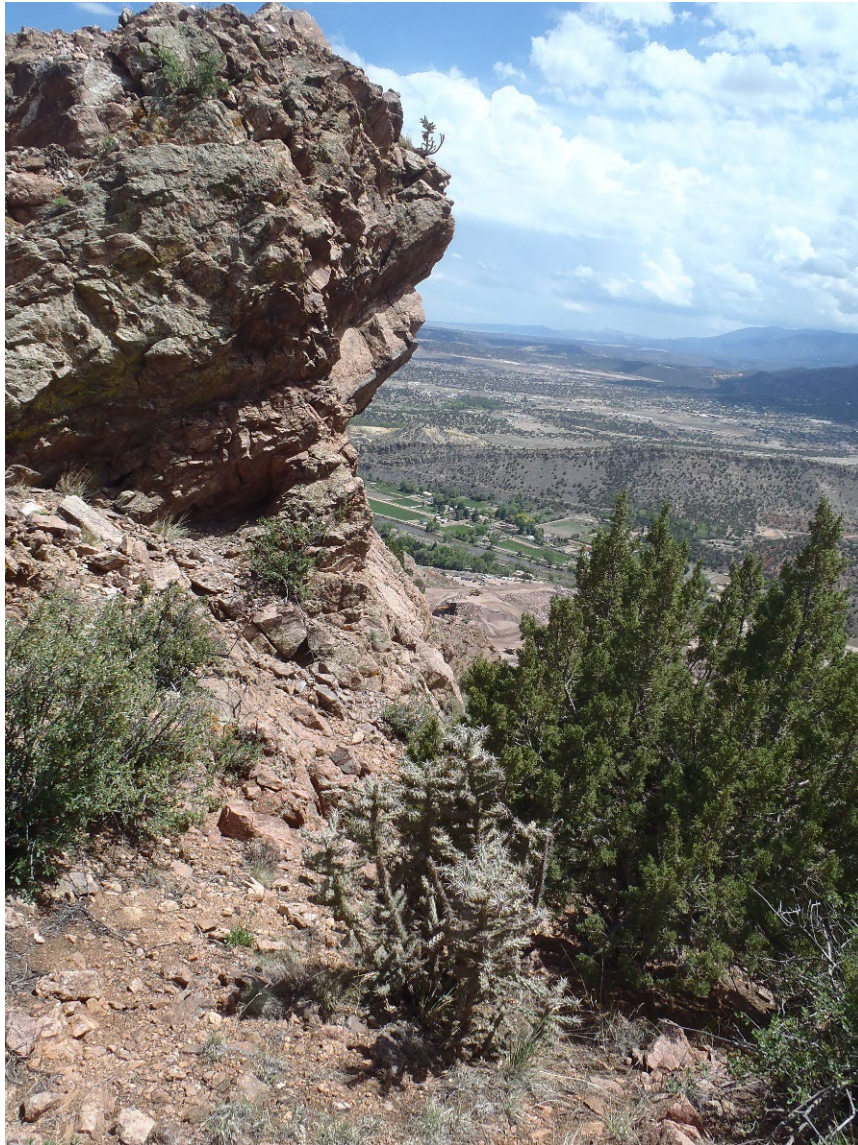
Explosives: The primary concern and focus of this inspection was the potential for blasted rock from the ridge on top of the planned latest expansion into the "Phase 3" area to roll out of the permit boundary on the west side. If blasted material were to settle outside the affected area boundary, the DRMS could consider it offsite impact. Mr. Diluzio also pointed out that retrieving such material would likely result in additional offsite disturbance.

Photo 2. Ridge overhang (looking SE from top of ridge).

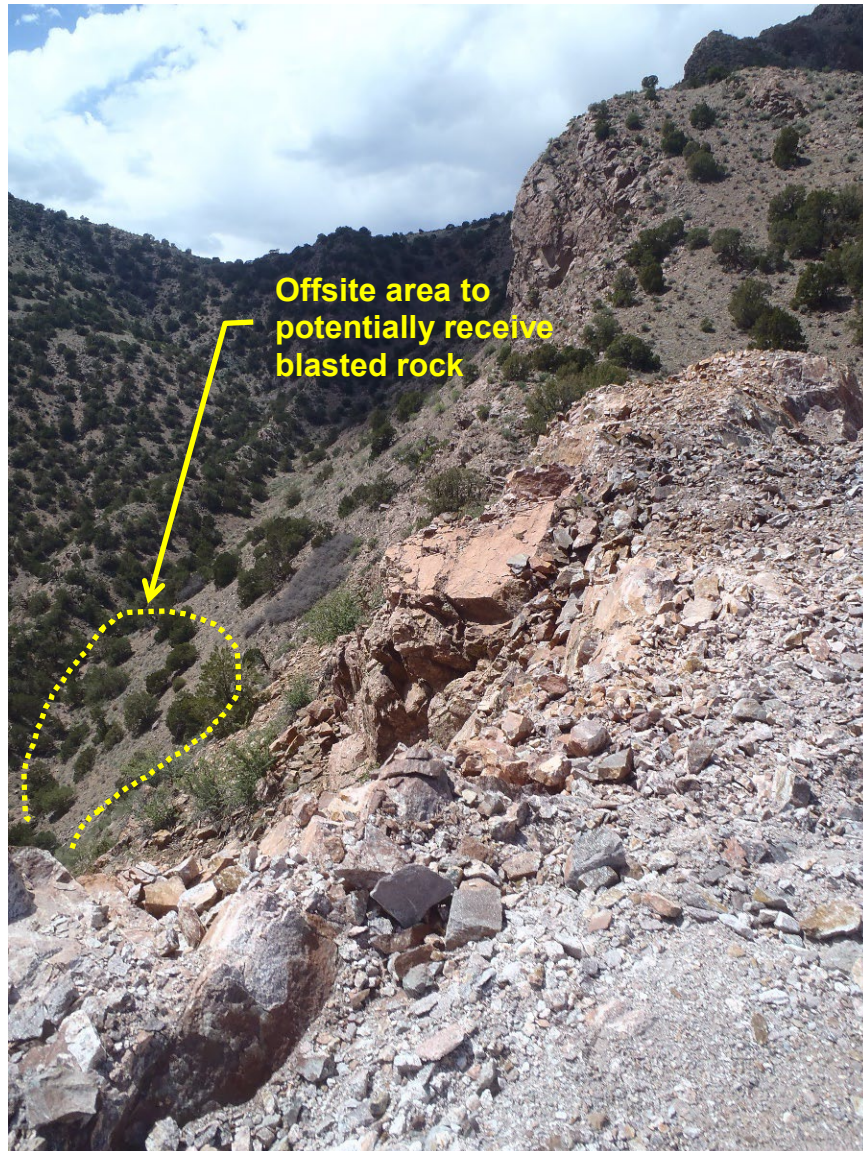
Photo 3. Ridge and steep toe facing the SW (looking west from top of ridge).
