MINERALS PROGRAM INSPECTION REPORT
PHONE: (303) 866-3567

MINE NAME: Coal Creek Resources	MINE/PROSPECTING ID#: M-1988-044	MINERAL: Sand	COUNTY: Arapahoe
INSPECTION TYPE: Monitoring	WEATHER: Cloudy	INSP. DATE: May 18, 2023	INSP. TIME: 11:00
OPERATOR: Schmidt Construction Company	OPERATOR REPRESENTATIVE: Mark Heifner, Dan Chavez	TYPE OF OPERATION: 112c - Construction Regular Operation	
REASON FOR INSPECTION: Normal I&E Program	BOND CALCULATION TYPE:	BOND AMOUNT: \$352,530.82	
DATE OF COMPLAINT: NA	POST INSP. CONTACTS: None	JOINT INSP. AGENCY: None	
INSPECTOR(S): Robin Reilly, GISP	INSPECTOR'S SIGNATURE:

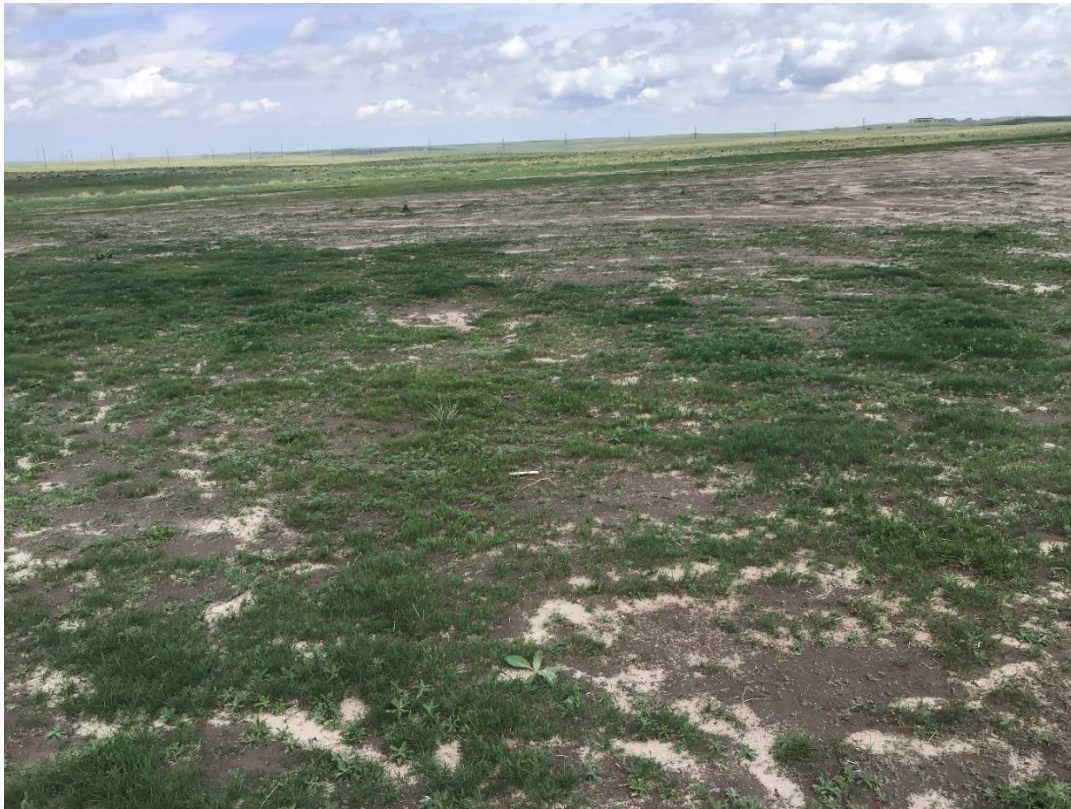
The area was planted in 2014 and appeared to be establishing with adequate cover. Flat areas leading up to the pit were greening up with an abundance of kochia (*Bassia scoparia*) and Russian thistle (*Salsola tragus*). Portions of these areas were seeded in fall of 2022. The seeded weatgrasses (cool season) were sparse as were perennials and warm season species had not yet emerged. Reseeding during 2023 will be necessary due to preponderance of weed seedlings. Vegetation on the west facing slopes of the highwall appeared well established at the time of inspection. Seeding occurred in 2022 at the processing area. Bare spots and erosional features were apparent in portions of the processing area. Vegetation included *Pascopyrum smithii*, *Astragalus* legumes and *Oxytropis spp*. The approximate four acres of processing area are scheduled for reseeding his spring.

Photo 1: Seedlings of Russian thistle were prevalent in area seeded in 2022 (looking north).

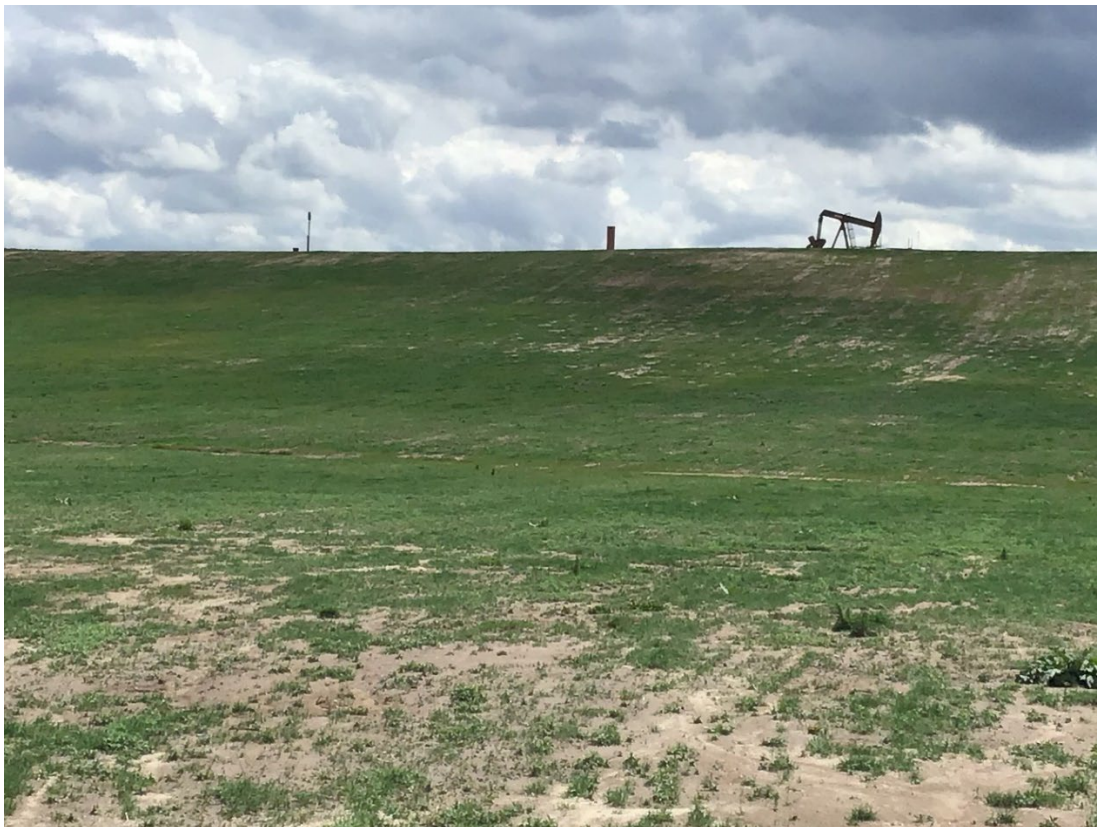
Photo 2: Looking east across the former pit and up the slopes of the former highwall area.

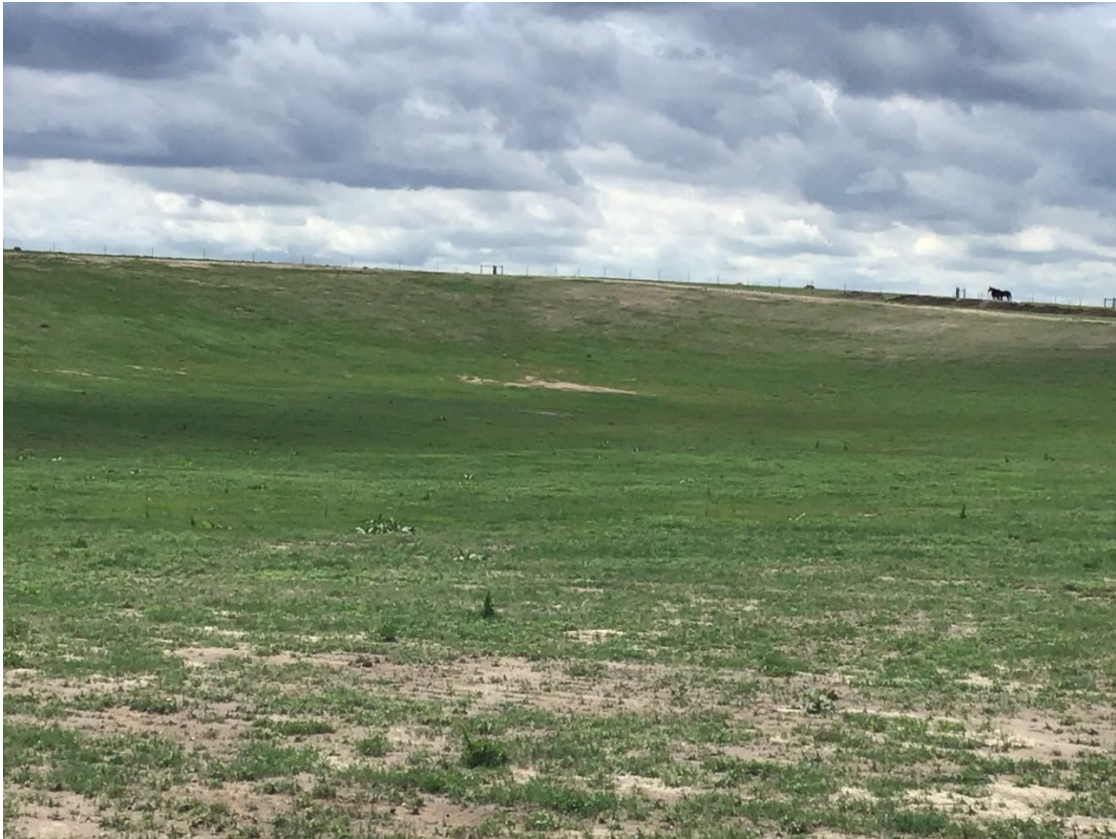
Photo 3: Looking south east, pit and higwall area.

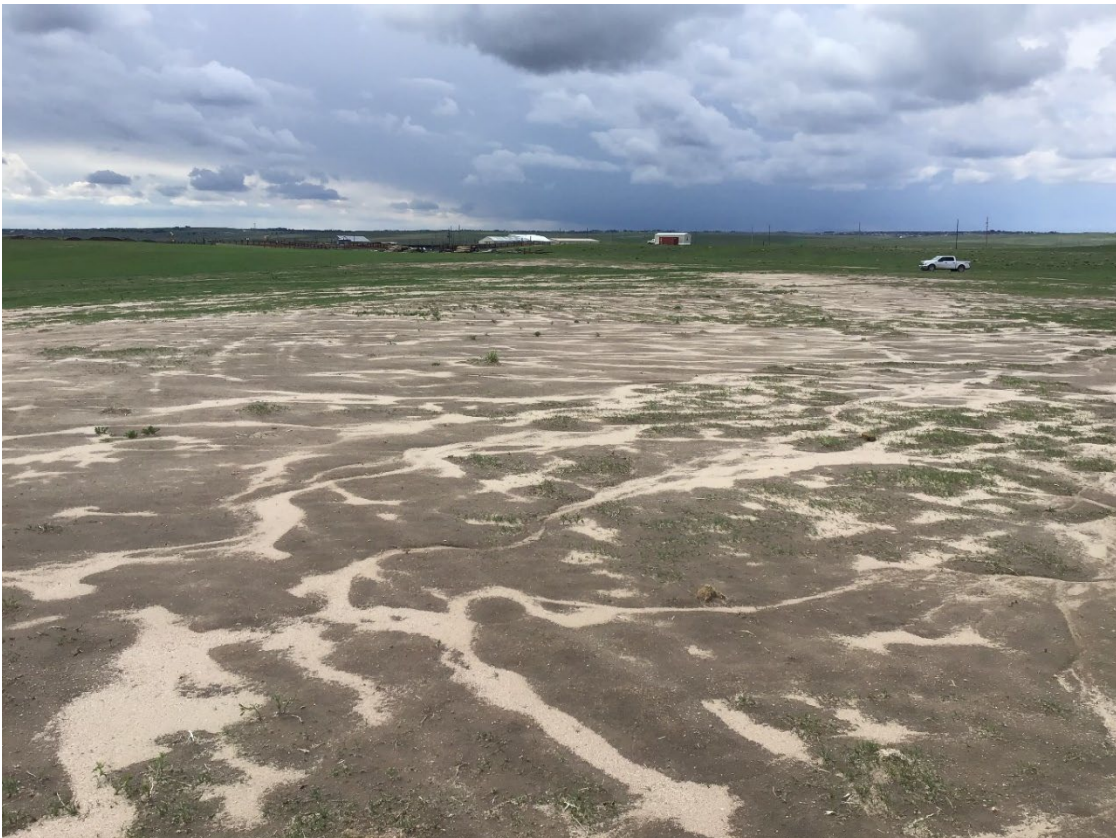
Photo 4: Sparsely vegetated area at the processing area of approximately 4 acres showing signs of overland flow.

The operator agreed to reseeding and mitigation of erosional features as noted in this report. The site appeared stable with gentle slopes that have a western aspect. The area is sprayed for weeds as part of a grazing permit.

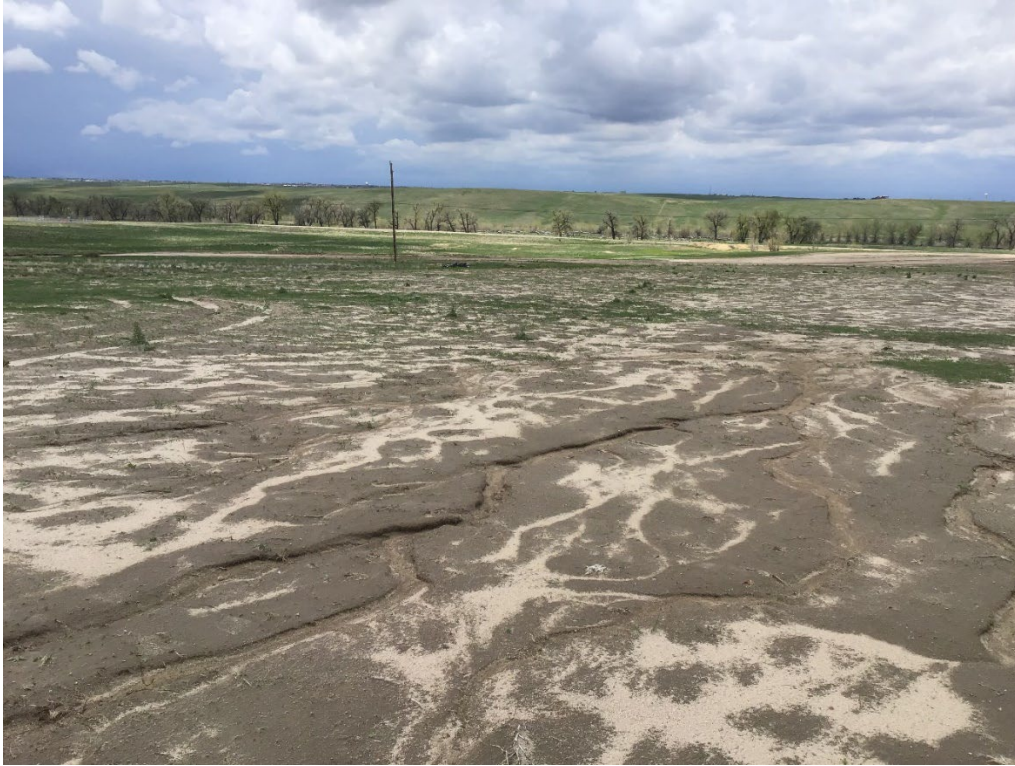
Photo 5: Sparsely vegetated former processing area showing rivulets.

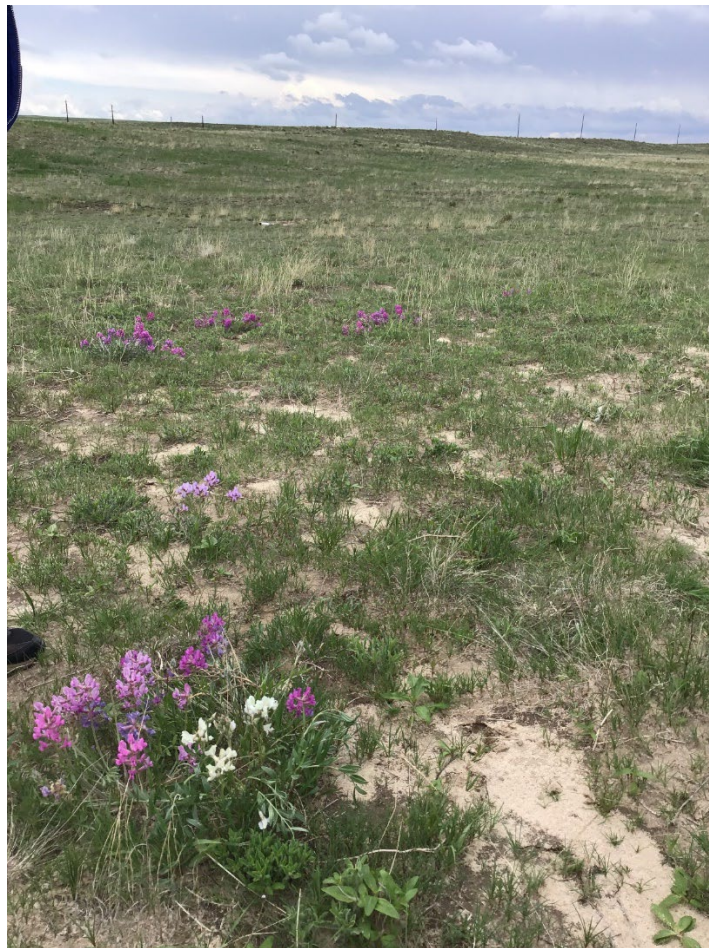
Photo 6: Blooming Oxytropis, (loco weed) among cool season grasses.

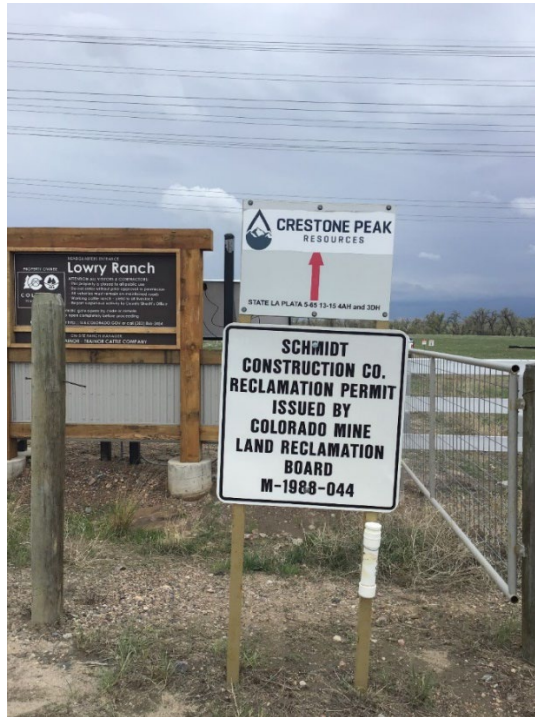
The site is authorized for intermittent operation although no mining is expected. A mine identification sign as required by Rule 3.1.12 was observed at the entrance. The permit boundary is clearly marked with perimeter fencing.

Photo 7: Mine identification sign posted at entrance from Quincy Ave.
