MINERALS PROGRAM INSPECTION REPORT
PHONE: (303) 866-3567

MINE NAME: Superior S&G Pit	MINE/PROSPECTING ID#: M-1979-189	MINERAL: Sand and gravel	COUNTY: Arapahoe
INSPECTION TYPE: Surety Release Inspection	WEATHER: Cloudy	INSP. DATE: May 18, 2023	INSP. TIME: 09:00 a.m.
OPERATOR: City of Aurora	OPERATOR REPRESENTATIVE: Brian Green	TYPE OF OPERATION: 112c - Construction Regular Operation	
REASON FOR INSPECTION: Normal I&E Program	BOND CALCULATION TYPE:	BOND AMOUNT: \$0.00	
DATE OF COMPLAINT: NA	POST INSP. CONTACTS: None	JOINT INSP. AGENCY: None	
INSPECTOR(S): Robin Reilly, GISP	INSPECTOR'S SIGNATURE:

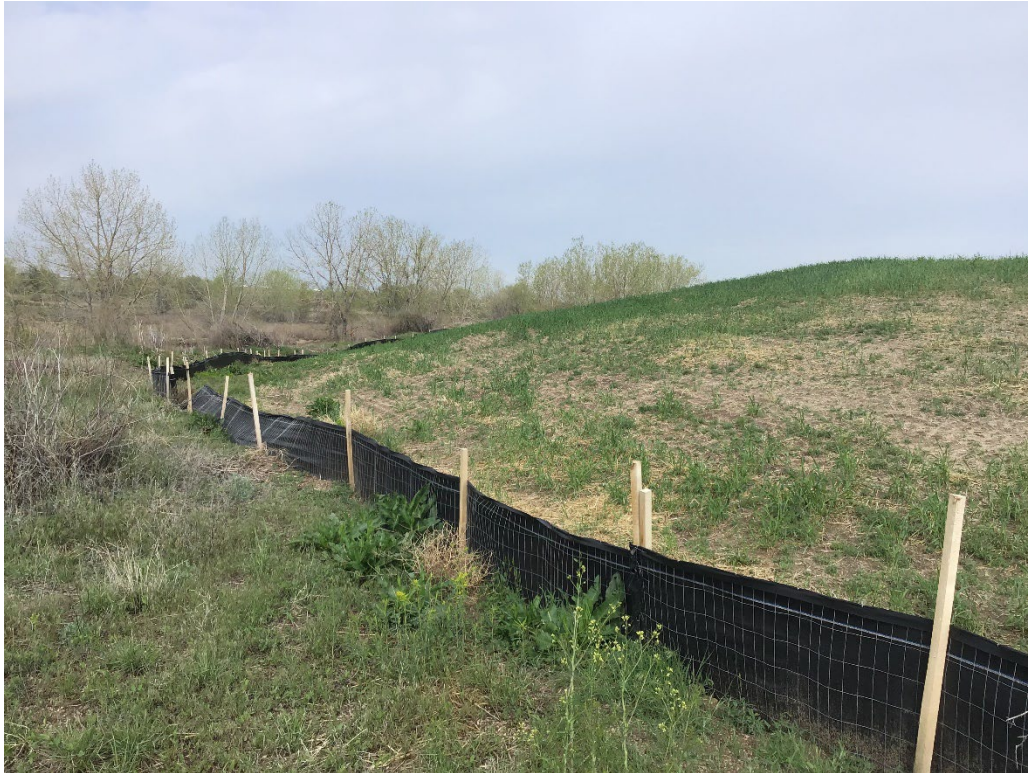
An overburden stockpile located at the north east corner of the site had been gently sloped, vegetated and contained with a silt fence. The pile will remain as a permanent pile as is. The pile appeared stable with adequate cover. The portion of the site visited appeared stable and reclamation appeared to follow the reclamation plan with diverse native and wetland vegetation beginning to establish.

Photo 1: Overburden pile that will remain, looking west.

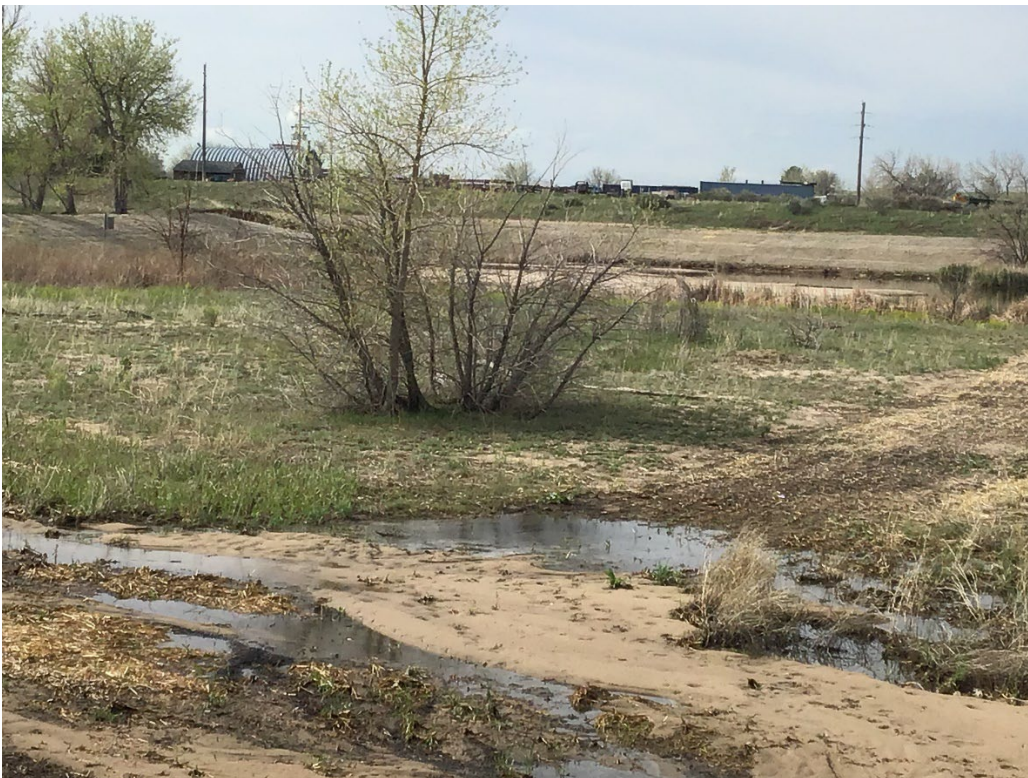
Photo 2. Looking south to eastern section ponds. Banks are blanketed and seeded.

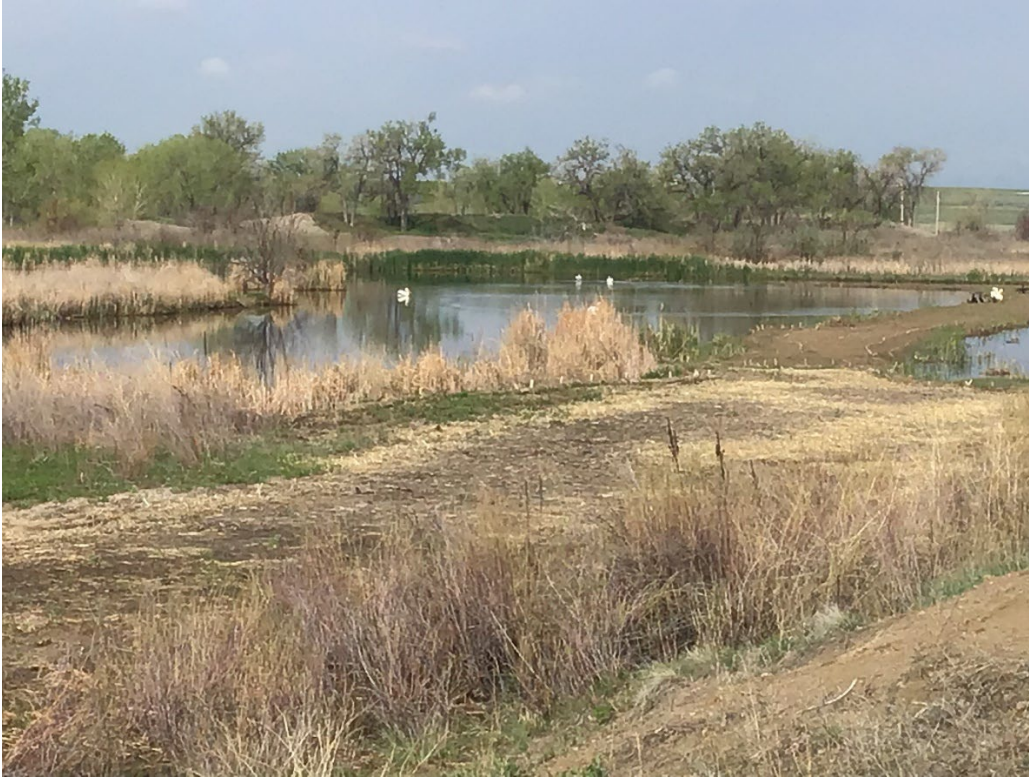
Photo 3: Looking se at ponds

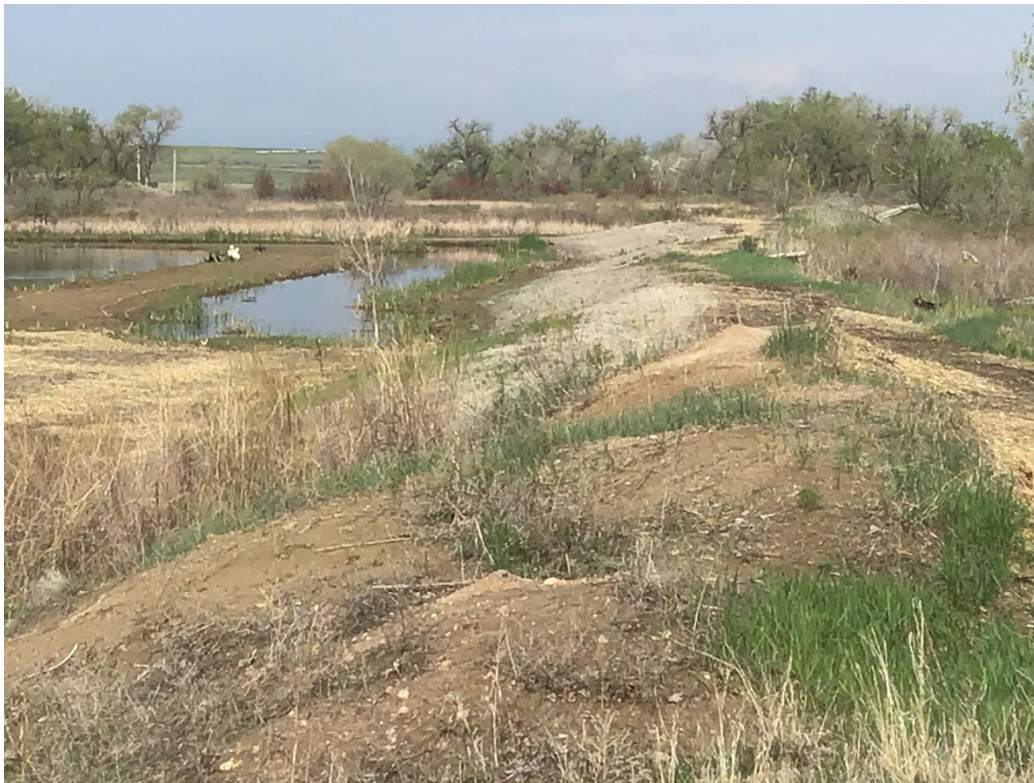
Photo 4: Looking down a low ridge between dewatering ditch and ponds.

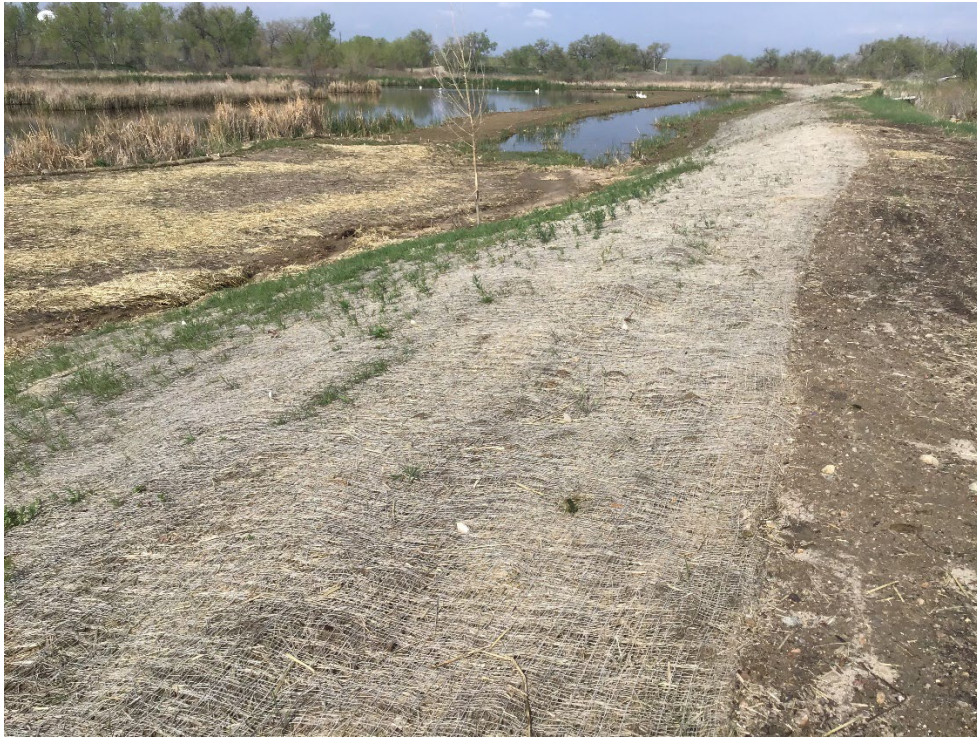
As Eagles were nesting, the inspection comprised a partial site inspection avoiding the buffer around the nesting site. The areas east of the buffer were visited. The eagle was seen roosting on a treetop. Pelicans, avocet and other waterfowl were observed at the time of inspection. Vegetation is establishing on the east end of the Ponds with lupines and legumes blooming and native grasses emerging. Slopes are shallow exhibiting a 3H to 1H ration. Biodegradable erosion control blankets were present on most slopes along the pond banks and vegetation was beginning to emerge through the blankets, although vegetation appeared sparse. Warm season grasses had not yet emerged.

Photo 5: *Example of the erosion/ vegetation blankets and the slopes along the ponds.*

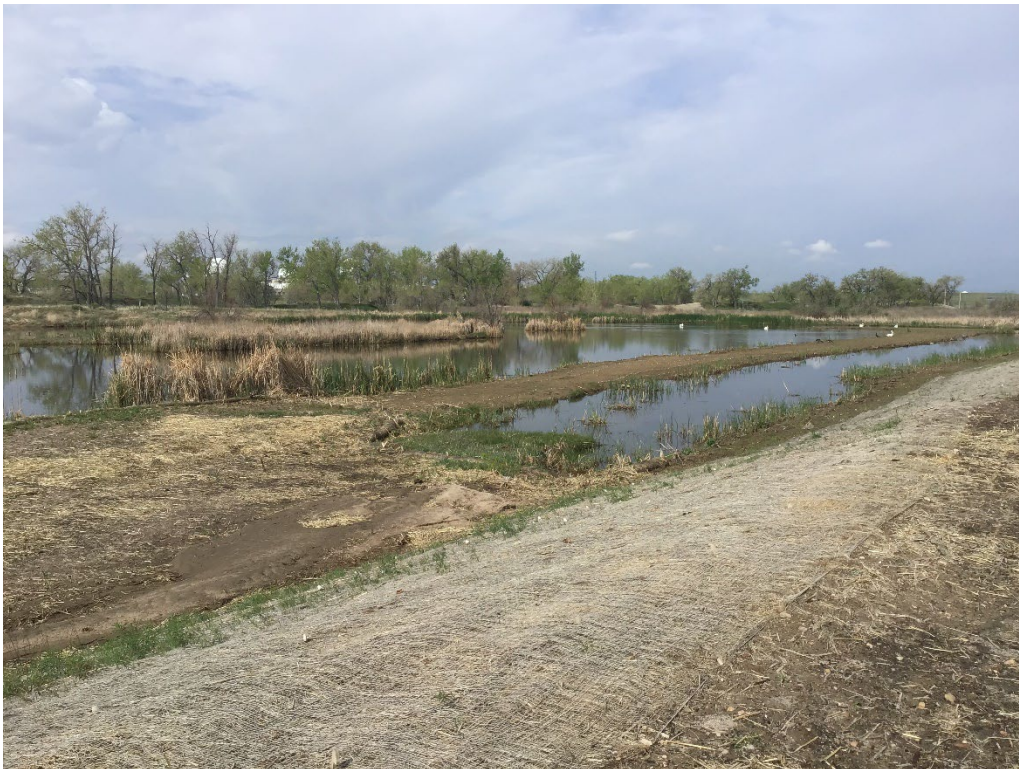
Photo 6: *looking west*
