## New Horizon Mine, C-1981-008, May Complete Inspection Report

<b>Permit Number:</b> C-1981-008 <b>Mine Name:</b> New Horizon Mine <b>Operator:</b> Elk Ridge Mining and Reclamation, LLC <b>Operator Address:</b> Mr. Tony Tennyson P.O. Box 628 27646 West 5th Avenue Nucla, CO 81424	<b>County:</b> Montrose <b>Operation Type:</b> Surface <b>Permit Status:</b> Active <b>Ownership:</b> Private
	<b>Operator Representative Present:</b>  Mindy Sickles
<b>Operator Representative Signature: (Field Issuance Only)</b>

<b>Inspection Start Date:</b> May 23, 2023 <b>Inspection Start Time:</b> 11:35 <b>Inspection End Date:</b> <b>Inspection End Time:</b>		<b>Inspection Type:</b> Coal Complete Inspection <b>Inspection Reason:</b> Normal I&E Program <b>Weather:</b> Clear	
<b>Joint Inspection Agency:</b>  None		<b>Joint Inspection Contacts:</b>  None	
<b>Post Inspection Agency:</b>  None		<b>Post Inspection Contacts:</b>  None	
<b>Inspector(s):</b>  Clayton Wein	<b>Inspector's Signature:</b>  <i>Clayton Wein</i>		<b>Signature Date:</b>  6/5/2023

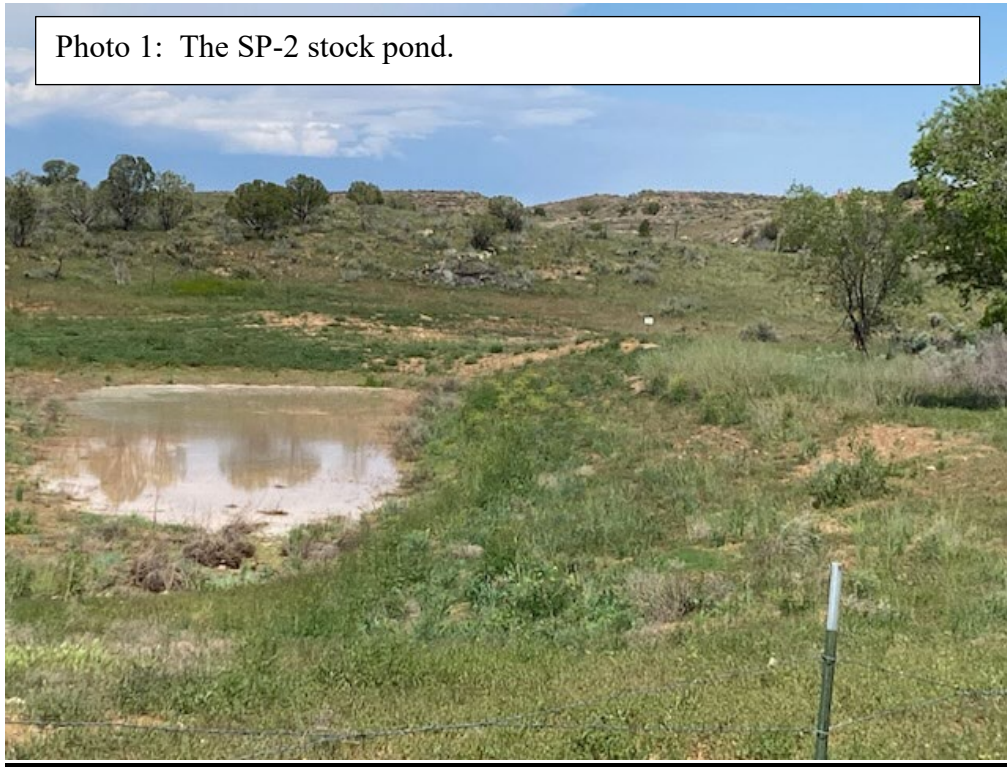
Stock Pond SP-2 was holding water during the inspection. There was no discharge through the primary spillway. The pond's embankment was stable with vegetative cover (Photo 1). There were no indications of erosional features. The primary outlet for the pond was clear of debris. The bottom of Pond 012 was damp at the time of the inspection (Photo 2). The primary outlet for the pond was observed to be free of obstructions. There were no indications of instability or erosion on the embankment. The embankment was covered with vegetation. Pond 013 was impounding water from the French drain and from irrigation waters (Photo 3). The level of water in the pond was entering the discharge outlet. The outlet was clear of debris and functioning as designed. The pond's embankment was vegetated and stable. No erosional features were identified. Pond 015 was dry (Photo 4). The embankment was stable with some vegetative cover. The minor rills observed on the pond's embankment had not enlarged during the spring. The outlet for the pond was unobstructed. Pond 016 was holding water during the inspection (Photo 5). No discharge was observed from the pond. The outlet was clear of debris. Pond 016's embankment was stable with vegetative cover. There were no erosional concerns identified. Pond 018 was observed to be dry. The outlet for the pond was unobstructed. The embankment was stable with vegetation. No indications of erosion were identified.

Photo 1: The SP-2 stock pond.

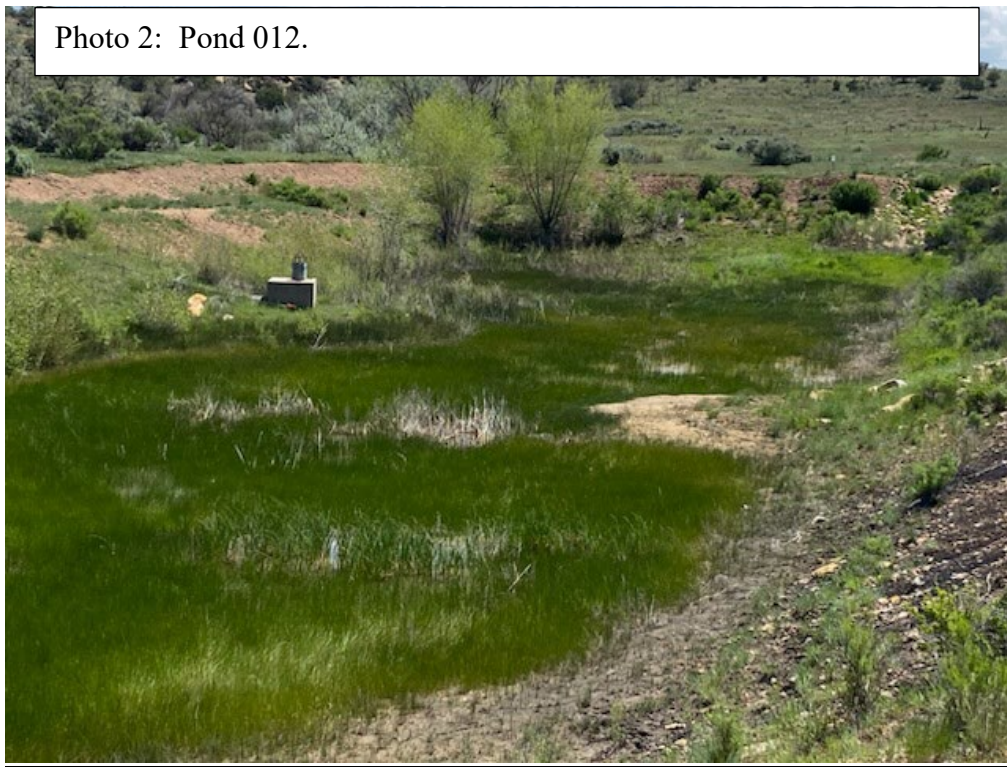
Photo 2: Pond 012.

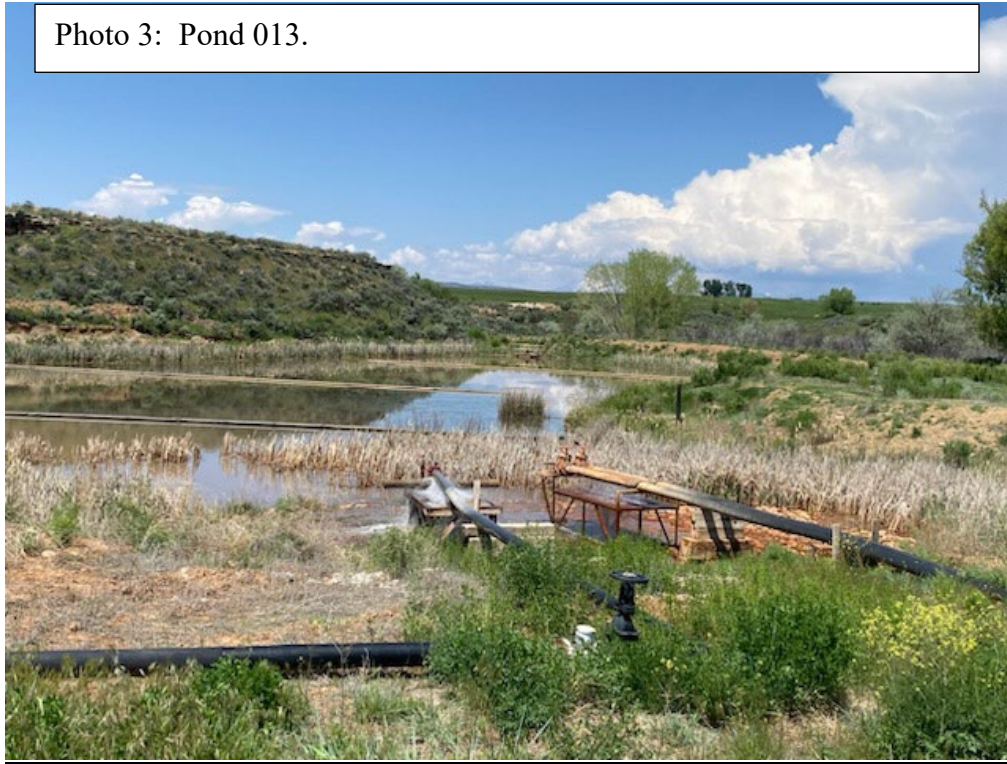
Photo 3: Pond 013.

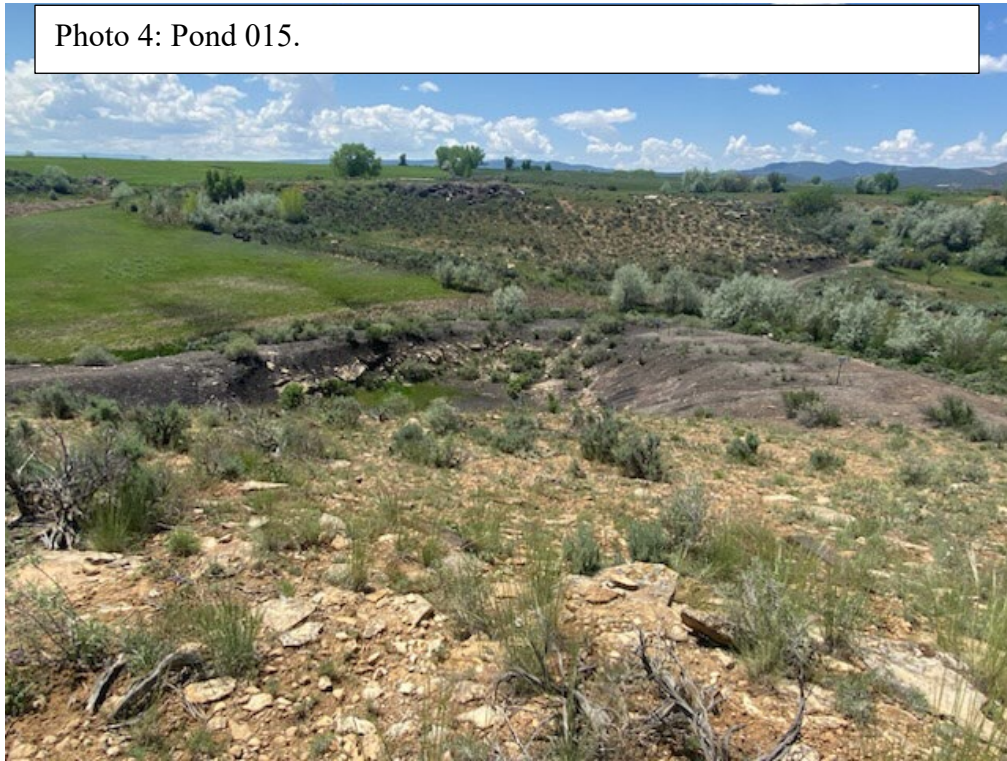
Photo 4: Pond 015.

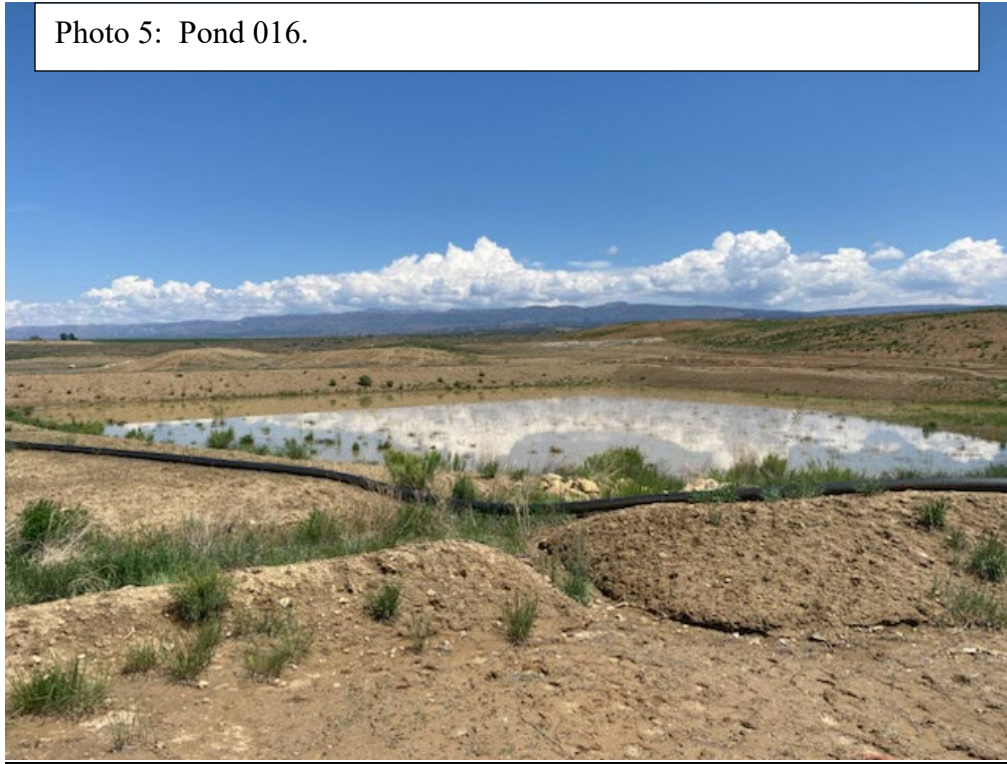
Photo 5: Pond 016.

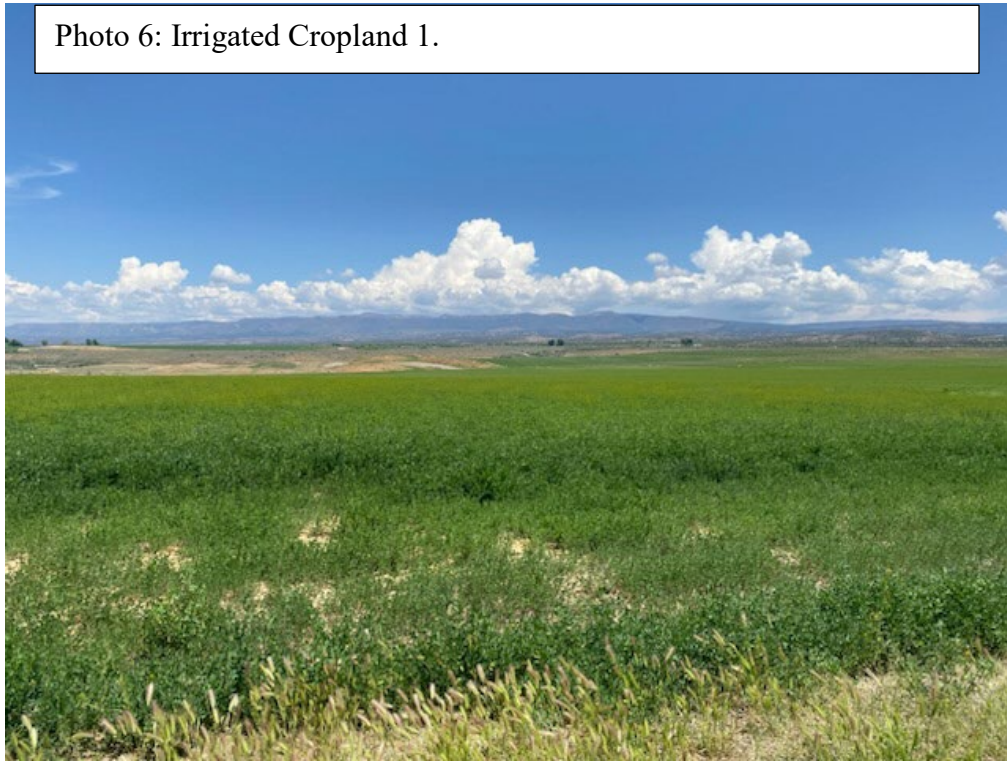
Irrigated Cropland No. 1 (IC-1) is to the west of IP-10 across 2700 Road. IC-1 was covered with established vegetative cover (Photo 6). The field was stable and there were no erosional features observed.

Photo 6: Irrigated Cropland 1.

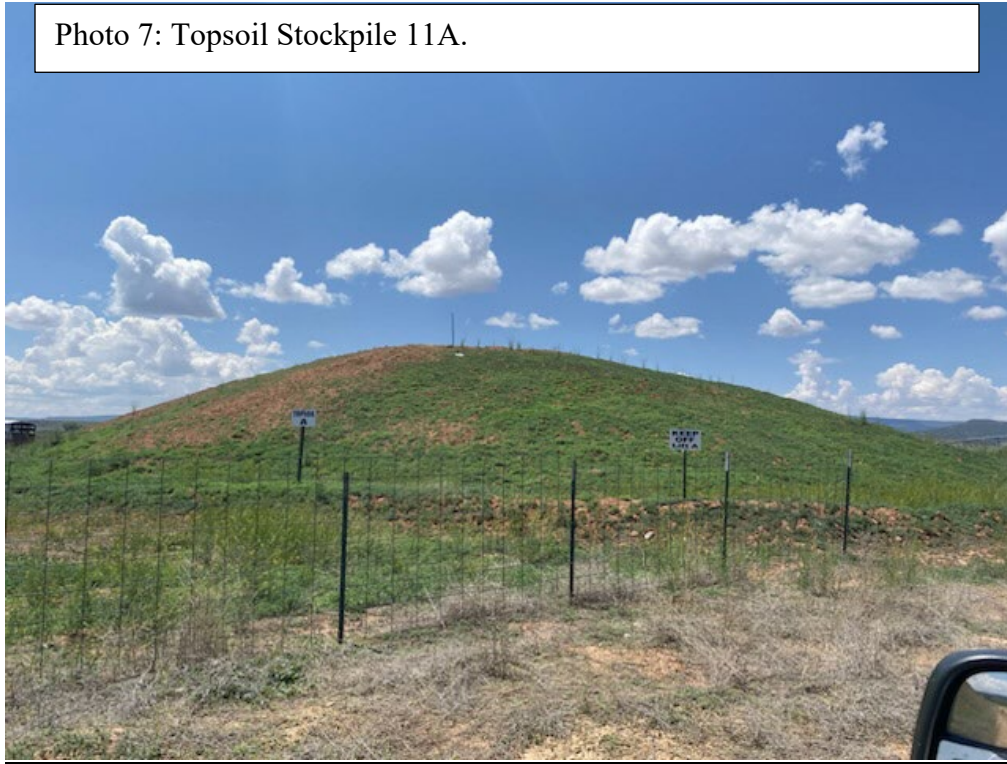
Topsoil stockpiles 4, 5, 11A (Photo 7), 11B (Photo 8), 12 (Photo 9) and 13 were visited during the inspection. The topsoil piles were observed to be stable with sufficient vegetative cover. The perimeter ditches for the piles were stable and in good condition. No erosional concerns were identified. There was no loss of topsoil resource observed. Topsoil pile markers were observed at each of the stockpiles. The signs were posted in un-

Photo 7: Topsoil Stockpile 11A.

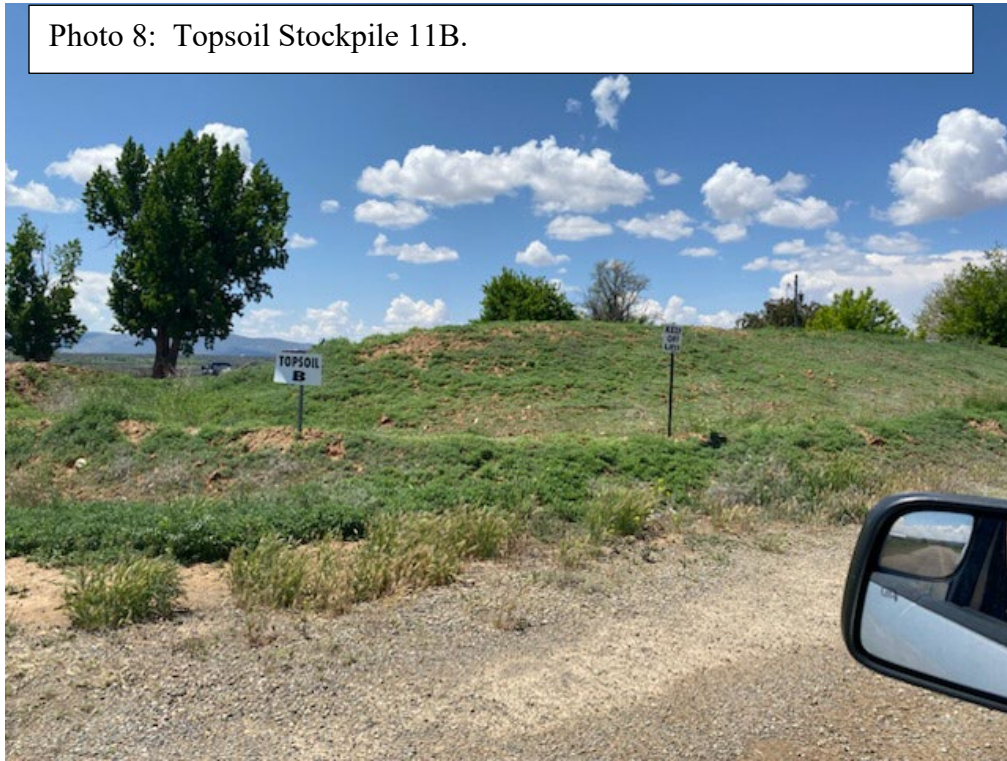
Photo 8: Topsoil Stockpile 11B.

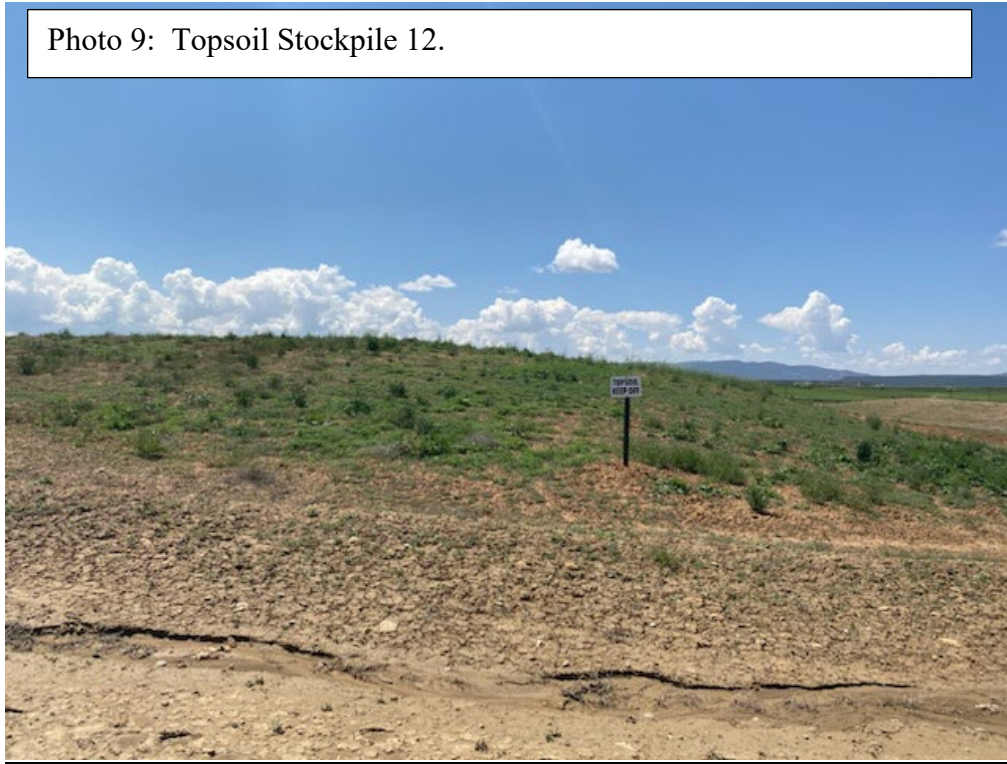
Photo 9: Topsoil Stockpile 12.
