New Horizon Mine, C-1981-008, May Complete Inspection Report

Permit Number: C-1981-008 Mine Name: New Horizon Mine Operator: Elk Ridge Mining and Reclamation, LLC Operator Address: Mr. Tony Tennyson P.O. Box 628 27646 West 5th Avenue Nucla, CO 81424	County: Montrose Operation Type: Surface Permit Status: Active Ownership: Private
	Operator Representative Present: Mindy Sickles
Operator Representative Signature: (Field Issuance Only)

Inspection Start Date: May 23, 2023 Inspection Start Time: 11:35 Inspection End Date: Inspection End Time:		Inspection Type: Coal Complete Inspection Inspection Reason: Normal I&E Program Weather: Clear	
Joint Inspection Agency: None		Joint Inspection Contacts: None	
Post Inspection Agency: None		Post Inspection Contacts: None	
Inspector(s): Clayton Wein	Inspector's Signature: <i>Clayton Wein</i>		Signature Date: 6/5/2023

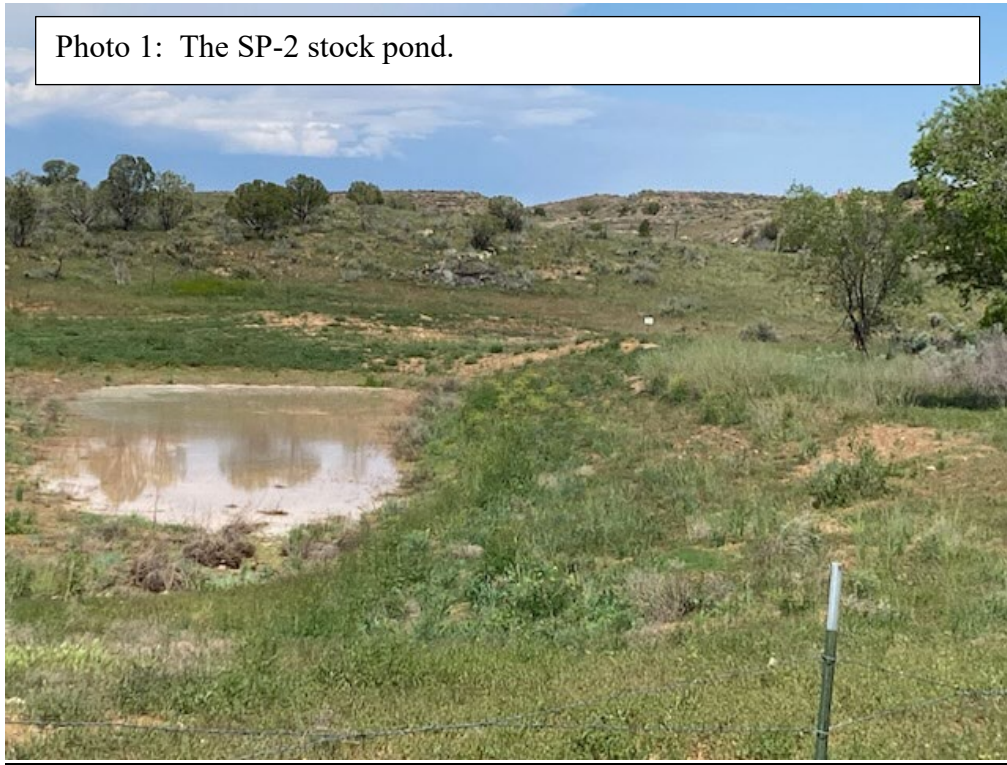
Stock Pond SP-2 was holding water during the inspection. There was no discharge through the primary spillway. The pond's embankment was stable with vegetative cover (Photo 1). There were no indications of erosional features. The primary outlet for the pond was clear of debris. The bottom of Pond 012 was damp at the time of the inspection (Photo 2). The primary outlet for the pond was observed to be free of obstructions. There were no indications of instability or erosion on the embankment. The embankment was covered with vegetation. Pond 013 was impounding water from the French drain and from irrigation waters (Photo 3). The level of water in the pond was entering the discharge outlet. The outlet was clear of debris and functioning as designed. The pond's embankment was vegetated and stable. No erosional features were identified. Pond 015 was dry (Photo 4). The embankment was stable with some vegetative cover. The minor rills observed on the pond's embankment had not enlarged during the spring. The outlet for the pond was unobstructed. Pond 016 was holding water during the inspection (Photo 5). No discharge was observed from the pond. The outlet was clear of debris. Pond 016's embankment was stable with vegetative cover. There were no erosional concerns identified. Pond 018 was observed to be dry. The outlet for the pond was unobstructed. The embankment was stable with vegetation. No indications of erosion were identified.

Photo 1: The SP-2 stock pond.

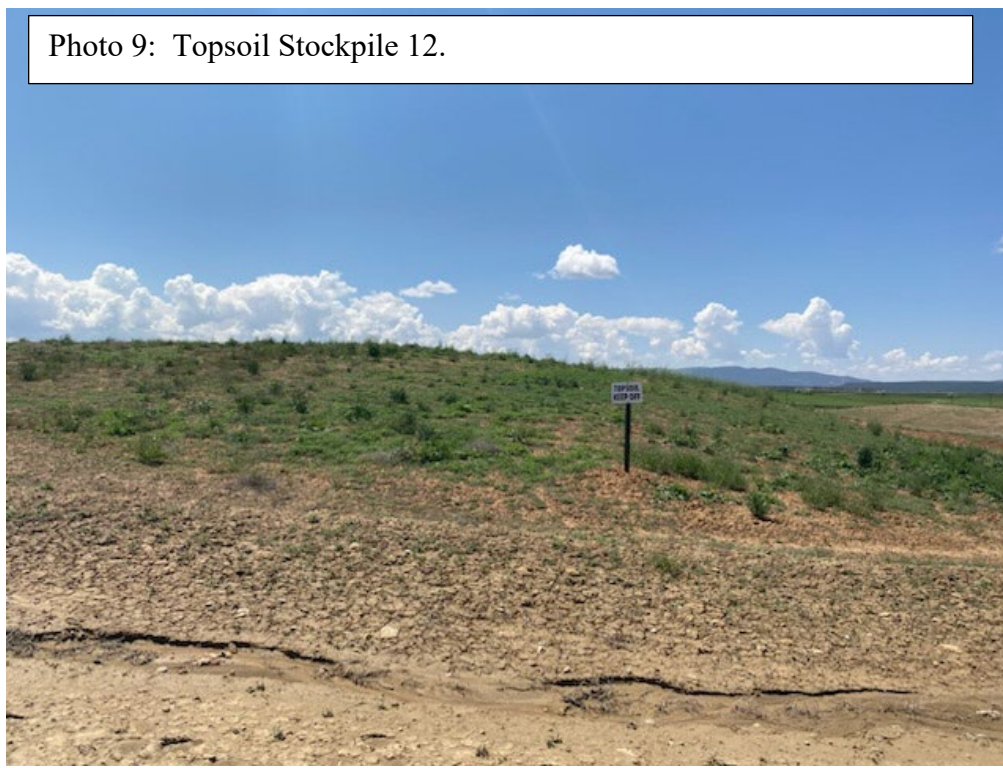
Topsoil stockpiles 4, 5, 11A (Photo 7), 11B (Photo 8), 12 (Photo 9) and 13 were visited during the inspection. The topsoil piles were observed to be stable with sufficient vegetative cover. The perimeter ditches for the piles were stable and in good condition. No erosional concerns were identified. There was no loss of topsoil

Photo 9: Topsoil Stockpile 12.
