## Roadside Mine, C-1981-041, May Partial Inspection Report

**PERMIT INFORMATION**

**INSPECTION INFORMATION**

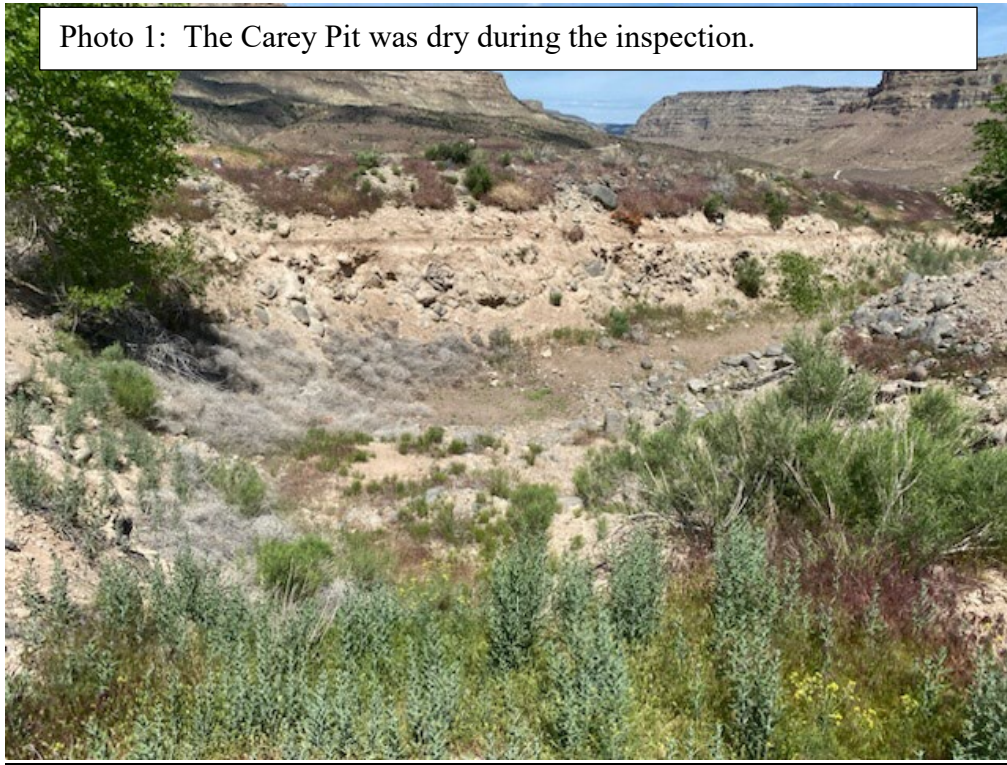
During the inspection of Tract 71, there was no water observed flowing from the landowner's buried pipe into the Carey Pit. The pit was observed to be dry (Photo 1). Also during the inspection of Tract 71, there was no water observed flowing in the landowner's north and east trenches. No impacts to the TR-69 Repair Area were observed.

Photo 1: The Carey Pit was dry during the inspection.

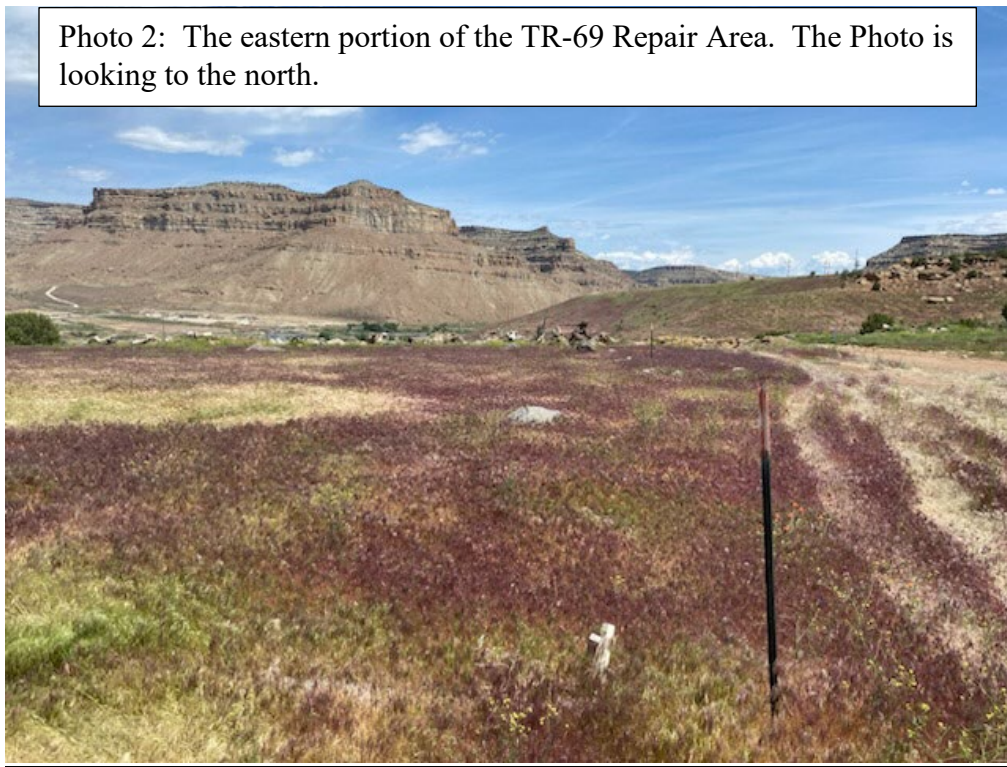
Photo 2: The eastern portion of the TR-69 Repair Area. The Photo is looking to the north.

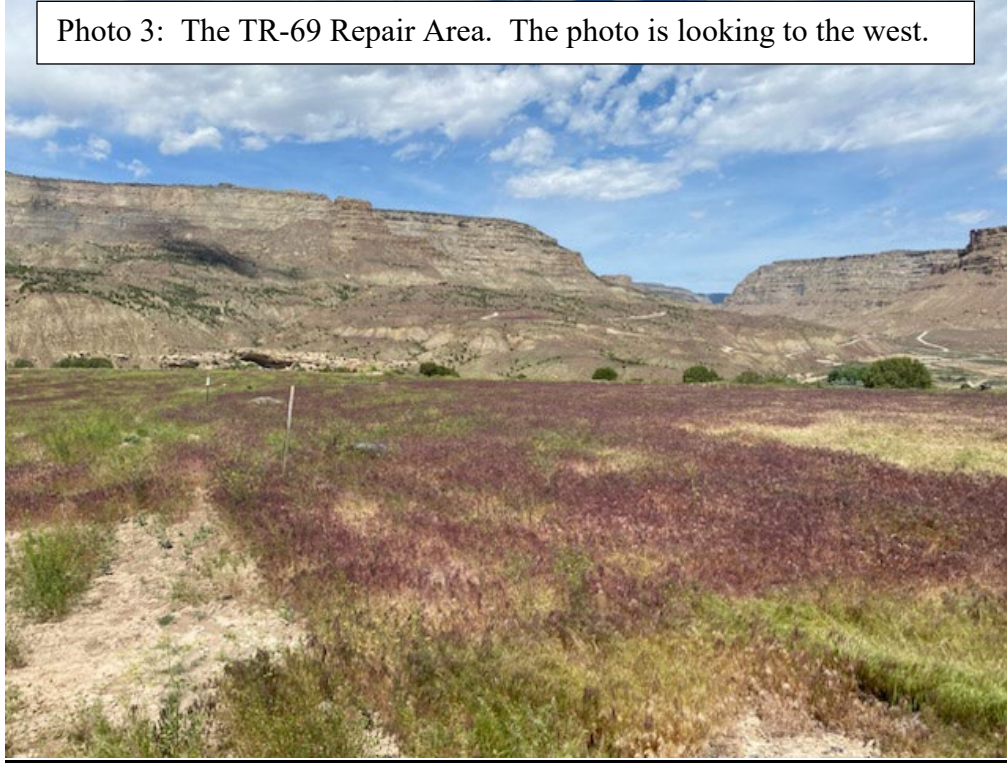
Photo 3: The TR-69 Repair Area. The photo is looking to the west.
