**PERMIT INFORMATION**

| <b>Permit Number:</b> C-1981-028<br><b>Mine Name:</b> Keenesburg Strip Mine<br><b>Operator:</b> Coors Energy Company<br><b>Operator Address:</b><br>Mr Ben Moline<br>P.O. Box 4030<br>Golden, CO 80402 | <b>County:</b> Weld<br><b>Operation Type:</b> Surface<br><b>Permit Status:</b> Permanent Cessation<br><b>Ownership:</b> Private |

**INSPECTION INFORMATION**

| <b>Inspection Start Date:</b> May 31, 2023<br><b>Inspection Start Time:</b> 09:30<br><b>Inspection End Date:</b> May 31, 2023<br><b>Inspection End Time:</b> 11:00 | | <b>Inspection Type:</b> Coal Partial Inspection<br><b>Inspection Reason:</b> Normal I&E Program<br><b>Weather:</b> Clear | |

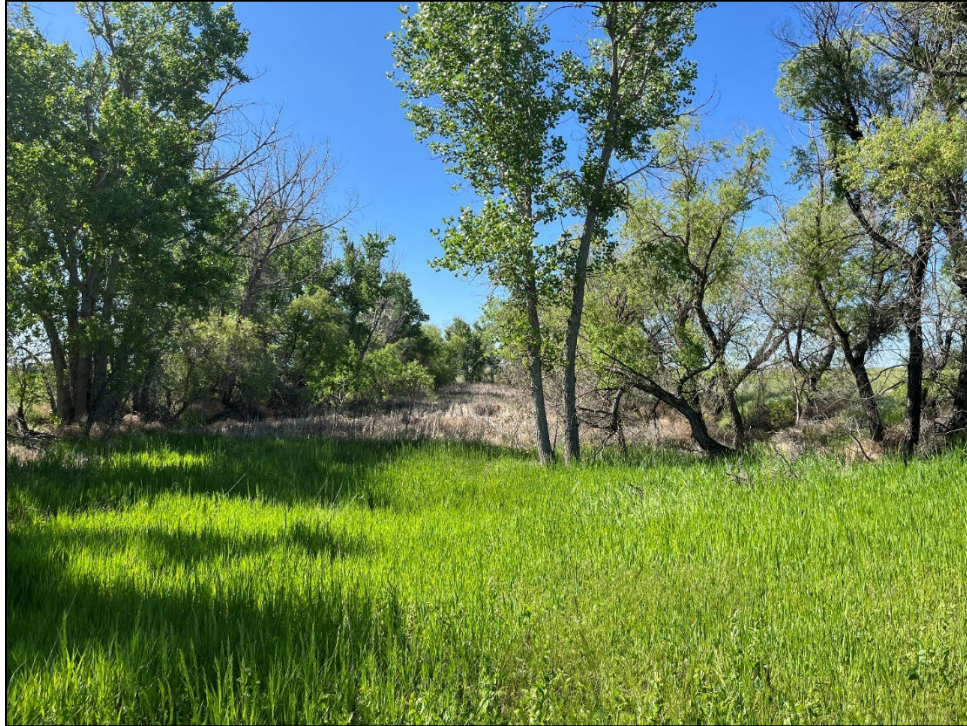
Two permanent ponds, the Dugout Pond to the west and Sediment Pond 2 to the north, were inspected. Both were found to be holding little to no water and were heavily overgrown with thick vegetation (Photos 1 and 2). Neither pond was discharging at the time of inspection. There were no problems observed with the spillway or other pond features (Photo 3).

*Photo 1: View south of the Dugout Pond, filled with thick vegetation*

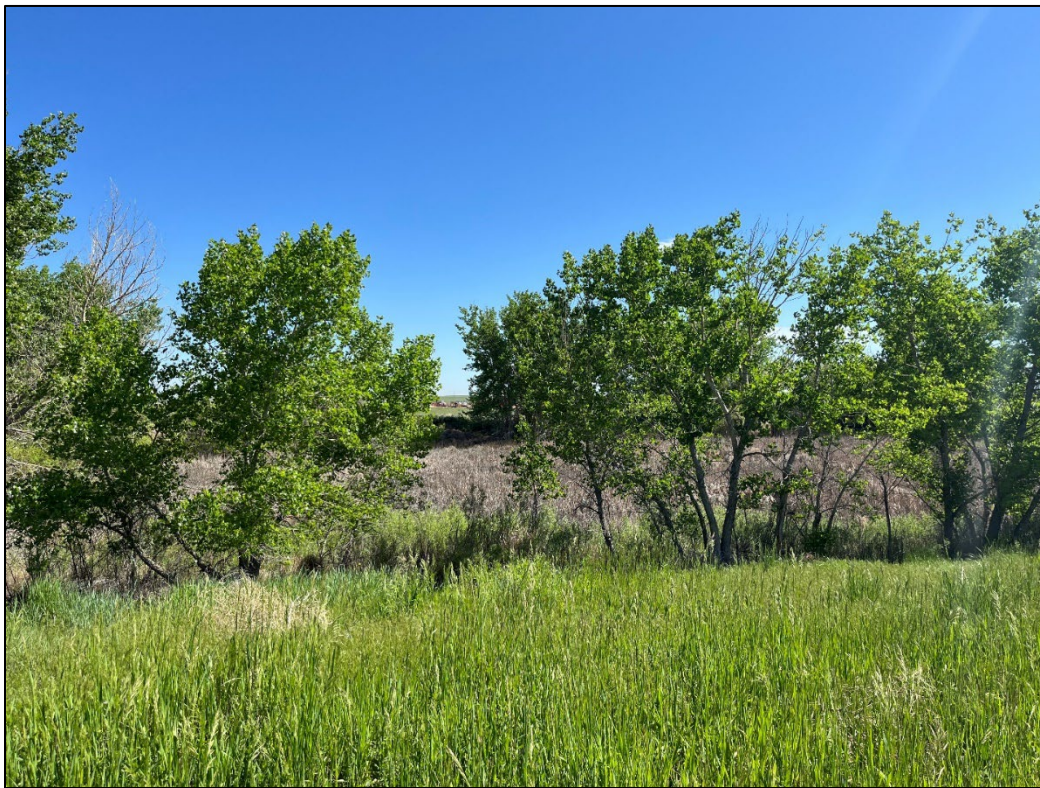
*Photo 2: View north of Sediment Pond 2, filled with thick vegetation*

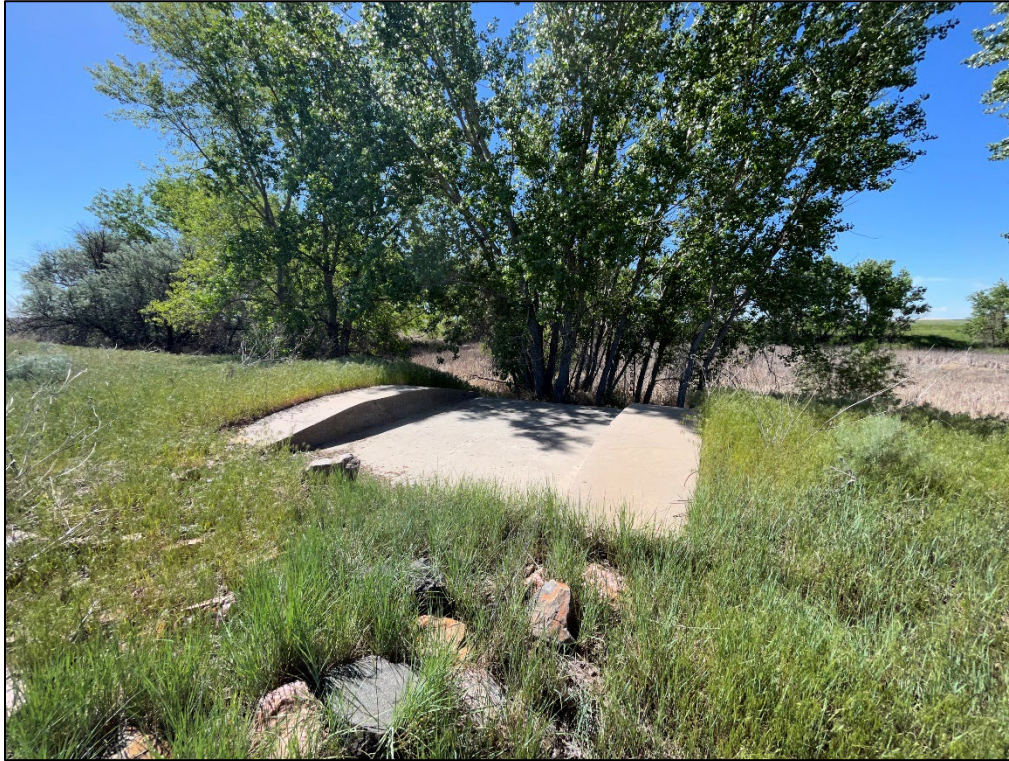
*Photo 3: Spillway at Sediment Pond 2*

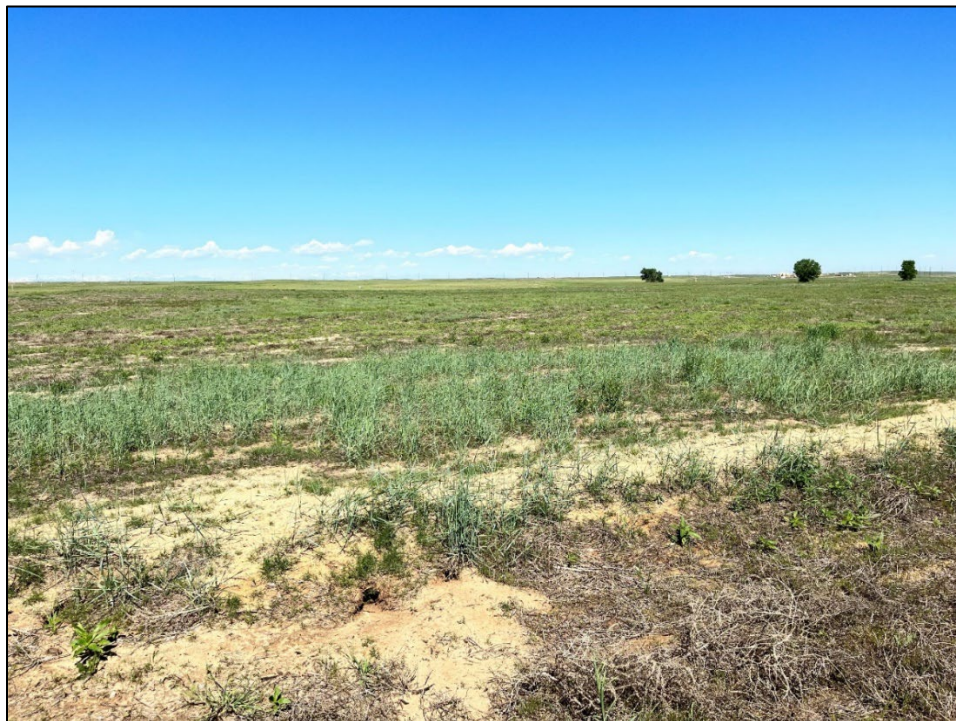
No critical erosion features were seen at the site. Bare spots were observed in some areas (Photos 4, 5, 6). Prairie dog activity is likely creating most of the small erosional features within the site (Photo 6).

The ground is still largely bare in areas most recently seeded in 2022 (Photos 8 and 9). Several patches of native and non-noxious grasses and forbs continue to thrive in areas of older reclamation across the site (Photos 4, 10-13). Some non-noxious weeds were noted across the site but were not seen in large patches (Photo 14).

*Photo 4: Bare patch of ground located along the eastern boundary of Section 25, a patch of Western wheatgrass (*Pascopyrum smithii*) is noted here*

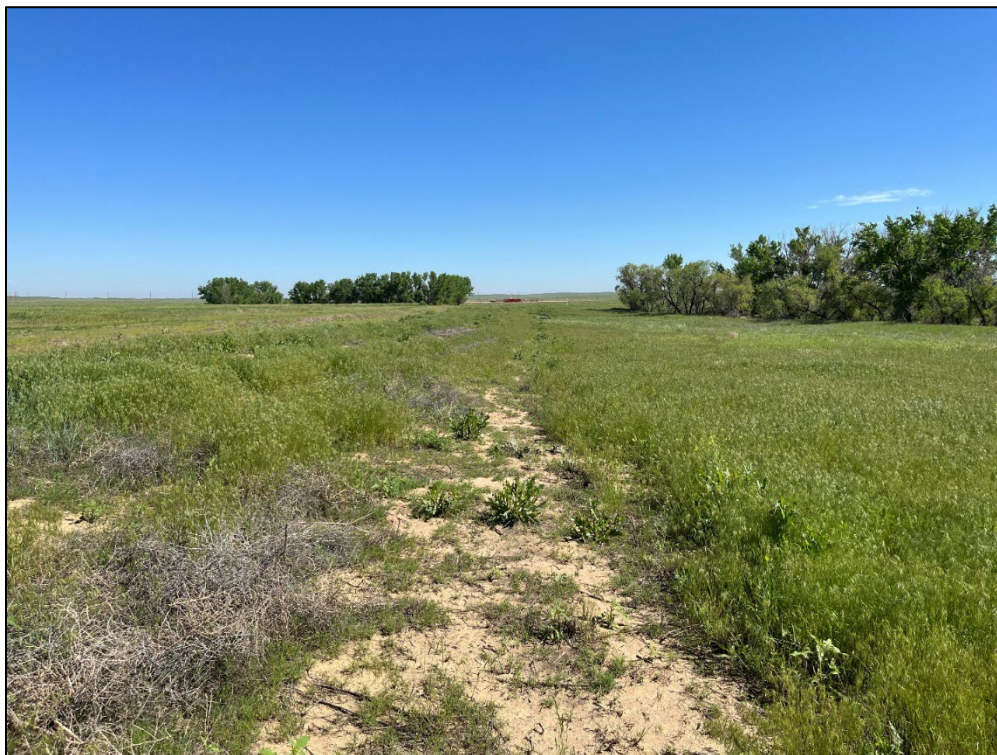
*Photo 5: A bare strip of soil lies along the western side of the Dugout Pond*

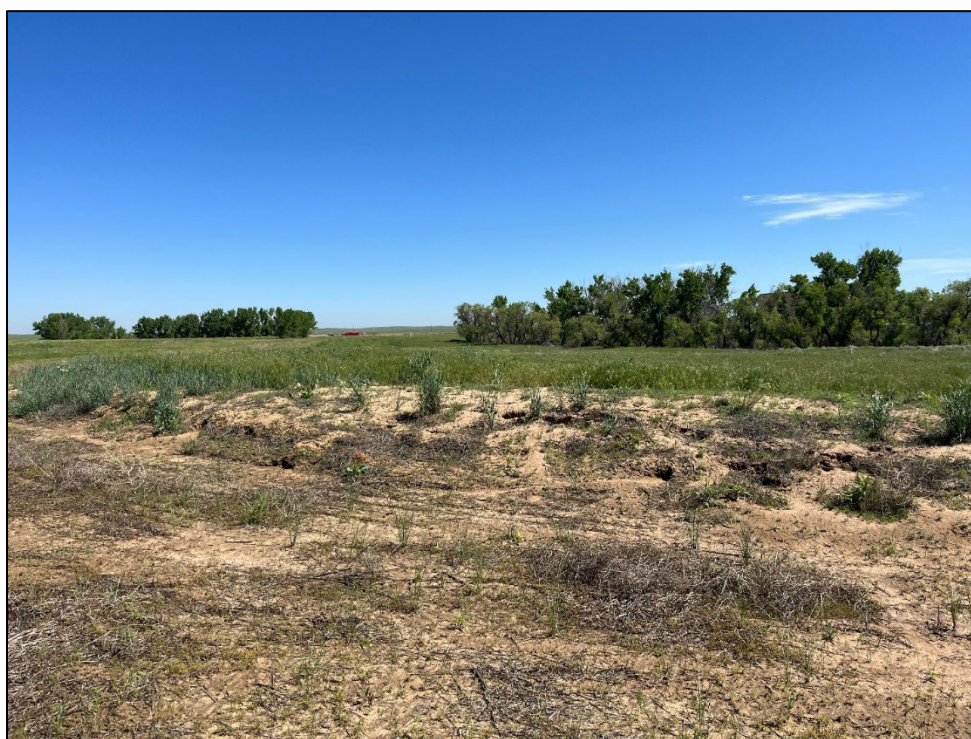
Several species of birds were heard and seen at the Dugout Pond and Sediment Pond 2. Small skinks were seen frequently among taller grasses. Evidence of prairie dogs was found throughout the site (Photo 6).

*Photo 6: Evidence of prairie dog activity, causing a small amount of erosion in bare areas*

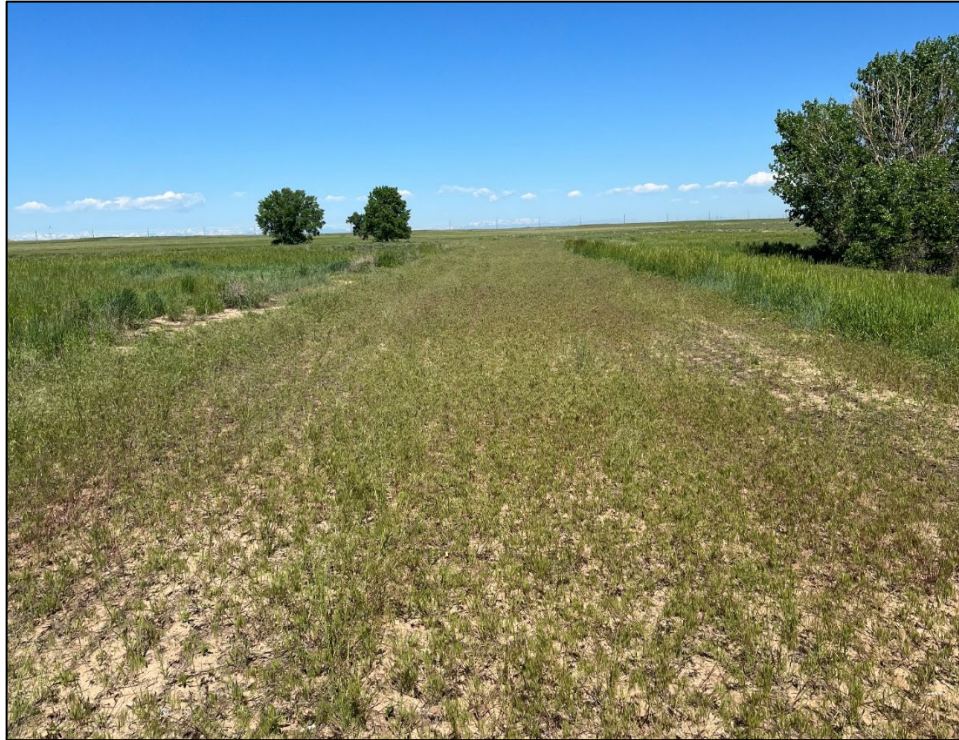
*Photo 7: Seeded area to the south of Sediment Pond 2, area is made up entirely of young cheatgrass.*

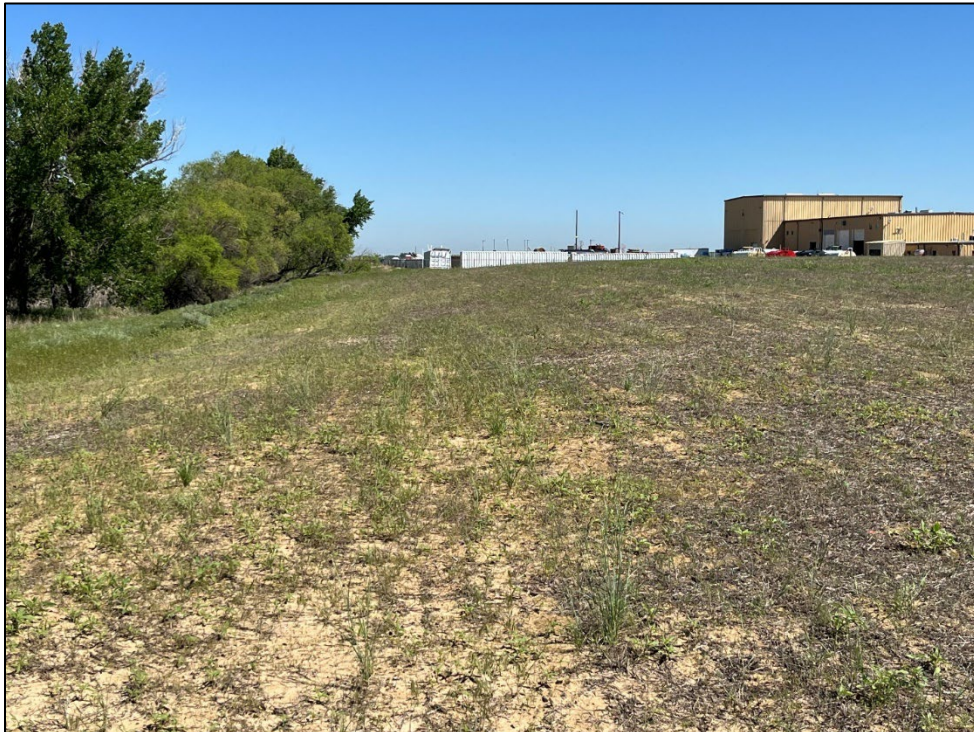
*Photo 8: View north of the area to the south of the facilities area which was reseeded in the spring of 2022.*

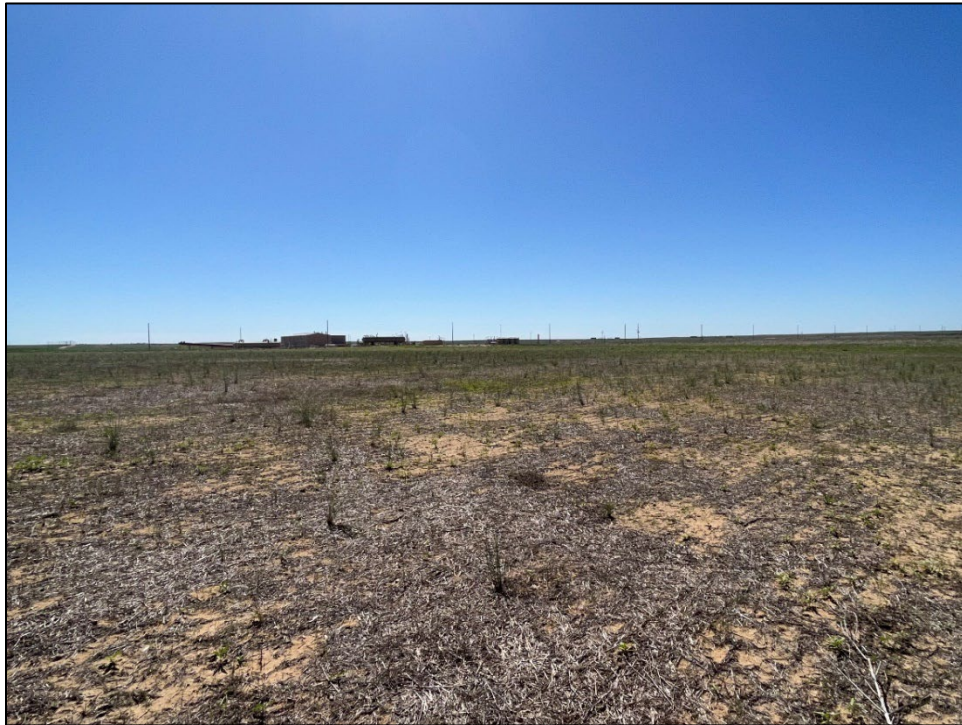
*Photo 9: View east of the area adjacent to the facilities area, reseeded in 2022*

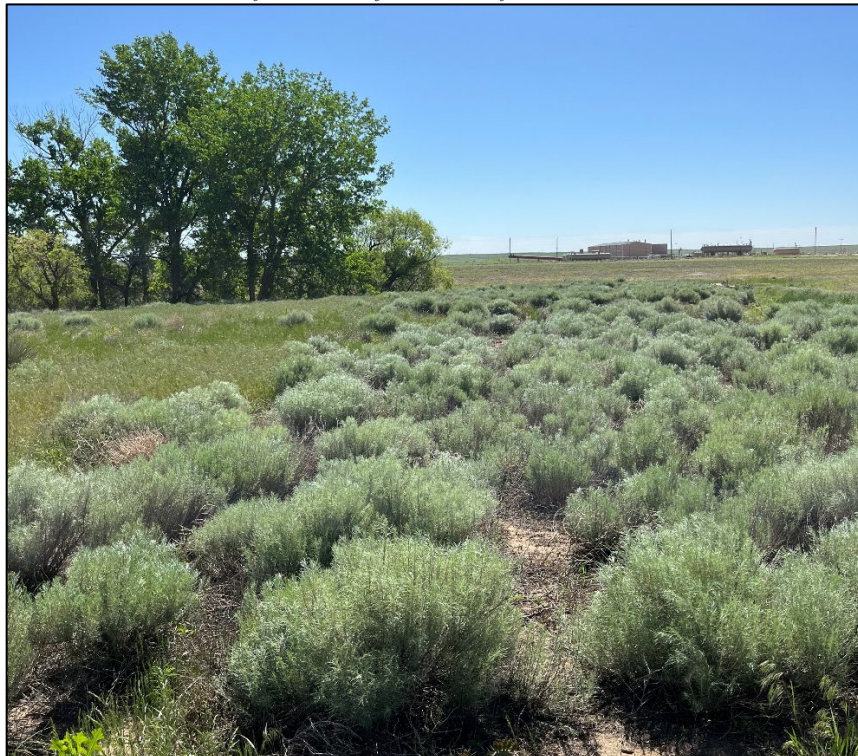
*Photo 10: View east of a patch of sagebrush growing adjacent to the Dugout Pond*

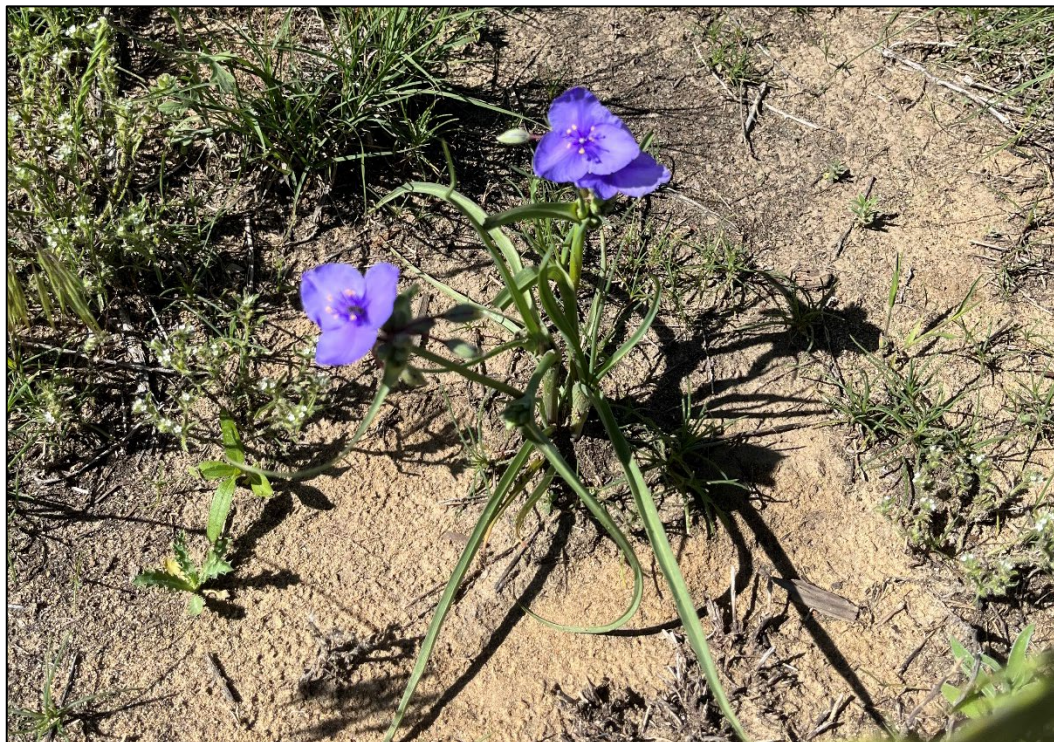
*Photo 11: Several small patches of Western spiderwort (Tradescantia occidentalis) were seen.*

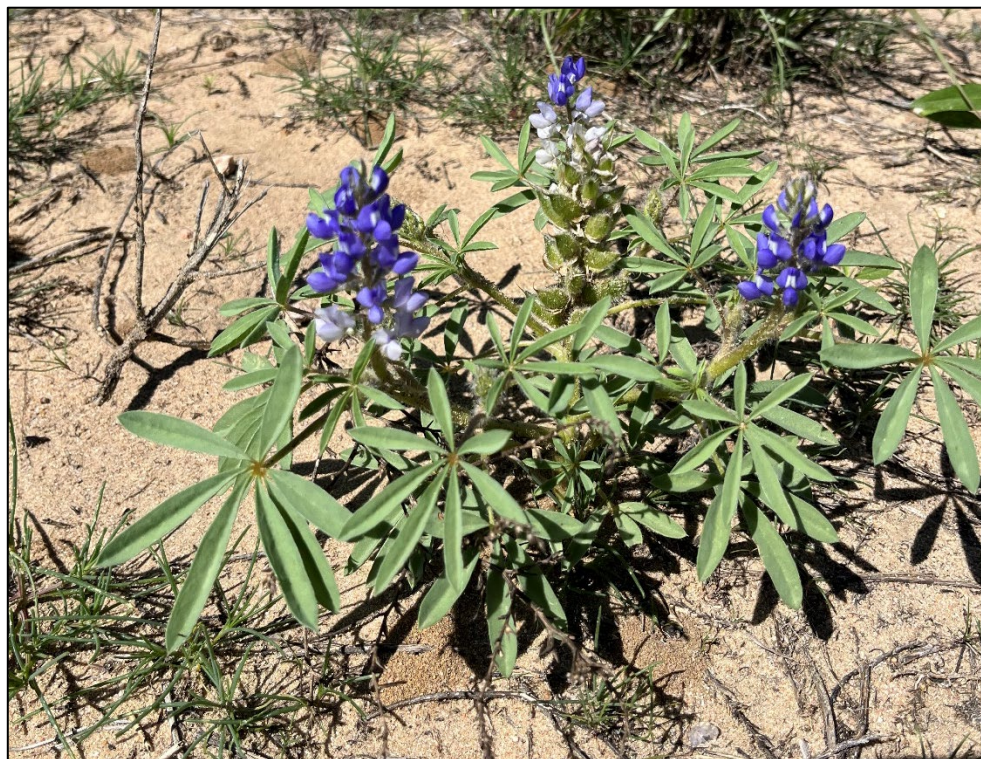
*Photo 12: Miniature lupine (Lupinus bicolor) was seen across all areas of older reclamation*

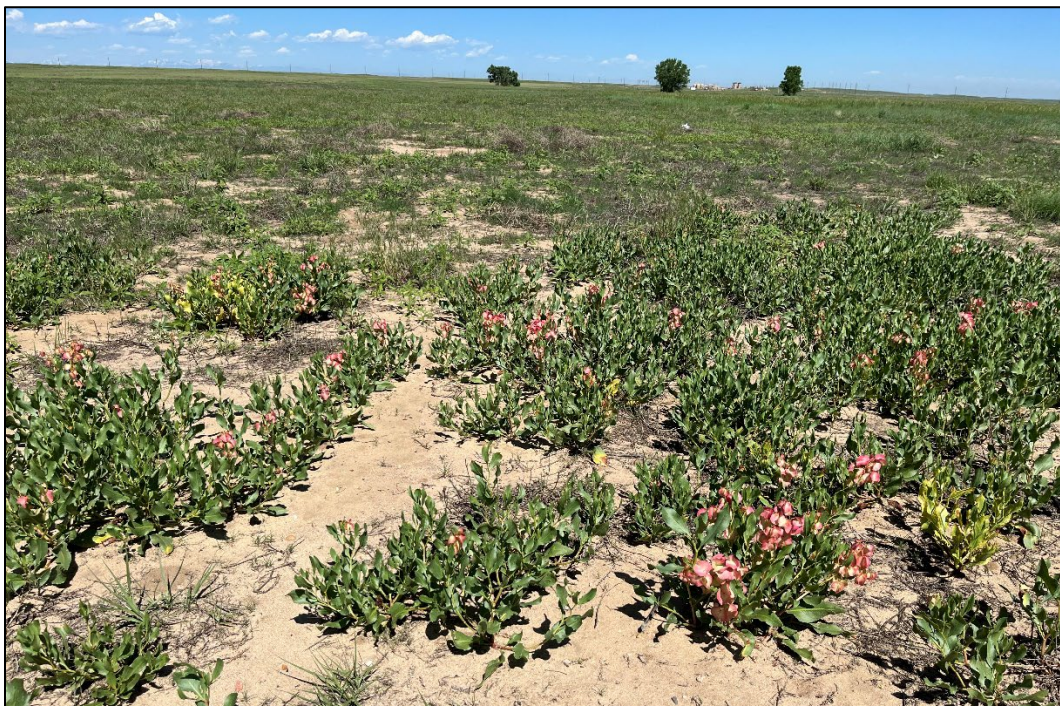
*Photo 13: A large patch of an unspecified wild begonia species was seen in Section 25.*

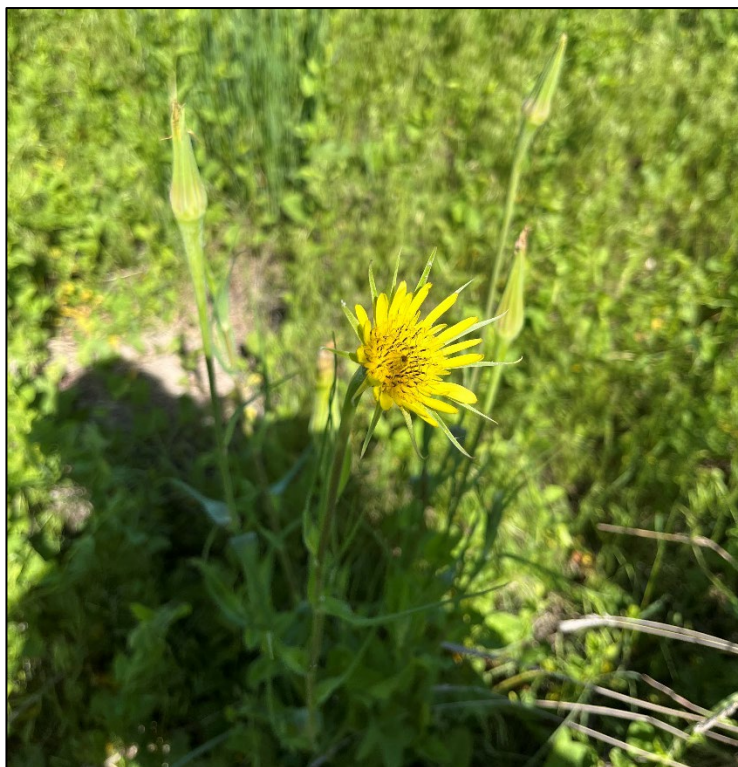
*Photo 14: A few plants of Yellow salsify (*Tragopogon dubius*) were seen near the Dugout Pond, Yellow salsify is considered a non-noxious weedy species*
