McClane Canyon Mine, C-1980-004 May 2023 Partial Inspection Report

PERMIT INFORMATION

Permit Number: C-1980-004
Mine Name: McClane Canyon Mine
Operator: ARC McClane Canyon, LLC

INSPECTION INFORMATION

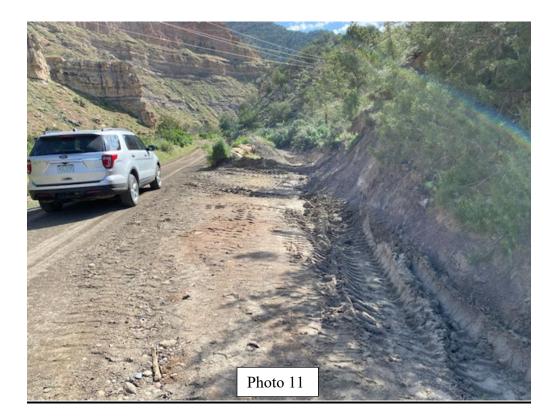
At the time of the inspection, Sump J had been cleaned and material from the cleaning was places near the inlet to the sump. This material will be moved to the drying area on the coal waste pile when it has dried

sufficiently for transport. The material identified in the April 19, 2023 inspection at the outlet of the sump had been moved to the drying area, no long impeding the ditch outlet of Sump J (Photo 11).

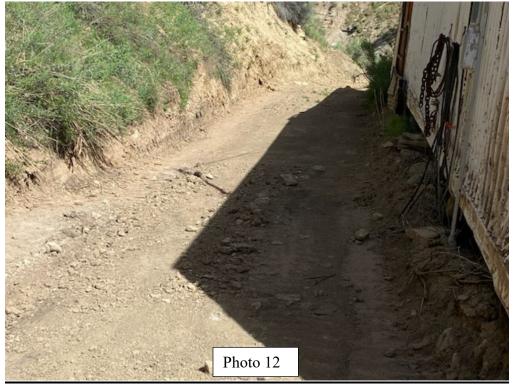
Ditch D-3 had been cleared of debris and was awaiting a mini-ex to complete the remainder of the work needed to re-establish the channel (Photo 12).

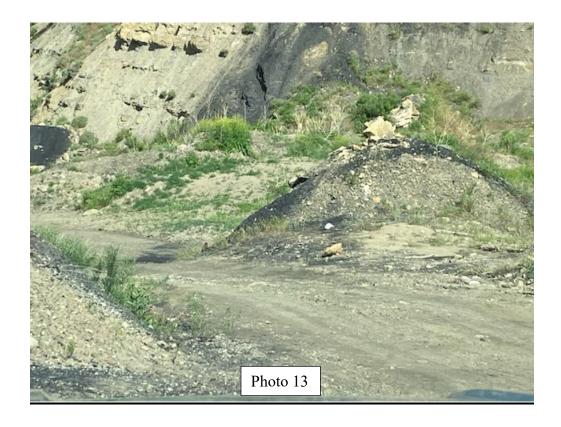
The Rills identified on the upper portion of the haul road had been filled and the road had been graded. There were no erosional features remaining (Photo 13).
