MINERALS PROGRAM INSPECTION REPORT
PHONE: (303) 866-3567

MINE NAME: Lee No 2 Placer	MINE/PROSPECTING ID#: M-1987-072	MINERAL: Gold	COUNTY: Gilpin
INSPECTION TYPE: Monitoring	WEATHER: Cloudy	INSP. DATE: May 18, 2023	INSP. TIME: 10:30
OPERATOR: Thomas Musch and Valerie Musch	OPERATOR REPRESENTATIVE: Don Hower	TYPE OF OPERATION: 110(2) - Hard Rock Limited Impact	
REASON FOR INSPECTION: Normal I&E Program	BOND CALCULATION TYPE:	BOND AMOUNT: \$2,750.00	
DATE OF COMPLAINT: NA	POST INSP. CONTACTS: None	JOINT INSP. AGENCY: None	
INSPECTOR(S): Brock Bowles	INSPECTOR'S SIGNATURE:

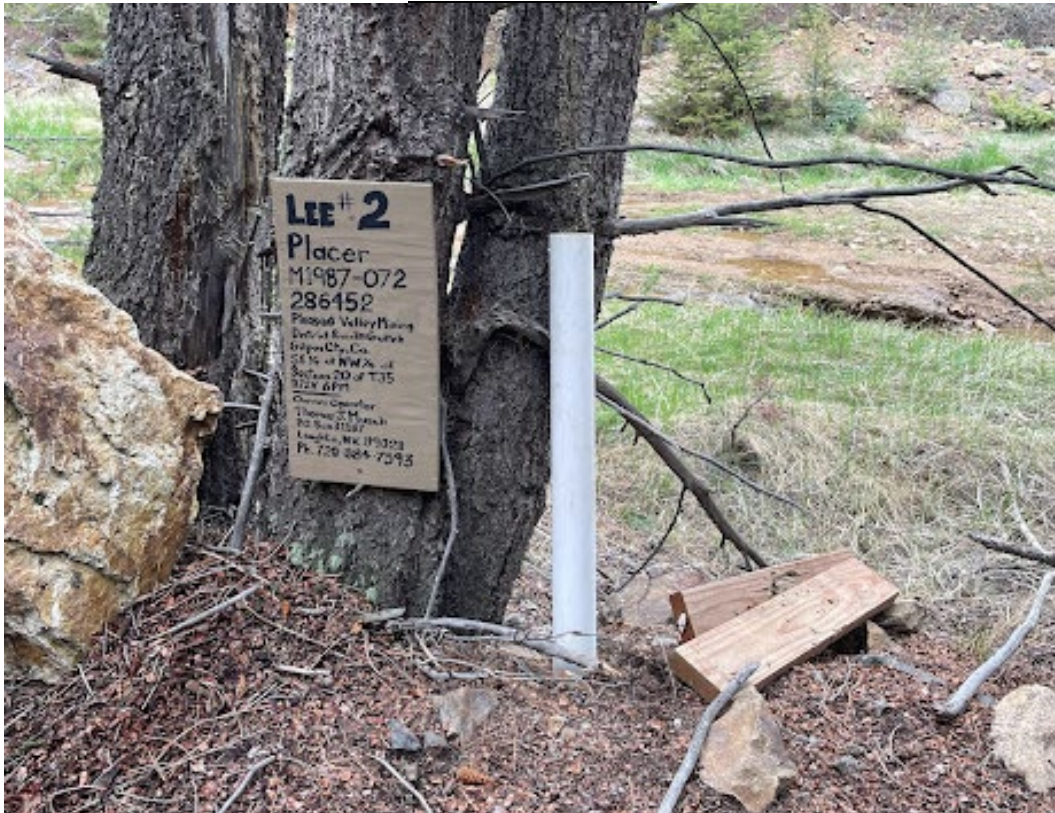
The mine entrance sign was in place (photo 1). The four corners of the permit boundary were marked with white PVC post. The southeast corner post was broken and needs to be replaced (photo 2). The mining area is about 30'x600' and straddles the creek bed.

Photo 1 – Mine entrance sign

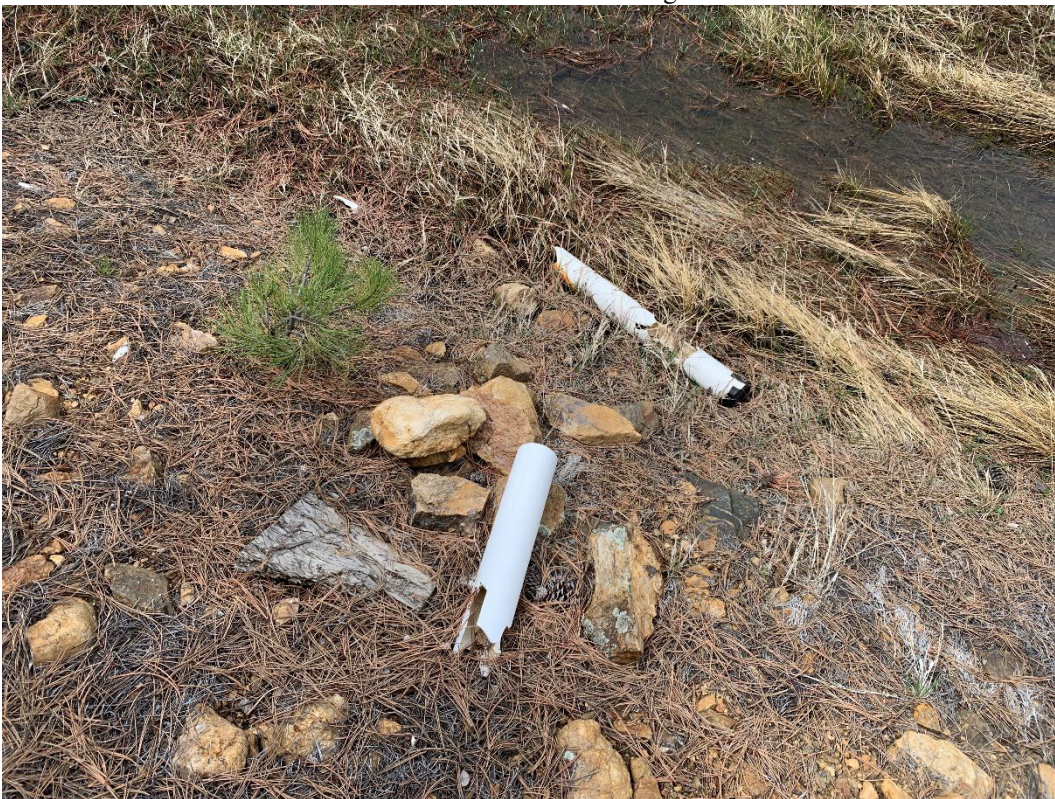
Photo 2 – Southeast corner post needs replacing

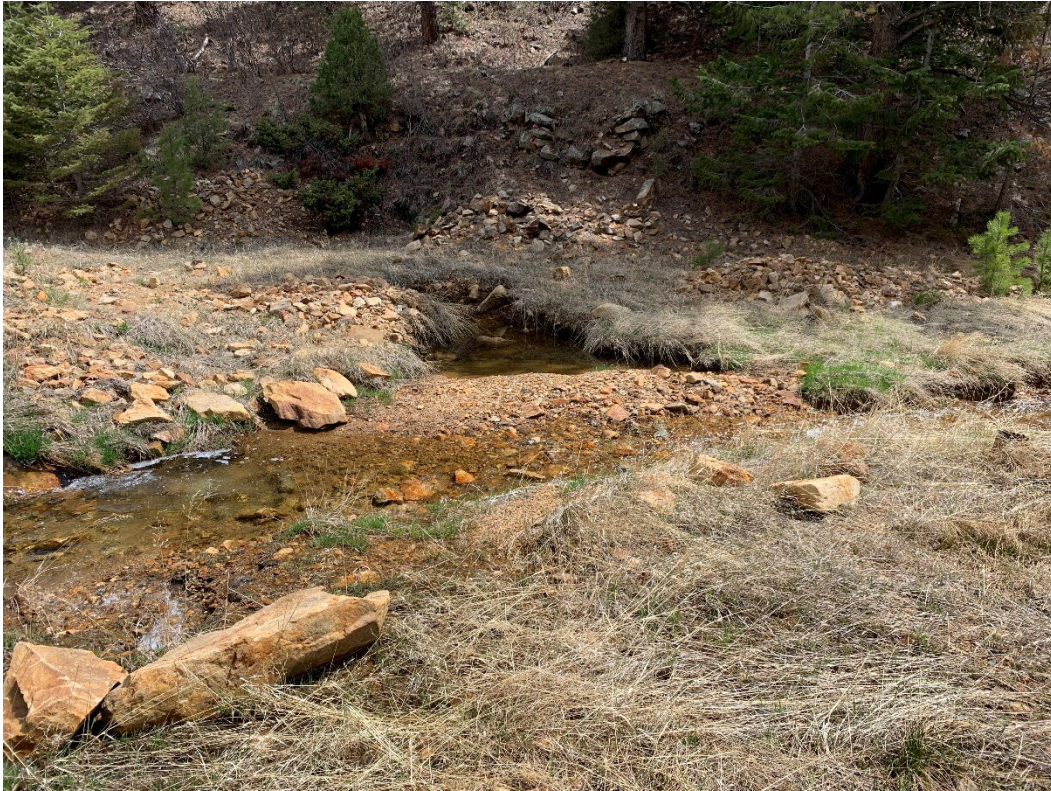
The disturbance from the mining was minimal and mostly takes place in the stream channel. Some mining activity goes into the northern bank of the creek creating adjacent small pools (photo 3). The excavated material from the adjacent pool is then used to backfill previous excavated areas. The newly backfilled areas are filling in with sediment and grasses are growing (photo 4).

Photo 3 – Creek bank excavation

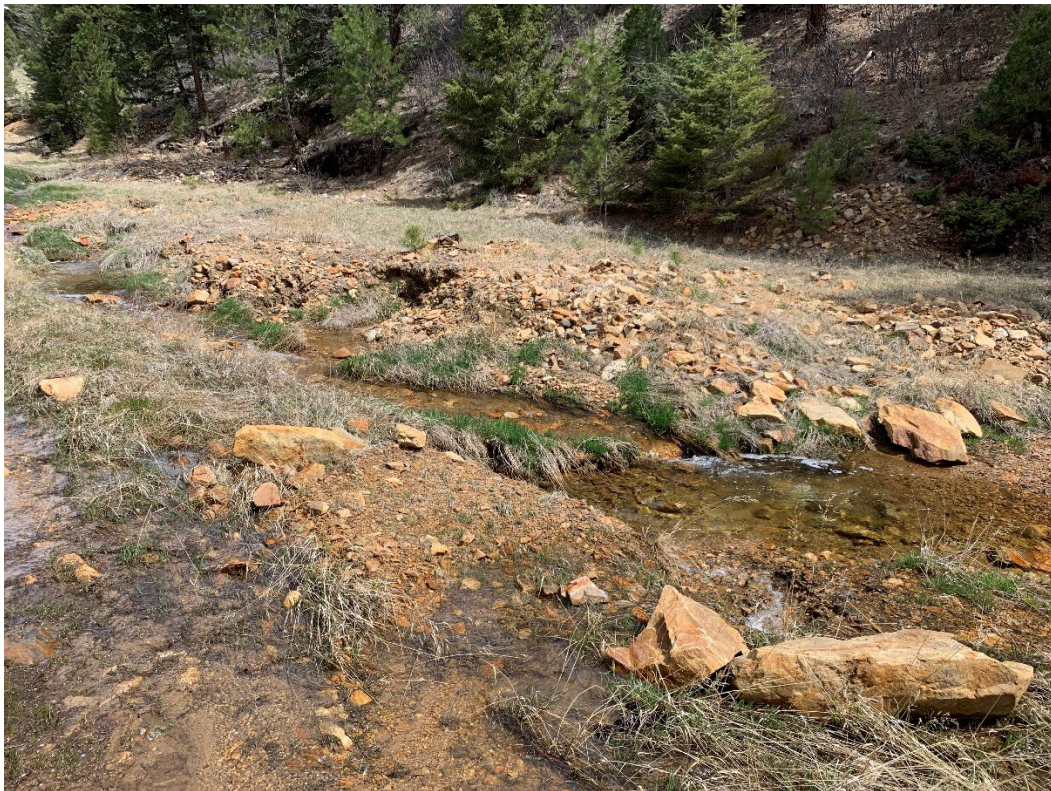
Photo 4 – Backfilled areas self-revegetating

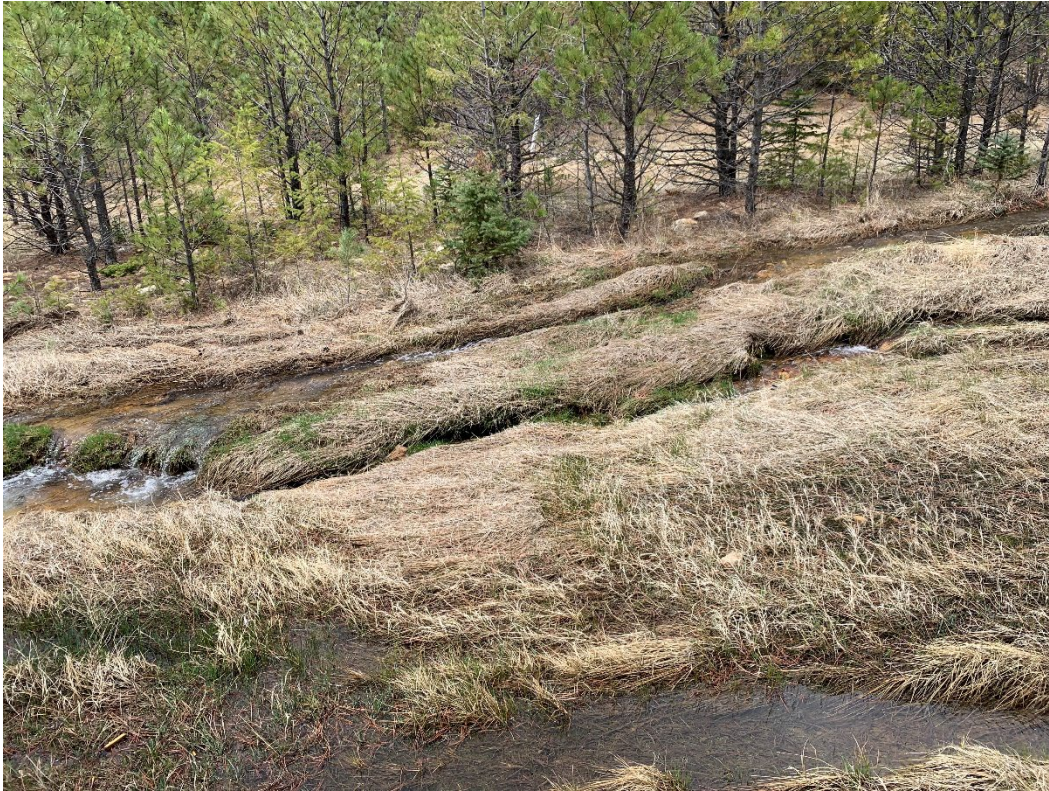
The area has a long history of being mined and old mine excavations are scattered throughout the site. These older workings are now overgrown with vegetation and trees. There is some non-mining related activity taking place upstream of the mining permit on the adjacent property. This activity has directed some of the water outside of the stream channel. As a result, water was flowing through the permit area in multiple channels including the road, small grassy meadows and stands of trees in the valley bottom (photo 5).

Photo 5 – Southern permit area saturated with spring runoff
