**MINERALS PROGRAM INSPECTION REPORT**  
**PHONE: (303) 866-3567**

<b>MINE NAME:</b> Henderson Mine	<b>MINE/PROSPECTING ID#:</b> M-1977-342	<b>MINERAL:</b> Molybdenum	<b>COUNTY:</b> Clear Creek, Grand
<b>INSPECTION TYPE:</b> Monitoring	<b>WEATHER:</b> Cloudy	<b>INSP. DATE:</b> May 19, 2023	<b>INSP. TIME:</b> 10:00
<b>OPERATOR:</b> Climax Molybdenum Company	<b>OPERATOR REPRESENTATIVE:</b> Geoff Niggeler	<b>TYPE OF OPERATION:</b> 112d-3 - Designated Mining Operation	
<b>REASON FOR INSPECTION:</b> Normal I&E Program	<b>BOND CALCULATION TYPE:</b>	<b>BOND AMOUNT:</b> \$135,204,778.00	
<b>DATE OF COMPLAINT:</b> NA	<b>POST INSP. CONTACTS:</b> None	<b>JOINT INSP. AGENCY:</b> None	
<b>INSPECTOR(S):</b> Brock Bowles Peter Hays	<b>INSPECTOR'S SIGNATURE:</b>

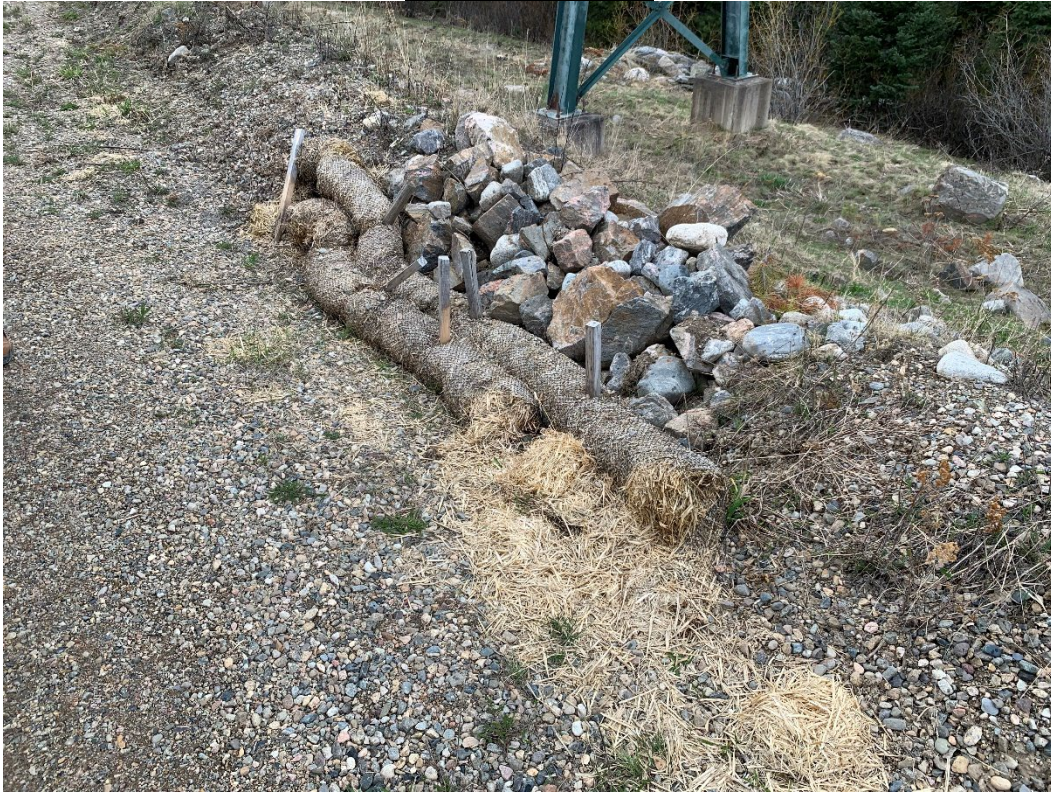
Photo 1 – Outfall OF-M31

OF-M31 was not impounding water. The roadside berm was in good condition directing water to the outfall. The rock dam was in good condition. The straw waddles are in need of repair (photo 1).

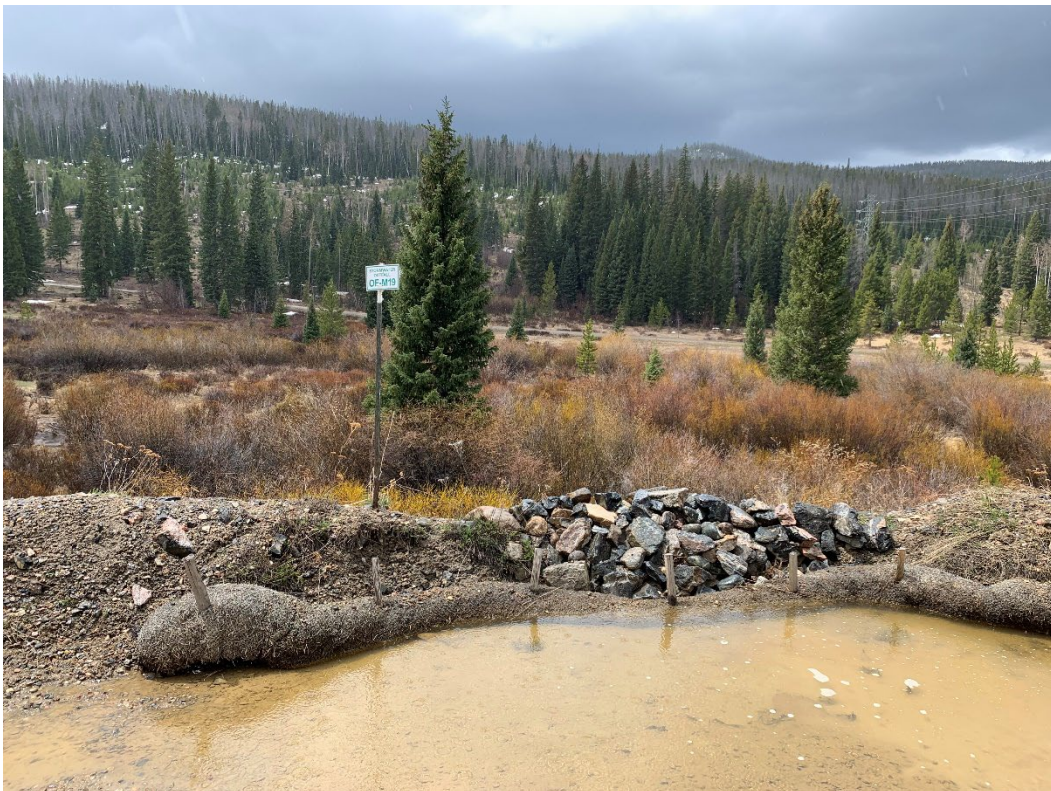
Photo 2 – OF-M19

OF-M19 was impounding water and in good working order. The berm, rock dam and waddle were in good condition. The water was being filtered through the waddle and discharging as designed (photo 2).

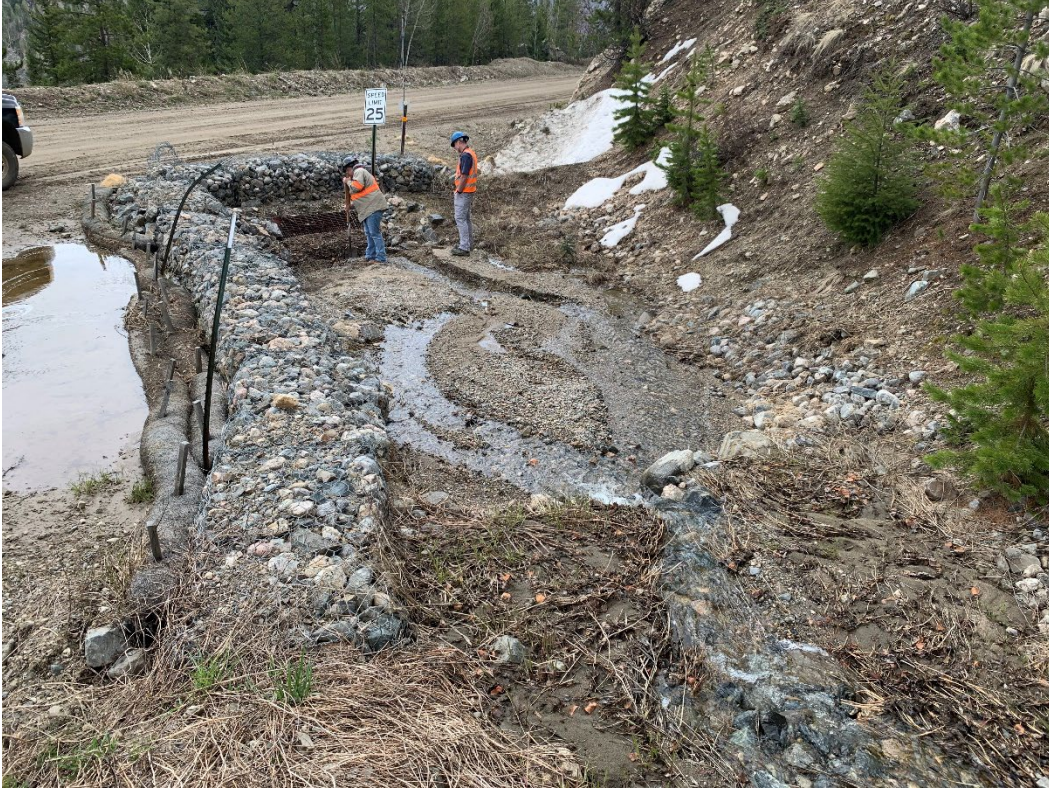
OF-M5 is a two part system. The upper part treats water from the main haul road. Water from the haul road is directed to a series of straw waddles and rock-filled gabion cages, which were both in good condition (photo 3). The water was pooled in front of the waddles, filtered through the waddles and discharged as designed into the channel below. The channel below the gabion cages directs the water from the upper conveyor access road to a culvert under the main haul road. The lower channel was full of sediment and the culvert inlet was nearly clogged. The inlet side of the culvert needs to be cleaned and all sediment control structures need to be re-established.

Photo 3 – OF-M5- water on left from haul road. Water from bottom of photo from conveyor access road

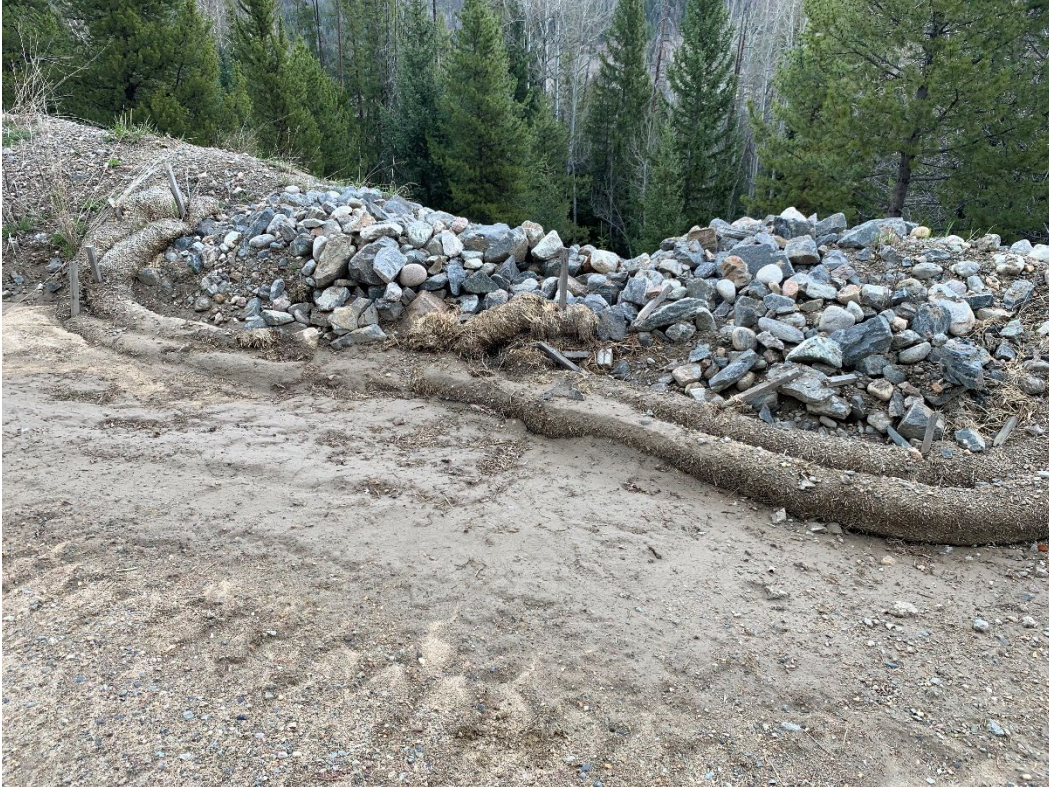
OF-M7 is along the haul road. It was not impounding water. The berms, rock dam and waddles were in good condition. The outfall is almost completely full of sediment and needs to be cleaned (photo 4).

Photo 4 – OF-M7 needs cleaning

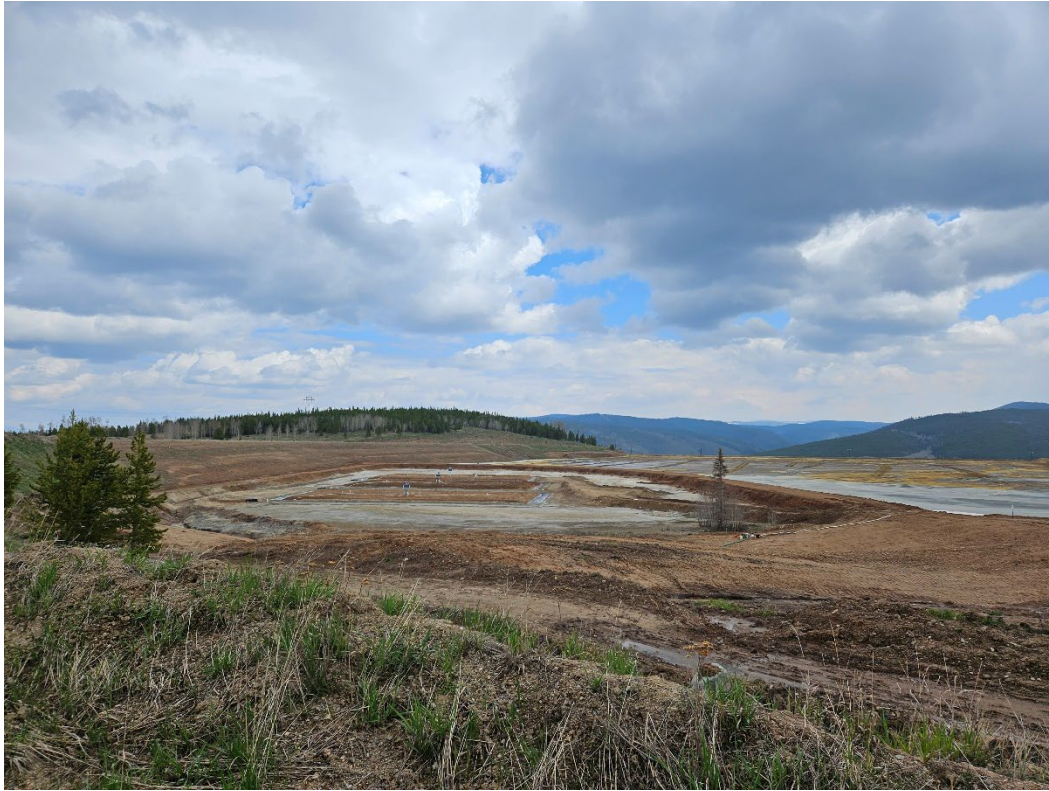
Vegetation test plots were installed on the north end of the tailings pile (photo 5). The purpose of the plots are to determine the best reclamation methods for reclaiming the tailings pile. The test plots were seeded last fall and the vegetation was just starting to sprout on the plots.

Photo 5 – Vegetation test plots on north end of tailings pile
