June 2023 New Horizon Partial Inspection Report

PERMIT INFORMATION

Permit Number: C-1981-008 Mine Name: New Horizon Mine Operator: Elk Ridge Mining and Reclamation, LLC Operator Address: Mr Tony Tennyson P.O. Box 628 27646 West 5th Avenue Nucla, CO 81424	County: Montrose Operation Type: Surface Permit Status: Active Ownership: Private
	Operator Representative Present: Cliff Chiles
Operator Representative Signature: (Field Issuance Only)

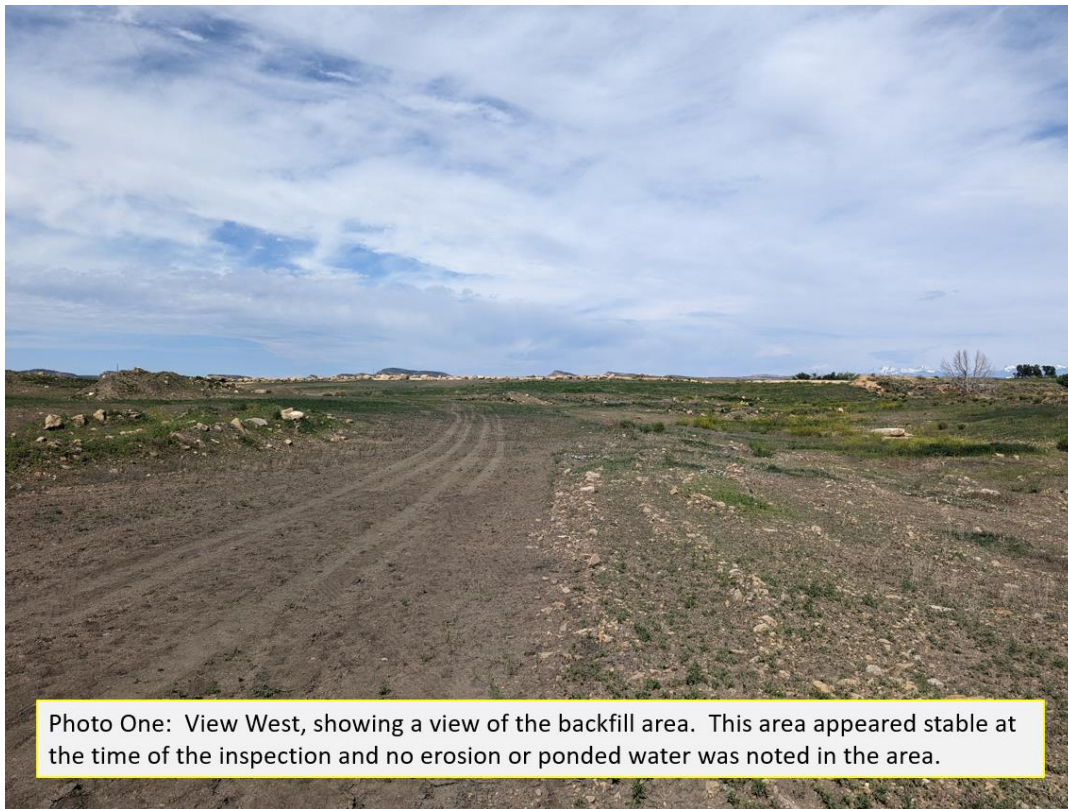
The backfill area near the Johnson Property Topsoil Storage Area was observed, no settling, slumping or erosion was noted. In the recent weeks precipitation events have become sparser, resulting in no ponded water in the backfill area. Minor and sporadic growth of annual weeds were noted in the area, however not considered a problem. The backfill area can be seen in Photo One.

Photo One: View West, showing a view of the backfill area. This area appeared stable at the time of the inspection and no erosion or ponded water was noted in the area.

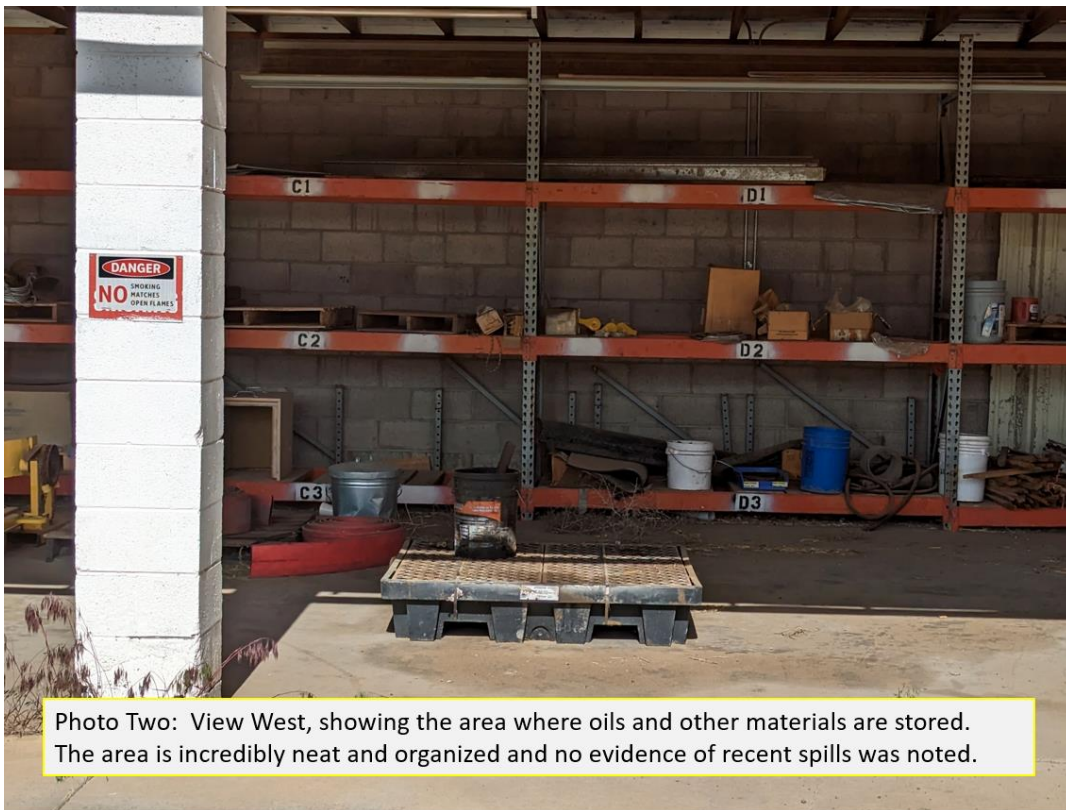
Located in the Pole Barn near the Mine Office at the Facilities Area, a small area is used to store oils and other substances needing secondary containment. This area was observed and only one 5 gallon bucket was located on the spill pallet as seen in Photo Two. Around the spill pallet the area is extremely clean and well kept. No evidence of fugative leaks or spills were noted and the area is in excellent condition.

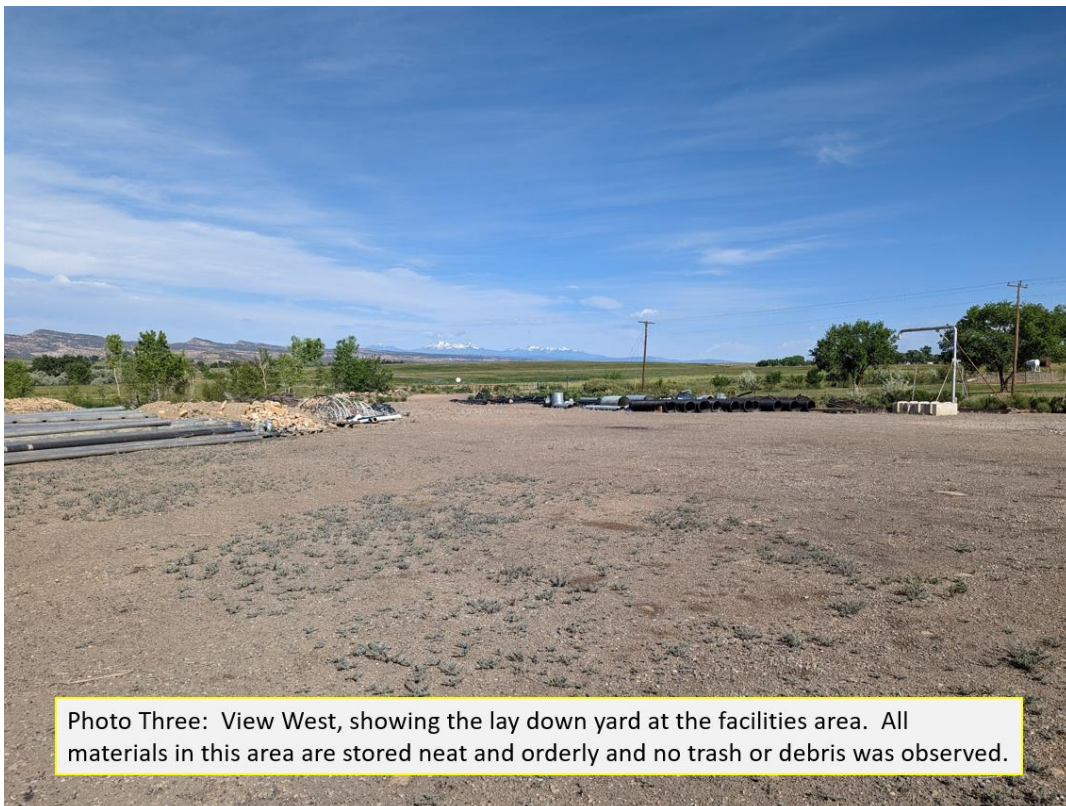
Also located at the Facilities Area is an area used as a lay down yard and storage for other items. This area was observed to be free from trash and debris, and all items stored in this area were organized, neat and orderly. The storage area can be seen in Photo Three.

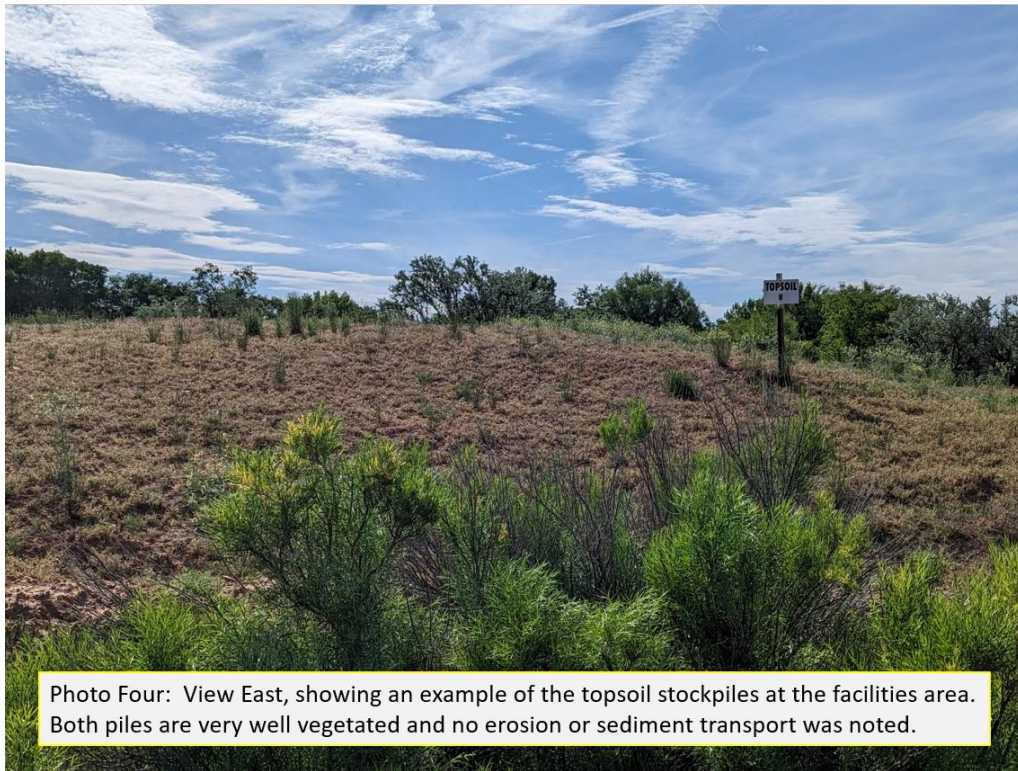
Two of the main topsoil storage areas were observed during this inspection, the facilities area stockpile area and the Johnson property topsoil storage Area. The stockpiles stored at the facilities area were in excellent condition and well vegetated. Both the mixed and topsoil B stockpiles showed no evidence of erosion or material transport with their ring berms in tact. An example of the stockpiles can be seen in Photo Four. Photo Five shows the reclamation success of the area where topsoil had been previously stored. This area is extremely well vegetated, and wildlife was observed utilizing the area.

Photo Four: View East, showing an example of the topsoil stockpiles at the facilities area. Both piles are very well vegetated and no erosion or sediment transport was noted.

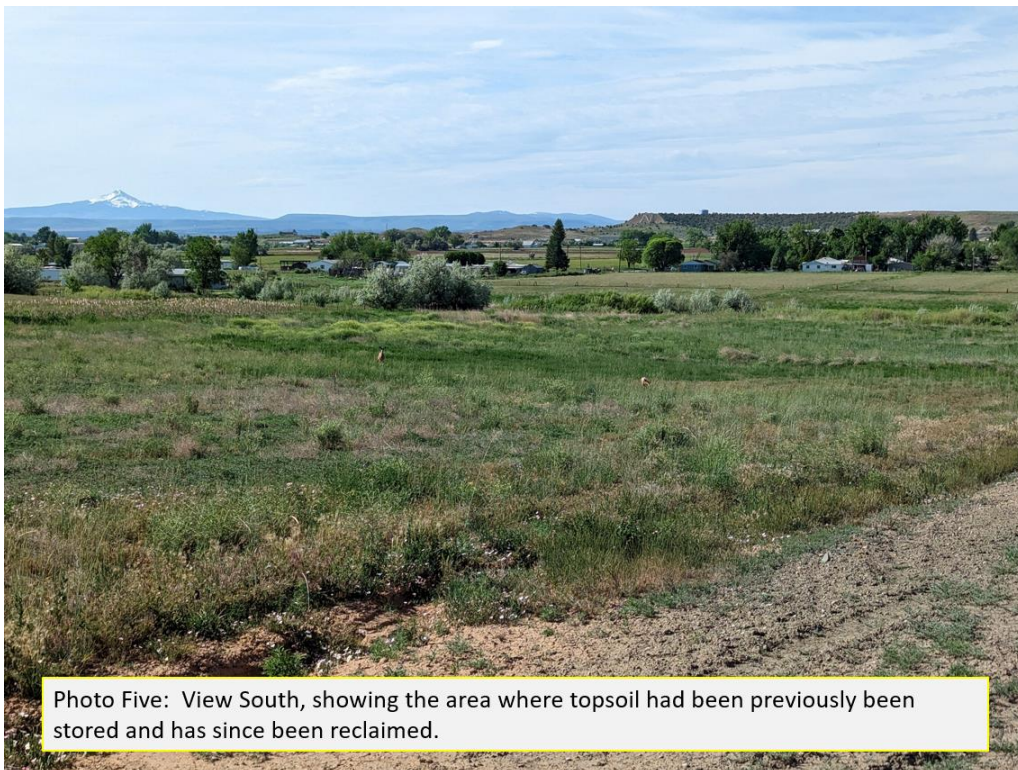
Photo Five: View South, showing the area where topsoil had been previously been stored and has since been reclaimed.
