MINERALS PROGRAM INSPECTION REPORT
PHONE: (303) 866-3567

MINE NAME: Colorado Rose Red Pit	MINE/PROSPECTING ID#: M-1978-332	MINERAL: Granite, granite gneiss	COUNTY: Larimer
INSPECTION TYPE: Monitoring	WEATHER: Clear	INSP. DATE: June 6, 2023	INSP. TIME: 10:00
OPERATOR: Colorado Rose Red Inc.	OPERATOR REPRESENTATIVE: Gary Kay, Caleb Liesveld	TYPE OF OPERATION: 110c - Construction Limited Impact	
REASON FOR INSPECTION: Normal I&E Program	BOND CALCULATION TYPE: Complete Bond	BOND AMOUNT: \$14,800.00	
DATE OF COMPLAINT: NA	POST INSP. CONTACTS: None	JOINT INSP. AGENCY: None	
INSPECTOR(S): Patrick Lennberg	INSPECTOR'S SIGNATURE:

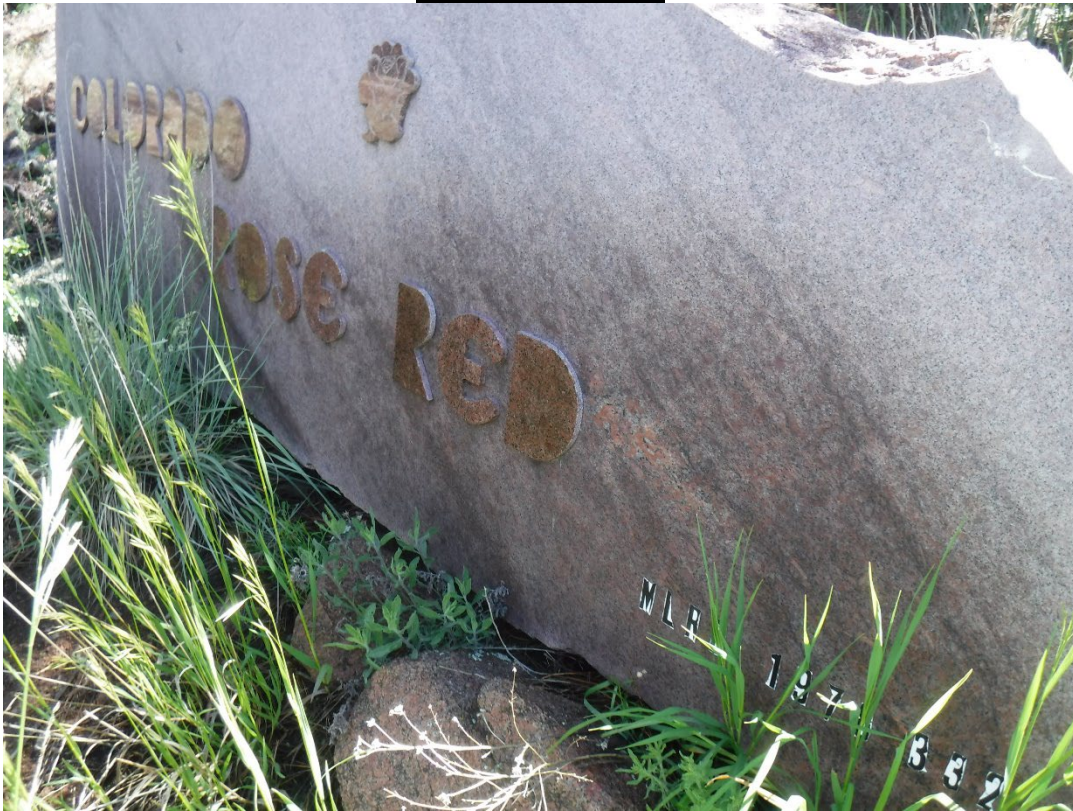
This is a 110c operation permitted for 9.9 acres. The permit is for the mining of dimensional granite for building materials and other uses. The mine is located on property owned by Colorado Rose Red, Inc. The mine is located in Larimer County. The site entrance is located approximately 8 miles west of Lyons, CO off of Hwy 36 in Pinewood Springs. The approved post-mining land use is industrial/commercial. A mine sign was posted at the mine entrance pursuant to Rule 3.1.12.

Photo 1: Mine sign at entrance

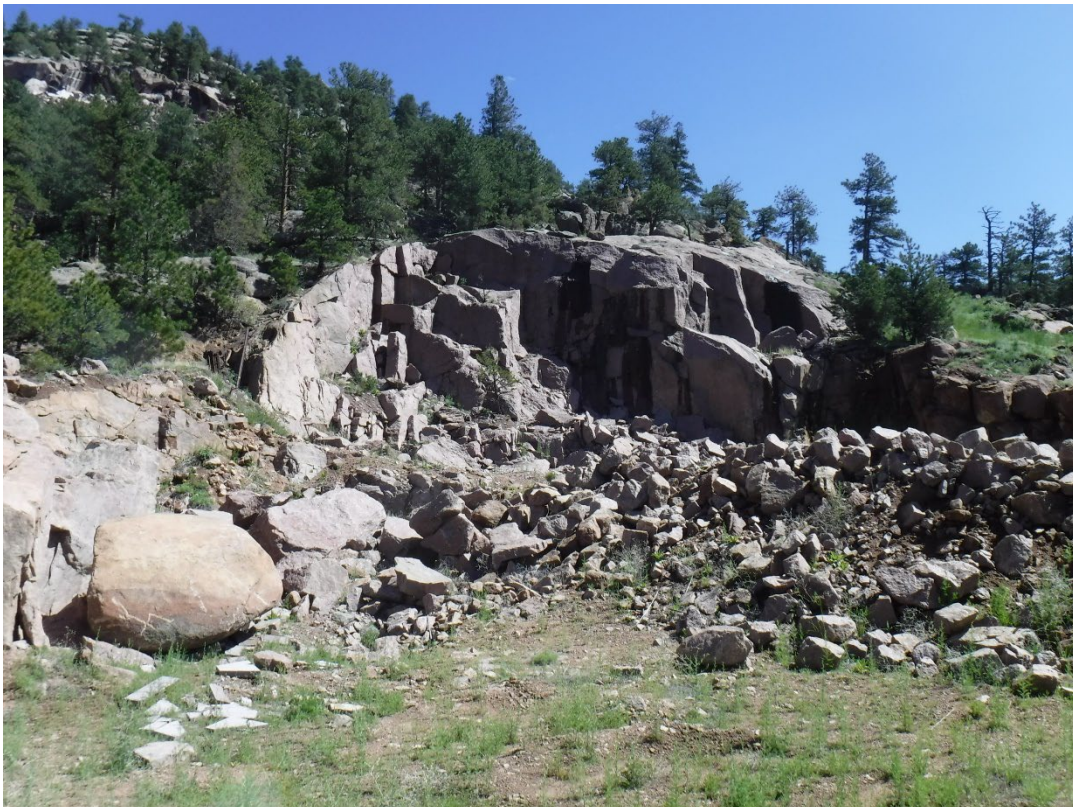
The site was not active at the time of inspection. The southern area, where the 111 was located, has not seen any activity for several years. At the northern end of the permit up on the mountain side is the location of most current mining activity. Mining in this area is done in one main underground chamber. The chamber is 10-15 feet in height and approximately 25 feet wide by 50 feet deep. Stone blocks are removed and polished for counter tops and principally monuments. Mining is slow and has not advanced much since the last inspection.

Photo 2: Location of the former 111 permit

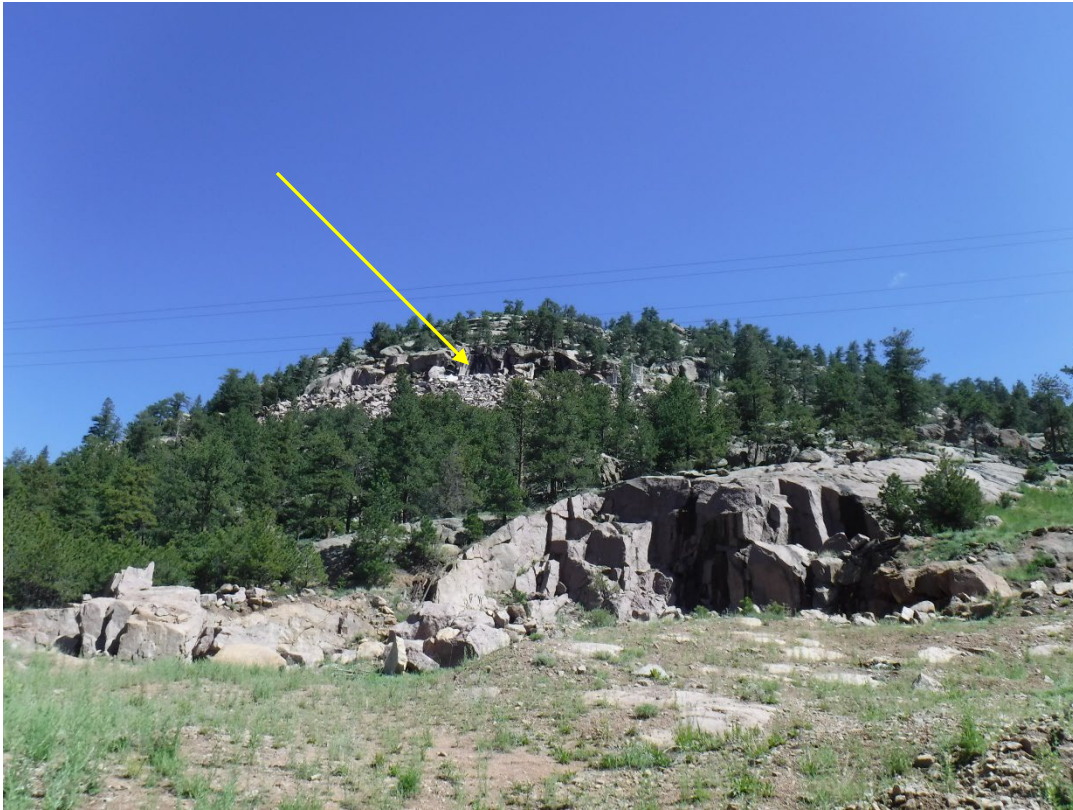
Photo 3: The 111 permit area relative to the active mining area, yellow arrow

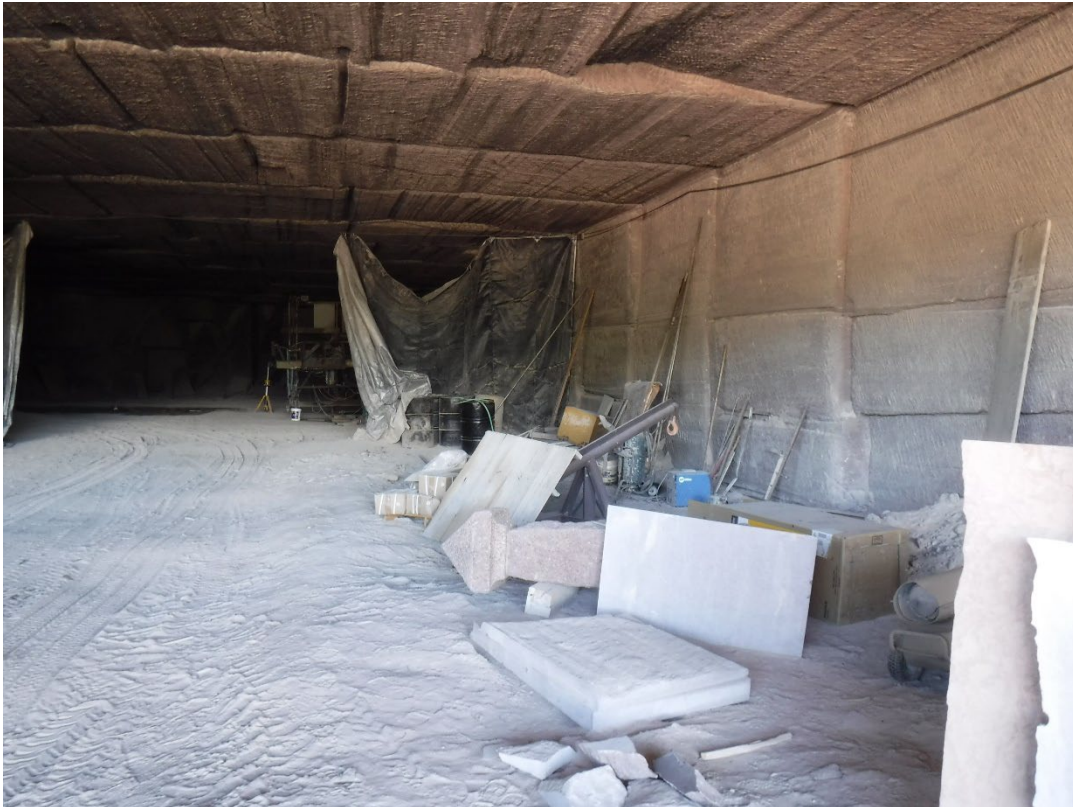
Photo 4: Entrance to primary mining chamber

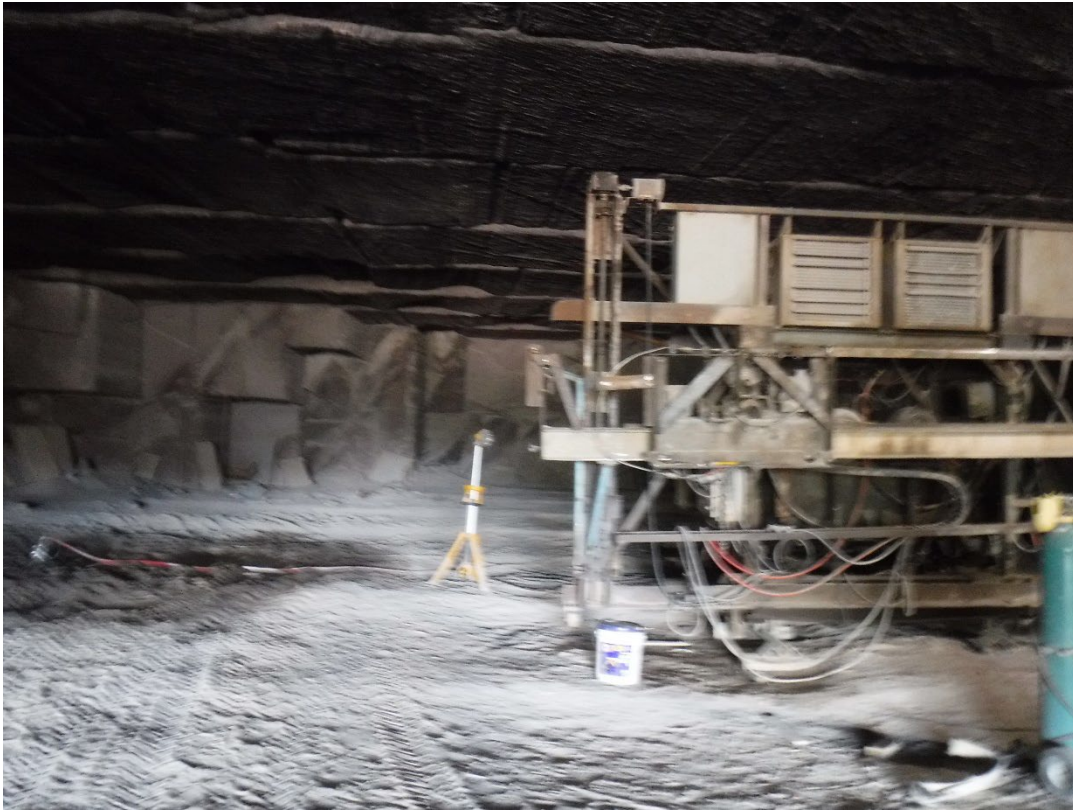
Photo 5: End of primary mining chamber

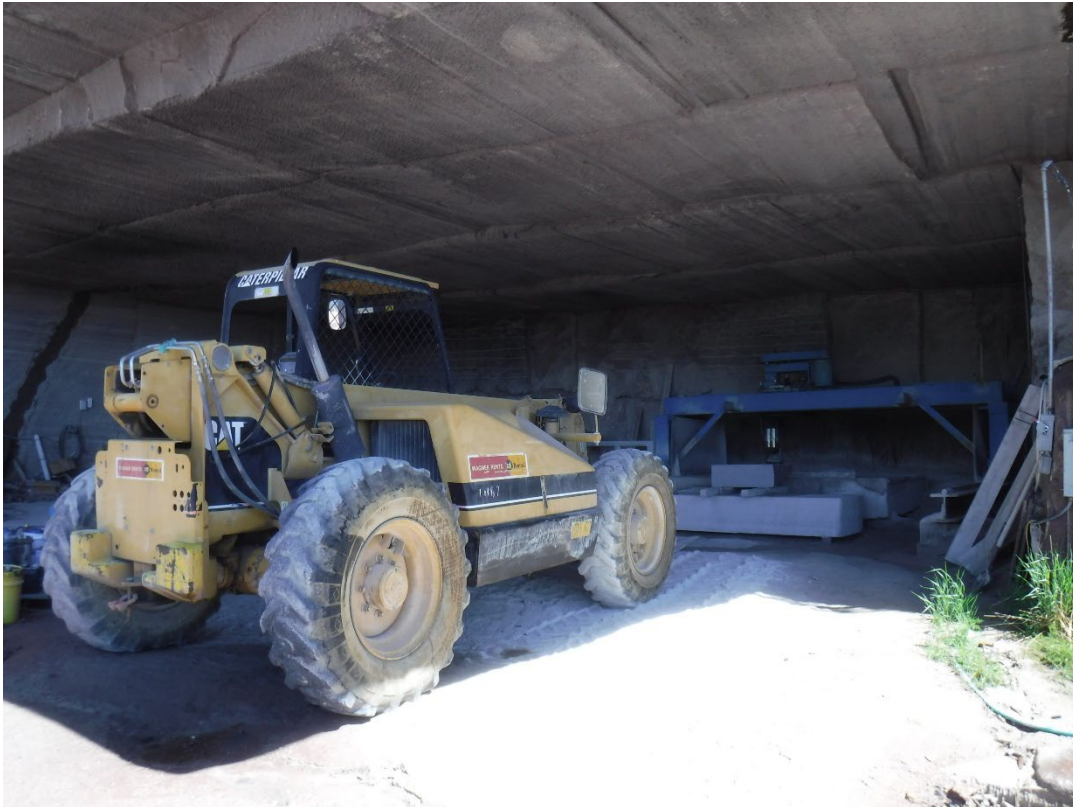
Photo 6: Work area adjacent to primary mine chamber

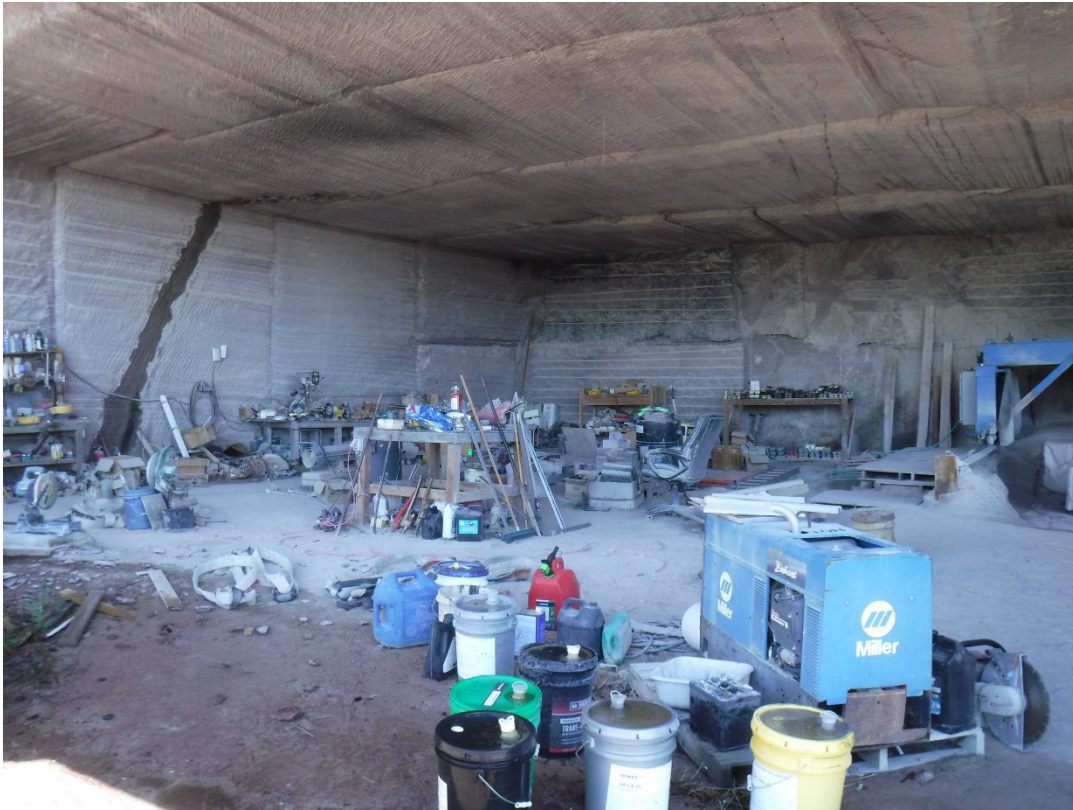
Photo 7: Tool and storage area

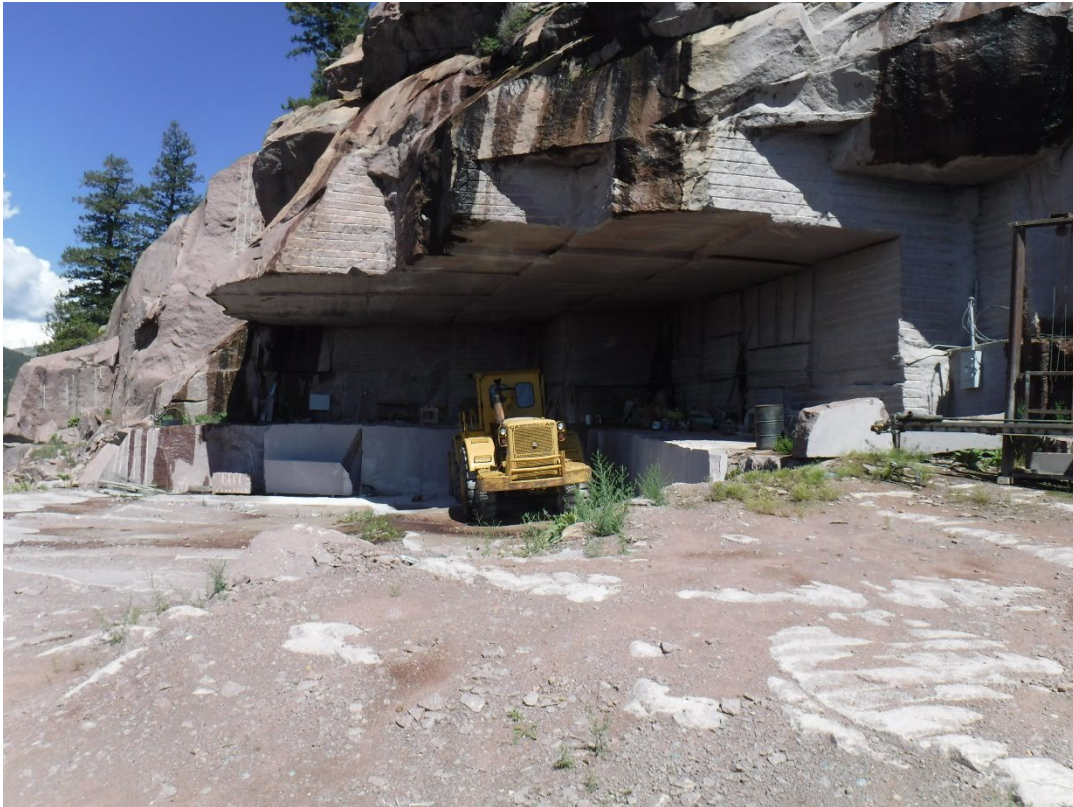
Photo 8: Garage
