MINERALS PROGRAM INSPECTION REPORT
PHONE: (303) 866-3567

MINE NAME: Carrizo Stone North	MINE/PROSPECTING ID#: M-2005-067	MINERAL: Sandstone (silica, stc quartzite)	COUNTY: Baca
INSPECTION TYPE: Monitoring	WEATHER: Cloudy	INSP. DATE: May 31, 2023	INSP. TIME: 13:00
OPERATOR: Carrizo Stone, LLC	OPERATOR REPRESENTATIVE: Fred Reyes	TYPE OF OPERATION: 112c - Construction Regular Operation	
REASON FOR INSPECTION: Normal I&E Program	BOND CALCULATION TYPE:	BOND AMOUNT: \$43,449.00	
DATE OF COMPLAINT: NA	POST INSP. CONTACTS: None	JOINT INSP. AGENCY: None	
INSPECTOR(S): Brock Bowles Patrick Lennberg	INSPECTOR'S SIGNATURE:

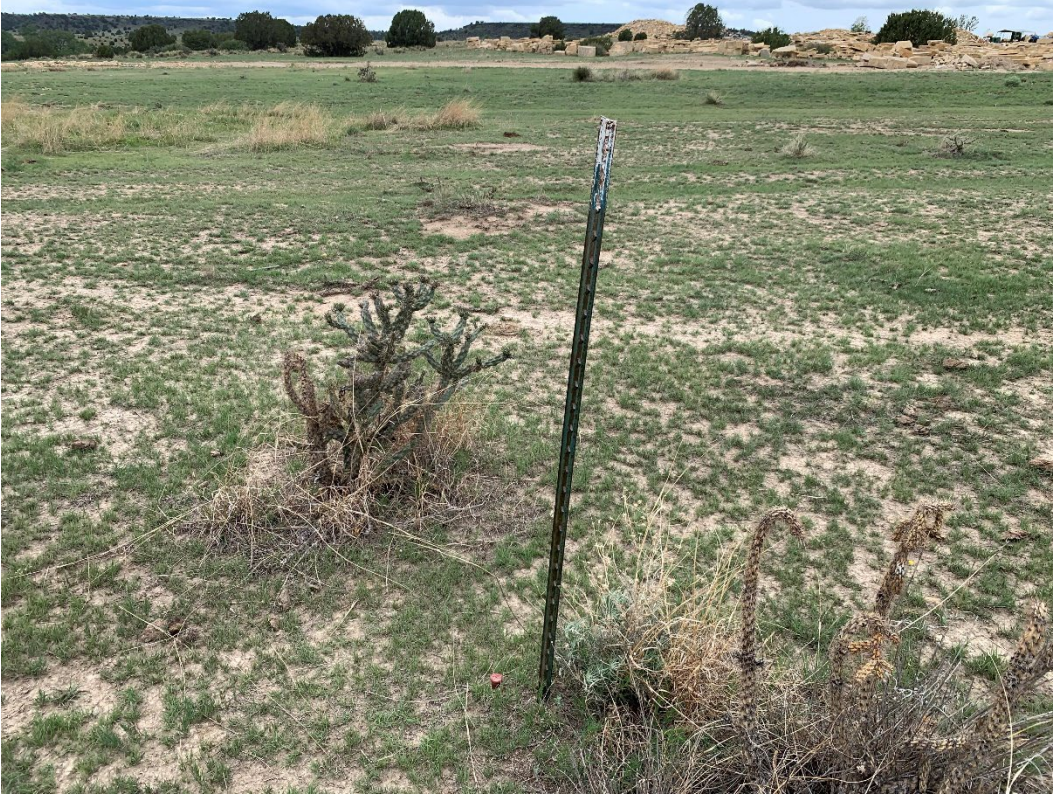
The mine entrance sign was in place but will have to be updated after the SO is approved with the new operator information. The permit boundary markers were in place on all four sides of the permit area (photo 1).

Photo 1 – Southeast corner marker

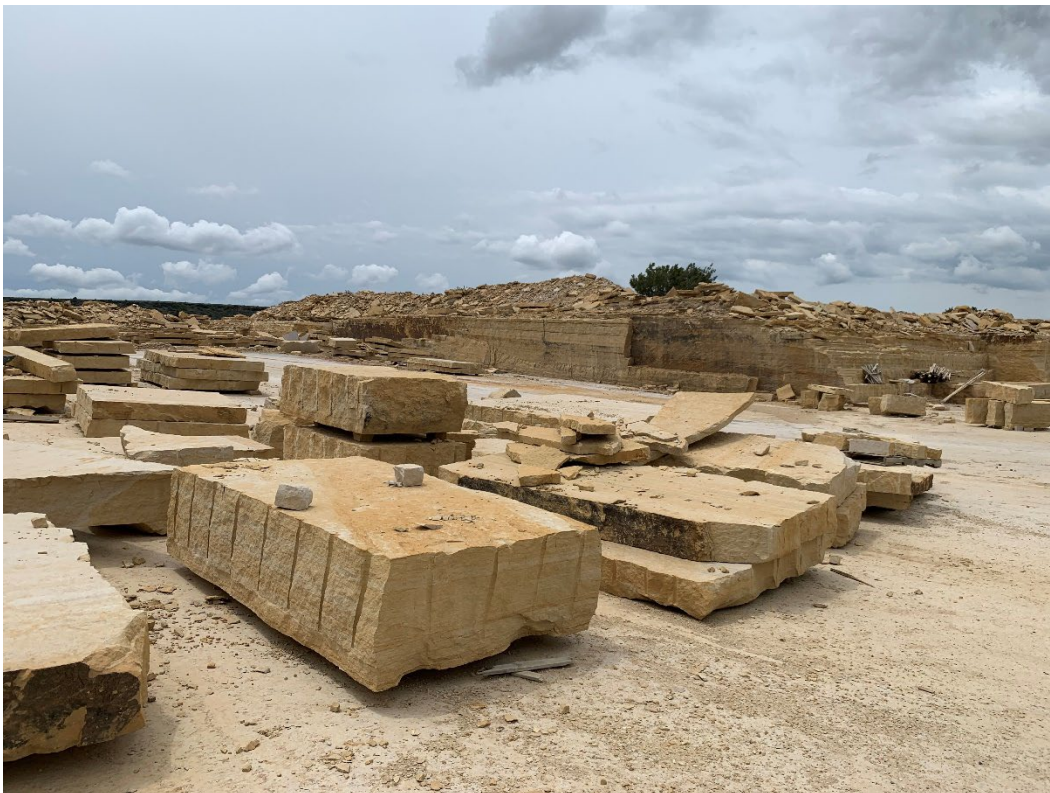
The mining pit area consists of a high wall about 700 feet long and averages 8 feet high (photo 2 & 3). The sandstone is mined using an expansive grout mining technique. This technique involves drilling a series of holes in the sandstone and filing the holes with expansive grout. The grout expands over a short period of time creating a fault along the drill holes without the fractures caused by blasting. The stone is then cut to size for transport.

Photo 2 – Main pit area and highwall, facing northwest

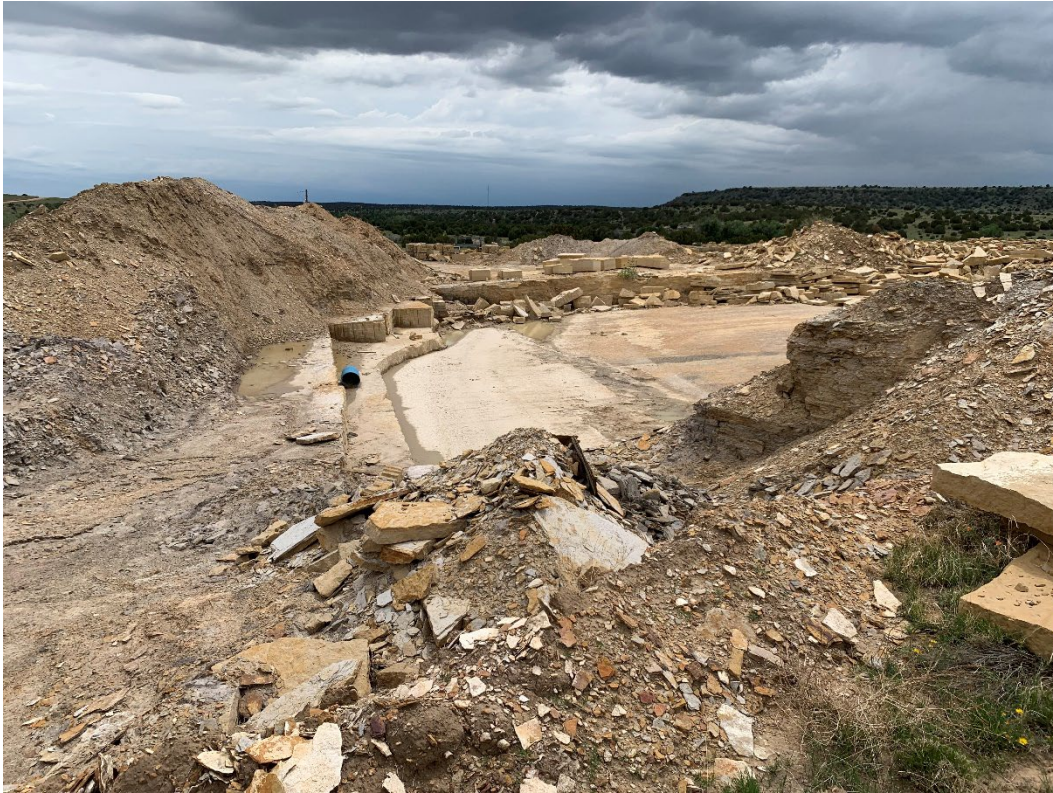
Photo 3 – Pit and highwall on east side of pit area.

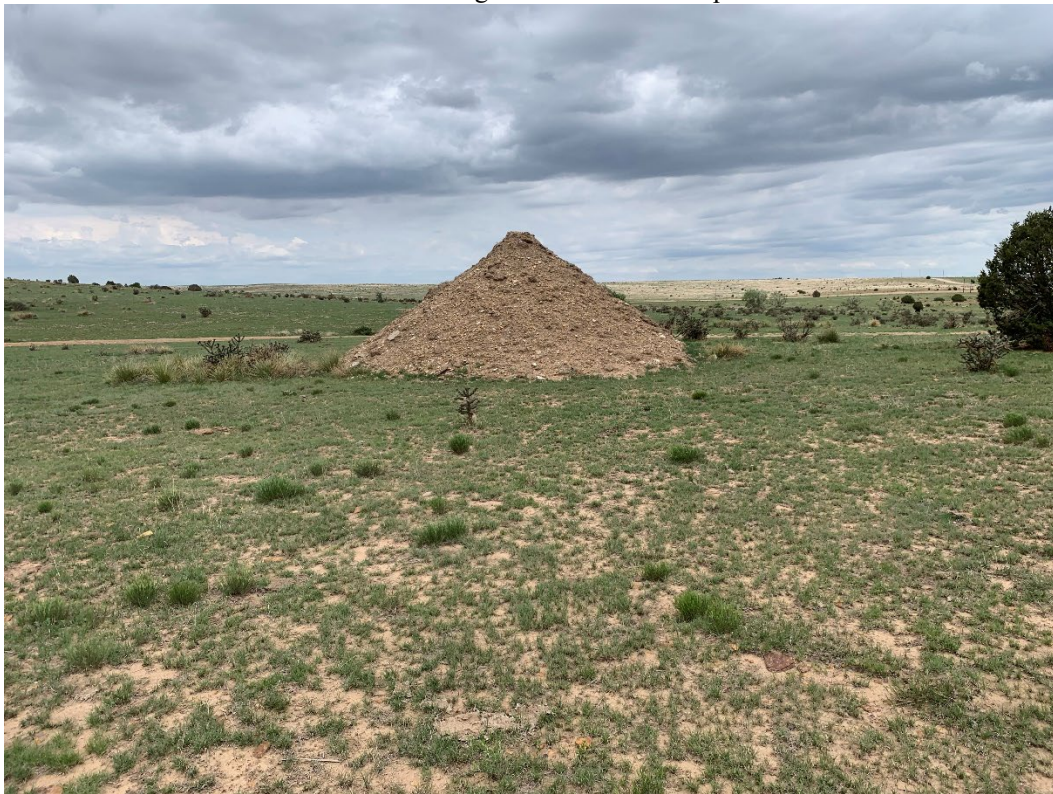
Several topsoil/overburden piles were placed around the perimeter of the pit area (photo 4). No signs of excessive erosion or noxious weeds were noted.

Photo 4 – Topsoil stockpile northeast of pit area
