MINERALS PROGRAM INSPECTION REPORT
PHONE: (303) 866-3567

MINE NAME: Carrizo Stone South	MINE/PROSPECTING ID#: M-2006-024	MINERAL: Sandstone (silica, st quartzite)	COUNTY: Baca
INSPECTION TYPE: Monitoring	WEATHER: Cloudy	INSP. DATE: May 31, 2023	INSP. TIME: 14:00
OPERATOR: Carrizo Stone, LLC	OPERATOR REPRESENTATIVE: Fred Reyes	TYPE OF OPERATION: 110c - Construction Limited Impact	
REASON FOR INSPECTION: Normal I&E Program	BOND CALCULATION TYPE: Complete Bond	BOND AMOUNT: \$15,000.00	
DATE OF COMPLAINT: NA	POST INSP. CONTACTS: None	JOINT INSP. AGENCY: None	
INSPECTOR(S): Brock Bowles Patrick Lennberg	INSPECTOR'S SIGNATURE:

PHOTOGRAPHS

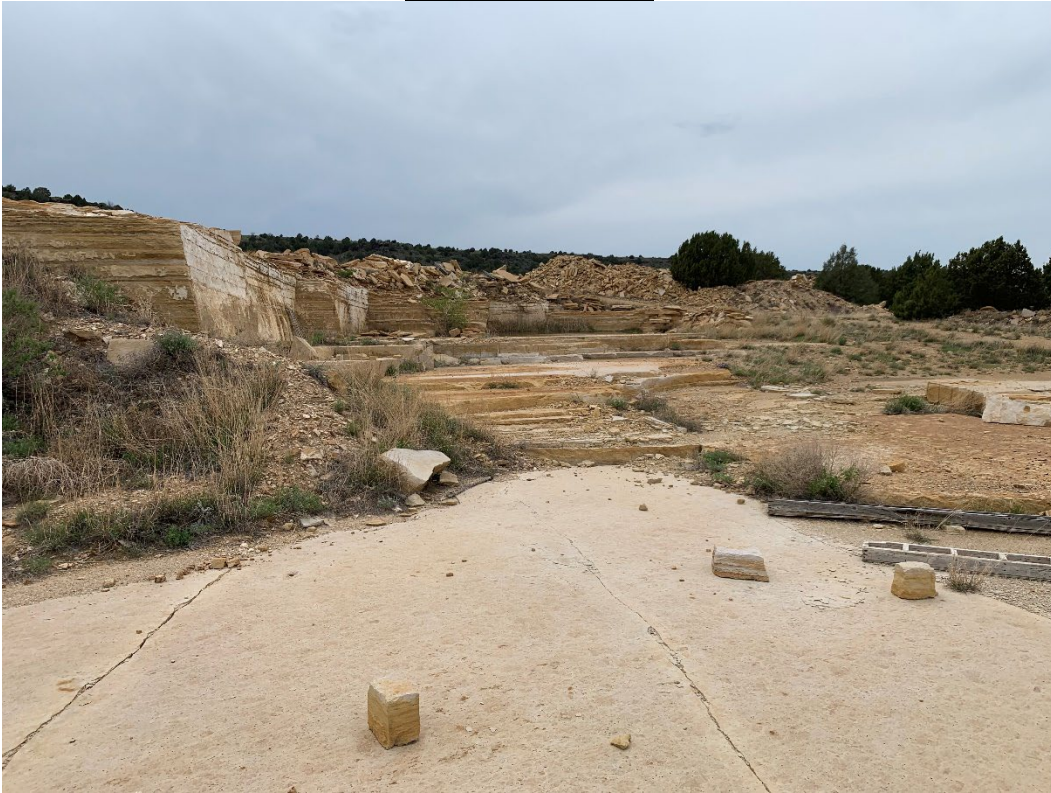
The mining pit area consists of a high wall about 200 feet long and 15 feet high (photo 1). The sandstone is mined using an expansive grout mining technique. This technique involves drilling a series of holes in the sandstone and filling the holes with expansive grout. The grout expands over a short period of time creating a fault along the drill holes without the fractures caused by blasting. The stone is then cut to size for transport.

Photo 1 – Highwall, pit area facing west

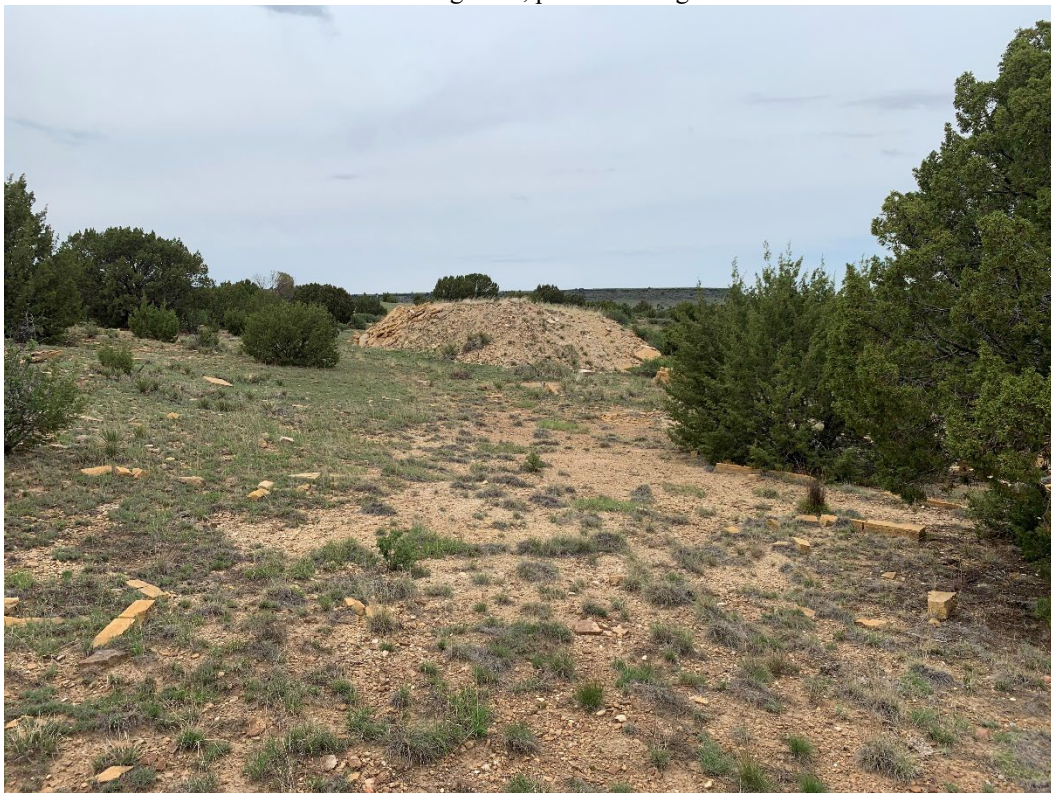
There are a couple of topsoil/overburden piles staged around the perimeter of the pit area (photo 2). The overburden piles had vegetation growing on the north side of the pile, but the south side was bare due to the angle facing the sun. There are also several stone waste piles that can be easily be used to back fill the highwall.

Photo 2 – Topsoil/overburden pile north of pit area.
