MINERALS PROGRAM INSPECTION REPORT
PHONE: (303) 866-3567

MINE NAME: Sooner Lucky Strike Mine and Mill	MINE/PROSPECTING ID#: M-1982-020	MINERAL: Gold and silver	COUNTY: Gunnison
INSPECTION TYPE: Monitoring	WEATHER: Clear	INSP. DATE: June 7, 2023	INSP. TIME: 09:30
OPERATOR: ALSH, LLC	OPERATOR REPRESENTATIVE: Jake Wilkinson	TYPE OF OPERATION: 110d - Designated Limited Impact	
REASON FOR INSPECTION: Normal I&E Program	BOND CALCULATION TYPE:	BOND AMOUNT: \$49,992.54	
DATE OF COMPLAINT: NA	POST INSP. CONTACTS: None	JOINT INSP. AGENCY: None	
INSPECTOR(S): Dustin Czapla	INSPECTOR'S SIGNATURE:

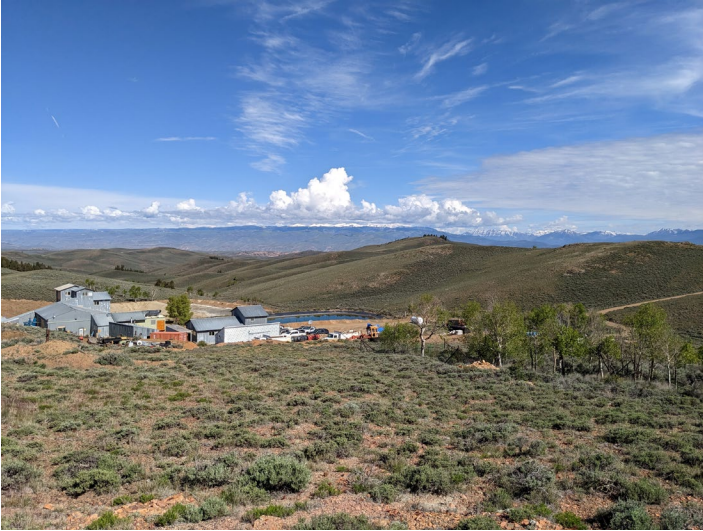
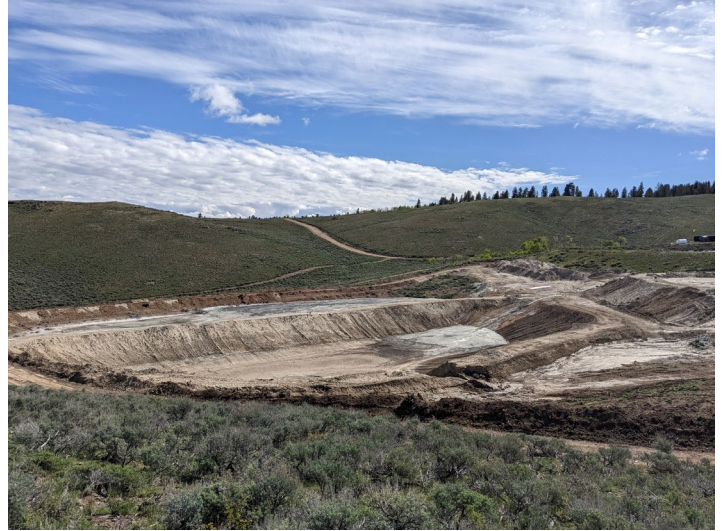
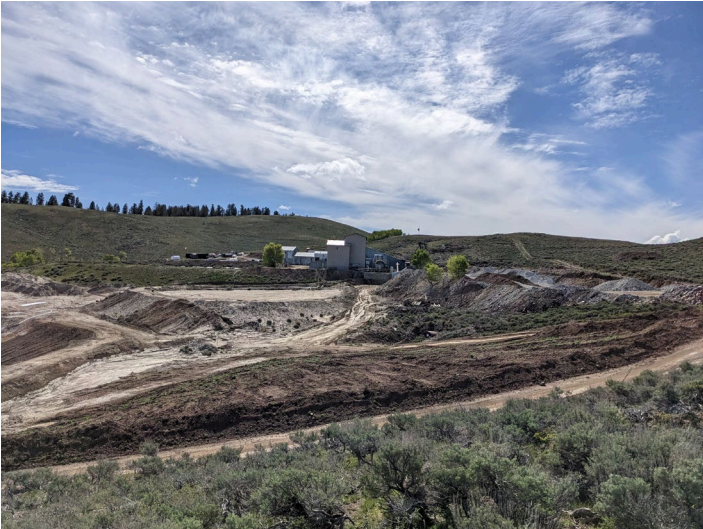
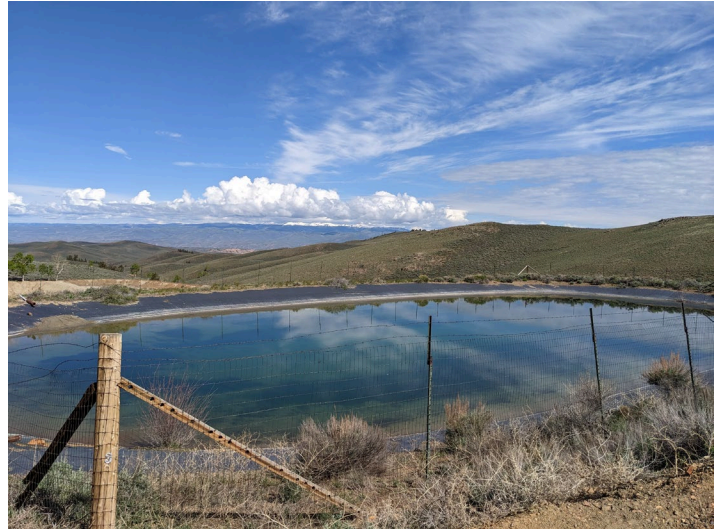
Adequate mine identification signage was noted at the entrance to the site.

The affected area was marked by posts adequate to delineate the affected area boundary.

The mill was not operating during this inspection. When it is operating, the mill processes ore from the CRG Gold Links mines in the Gold Creek area. Recirculation water for the mill is contained in the lined pond on the north side of the mill building. The pond had several feet of freeboard during this inspection. A primary settling pond is located downslope on the west side of the mill building. This pond was dry during the inspection.

Topsoil remains stockpiled in a berm at the west end of the site.

The area around the mill facility appeared well kept.
