Bowie No. 2 Mine May 31, 2023 Inspection Report

Permit Number: C-1996-083 Mine Name: Bowie No. 2 Mine Operator: Bowie Resources, LLC Operator Address: Mr. Basil Bear P.O. Box 1488 Paonia, CO 81428	County: Delta Operation Type: Underground Permit Status: Active Ownership: Private
	Operator Representative Present: NA
Operator Representative Signature: (Field Issuance Only)

Inspection Start Date: May 31, 2023 Inspection Start Time: 11:00 Inspection End Date: May 31, 2023 Inspection End Time: 12:40		Inspection Type: Coal Partial Inspection Inspection Reason: Normal I&E Program Weather: Clear	
Joint Inspection Agency: None		Joint Inspection Contacts: None	
Post Inspection Agency: None		Post Inspection Contacts: None	
Inspector(s): Clayton Wein	Inspector's Signature: <i>Clayton Wein</i>		Signature Date: 6/12/2023

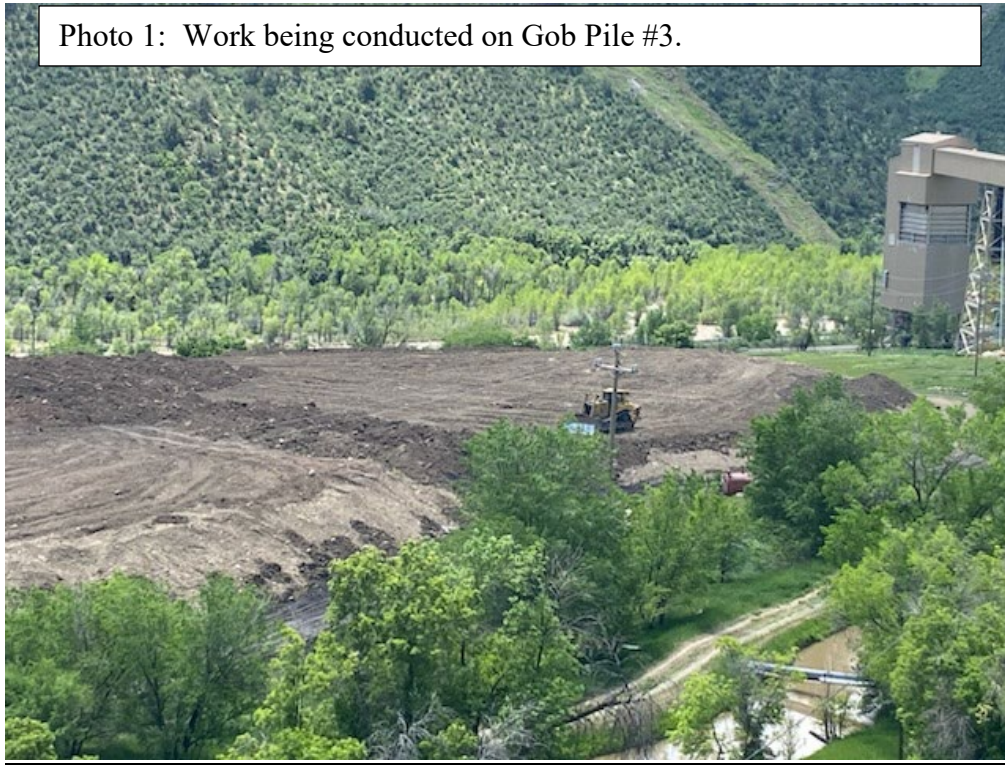
During the inspection, work was continuing on Gob Pile #3 (Photo 1). The placement of subsoil on the slopes and a portion of the top of the pile had progressed. The pile was stable and there were no indications of erosion.

Photo 1: Work being conducted on Gob Pile #3.

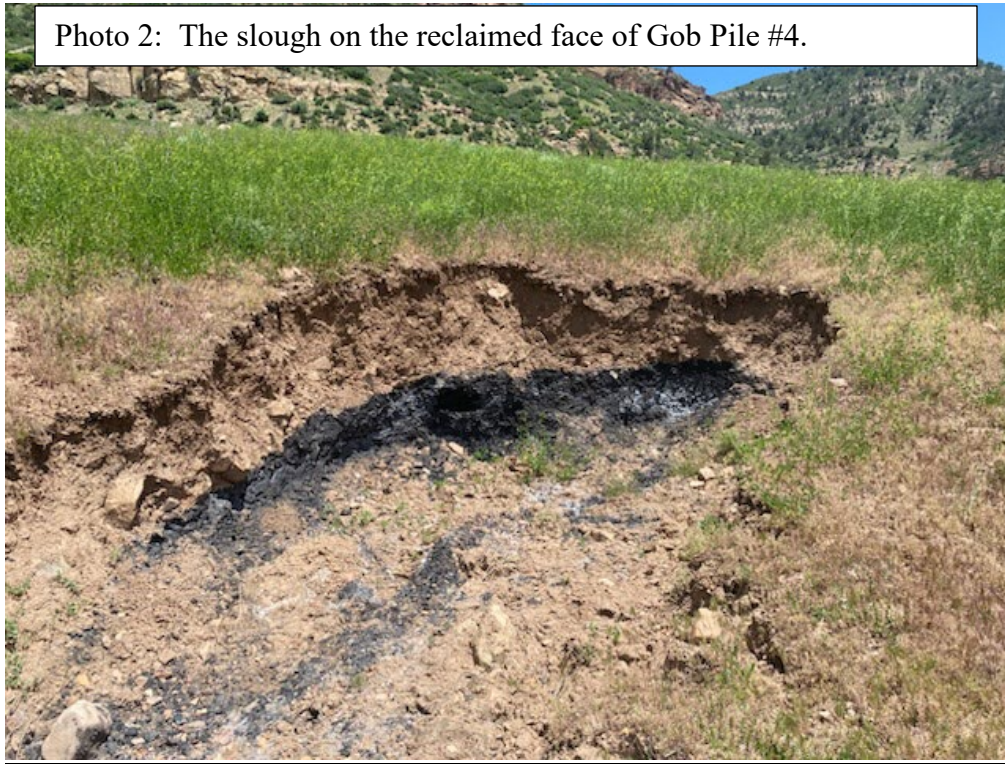
Gob Pile #4 has been vegetated for several years. With the exception of a slough observed on the pile, the rest of the pile was stable with vegetative cover. There were no additional erosional features identified during the inspection. The slough on the pile had not enlarged since the Division's May 9, 2023 inspection. There was no evidence of any recent seepage of water out of the slough (Photo 2). If the area impacted by the slough continues to remain dry, repairs to Gob Pile #4 should be conducted.

Photo 2: The slough on the reclaimed face of Gob Pile #4.

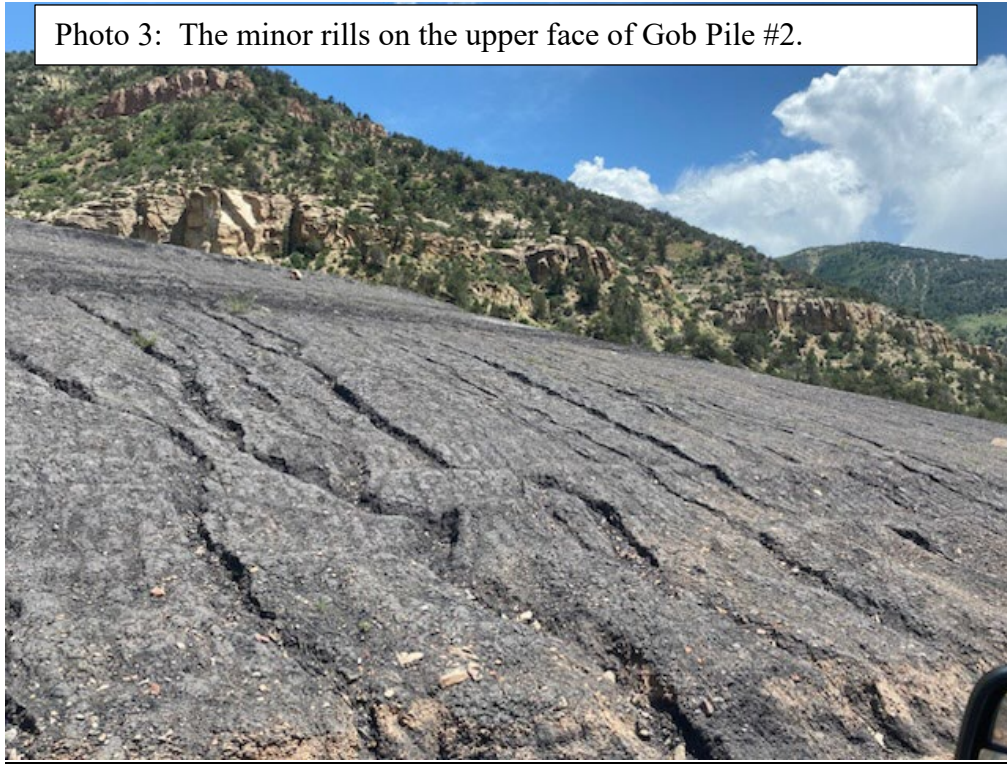
Gob Pile #2 remains half reclaimed. The remaining placement of subsoil and topsoil on the pile will be conducted once reclamation work at Gob Pile #3 is complete. The lower portion of the face of Gob Pile #2 has been vegetated for a number of years. The lower portion of the pile was stable with vegetative cover. There were no indications of erosion. There is a small seep located at the base of the pile next to the haul road. The seep remained similar in size as previous inspections. There was no flow coming out of the seep during the inspection. The upper face and top of Gob Pile #2 remains exposed. The face of the pile was stable with minor erosional rills (Photo 3). The rills were not significant enough in size or depth to have affected the stability of the pile. The top of the pile was stable with no erosional concerns. All surface flow on the top of the pile is directed to a riprap lined channel on the eastern end at the top of the pile. There was no surface runoff observed during the inspection.

Photo 3: The minor rills on the upper face of Gob Pile #2.

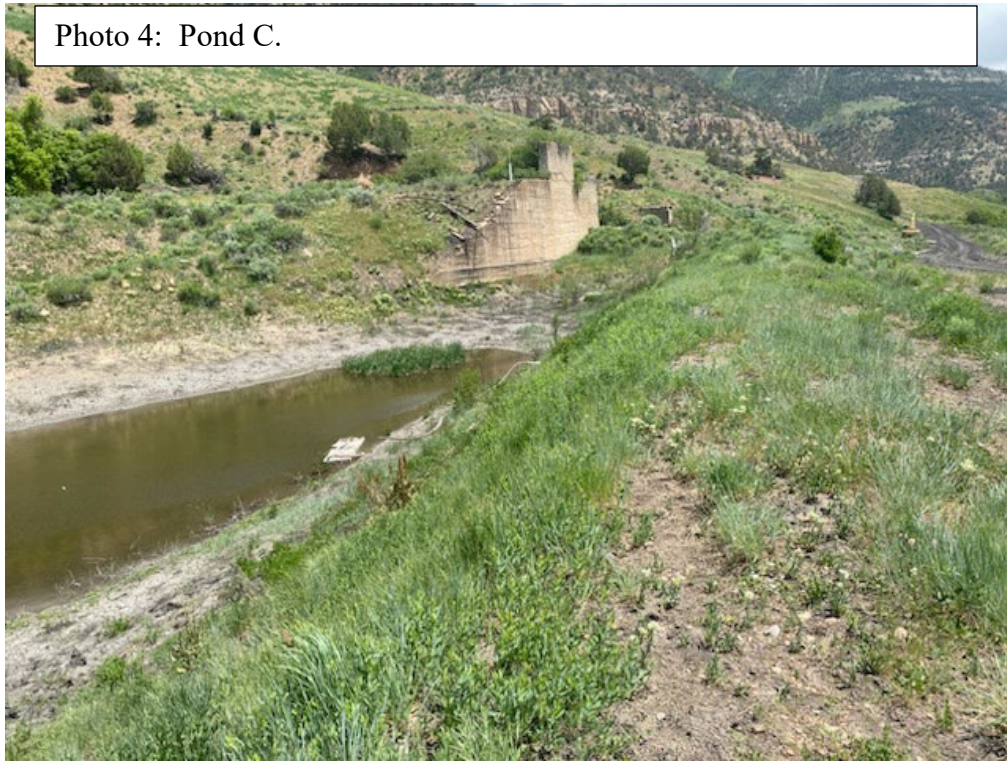
Ponds B, C and D were visited during the inspection. Pond B was holding a small amount of water in it. No discharge was occurring from the pond. The outlet for the pond was unobstructed. Pond B's embankments were stable with vegetative cover. There were no erosional features identified. Pond C was also holding a small amount of water in it (Photo 4). The level of water in the pond was well below the primary spillway. The embankment was vegetated and stable. No erosional concerns were observed. Pond D was dry during the inspection (Photo 5). The spillway was clear of debris. The pond's embankment was stable and covered with vegetation. There were no indications of erosion.

Photo 4: Pond C.

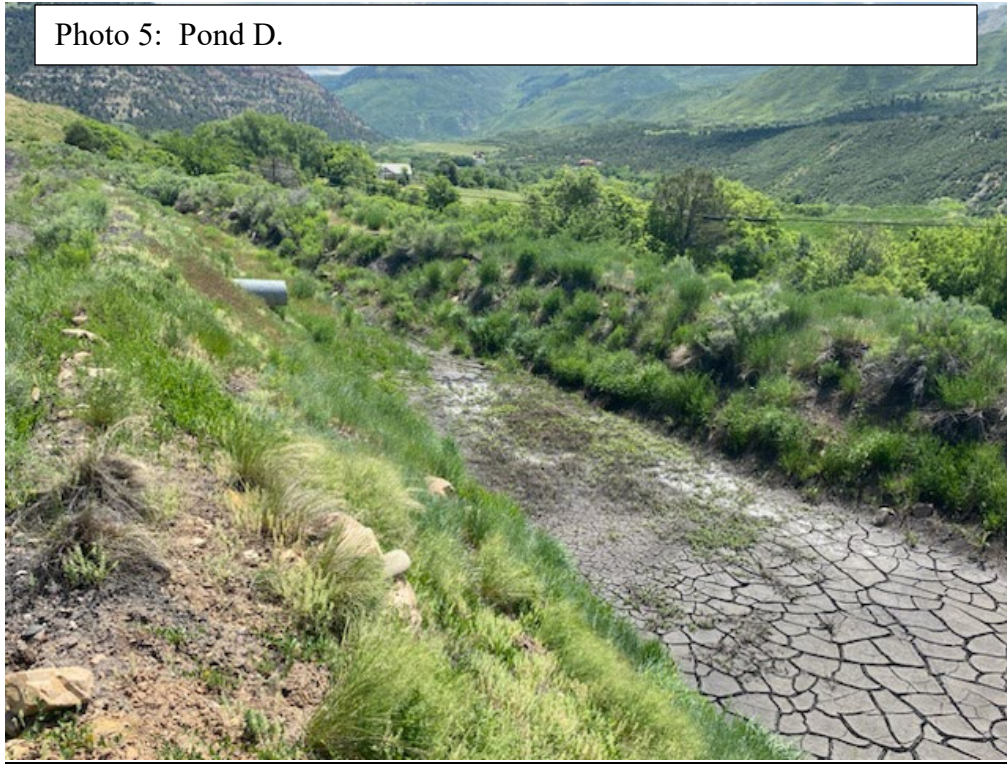
Photo 5: Pond D.

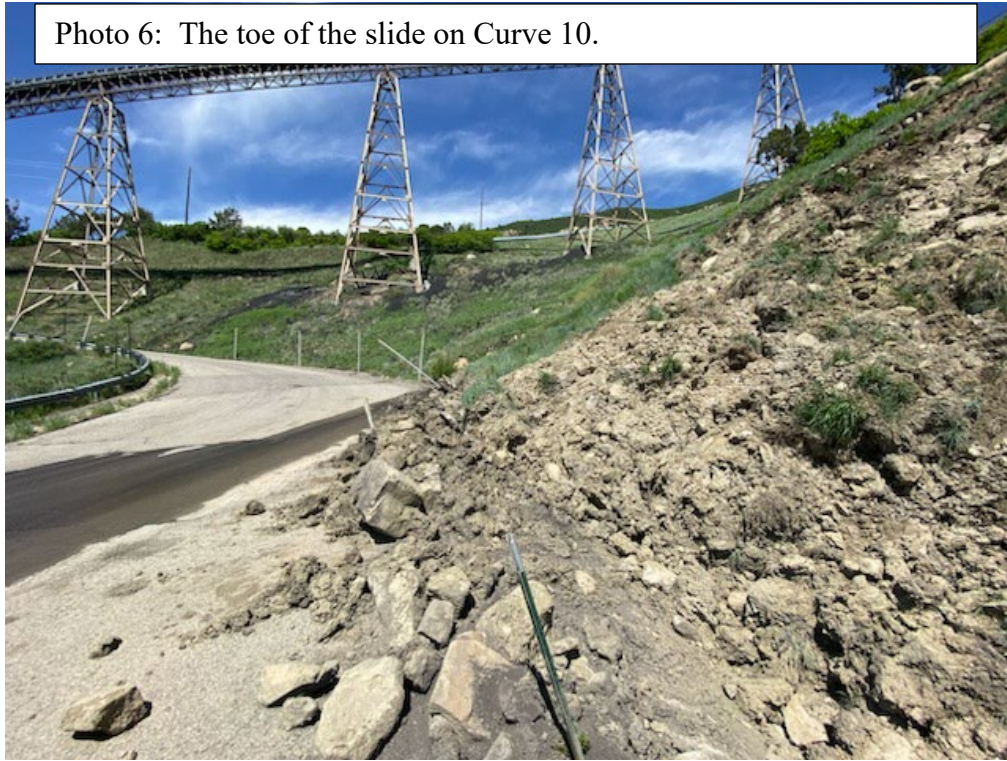
Ditches along the main haul road were in good condition and functioning as designed. There is a slide above Curve 10 that has crushed the concrete ditch (Photo 6). Flow on the north side of the haul road was temporarily being diverted across the haul road and into the ditch on the south side of the road (Photo 7). The operator is currently working on a permanent solution to the impacted ditch and will submit a revision to the Division in the near future. All water flowing across the haul road was observed to be captured in the temporary diversion ditch which connected to the existing ditch leading to pond B. The Slide had moved since the Division's May 9, 2023 inspection. It is likely that the impacted area on Curve 10 will continue to move as long as there is still moisture in the soils above Curve 10. Access to the road above the slide was still available.

Photo 6: The toe of the slide on Curve 10.

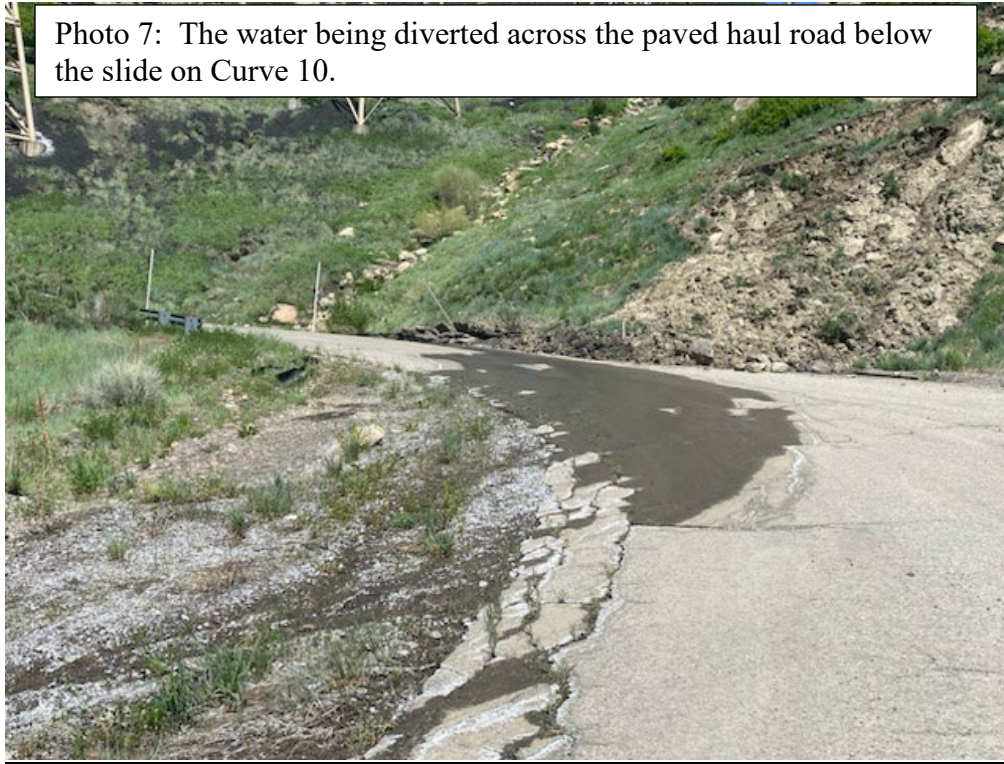
Photo 7: The water being diverted across the paved haul road below the slide on Curve 10.

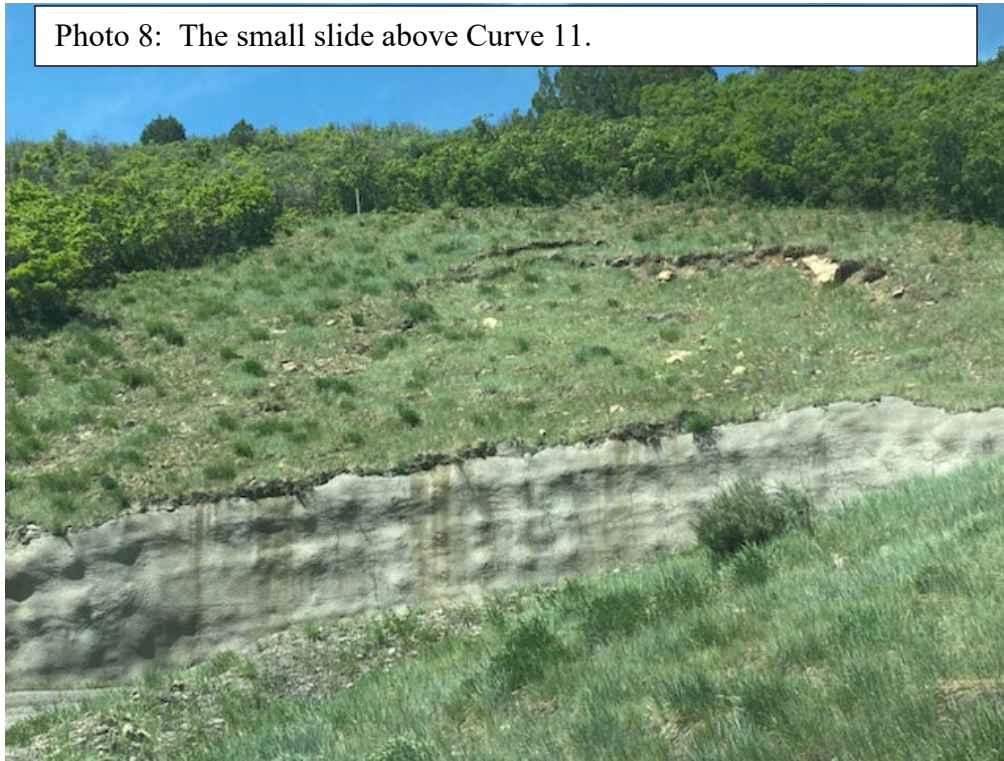
The main haul road was observed to be stable during the inspection. Please refer to the Hydrology section of this report for details regarding the slide on Curve 10. With exception to the slide above Curve 10, the remaining ditches and culverts along the main haul road were clear of debris and functioning as designed to transport runoff to Ponds B and C. A Minor slide above Curve 11 has been noted in previous Division Inspection Reports (Photo 8). The slide appeared to be dry and had not moved since the Division's previous inspection.

Photo 8: The small slide above Curve 11.

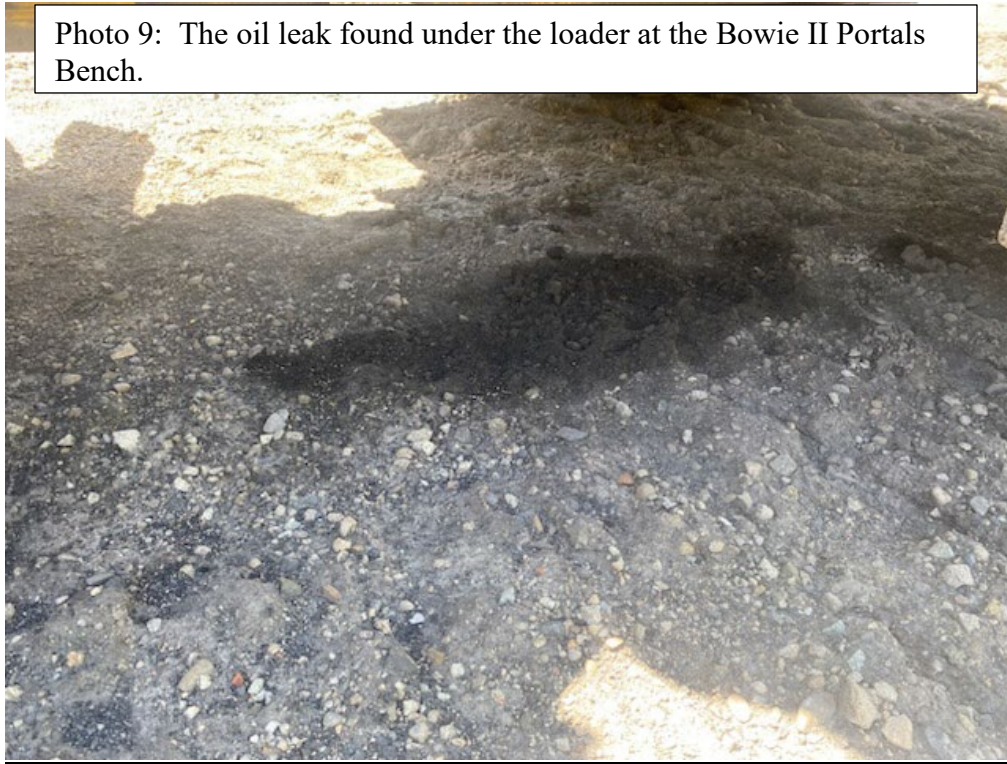
the pad for non-coal waste. Fuel storage is also located on this bench. The fuels were located in areas with secondary containment. There were no off-site impacts observed. Equipment was parked on this bench during the inspection. **The loader was observed to have a small leak dripping from underneath it (Photo 9). Please remove the contaminated soil and dispose of in accordance with the approved Spill Prevention Control and Countermeasures plan. Please also place an oil drip pan underneath the loader to prevent future contamination of soils.** The lower portals bench (Bowie III portals) was stable. The slide observed on the western slope had not moved since the Division's previous inspection. There was no seepage observed coming from the slide. The small slide on the north slope was also in the same condition as observed during the May 9, 2023 inspection. No further impacts were observed. The coal stockpile pad located at the base of the paved haul road and the conveyor was stable with no indications of erosion. No off-site impacts were observed.

Photo 9: The oil leak found under the loader at the Bowie II Portals Bench.

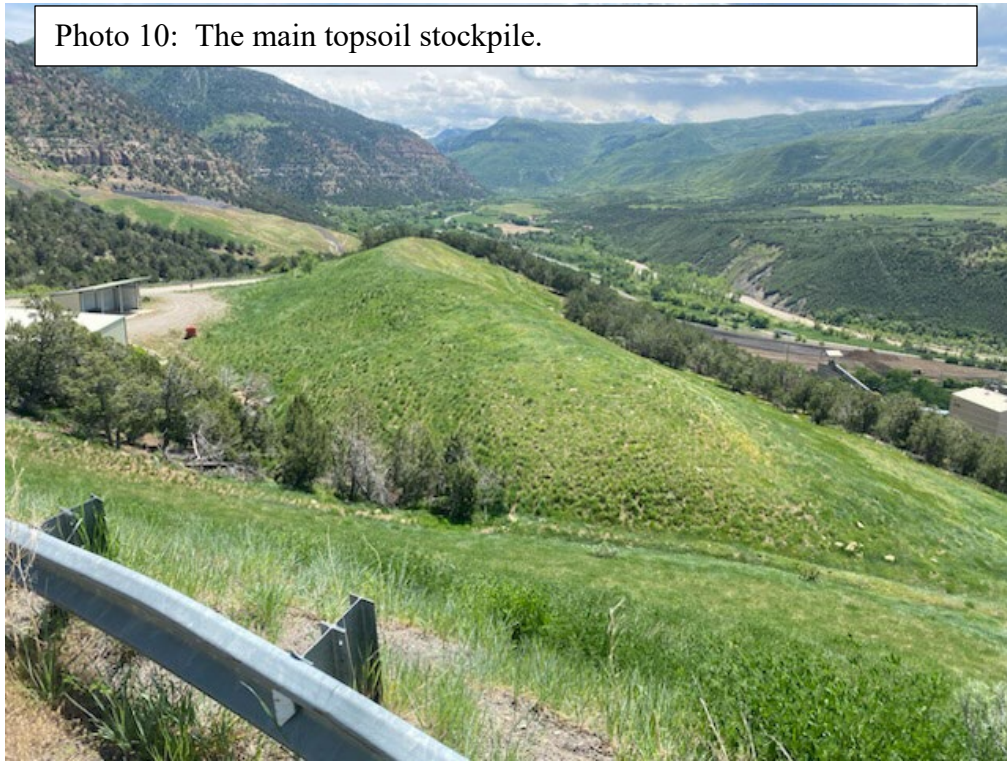
The main topsoil pile located north of the coal stockpile pad and adjacent to the paved haul road, was stable with sufficient vegetative cover (Photo 10). There were no indications of erosional features observed. The topsoil pile marker was in place. The perimeter ditch for the pile was dry during the inspection. There were no indications of erosion. The ditch was vegetated and stable.

Photo 10: The main topsoil stockpile.
