MINERALS PROGRAM INSPECTION REPORT
PHONE: (303) 866-3567

MINE NAME: Nahcolite Project	MINE/PROSPECTING ID#: M-1983-194	MINERAL: Carbonates	COUNTY: Rio Blanco
INSPECTION TYPE: Monitoring	WEATHER: Cloudy, Raining intermittently	INSP. DATE: June 5, 2023	INSP. TIME: 11:30
OPERATOR: Natural Soda LLC	OPERATOR REPRESENTATIVE: Kirk Dealing	TYPE OF OPERATION: 112d-3 - Designated Mining Operation	
REASON FOR INSPECTION: Normal I&E Program	BOND CALCULATION TYPE: None	BOND AMOUNT: \$4,433,331.00	
DATE OF COMPLAINT: NA	POST INSP. CONTACTS: DRMS	JOINT INSP. AGENCY: U.S.BLM	
INSPECTOR(S): Amy Yeldell Todd Jesse	INSPECTOR'S SIGNATURE:

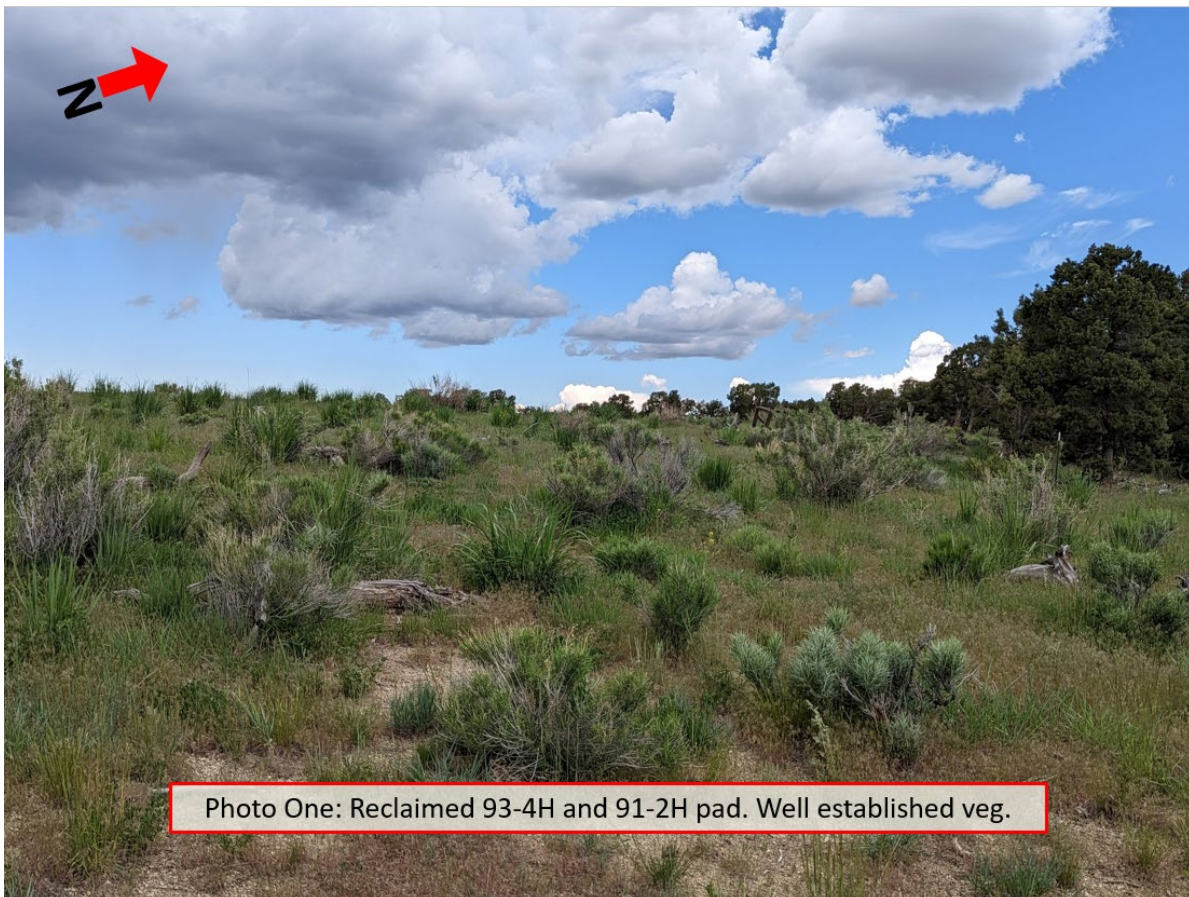
Pad 93-4H, 91-2H was reclaimed a number of years ago (Photo One). Vegetation on the reclaimed pad area is generally 70% cover or greater and comparable to surrounding undisturbed areas. Grasses such as Basin wildrye, brome and western wheatgrass; Forbs such as Gooseberry globe-mallow, vetch; and Shrubs such as sage, and rabbit brush appear to be thriving. There were some noxious species such as cheatgrass and tansy mustard but they do not appear to be impacting positive growth of desirable species.

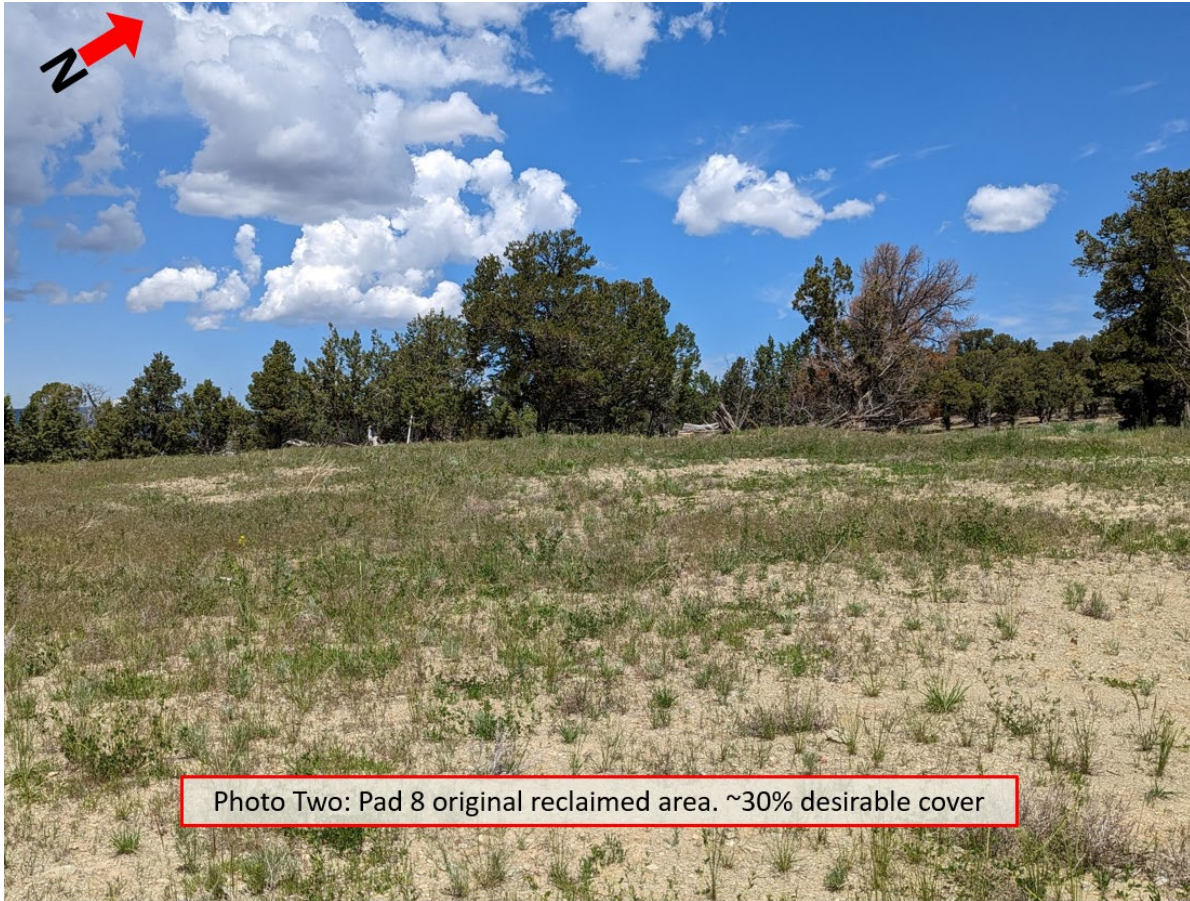
Final reclamation of Pad 8 occurred in fall of 2021 (Photo Two). A small portion on the southeast corner was reclaimed in fall of 2022. Overall cover of desirable species is less than 50%. Yellow-sweet clover and cheatgrass appear to be the predominant species. Some perennial grasses, sage and rabbit brush are beginning to establish. Higher densities of noxious weeds were observed in the reclaimed area as compared to undisturbed areas adjacent to the pad. Multiple weed treatments throughout the growing season may help relieve competitive pressure on desirable plants.

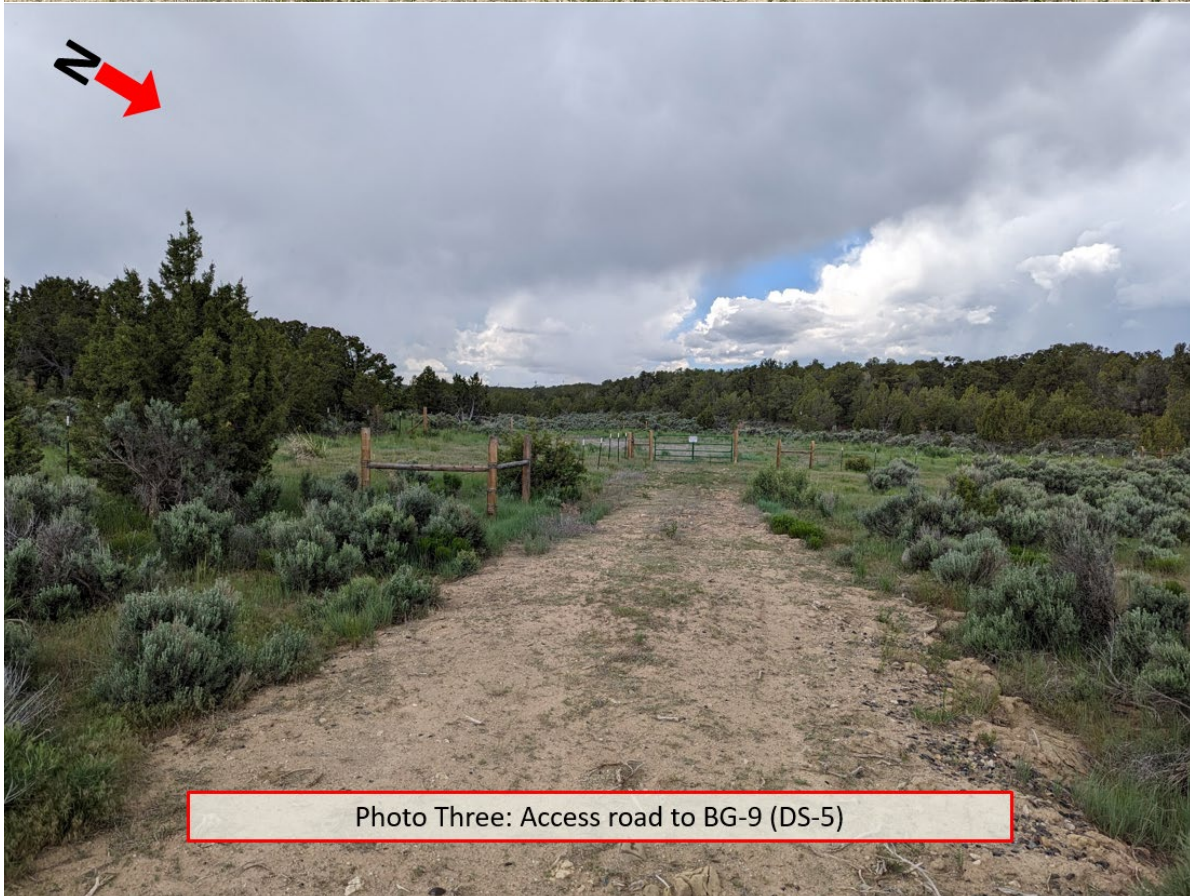
The access road to BG-9 (DS-5) is sparse with very little desirable vegetation evident (Photo Three). Within the fenced in portion of the pad perennial grasses and some forbs and shrubs have established. Cheat grass is intermixed in the exterior or reclaimed areas. However the desirable species appear to be competing well with the noxious threats. Skeletons of dead annual weeds were also observed throughout the recent final reclamation area (Photo Four). These weeds appear to be displacing desirable species. Additional seeding of the access road is recommended. The recently reclaimed interior portions may continue to establish without additional seeding if noxious weeds are sufficiently managed.

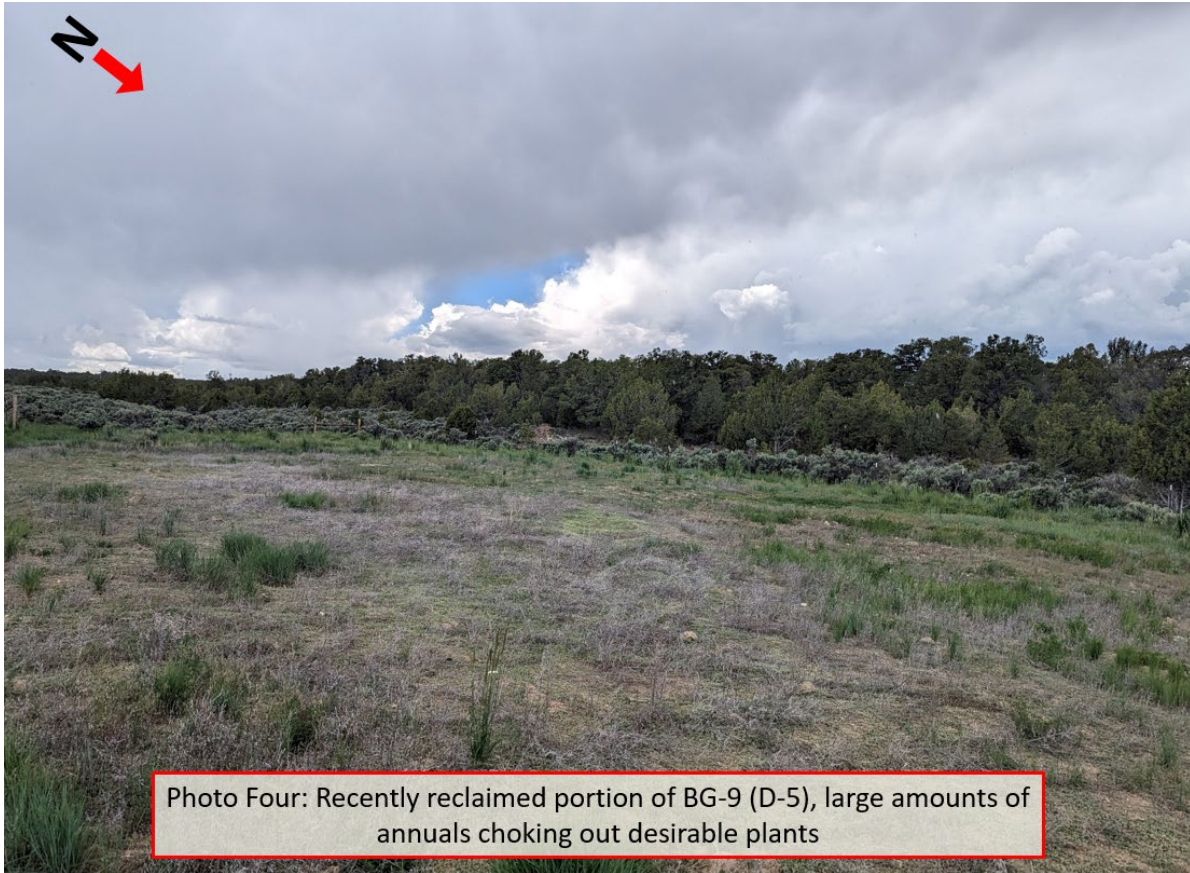
Photo Four: Recently reclaimed portion of BG-9 (D-5), large amounts of annuals choking out desirable plants

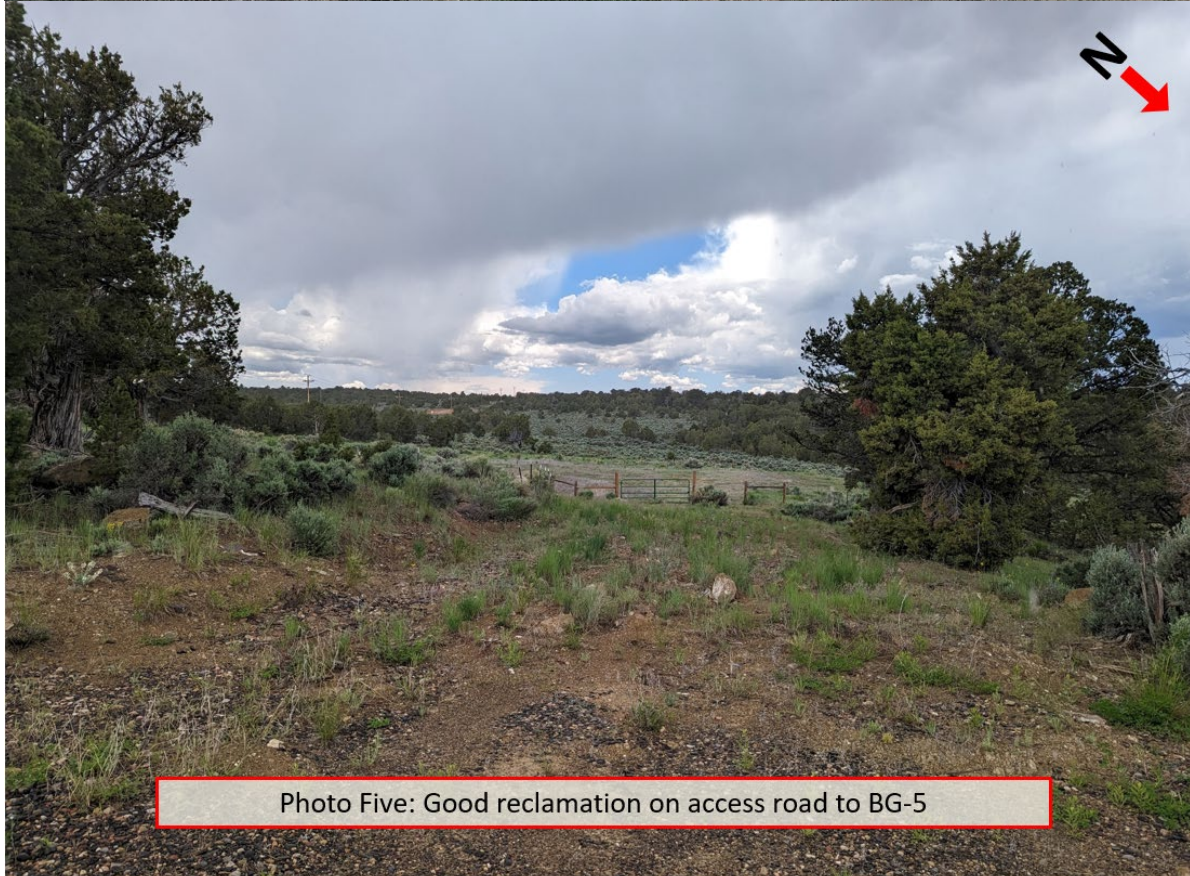
The access road to BG-5 is beginning to establish well despite the rocky soil material (Photo Five). Unfortunately within the fenced in area the recently reclaimed area has very little reclamation success. Annual noxious weeds appear to be choking out nearly all desirable vegetation (Photo Six). Perimeter interim reclaimed areas have well established grasses and shrubs that appear to be resilient to the intermixed cheatgrass. Vegetation in the interim areas is similar in composition to the adjacent undisturbed areas. Reclamation efforts should focus on controlling noxious weeds within the recent reclaimed areas (and adjacent areas) and additional seeding this fall.

Photo Five: Good reclamation on access road to BG-5

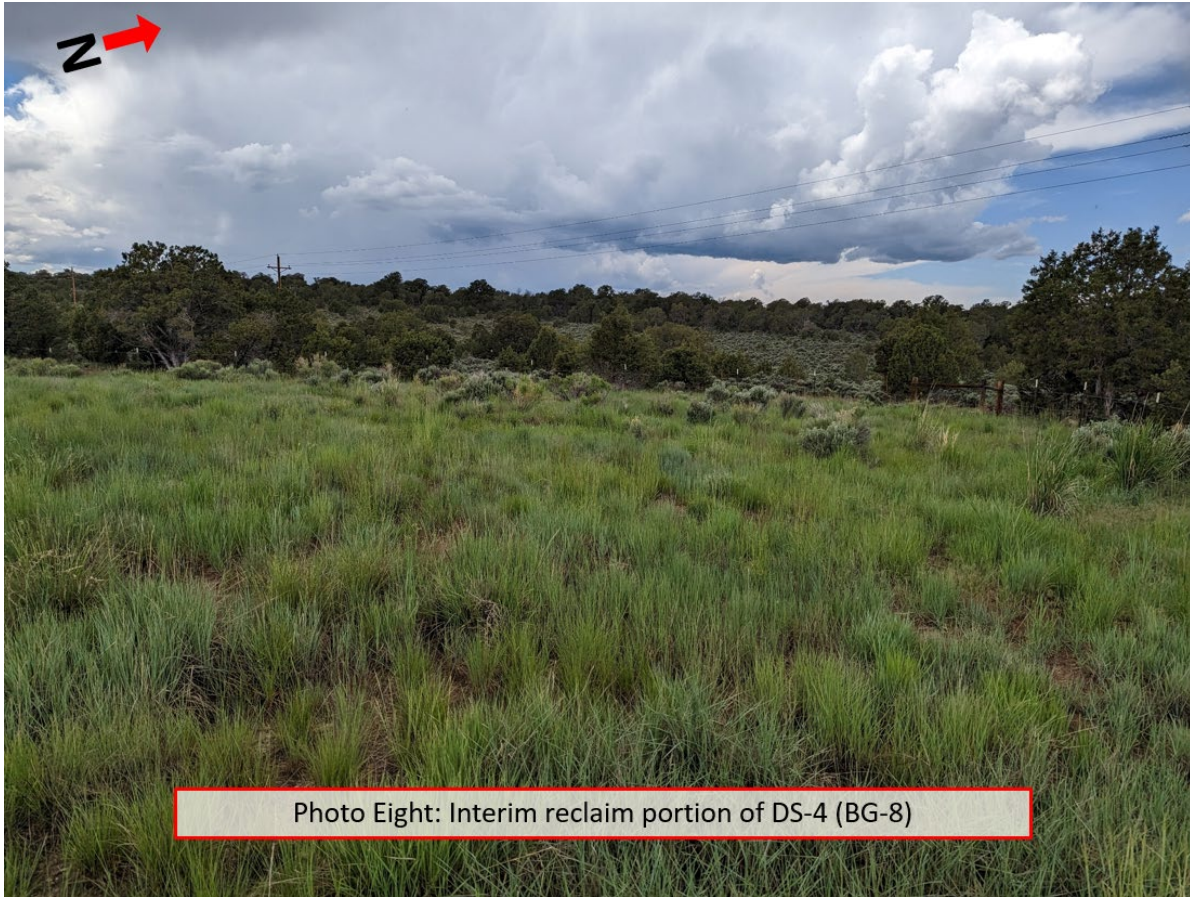
The access road to DS-4 (BG-8) is varied (Photo Seven). Vegetation in some areas is well established with desirable species or pockets of completely bare ground. Conditions within the pad were similar. The interim areas have well established perennial grasses with a few shrubs and minimal cheatgrass infestation (Photo Eight). While the recently reclaimed areas are nearly bare. This pad may have some soil quality issues given the distinct difference in reclamation success. The pad within the fence should be reseeded this fall. Soil sampling

Photo Eight: Interim reclaim portion of DS-4 (BG-8)

to see if a larger problem is to blame for the failure also is recommended.

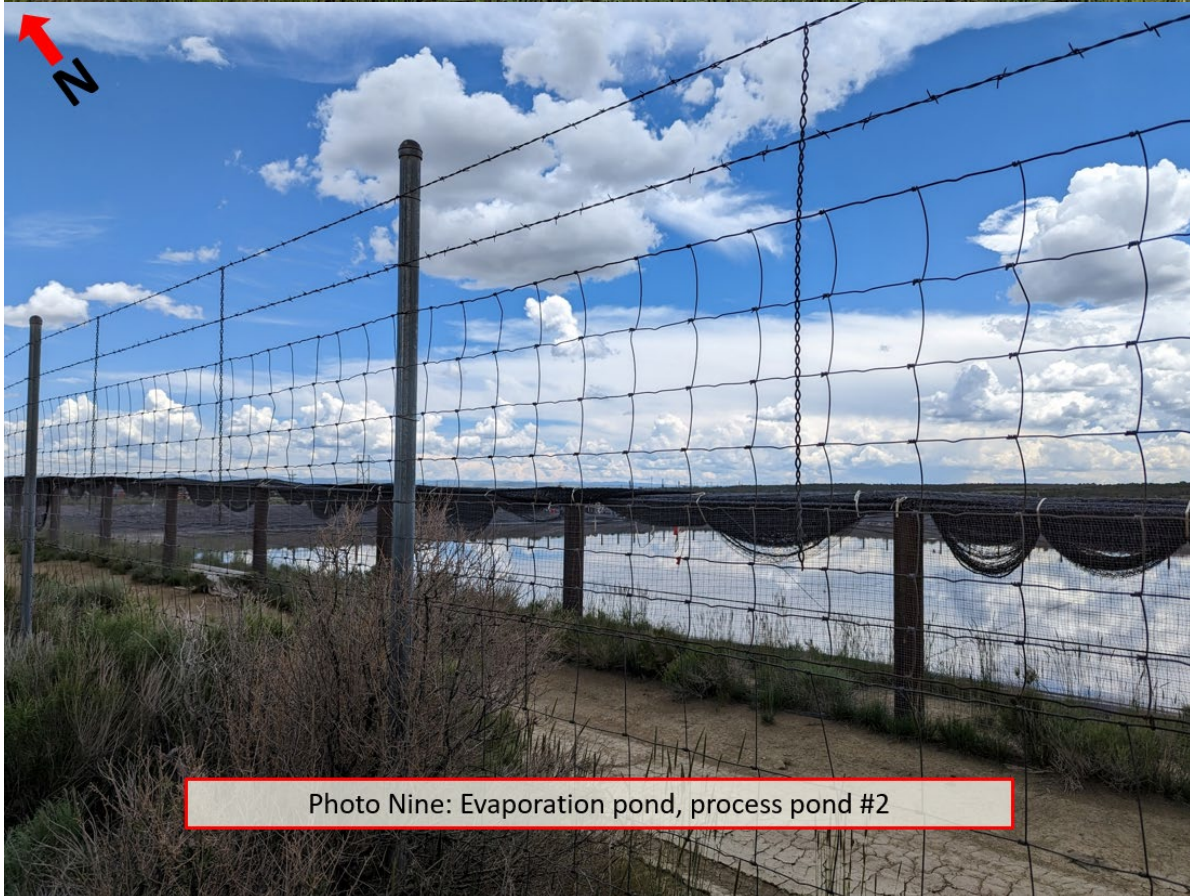
The Division inspected the evaporation/process water pond (EPF). The pond appeared to be functional at the time of the inspection. The evaporation pond consists of two compartments. One is approximately 3 acres and contains process water (process pond #1) which can be recycled throughout the system. The second compartment (process pond #2) is approximately 7 acres and contains fluids which do not meet food grade standards and thus cannot be reused (Ex. boiler blowdown water), (Photo Nine). There is a dike between the two ponds that is approximately three feet lower than the perimeter of the pond to allow additional freeboard if needed. The pond itself is double lined, the primary top is 60 mil HDPE liner, and the second bottom is a 40 mil HDPE liner. Between the two liners is drainage netting that assist the flow of fluids leaked from the primary liner to the sump (leach pump) located between liners.

Photo Nine: Evaporation pond, process pond #2

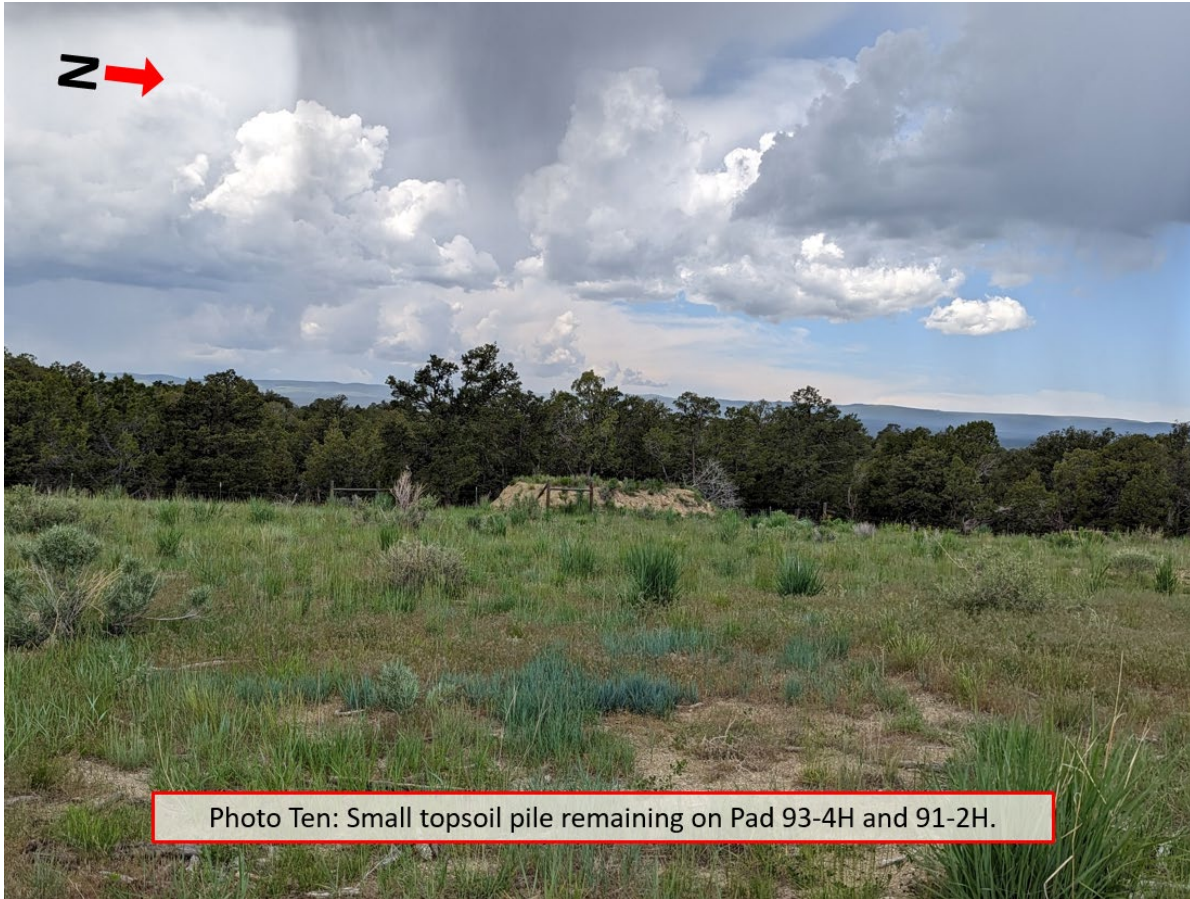
A small stockpile of topsoil still remains on the southwest corner of the 93-4H, 91-2H pad. It appears to be self-reclaimed and stable (Photo Ten).

Photo Ten: Small topsoil pile remaining on Pad 93-4H and 91-2H.
