Inspection Report and Cost Estimate for M-2001-038 Bennett Pit

MINERALS PROGRAM INSPECTION REPORT
PHONE: (303) 866-3567

MINE NAME: AFS - Bennett Pit	MINE/PROSPECTING ID#: M-2001-038	MINERAL: Sand and borrow material construction	COUNTY: Adams
INSPECTION TYPE: Monitoring	WEATHER: Clear	INSP. DATE: May 10, 2023	INSP. TIME: 11:15
OPERATOR: Albert Frei & Sons Inc.	OPERATOR REPRESENTATIVE: Ben Frei	TYPE OF OPERATION: 112c - Construction Regular Operation

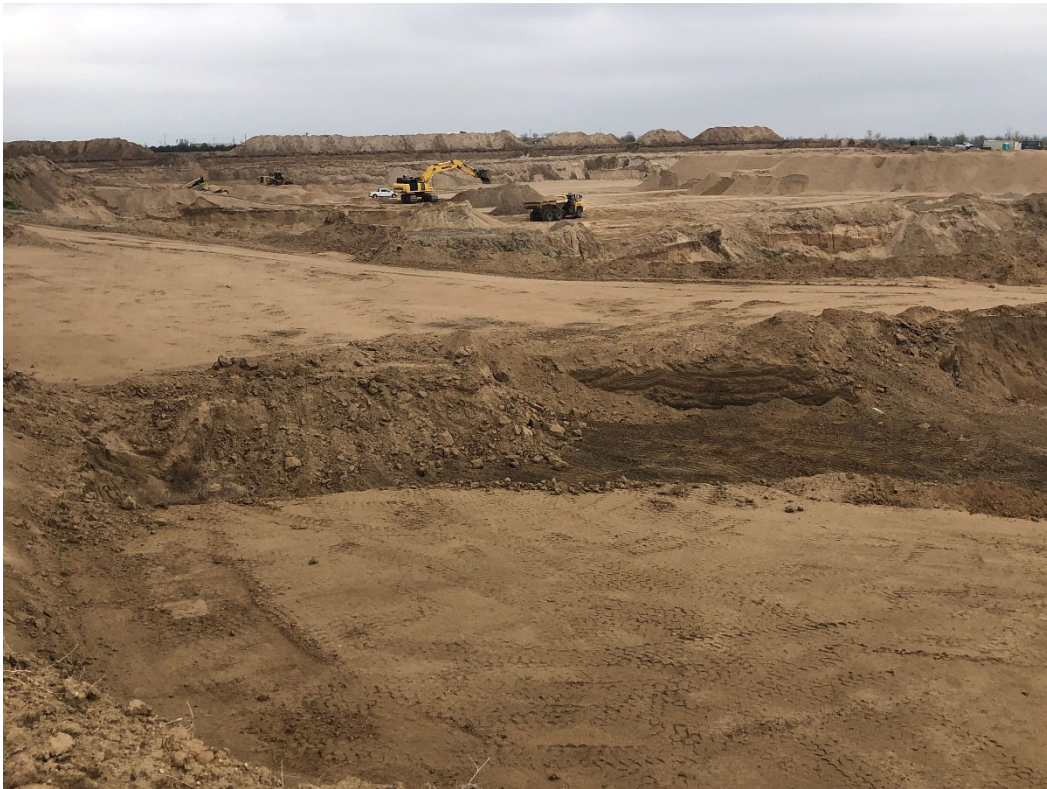
The mine was active during this inspection. Mining equipment was observed working in the northern end of the pit, and trucks were entering and leaving the site. Stockpiles of material were noted in the pit area near the entrance. The original Bennett Pit was permitted for 47.75 acres. On October 25, 2019, the Division approved Amendment 1 (AM1) which added 60.31 acres to the permit area to allow the mine to expand to the north and south and extend the life of the mine. According to the 2022 Annual Report, mining in the south area is complete. Mining is ongoing to the east and the north. The maximum allowed disturbance at one time is 60 acres. Based on Google imagery from 06/2023, the Division estimates the current disturbance footprint is approximately 60 acres. The Operator is reminded that a Technical Revision is required prior to disturbing land beyond 60 acres to ensure the financial warranty is adequate to complete reclamation.

Photo 1. Looking northeast across the active mining area.

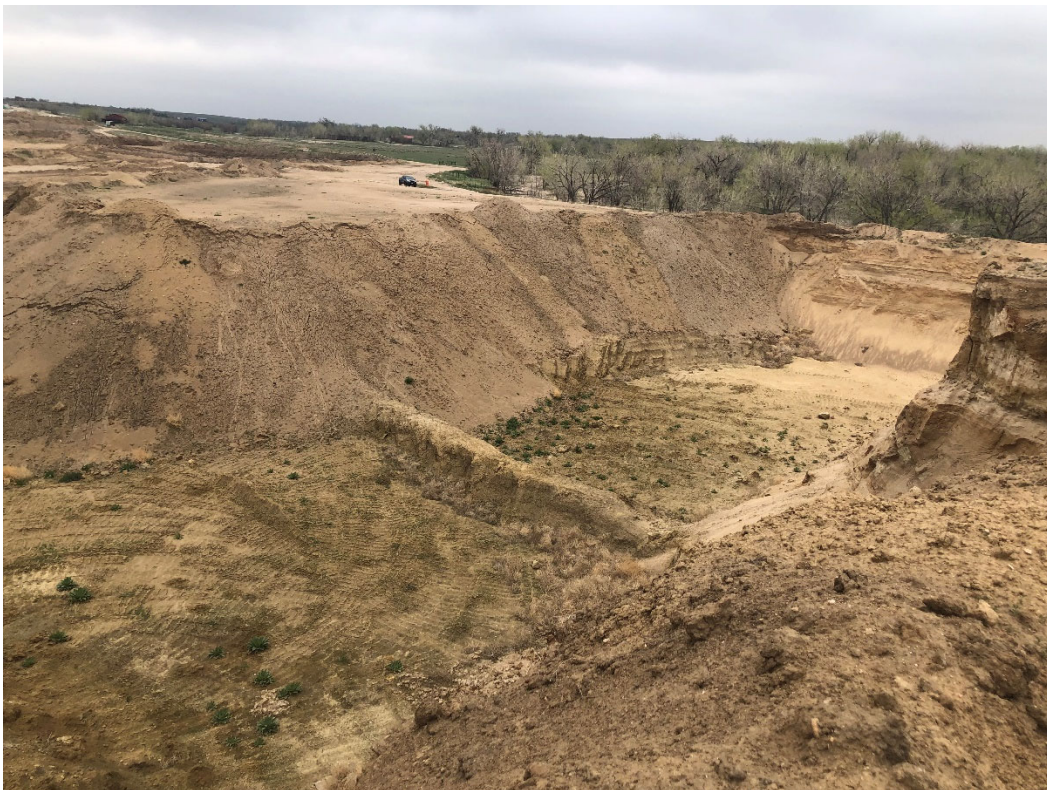
An access road runs around the perimeter of the active mining area. The mine plan calls for a 25-foot setback from the permit line to the mining area. The Operator is maintaining this setback around the site. The Division observed the mined pit in the south end of the permit area and noted a steep 40-foot highwall, ranging 50-75 feet from the southern permit boundary. According to the approved mine plan, the Operator will place overburden, reject rock and inert materials along the base of the face in this area and then cut/ fill the 70-foot-wide mined area to create the final 3H1:V slope over the fill.

Photo 2. Looking east across the pit at the south end of the permit area.

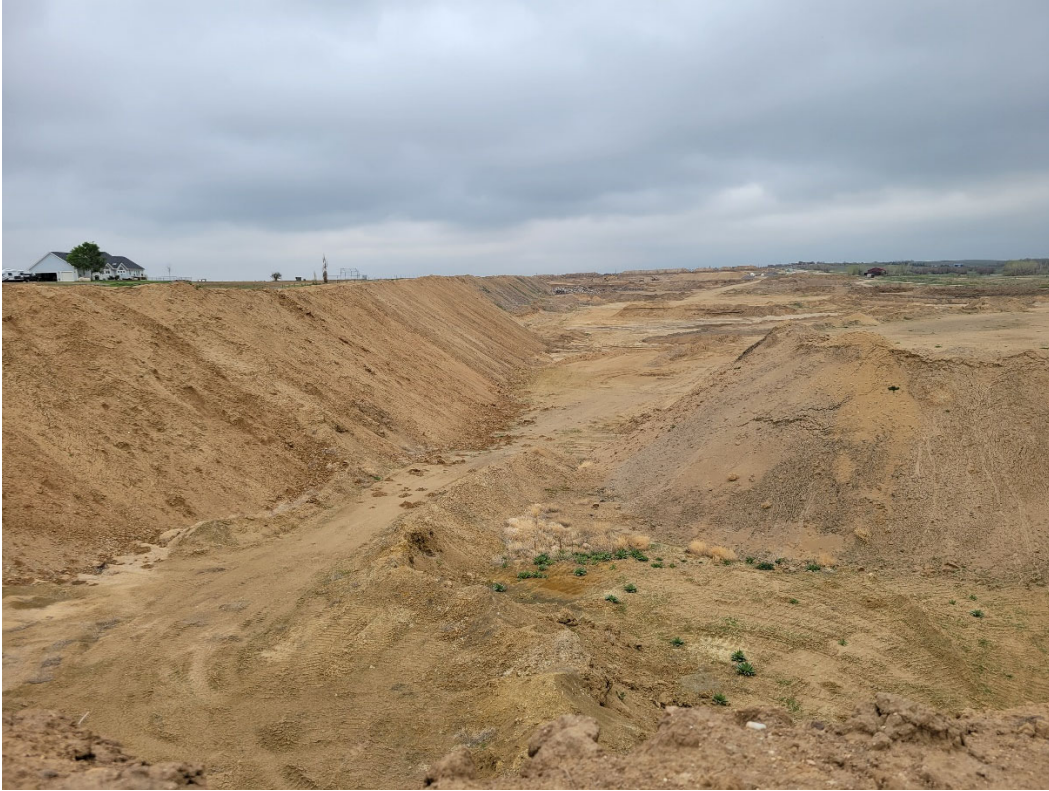
A 3,200 ft. steeply sloped highwall runs along the western boundary of the pit. Overburden was observed stored above the highwalls on the western and northern ends of the active mining area which, according to the approved reclamation plan, will be used to create the final slopes of 3H:1V. Through the approval of Technical Revision 1 (TR1), the Operator is allowed to import inert material onto the site for backfill. During this inspection, the Division observed inert material along the base of the western highwall. Large pieces of concrete and asphalt and other fragments of material were noted. The Operator submitted an Inert Fill Ticket List to the Division with the 2022 Annual Report.

Photo 3. Looking north along the western highwall.

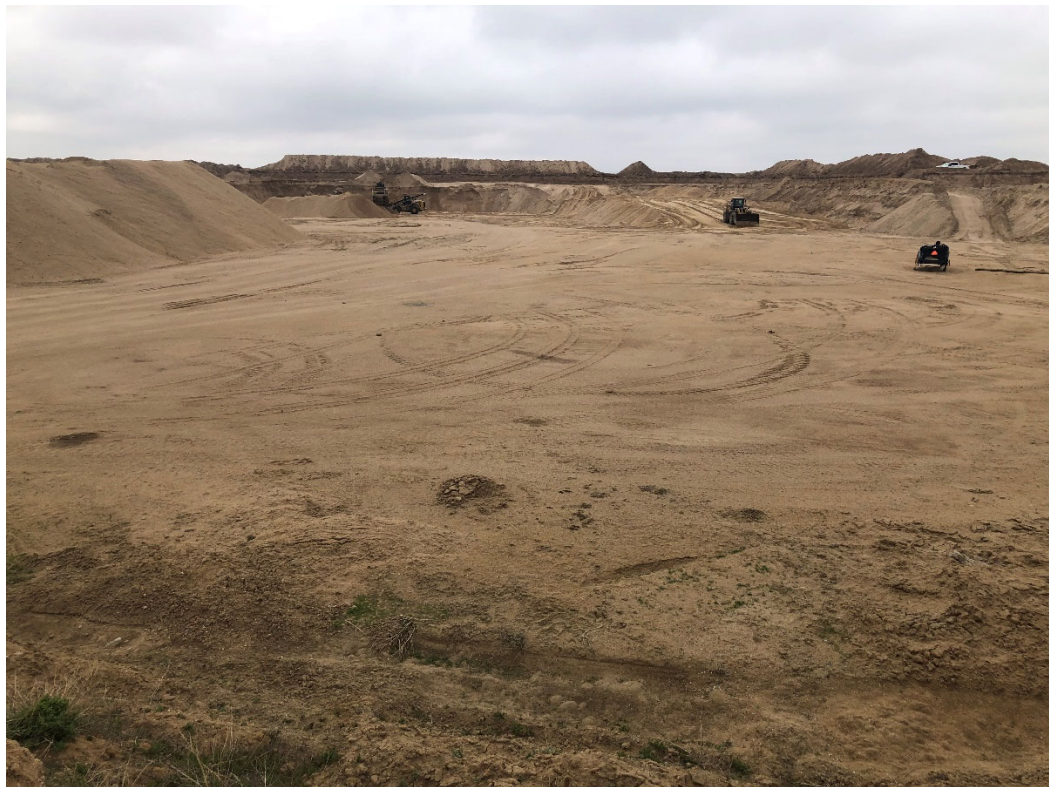
Photo 4. Looking west from the front entrance into the active north mining area.

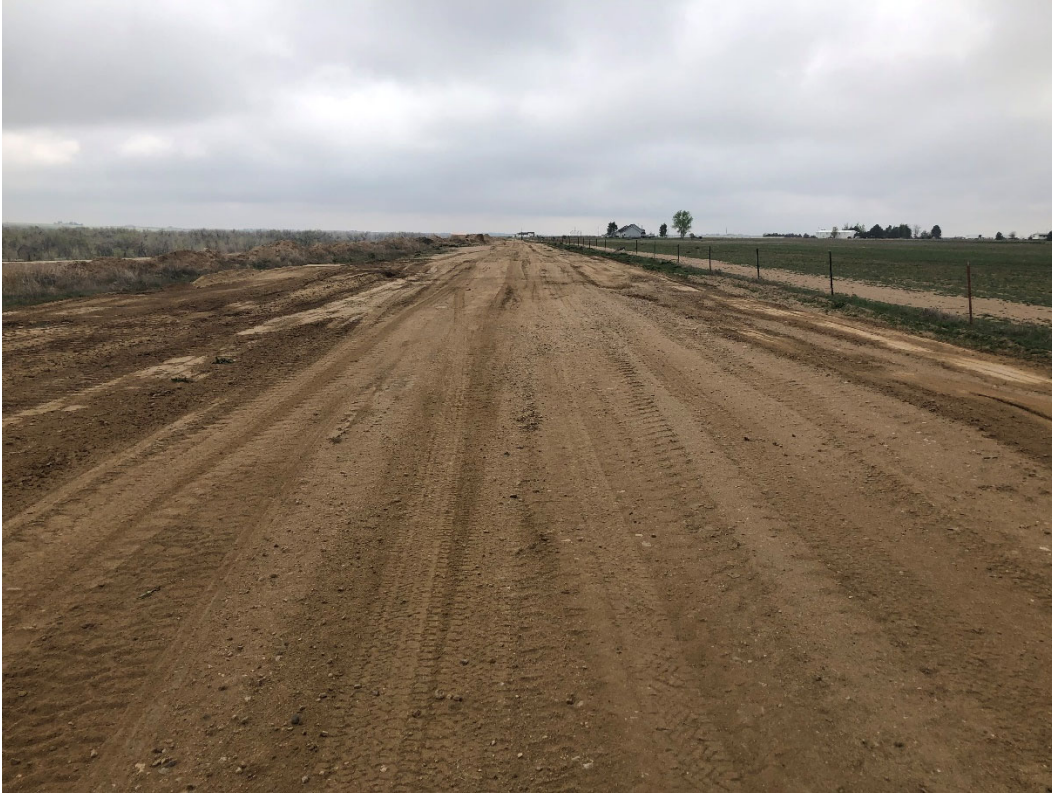
Photo 5. Looking south down the access road that runs along the western boundary. Fencing surrounds the permit area.

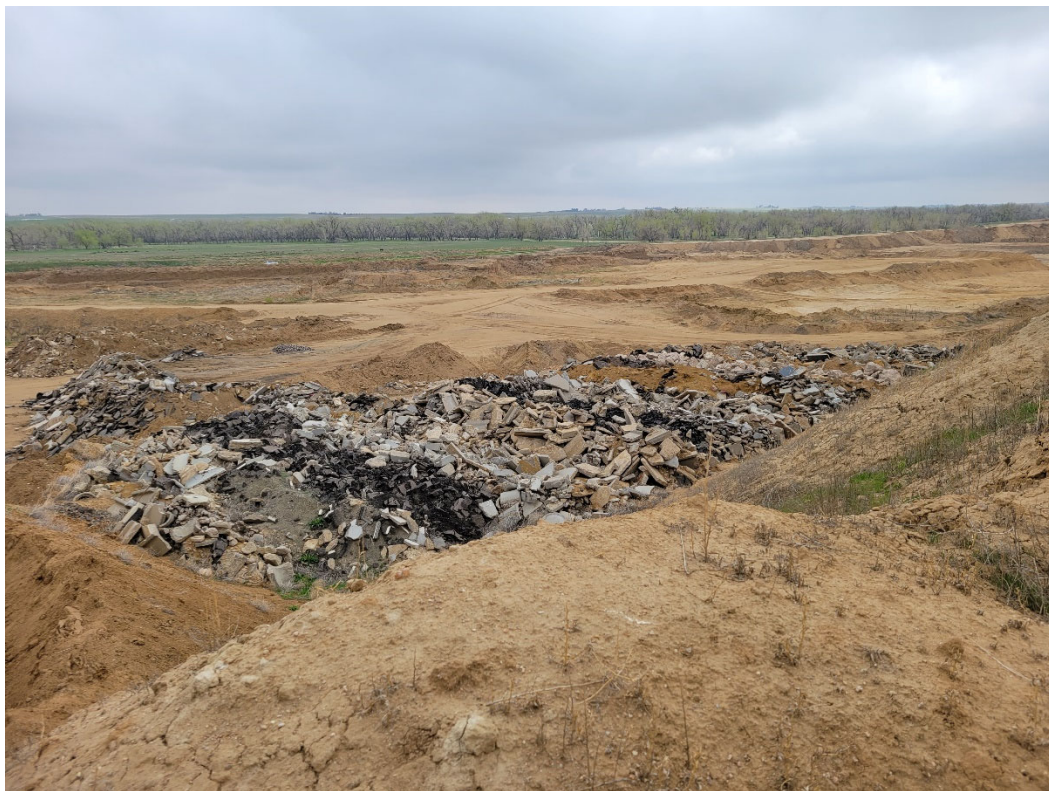
Photo 6. Inert fill placed at the base of the western highwall.

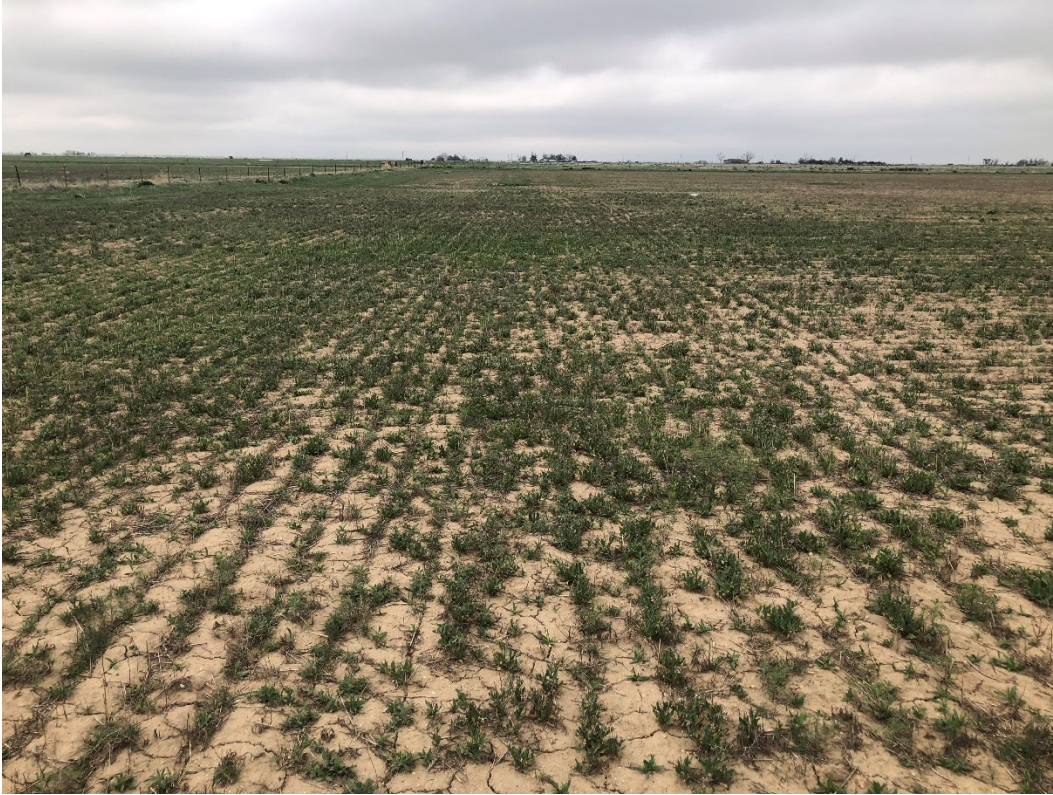
The Division viewed the fields on the west and north sides of the active mining area within the permit boundary. These fields remain undisturbed by mining. Evidence of recent drill seeding to control wind/water erosion was noted.

Photo 7. Looking west at the undisturbed portion of the north expansion area.

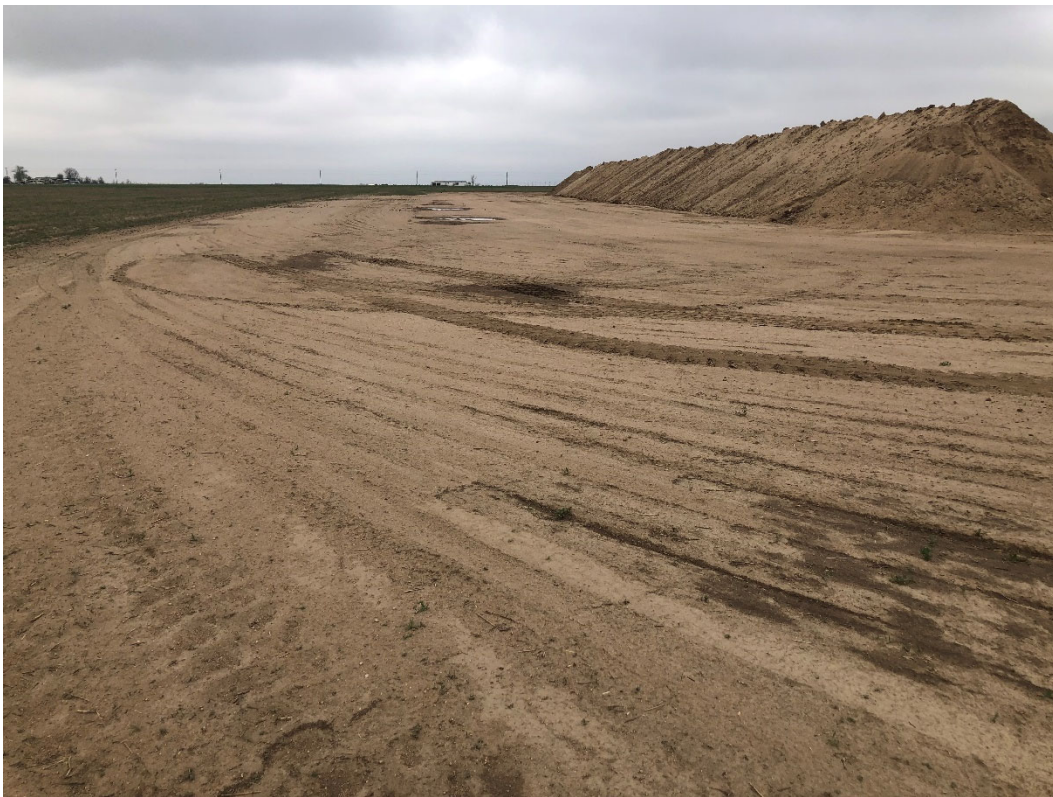
Photo 8. Looking north along the access road behind the active mining face and the undisturbed portion of the north area.

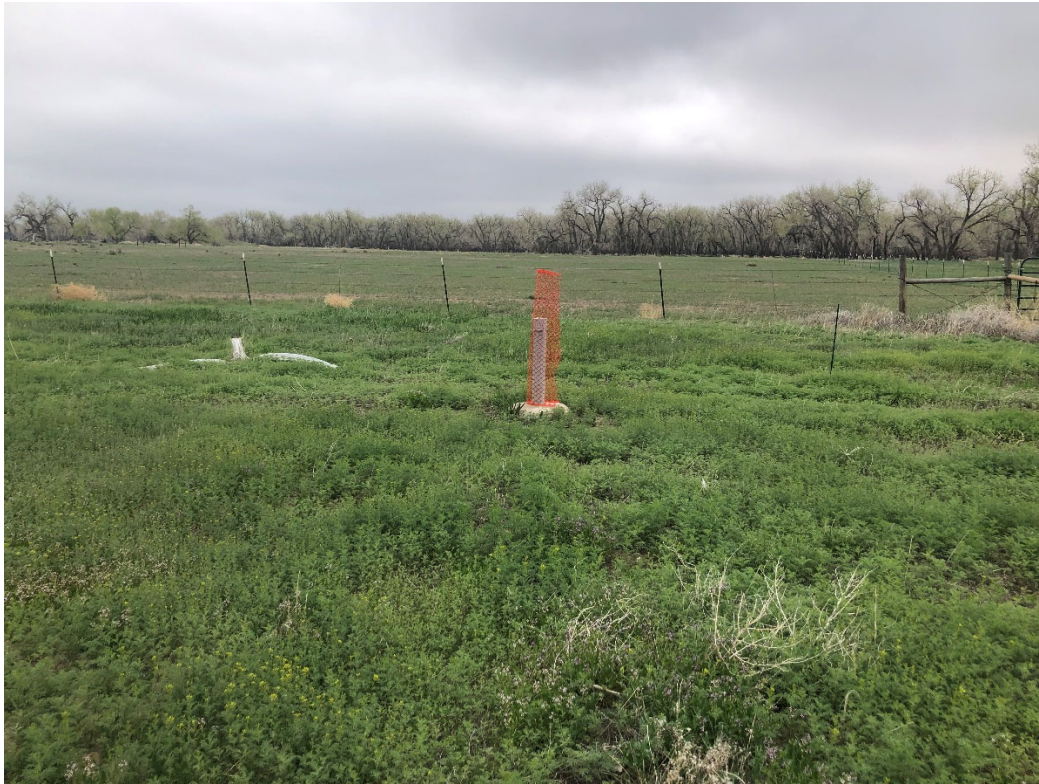
received by the Division on July 27, 2022, along with the annual report. The Division reviewed the water level and water quality data and no issues were noted. During the inspection, the Division observed the 5 monitoring wells on the southern end of the permit area, clearly marked and accessible.

Photo 9. Looking southeast at monitoring well located on the east side of the mining area.

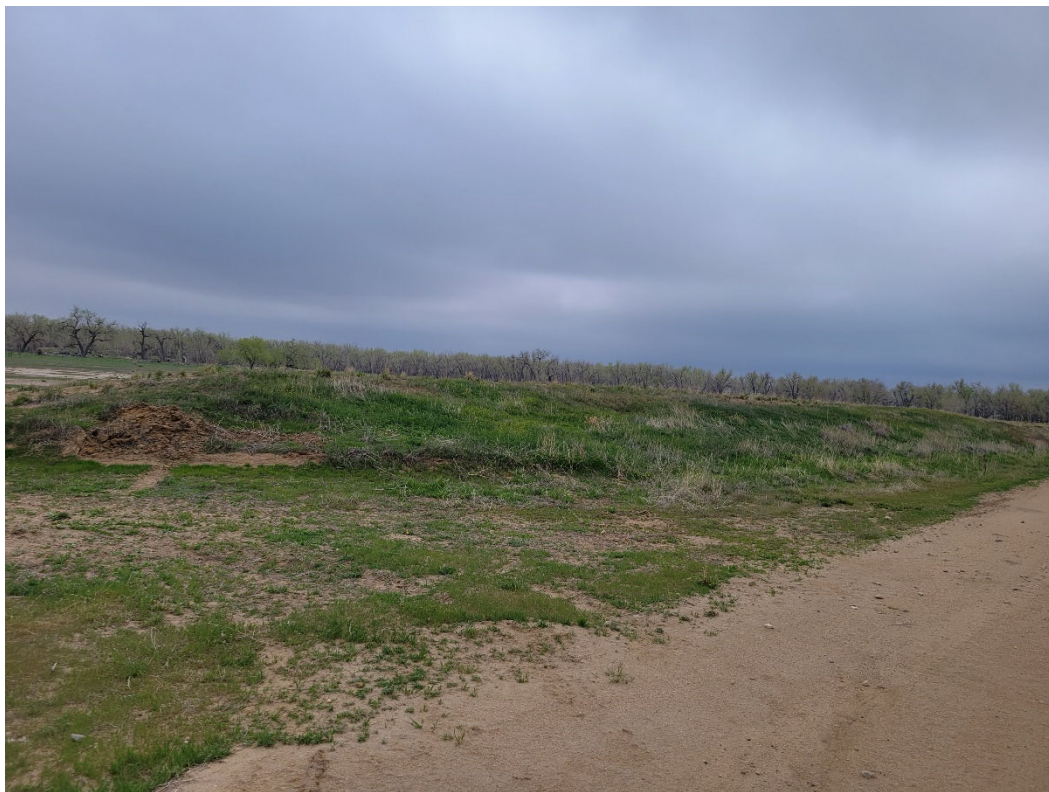
Topsoil was observed in a long strip along the eastern permit boundary. Stabilizing vegetation has established on the pile and no erosional features were observed.

Photo 10. Vegetated topsoil pile on the east side of the pit, along the access road.

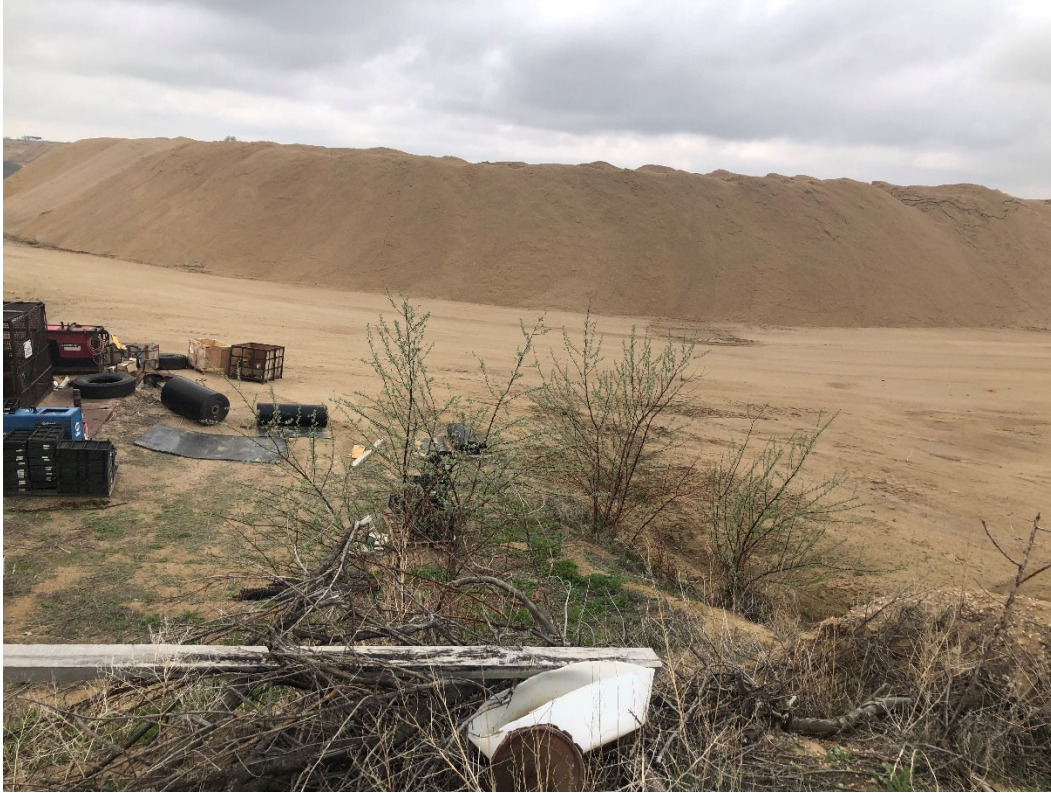
Photo 11. Russian olive trees next to the fuel and equipment storage area near the front entrance.

Russian olive trees were noted around the fuel storage area near the front entrance. The Division recommends removing the invasive Russian olive trees in the pit and around the fuel storage area near the front entrance.

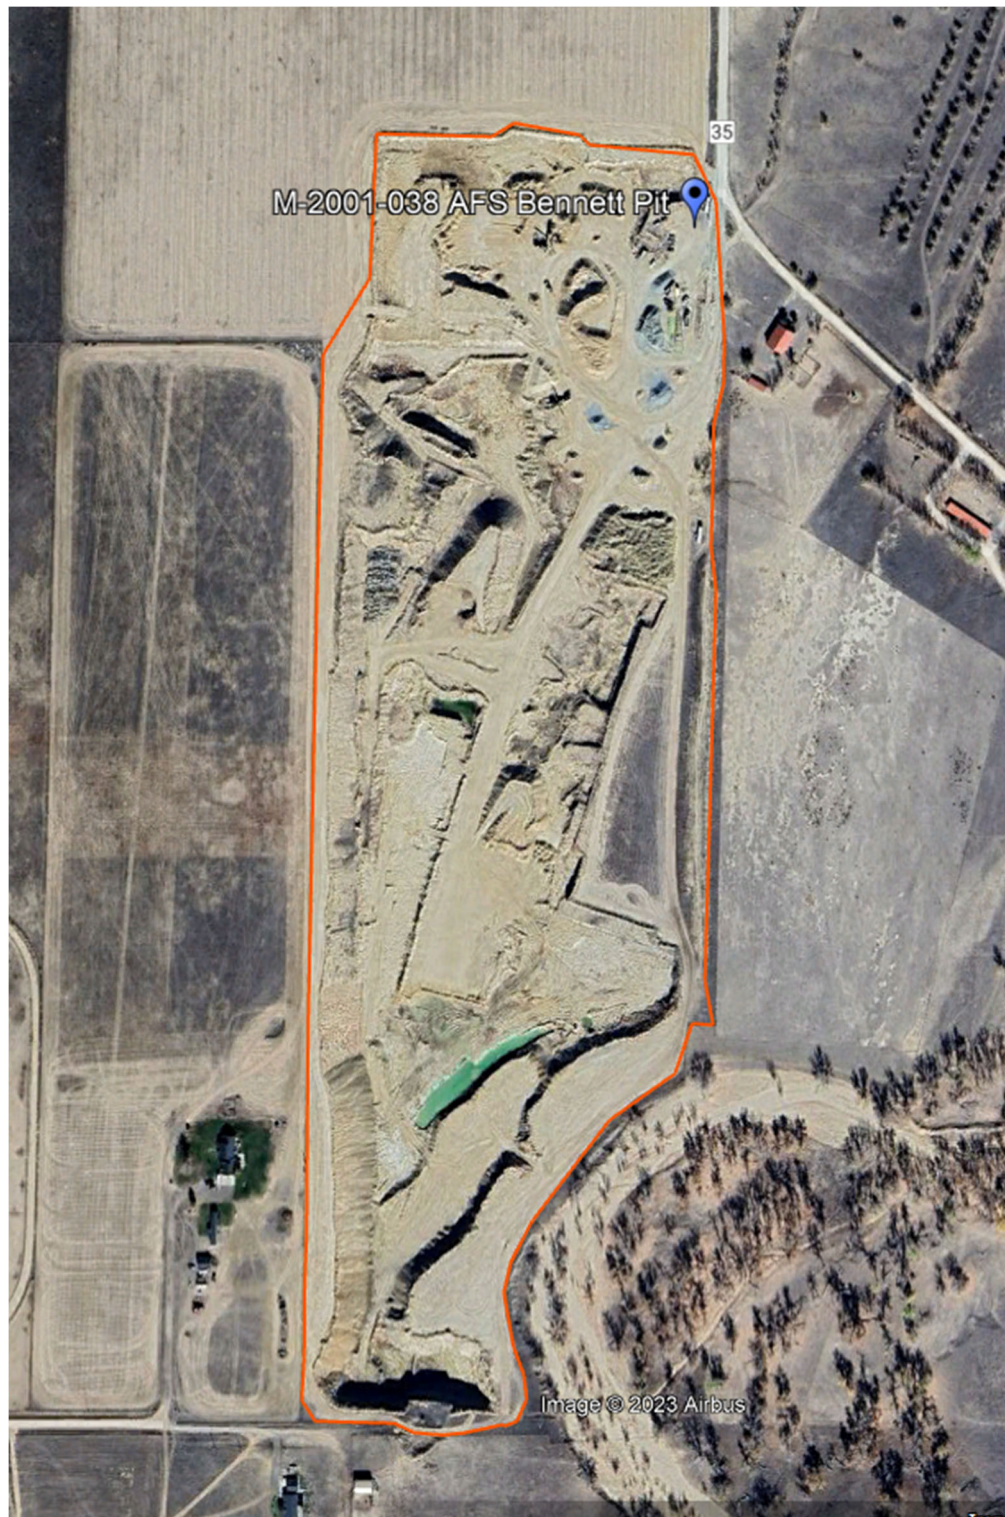
PROBLEM/POSSIBLE VIOLATION: Problem: The financial warranty is not adequate to reclaim the site in accordance with the approved reclamation plan. This is a failure to maintain the proper financial warranty amount to complete reclamation of the affected lands pursuant to C.R.S. 34-32.5-117(4)(b) of the Act.

Photo 12. Google earth imagery from 06/2023 showing approximate 60-acre disturbance area.

CORRECTIVE ACTIONS: The operator shall submit adequate financial warranty, as determined by the Division. The Division will be sending a separate surety increase notice to the operator regarding the increase of the financial warranty.
