Bowie #2 complete inspection, June 2023

PERMIT INFORMATION

Permit Number: C-1996-083 Mine Name: Bowie No. 2 Mine Operator: Bowie Resources, LLC Operator Address: Mr. Basil Bear P.O. Box 1488 Paonia, CO 81428	County: Delta Operation Type: Underground Permit Status: Active Ownership: Private
	Operator Representative Present: Basil Bear
Operator Representative Signature: (Field Issuance Only)

Inspection Start Date: June 8, 2023 Inspection Start Time: 08:00 Inspection End Date: June 8, 2023 Inspection End Time: 11:45		Inspection Type: Coal Complete Inspection Inspection Reason: Normal I&E Program Weather: Clear	
Joint Inspection Agency: None		Joint Inspection Contacts:	
Post Inspection Agency: None		Post Inspection Contacts:	
Inspector(s): Robert Zuber, P.E.	Inspector's Signature:

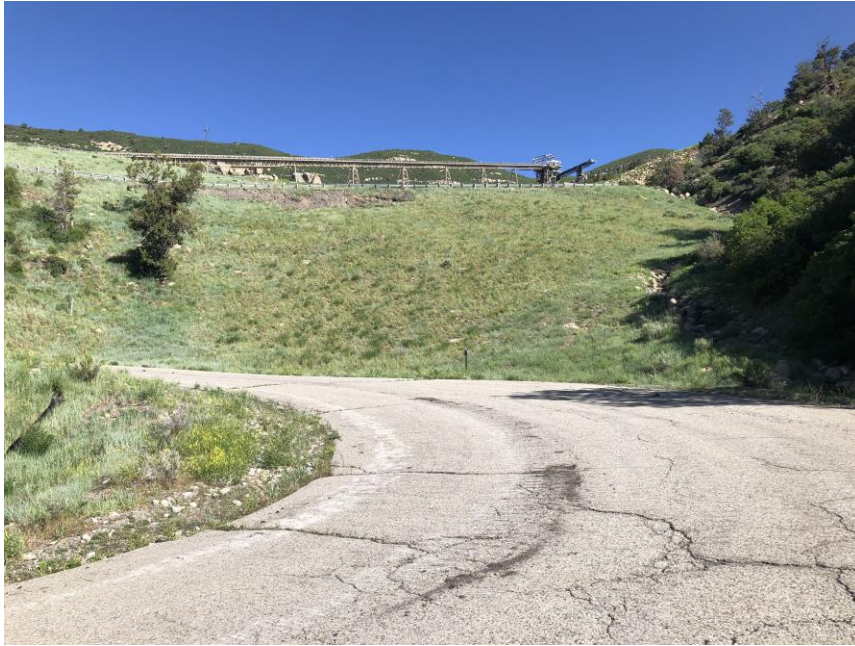
It appears that slumps above Curve Number 6 along the Haul Road, above the B Portal bench, and above Curve Number 11 have not moved significantly in the recent past. The ditch above the B Portal bench (Ditch B6) is in poor condition, and may be contributing to the problem with this slope. The Division recommends repairs to this ditch.

Curve 6, with small slide near road above

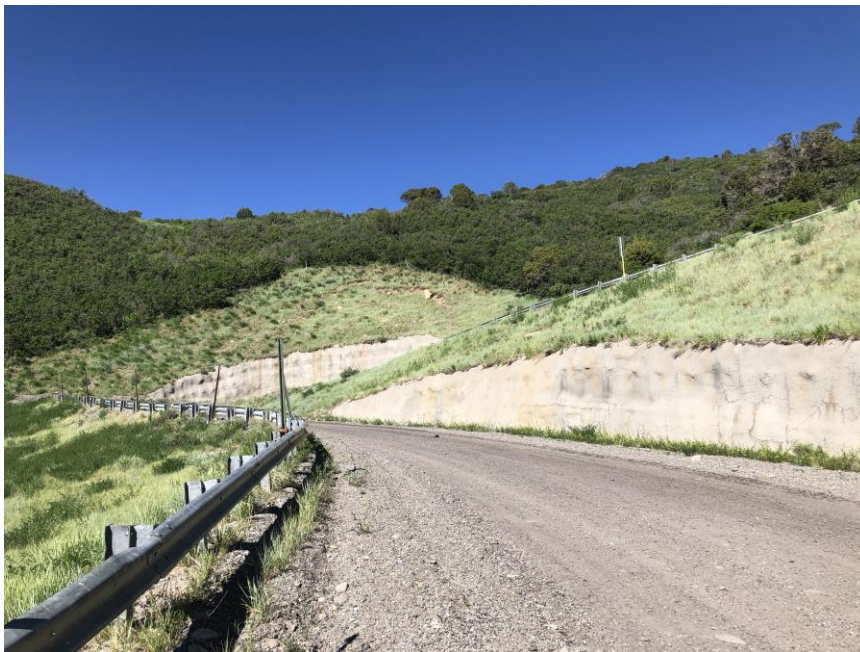
The culvert at Curve Number 11 was blocked. It was cleaned during the inspection by BRL staff.

Curve 11, with slope above

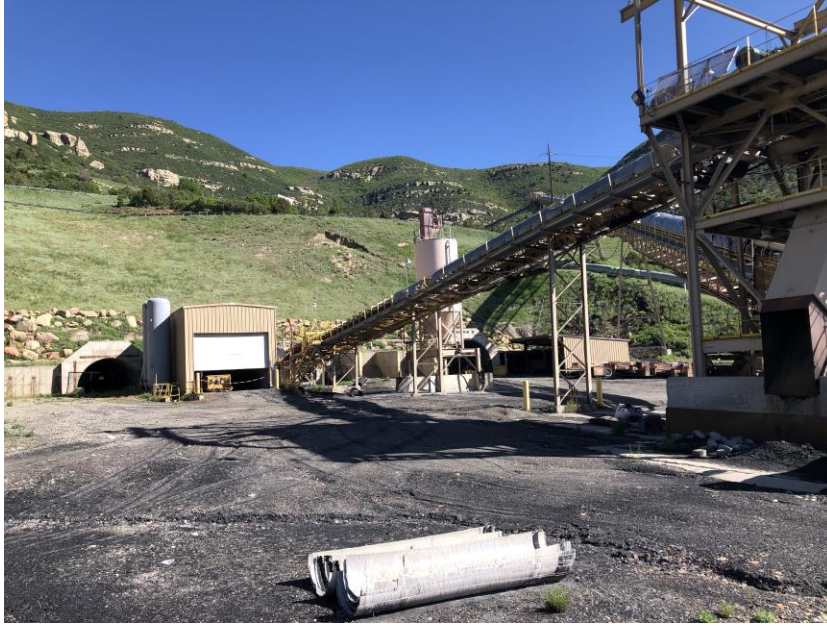
The ditch above the B Portal bench (Ditch B6) is in need of repairs. It appears to be holding water in some locations, rather than allowing it to flow away from the slope. No other problems with ditches were identified, including the temporary ditch below Curve Number 8.

B Portal bench, with slide above portal

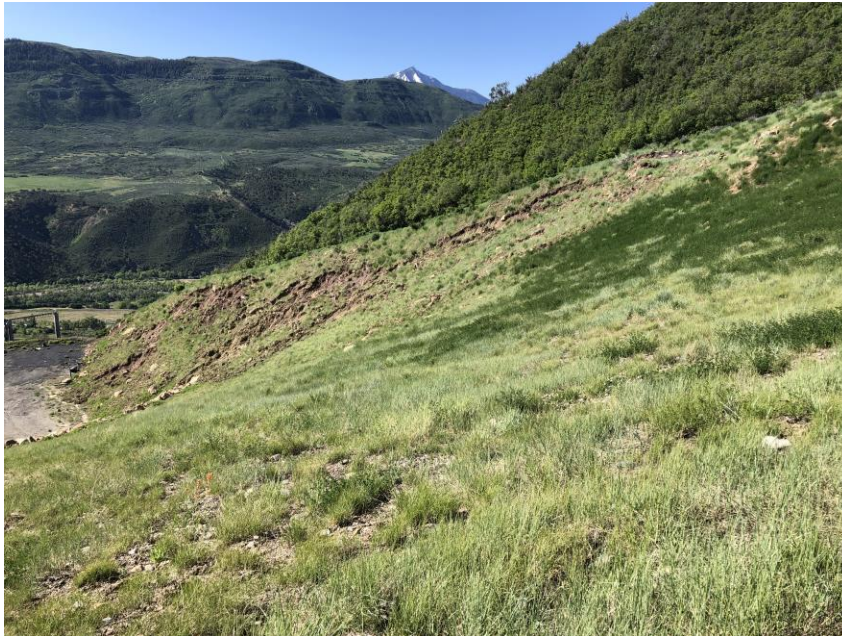
B Portal bench, with slide on west slope

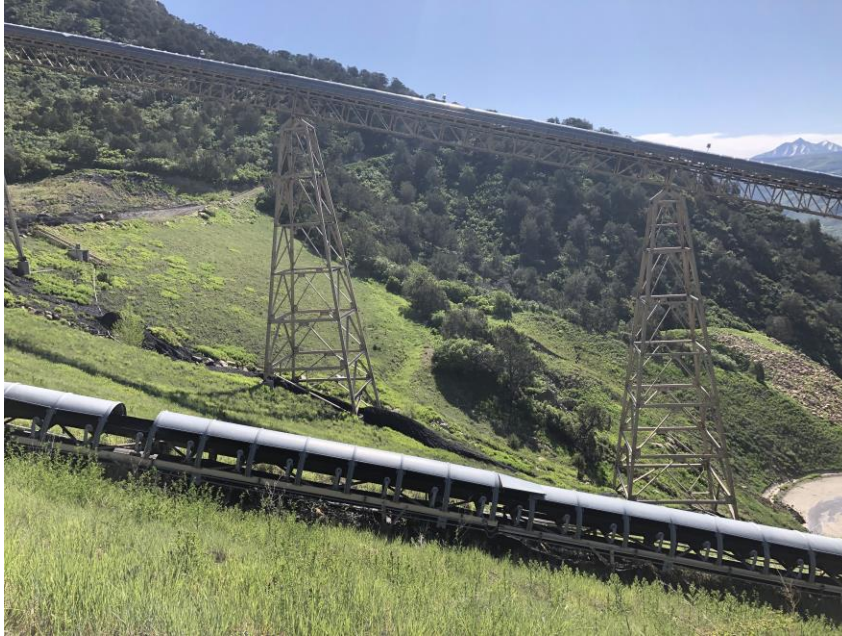
The slide above Curve Number 10 is an ongoing problem. The ground dropped approximately five feet. Ditch C8 continues to be blocked. Water was seeping out of this area and onto the road during the inspection, and BRL is waiting for it to dry out before performing any work on the slope (this appears to be prudent). Options to protect this slope were discussed with BRL, and these include:

Slope above Curve 10

- Use the road above this area to dig a diversion ditch to move water away from this slope and to Ditch C6
- Build a bench on the slope
- Riprap the slope like other slopes along the haul road (e.g., the slope above Curve Number 8)
- Repair the cracks but do not perform other structural improvements.

The Division trusts that BRL will identify a sufficient solution, but will continue to monitor the slide closely.

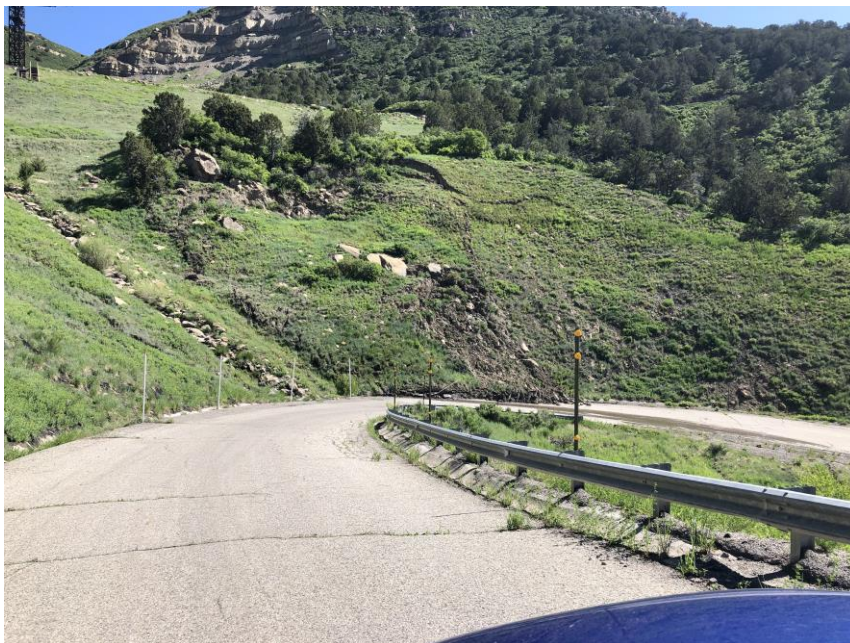
Curve 10, with large slide

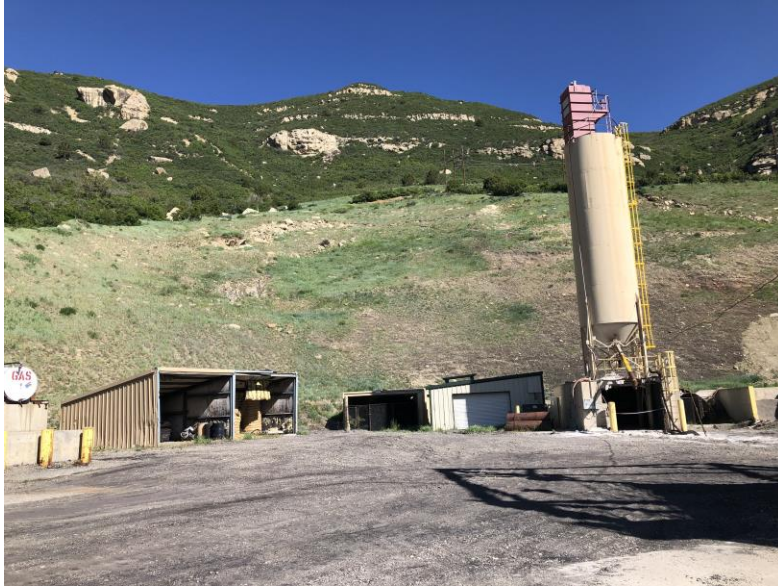
Slope above D Portal bench

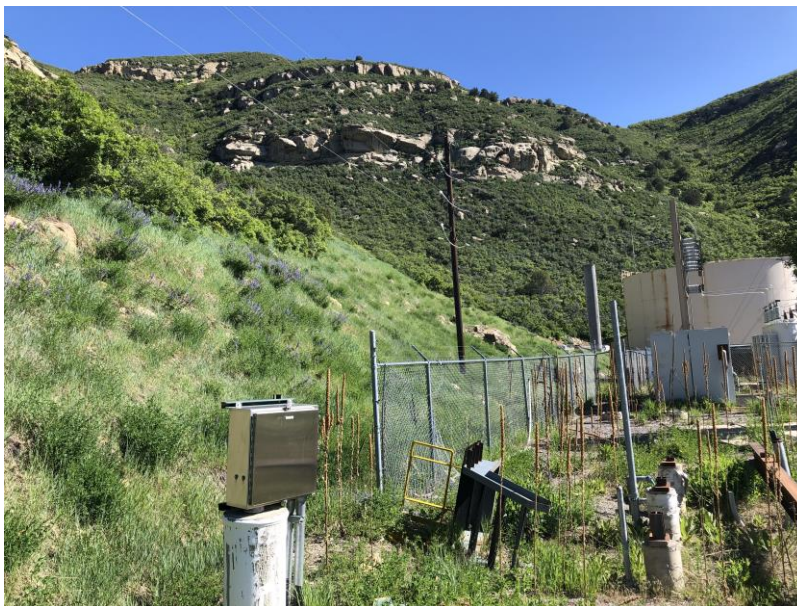
Slope above Utility Bench, with several lupine plants

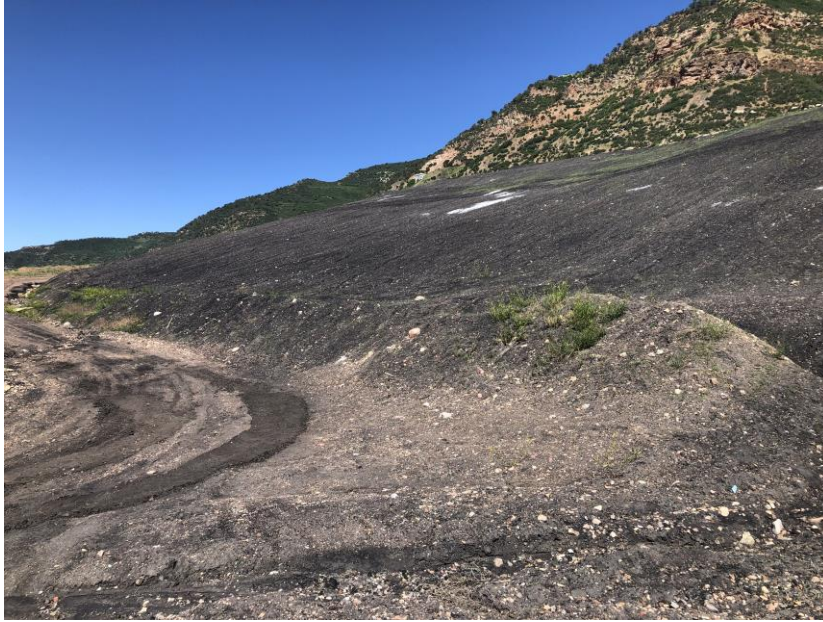
Gob Piles 1, 2, and 3 appeared stable. The ditches and BMPs on the upper part of Gob Pile 2 appeared to be functioning. Rills on the upper face of Gob Pile #2 have not significantly increased in size in recent months.

Upper face of Gob Pile #2

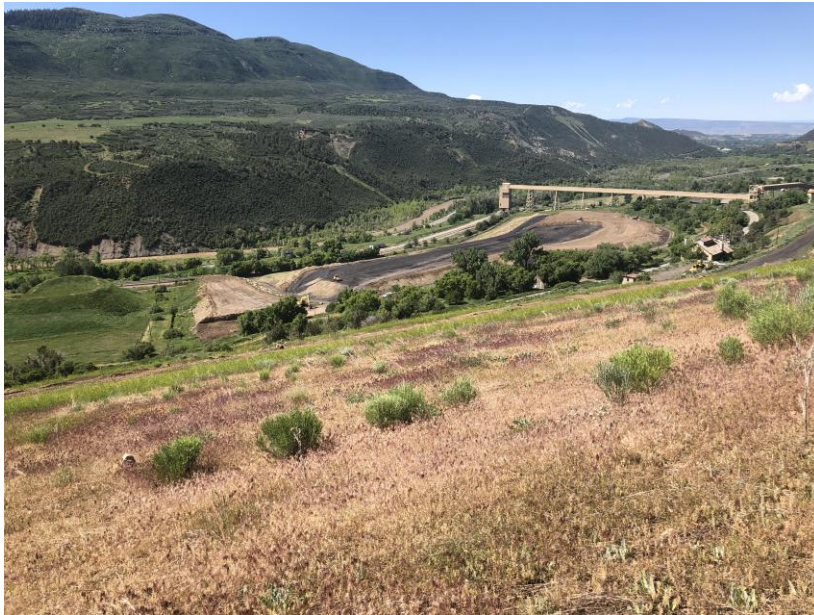
White top was seen on Topsoil Stockpile A. A large amount of cheat grass was seen on Gob Pile #2.

Gob Pile #3 (middle of photo) and cheat grass on Gob Pile #2 (foreground)
