June inspection reports

Permit Number: C-1981-012 Mine Name: New Elk Mine Operator: New Elk Coal Company, LLC Operator Address: Mr. Mark Gray 12250 Highway 12 Weston, CO 81091	County: Las Animas Operation Type: Underground Permit Status: Active Ownership: Private
	Operator Representative Present: John Terry
Operator Representative Signature: (Field Issuance Only)

Inspection Start Date: June 1, 2023 Inspection Start Time: 08:00 Inspection End Date: June 1, 2023 Inspection End Time: 12:00		Inspection Type: Coal Complete Inspection Inspection Reason: Normal I&E Program Weather: Clear	
Joint Inspection Agency: None		Joint Inspection Contacts:	
Post Inspection Agency: None		Post Inspection Contacts:	
Inspector(s): Brock Bowles Patrick Lennberg	Inspector's Signature:

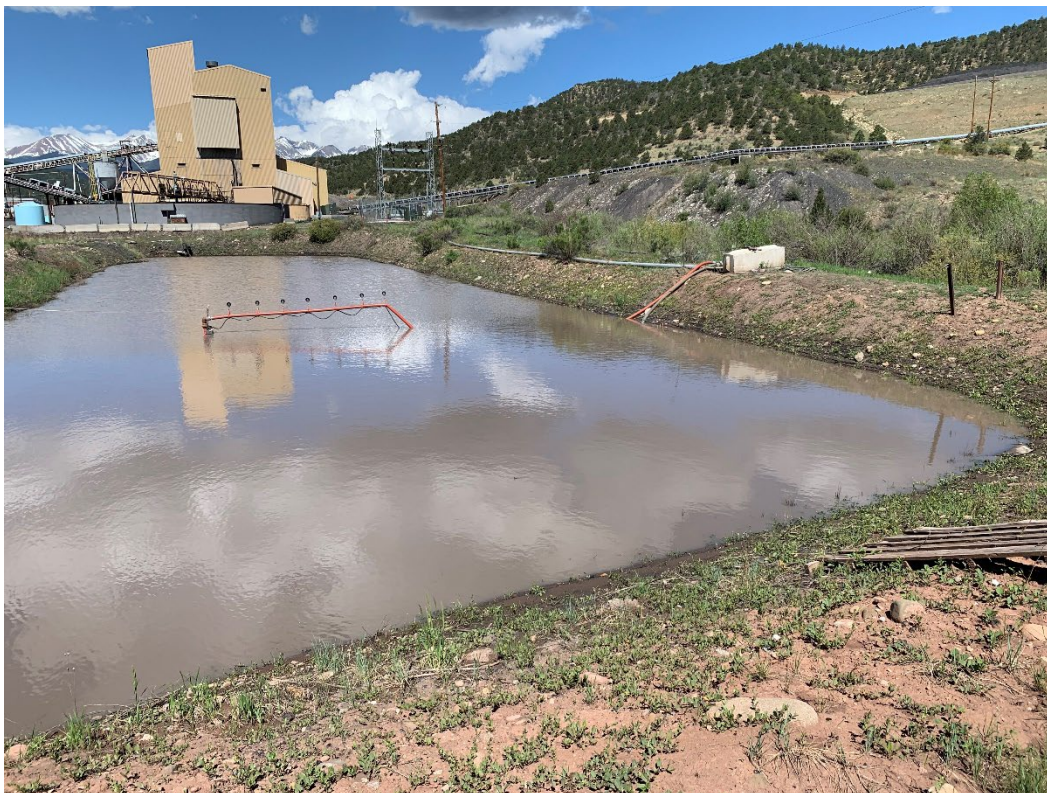
Photo 1 – Pond 6

Pond 6 contained water. The embankment appeared to be stable (photo 1).

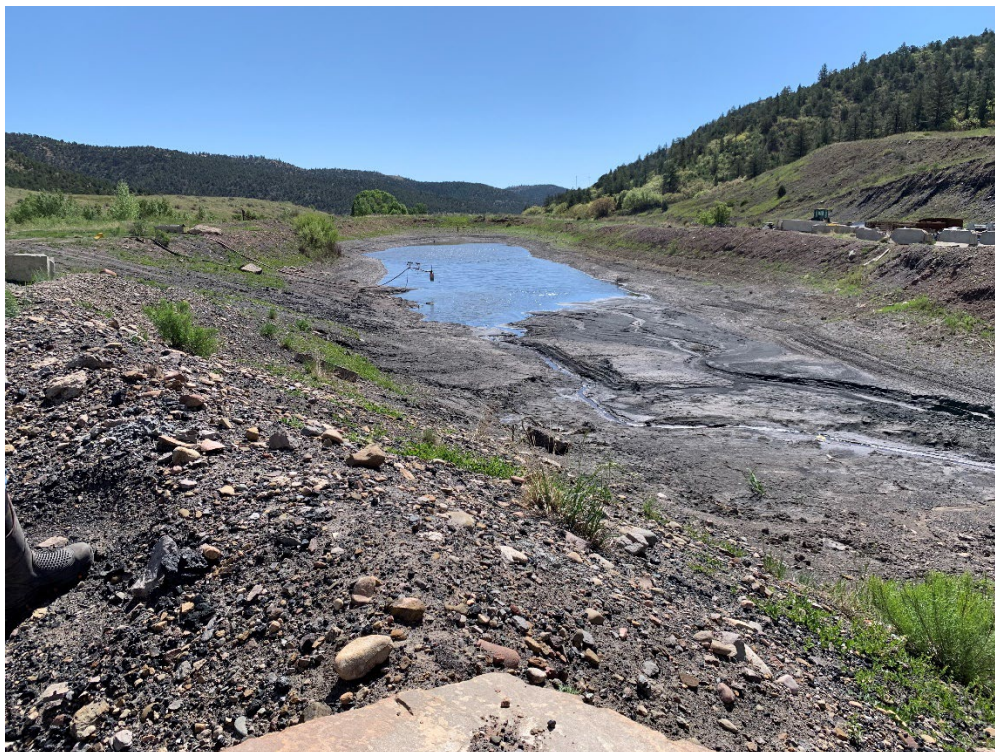
Photo 2 – Pond 7 facing east

Pond 7 contained some water but was really low and not discharging (photo 2). The embankment appeared stable. The primary and emergency spillways were clear of obstructions.

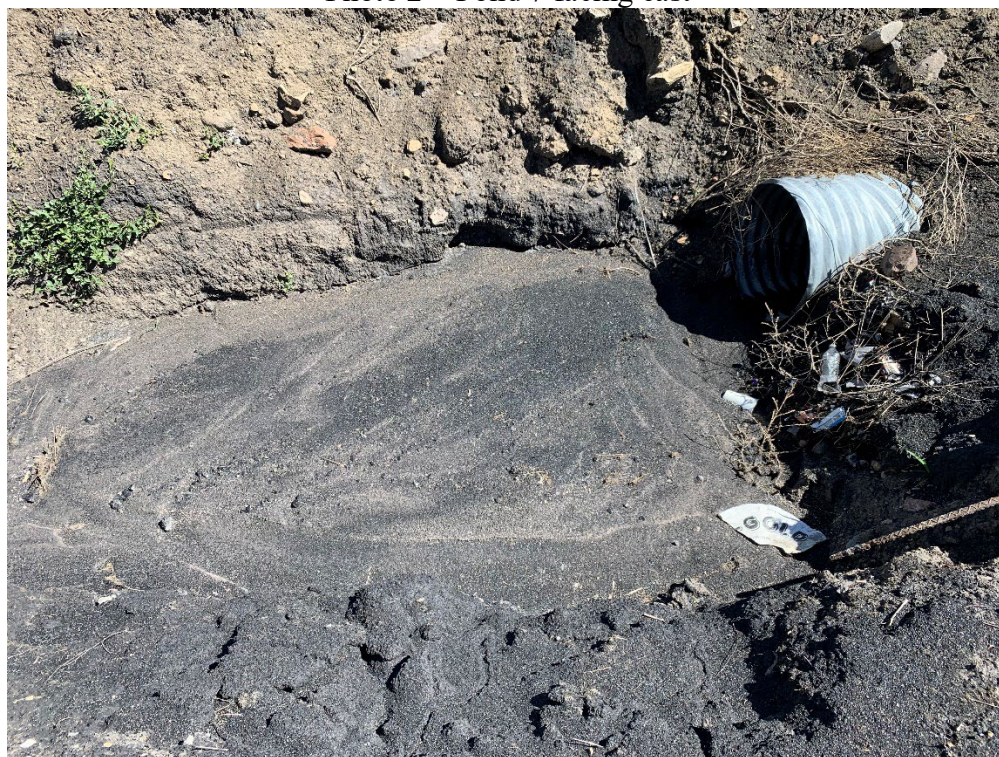
The culverts C9A, C9, C8, C5, C19 and ditches D2, D6, D5 D10, D10A, D11, D12 and D13 were in working order. Culvert C64, west of the wash plant needs to have the sump cleaned before it becomes sediment loaded (photo 3).

Photo 3 – The sump at culvert C64 needs cleaning

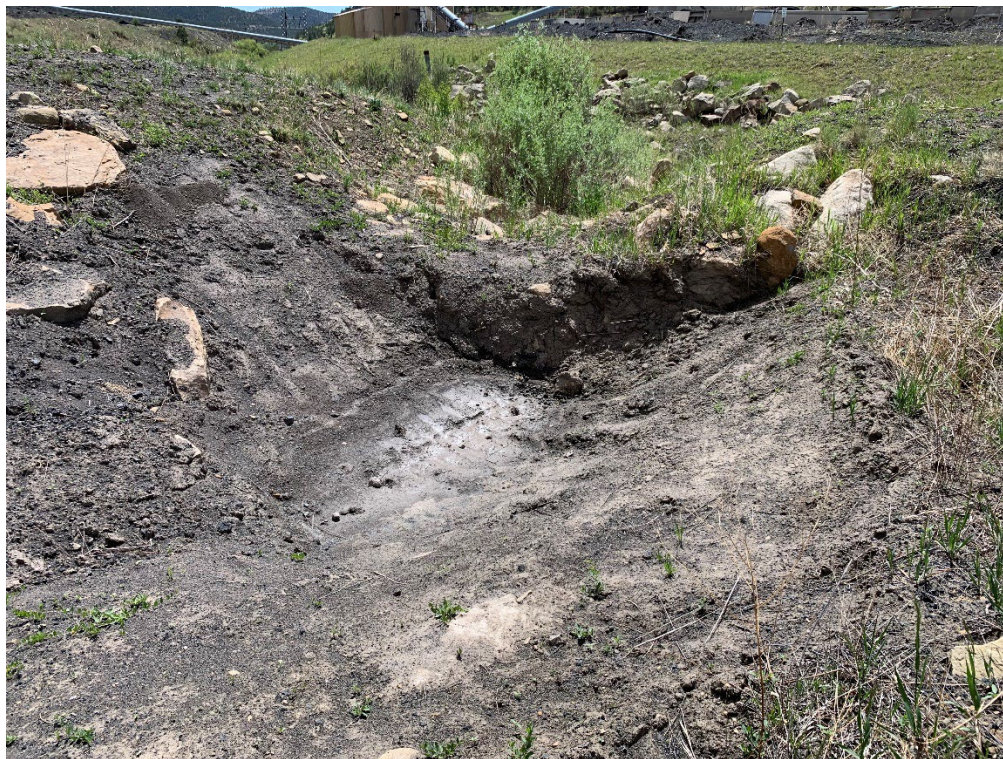
Photo 4 – Sump at Discharge 11

The sump at Discharge 11 has been re-established (photo 4). An additional sump has been established at the discharge end of culvert C30 to control sediment before being discharged (photo 5).

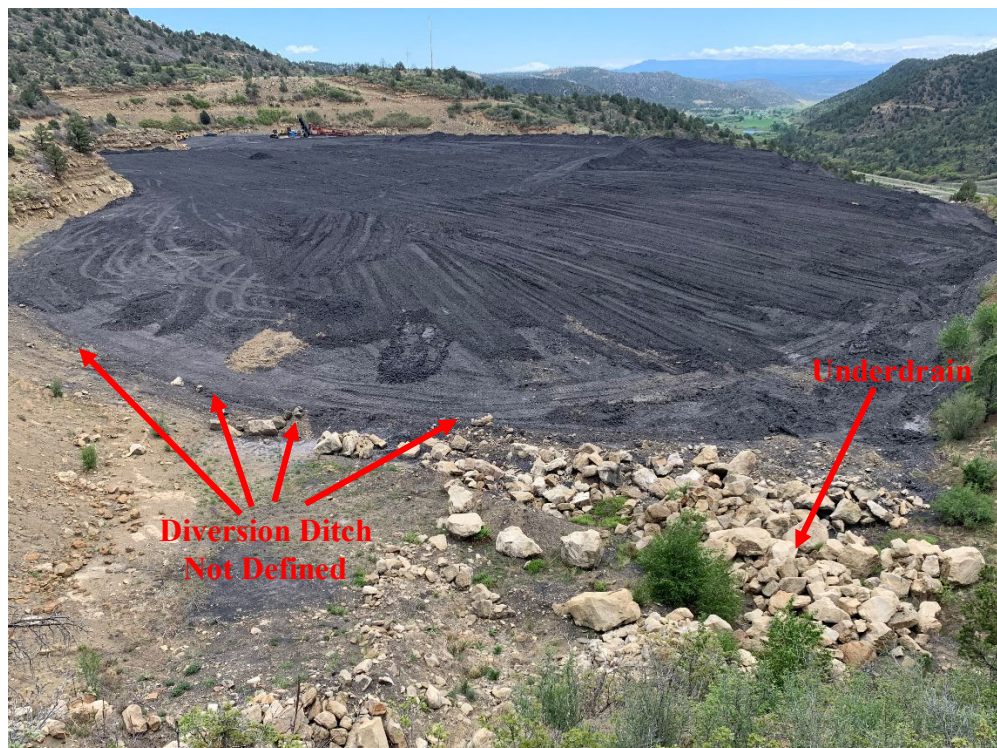
No coal waste was being placed on the RDA. The top of the pile was sloped to direct runoff to the perimeter ditch. The perimeter ditch in the area of the underdrain on the northwest corner of the RDA is not well defined (photo 6). The ditch in this area does not clearly direct water away from the underdrain and towards Pond 8 and needs to be re-established.

Photo 6 – Perimeter Ditch needs direct water past underdrain

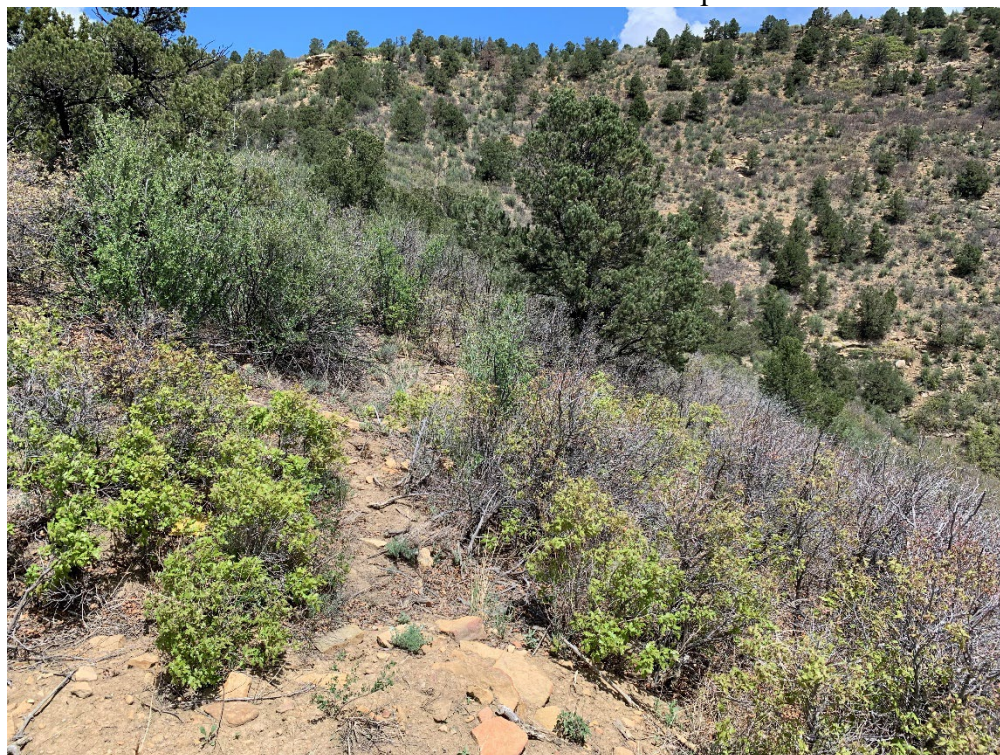
The clean water diversion ditch was walked to verify site maps and site conditions for TR77. The maps appear to be consistent with ground condition. The hillside above the clear water ditch is approximately 1h:1v and moderately covered with small trees, shrubs and bunch grasses. The soil surface consists of about 25% rock and 75% soil (photo 7). Topsoil appears to be sparse in this area.

Photo 7 – Hillside conditions above clear water diversion ditch

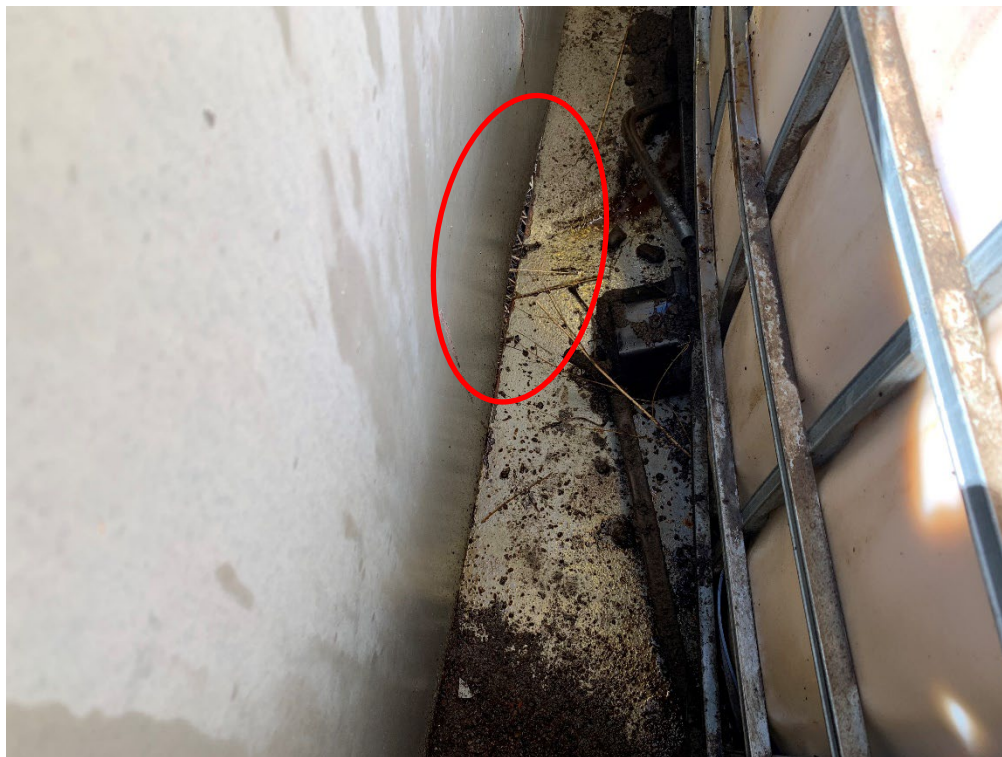
The damaged chemical storage containers in the Portable Explosives and Chemical Storage Area were put into secondary containment as noted in the April 2023 inspection report. It was noted during this inspection that there is a hole in the bottom of the secondary containment (photo 8). This situation needs to be addressed quickly.

Photo 8 – Break in the secondary containment floor
