# June inspection reports 1 message

Permit Number: C-1996-084 Mine Name: Lorencito Canyon Mine Operator: New Elk Coal Company, LLC Operator Address: Mr Mark Gray	County: Las Animas Operation Type: Surface Permit Status: Permanent Cessation Ownership: Private			
12250 Highway 12	<b>Operator Representative Present:</b>			
Weston, CO 81091				
	None			
Operator Representative Signature: (Field Issuance Only)

# **INSPECTION INFORMATION**

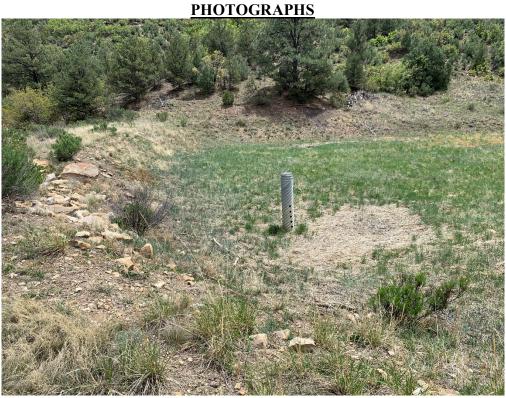
Pond 5 was dry. The embankment and pond floor were well vegetated (photo 1). The spillways were in operable condition and free of obstructions.

Photo 1 – Pond 5 Primary spillway and embankment

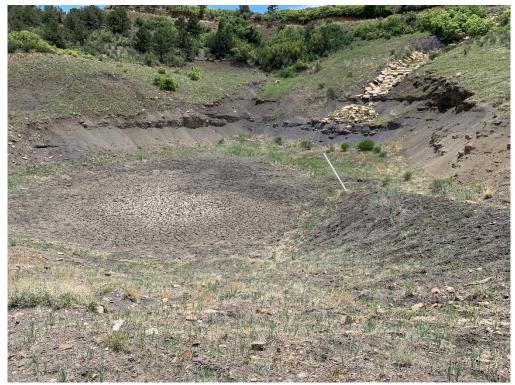
Photo 2 - Pond 9

Pond 9 was dry (photo 2). The embankment appeared stable. The primary and emergency spillways were clear of obstructions.

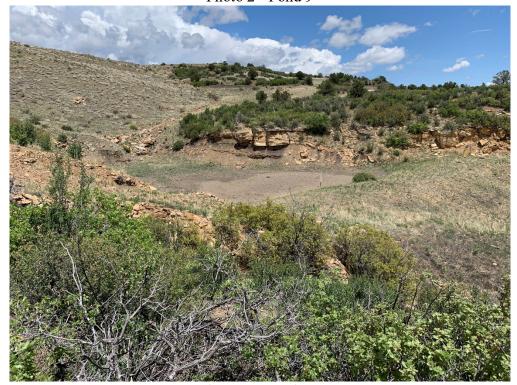
Photo 3 – Pond 9A

Pond 9A was dry (photo 3). The embankment has well established vegetation and appeared stable.
