STATE OF
COLORADO

Bowie No. 1 Mine May 31, 2023 Partial Inspection Report

Permit Number: C-1981-038 Mine Name: Bowie No. 1 Mine Operator: Bowie Resources, LLC Operator Address: Mr. Basil R Bear P.O. Box 1488 Paonia, CO 81428	County: Delta Operation Type: Underground Permit Status: Active Ownership: Private
	Operator Representative Present: NA
Operator Representative Signature: (Field Issuance Only)

Inspection Start Date: May 31, 2023 Inspection Start Time: 12:55 Inspection End Date: May 31, 2023 Inspection End Time: 13:40		Inspection Type: Coal Partial Inspection Inspection Reason: Normal I&E Program Weather: Cloudy	
Joint Inspection Agency: None		Joint Inspection Contacts: None	
Post Inspection Agency: None		Post Inspection Contacts: None	
Inspector(s): Clayton Wein	Inspector's Signature: <i>Clayton Wein</i>		Signature Date: 6/13/2023

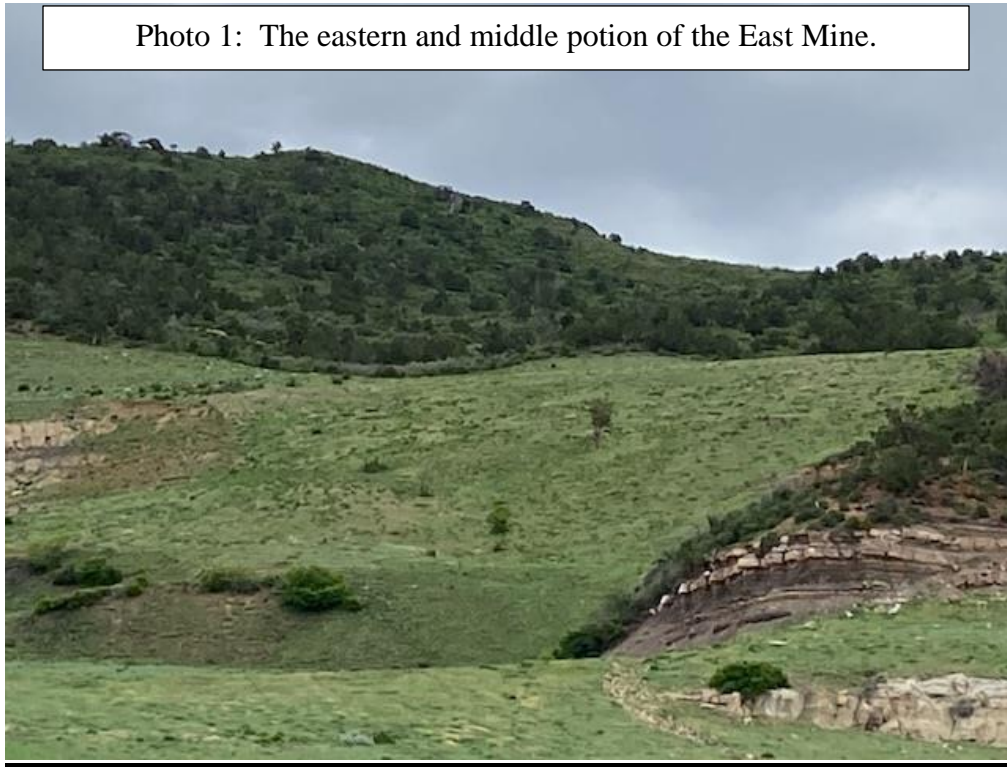
The inspection started at the East Mine. The east mining area has been reclaimed for several years. The benches were stable with vegetative cover (Photos 1, 2 and 3). There were no indications of erosional features identified. The Slide located on the reclaimed portals bench had not moved since the Division's May 9, 2023 inspection. There was no evidence of any seepage from the toe of the slide. The slide has appeared to remain stabilized. There were no off-site impacts observed. During the inspection of the East Mine, the Division observed Cedar Creek concluding their second day of vegetation sampling. The Division observed Cedar Creek recording data from transects at the southern portion of the East Mine. Transects were set up to collect data for woody plant density.

Photo 1: The eastern and middle portion of the East Mine.

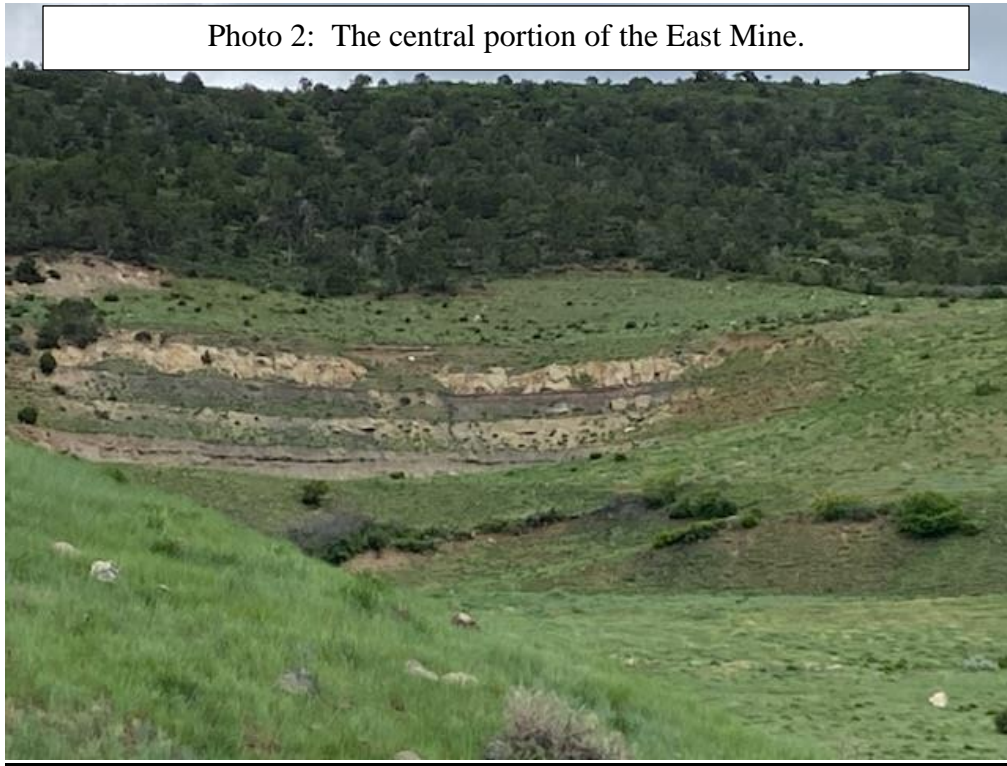
Photo 2: The central portion of the East Mine.

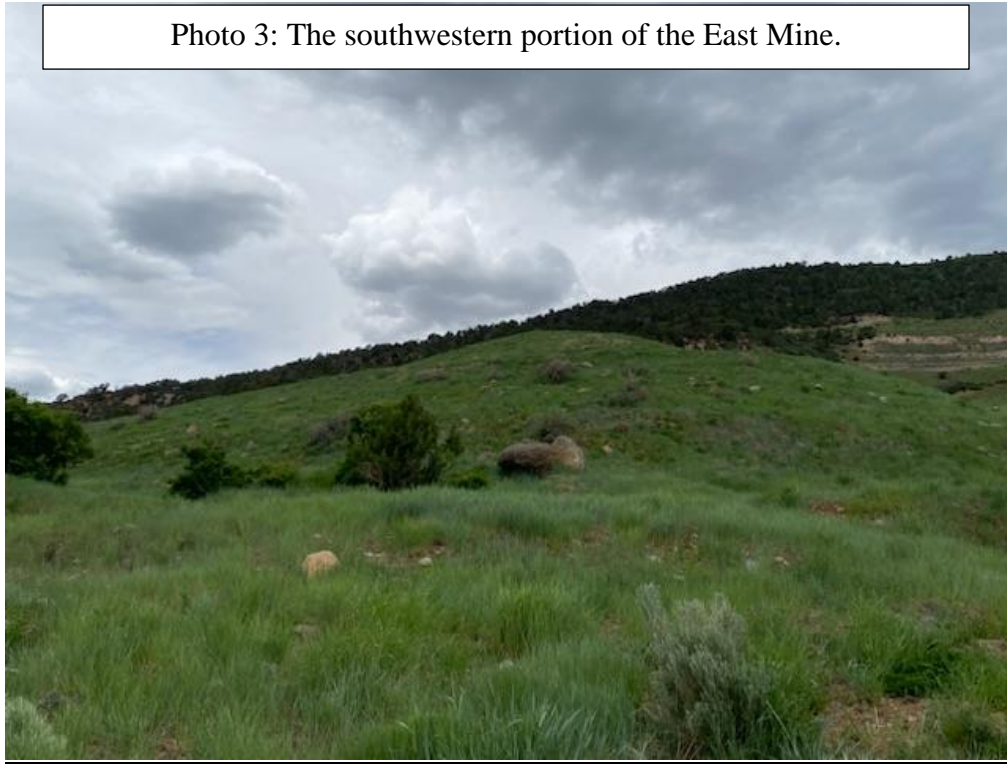
Photo 3: The southwestern portion of the East Mine.

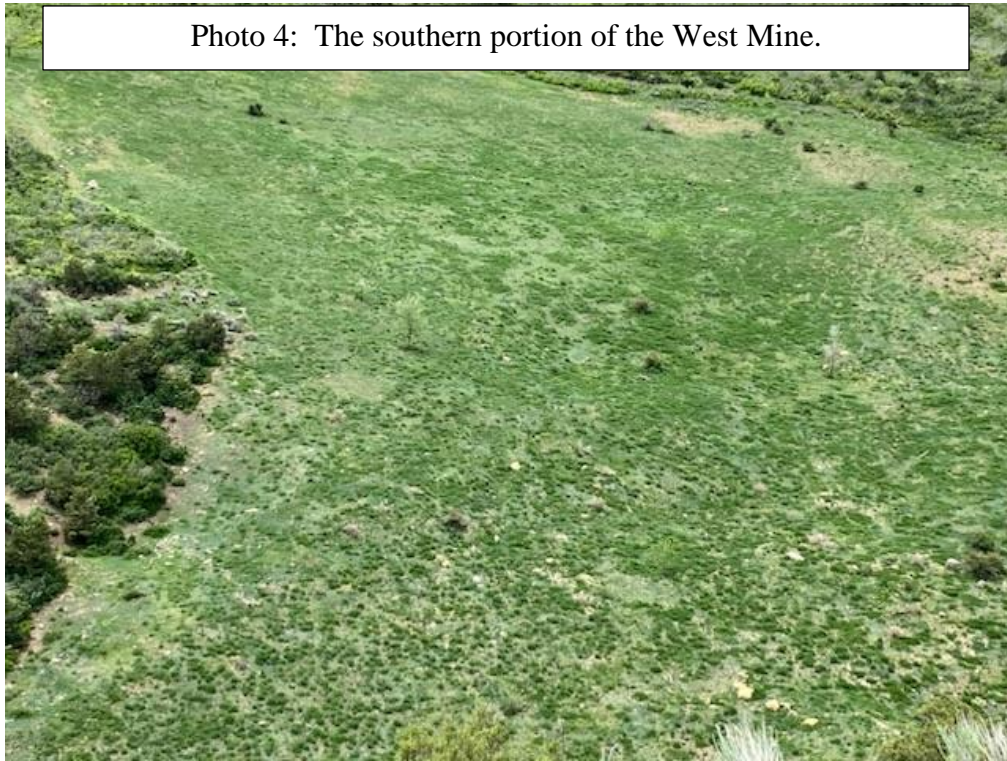
The West Mine has also been reclaimed for several years. The remaining permitted reclamation was covered with vegetation and was stable (Photos 4 and 5). There were no indications of erosional features observed.

Photo 4: The southern portion of the West Mine.

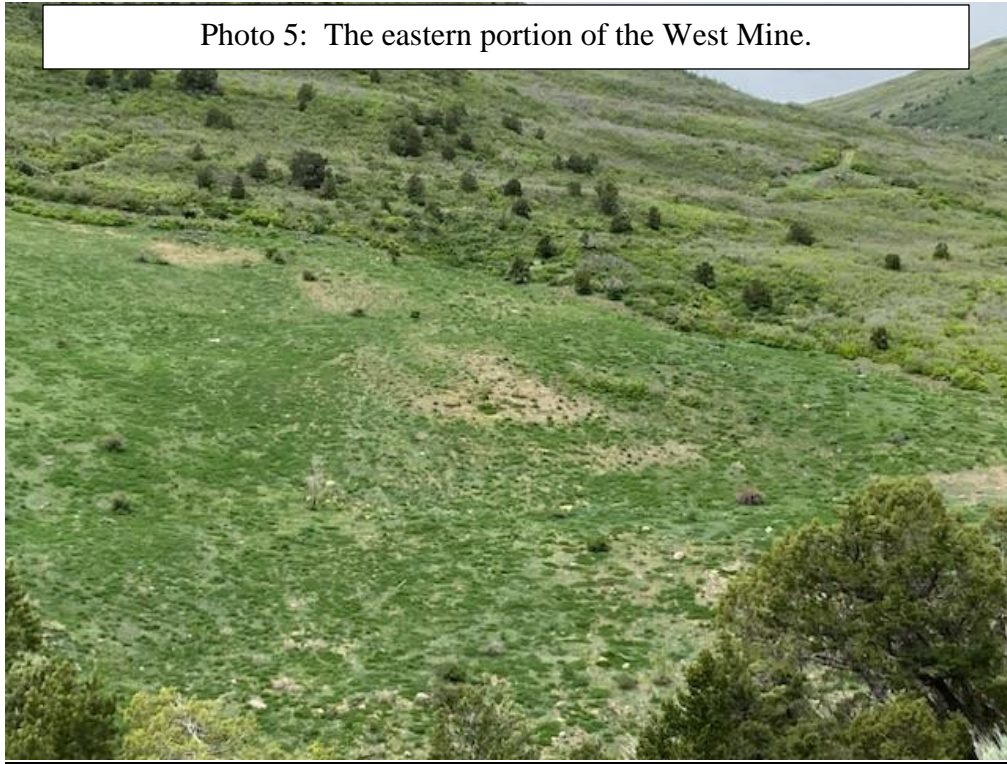
Photo 5: The eastern portion of the West Mine.

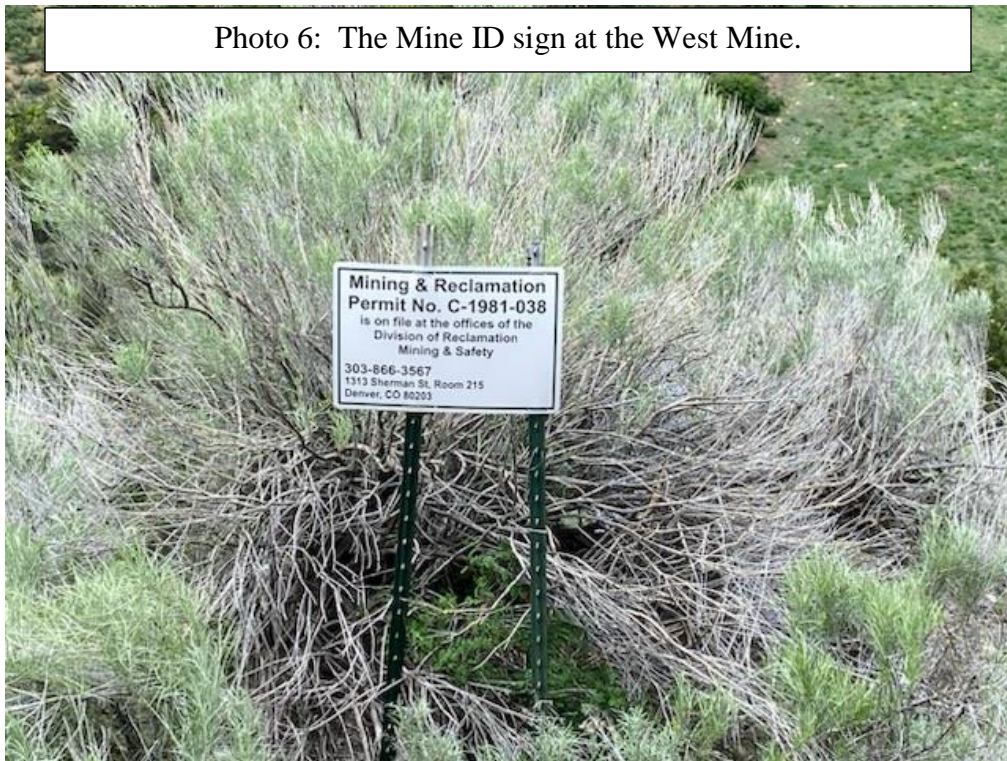
Mine Identification signs were noted to be posted at both the West (Photo 6) and the East Mines. The signs displayed current information about the permittee and the Division. The Permit number was displayed on the signs and the contact information for the Division. The signs were posted at the entrances to the permit area

Photo 6: The Mine ID sign at the West Mine.
