MINERALS PROGRAM INSPECTION REPORT
PHONE: (303) 866-3567

MINE NAME: Rock School Lease Experimental Nahcolite Mine	MINE/PROSPECTING ID#: M-1999-051	MINERAL: Carbonates	COUNTY: Rio Blanco
INSPECTION TYPE: Monitoring	WEATHER: Cloudy	INSP. DATE: June 5, 2023	INSP. TIME: 13:30
OPERATOR: Natural Soda LLC	OPERATOR REPRESENTATIVE: Jerry Daub	TYPE OF OPERATION: 112 - Hard Rock Regular Operation	
REASON FOR INSPECTION: Normal I&E Program	BOND CALCULATION TYPE: Complete Bond	BOND AMOUNT: \$122,494.25	
DATE OF COMPLAINT: NA	POST INSP. CONTACTS: None	JOINT INSP. AGENCY: None	
INSPECTOR(S): Amy Yeldell Todd Jesse	INSPECTOR'S SIGNATURE:

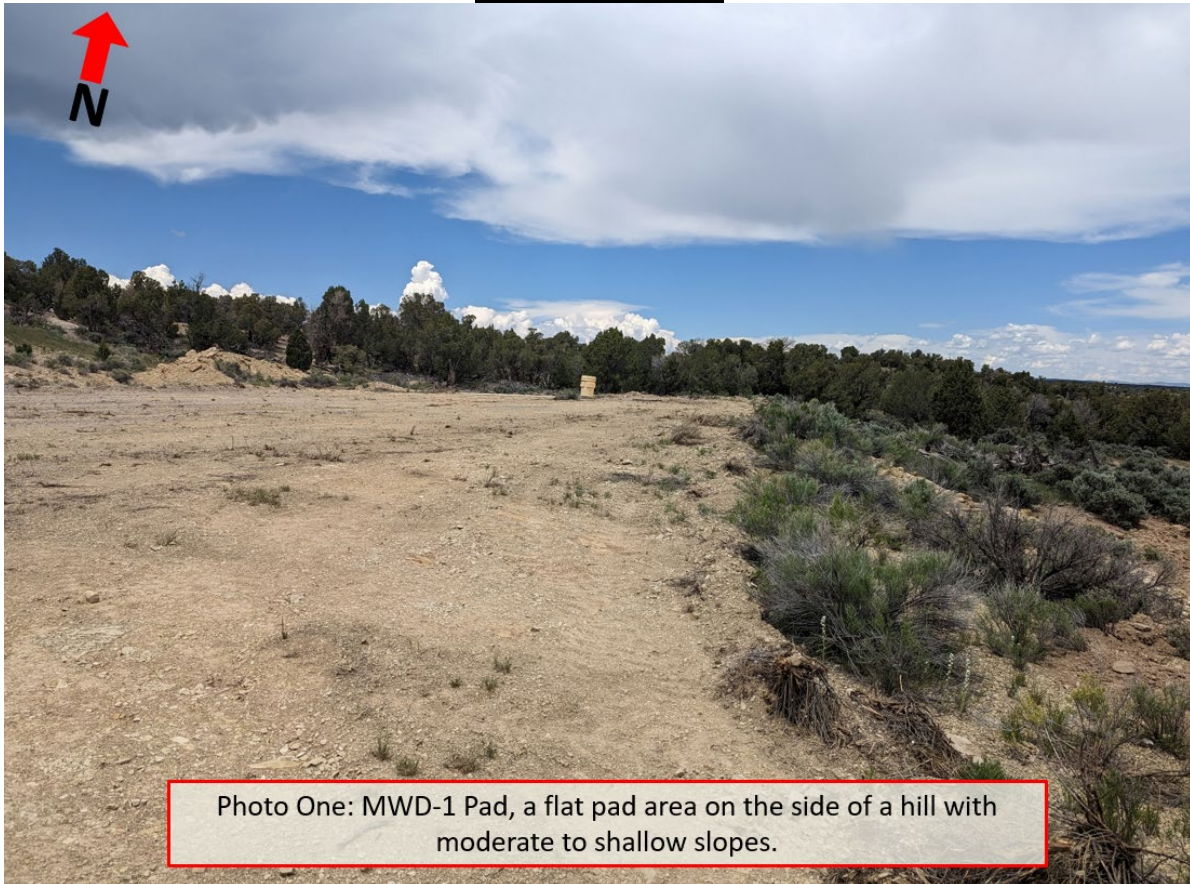
The pads remain flat with highwall slopes approximately 2H: 1V to level the pads on the sides of a hill (Photo One). Material can be cut/fill regarded to obtain final slope configuration of a 3H: 1V for final reclamation.

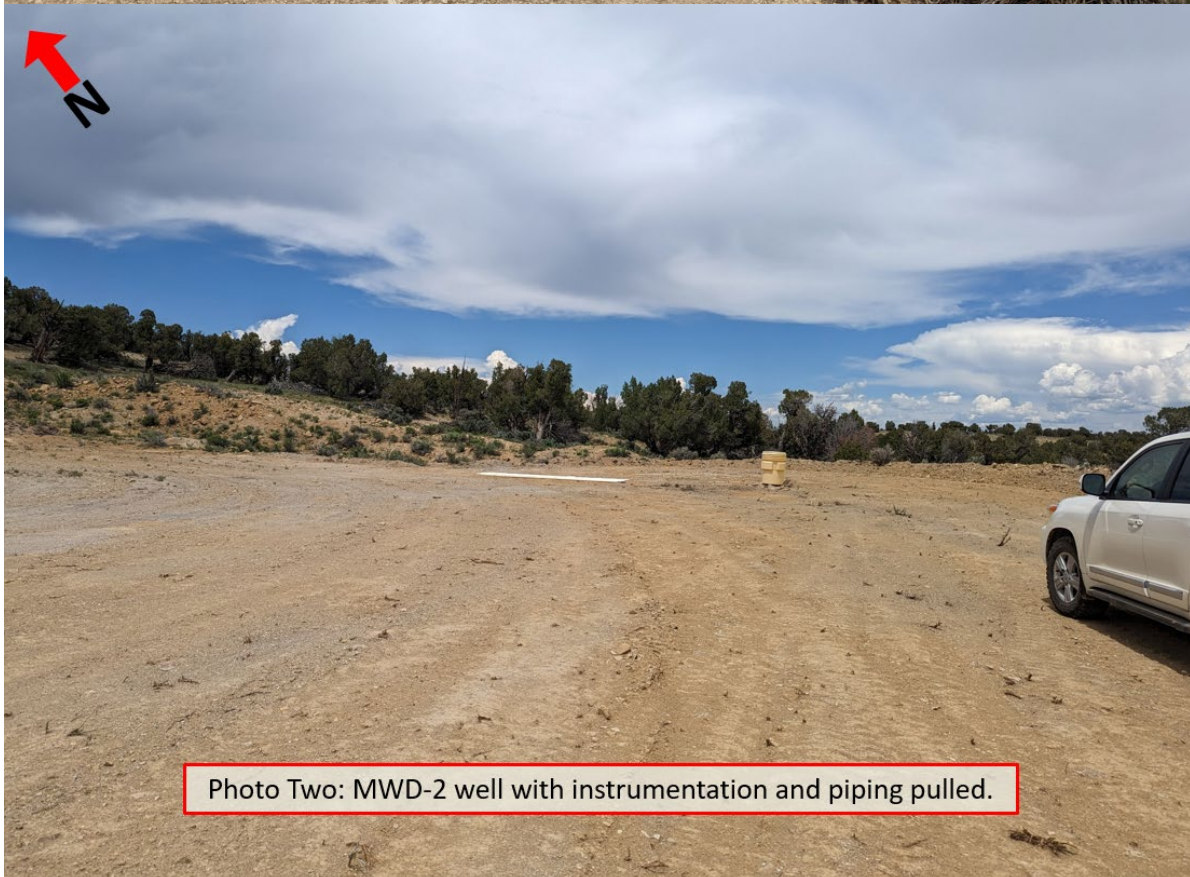
The hydrology monitoring program consists of three separate pads for a total of 6 wells. All wells were covered with a yellow spill kit drum. Mr. Daub indicated earlier this year all piping and pumps were pulled (Photo Two). Piping remains on site. Final plugging and abandonment of the wells is scheduled to begin June 19, 2023.

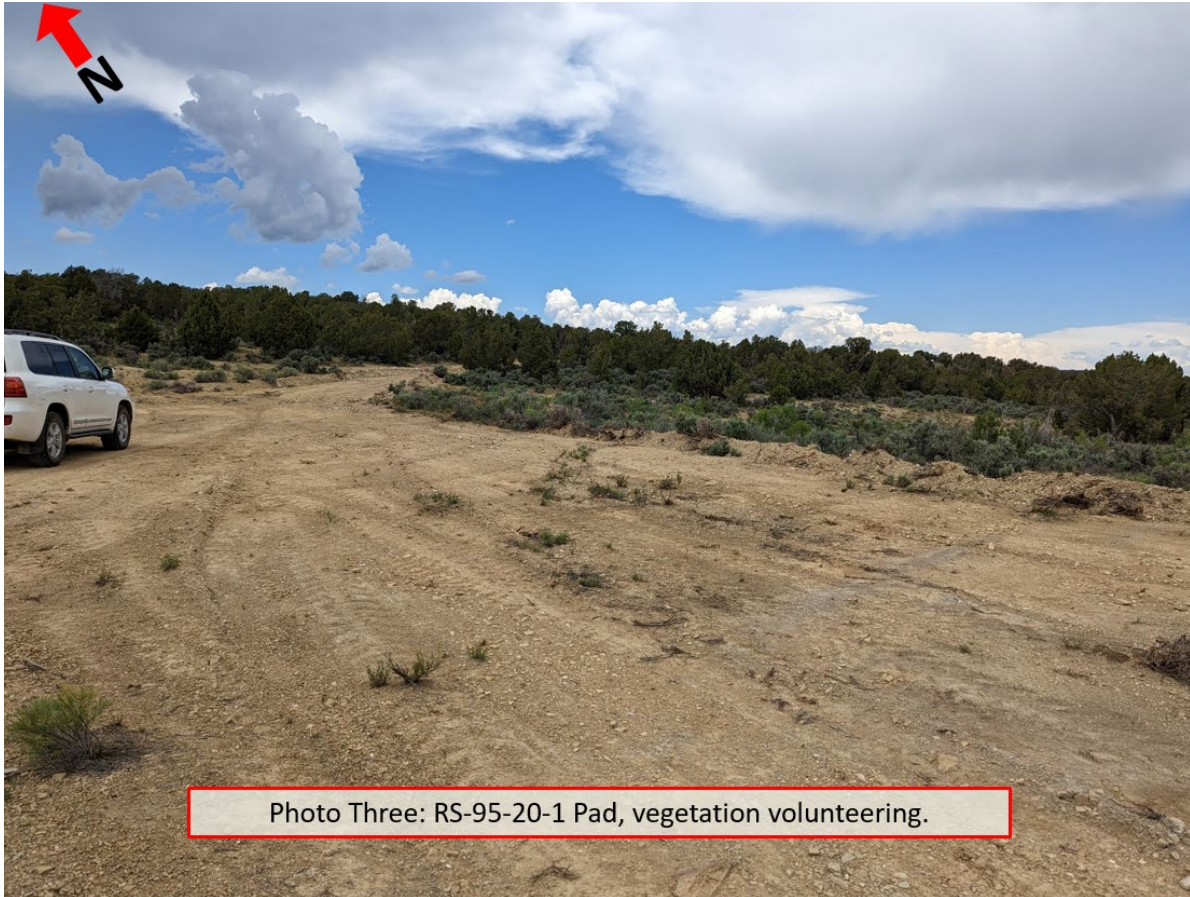
No revegetation has taken place to take. Given the lack of recent development on the pads vegetation has begun

to volunteer (Photo Three). Mr. Daub indicated that if plugging and abandonment of wells is complete early enough in the summer that grading and revegetation may take place fall of 2023.

Photo Three: RS-95-20-1 Pad, vegetation volunteering.

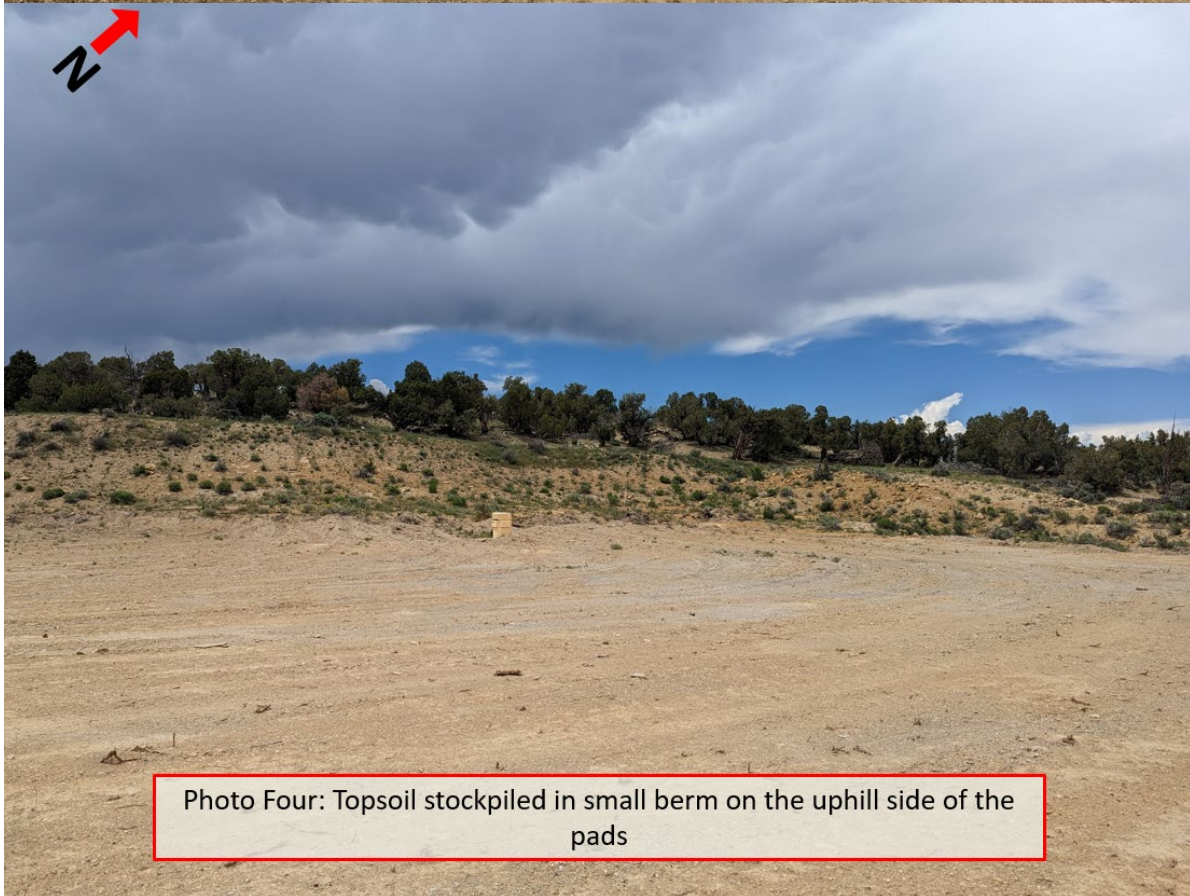
The limited amount of topsoil present on site was stockpiled for reclamation. Topsoil piles have are stabilized with vegetation (Photo Four).

Photo Four: Topsoil stockpiled in small berm on the uphill side of the pads
