## Diehl Borrow Pit M-2018-054 Monitoring Inspection Report

**MINERALS PROGRAM INSPECTION REPORT**  
**PHONE: (303) 866-3567**

| <b>MINE NAME:</b><br>Diehl Borrow Pit | <b>MINE/PROSPECTING ID#:</b><br>M-2018-054 | <b>MINERAL:</b><br>Borrow material for | <b>COUNTY:</b><br>Larimer |
| <b>INSPECTION TYPE:</b><br>Monitoring | <b>WEATHER:</b> Cloudy and cool | <b>INSP. DATE:</b><br>May 19, 2023 | <b>INSP. TIME:</b><br>10:30 |

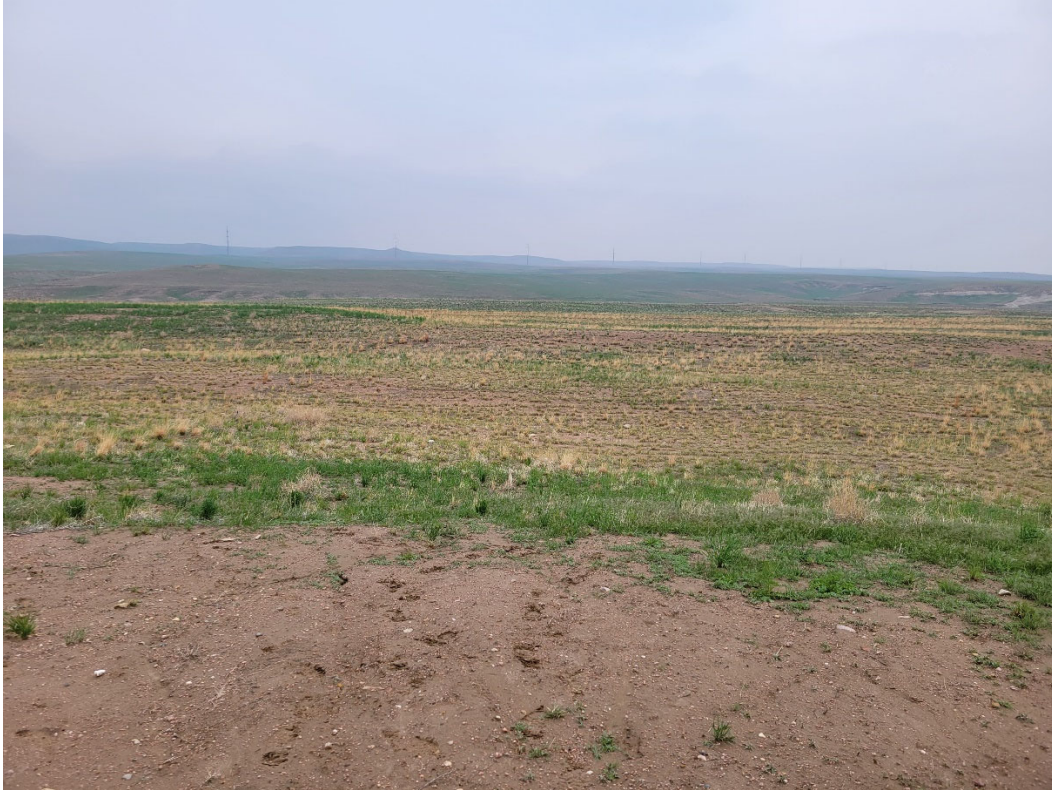
Photo 1. Overview of the south pit area from the mine entrance.

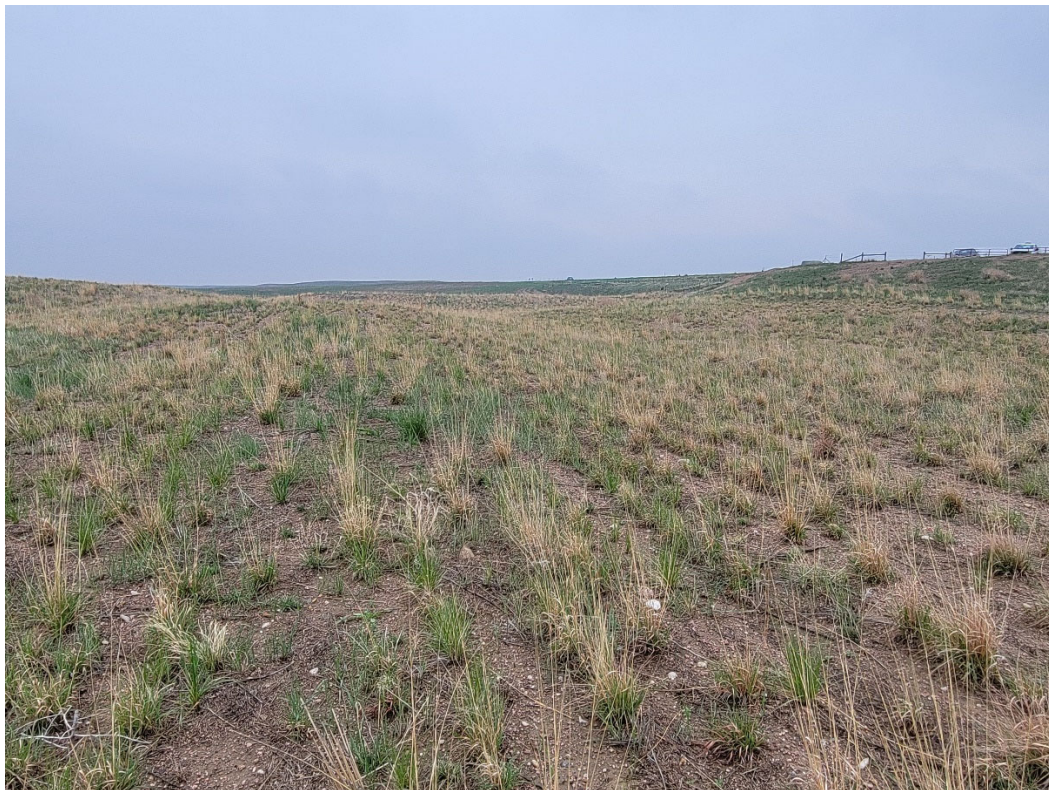
The south mining area was retopsoiled and seeded in the fall of 2019. Native grasses are establishing uniformly across most of this area. A former haul road is still evident in the center of the south mining area. This road needs to be reworked to loosen the soil and reseeded. Additionally, vegetation in the area around the haul road is patchy and sparse. A few patches of annual weeds were noted in the south mining area, primarily near the entrance, but in general the native grasses appear to be outcompeting the weeds.

Photo 2. Closer view of the vegetation in the south pit area, looking south.

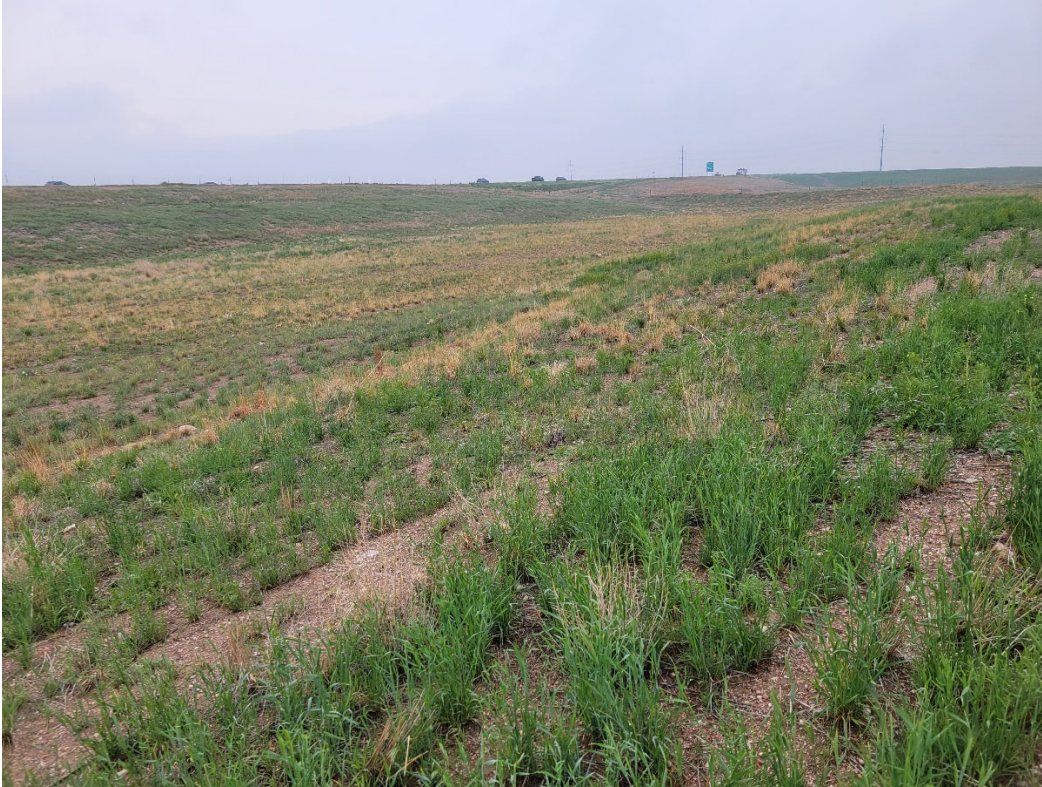
Photo 3. Looking north across the south mining area.

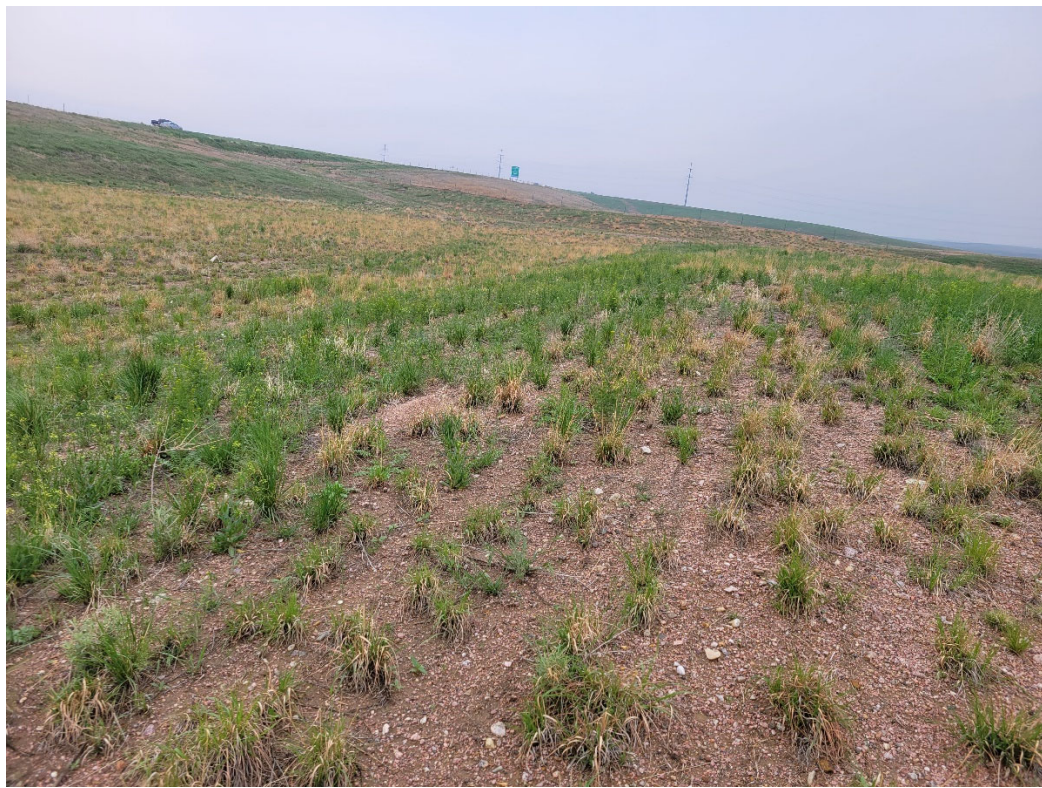
Photo 4. Closer view of native grasses establishing on the northern edge of the south mining area.

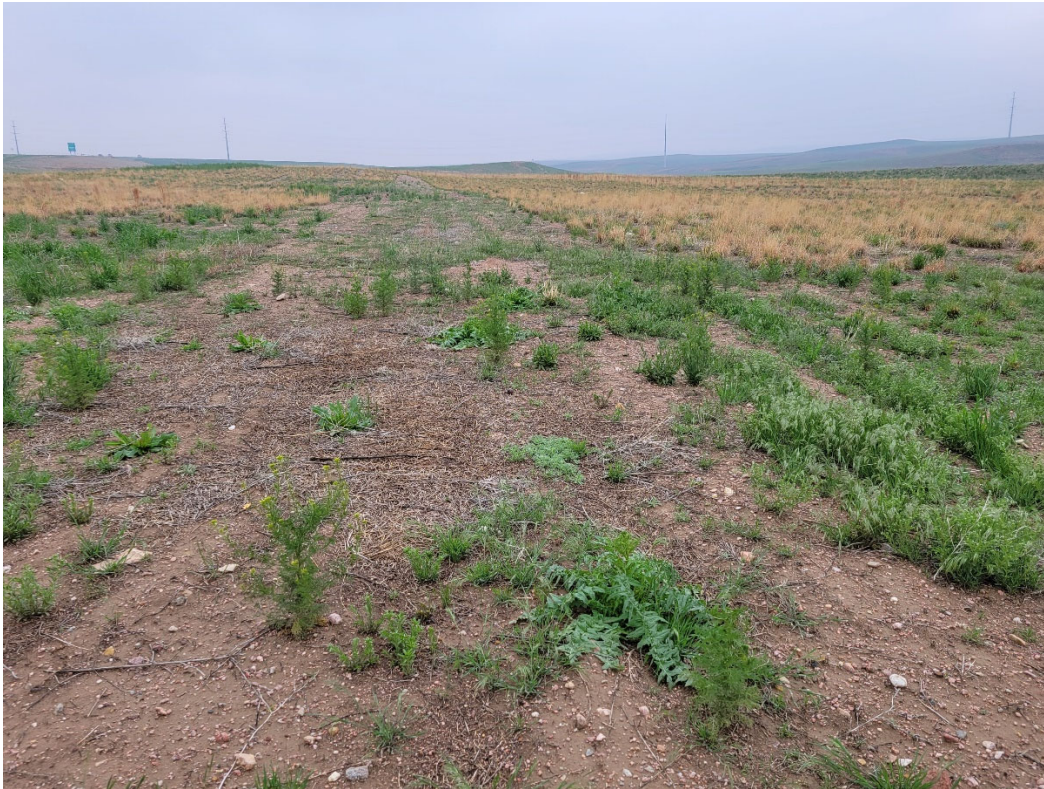
Photo 5. Former haul road in the center of the south mining area. Annual weeds noted in this area.

The Division recommends that the Operator review the approved reclamation plan, reclaim the haul road in the south area, continue to monitor revegetation success across the entire site and reseed and mulch areas as necessary. Additionally, the Operator will need to keep up with weed management and erosion control at the site until disturbed areas are stabilized with the desired vegetation.

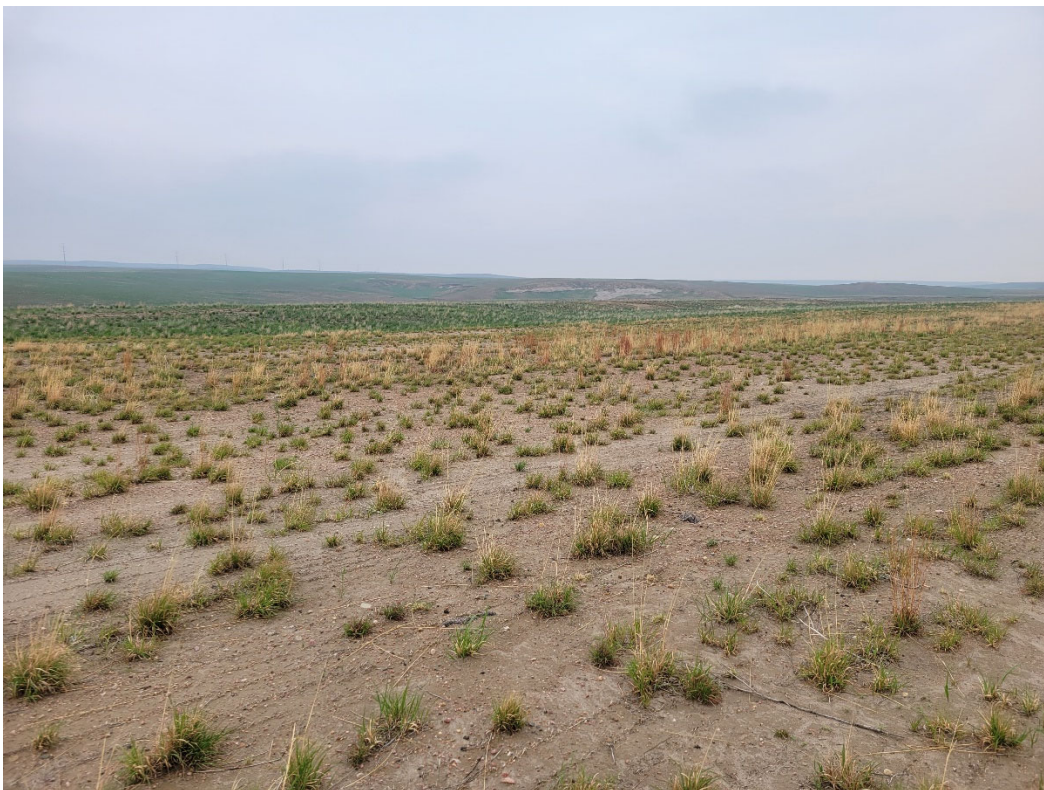
Photo 6. Patchy vegetation on the south end, adjacent to the haul road in the south mining area.

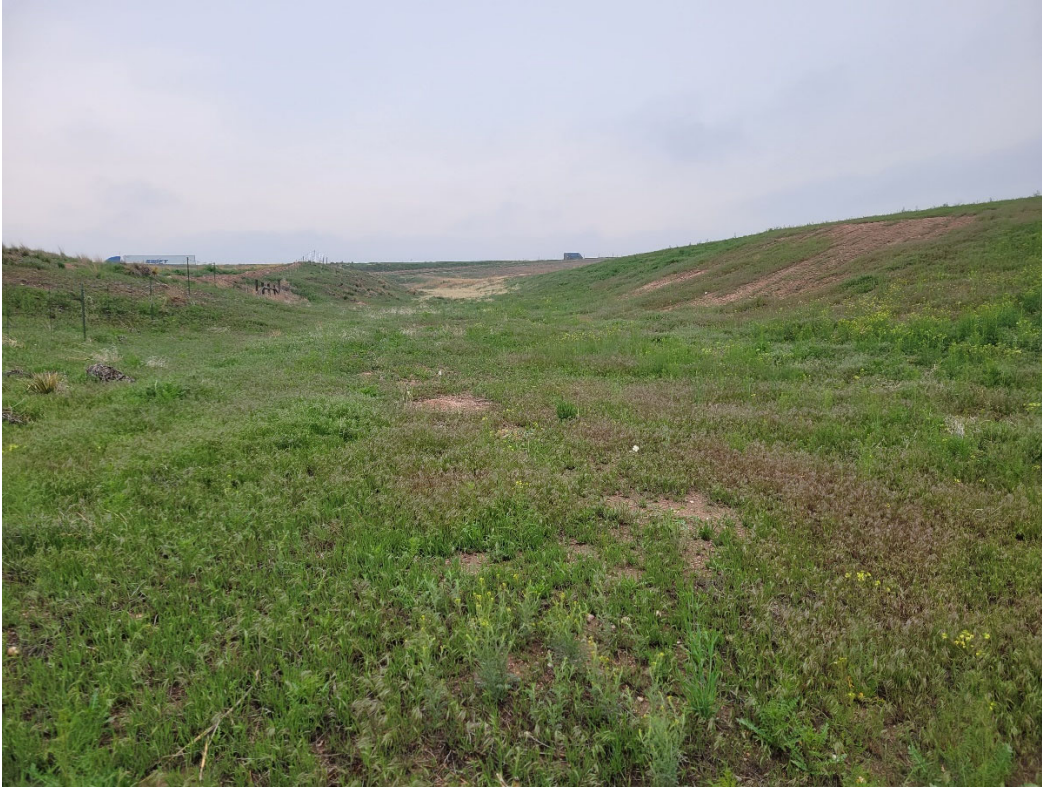
Photo 7. Undisturbed ephemeral drainage between the south and north mining areas.

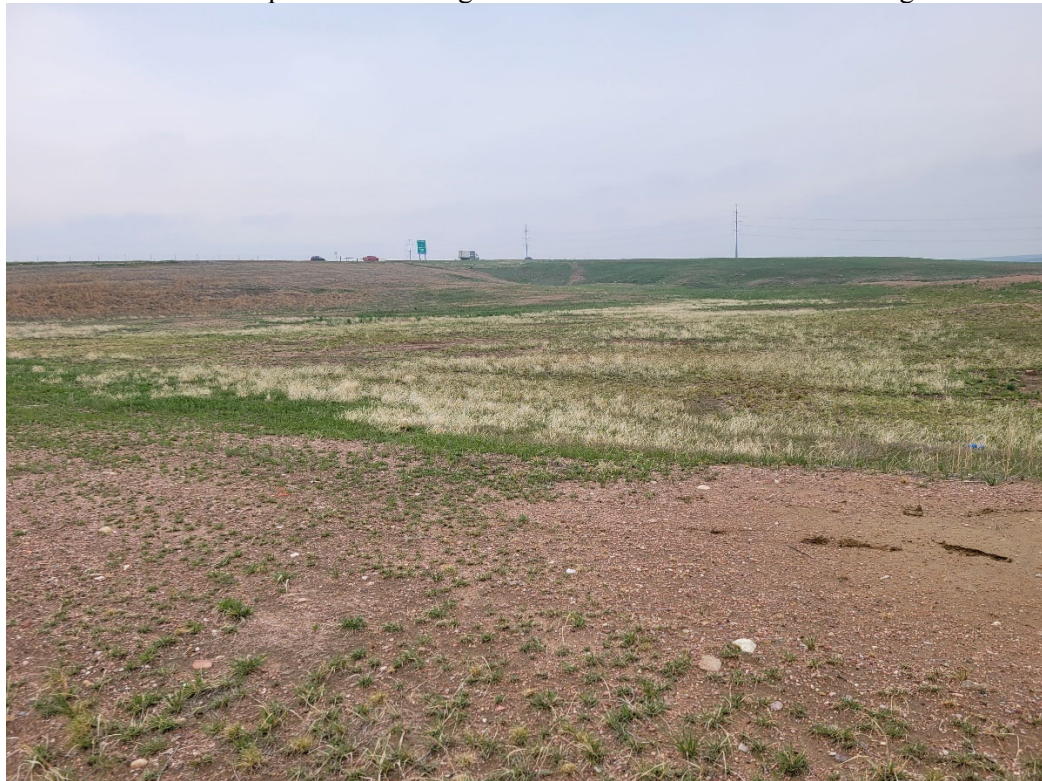
Photo 8. Looking north across the north mining area. Native grass is sprouting here.

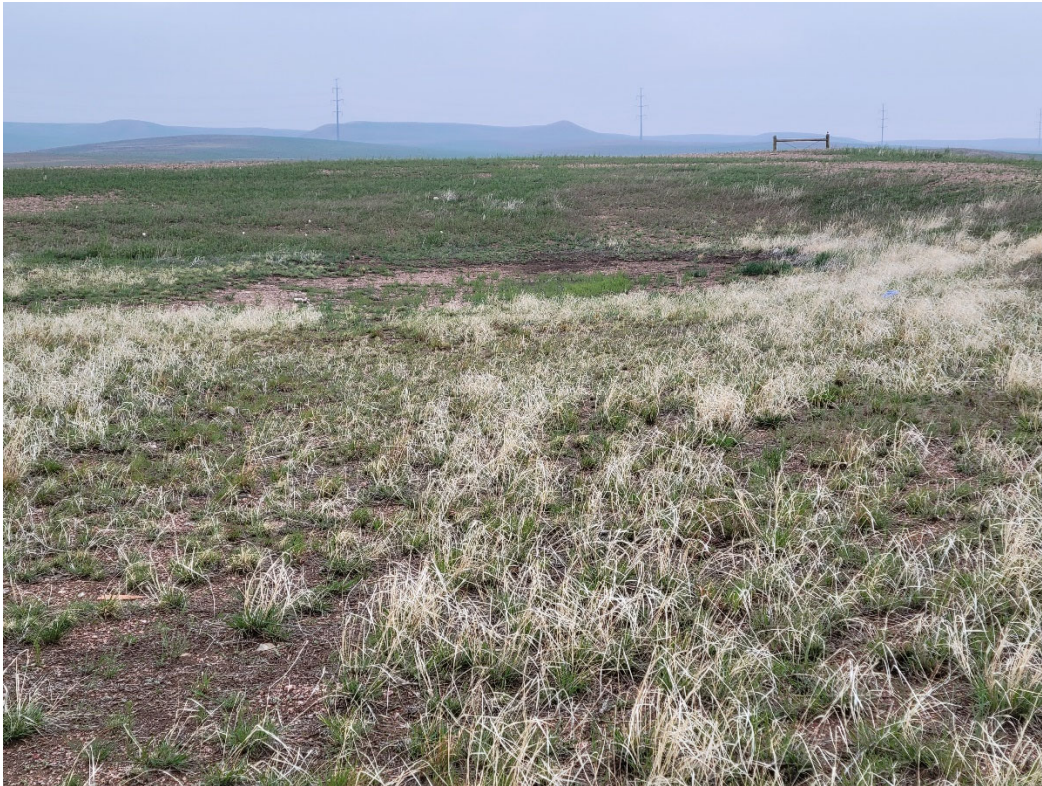
The south mining pit was dry during this inspection. A small amount of stormwater was noted in the pit in the north mining area. This area received a lot of rain over the past week, and it appeared that stormwater water is infiltrating quickly across the site.

Photo 9. Looking northeast across the former pit in the north mining area.

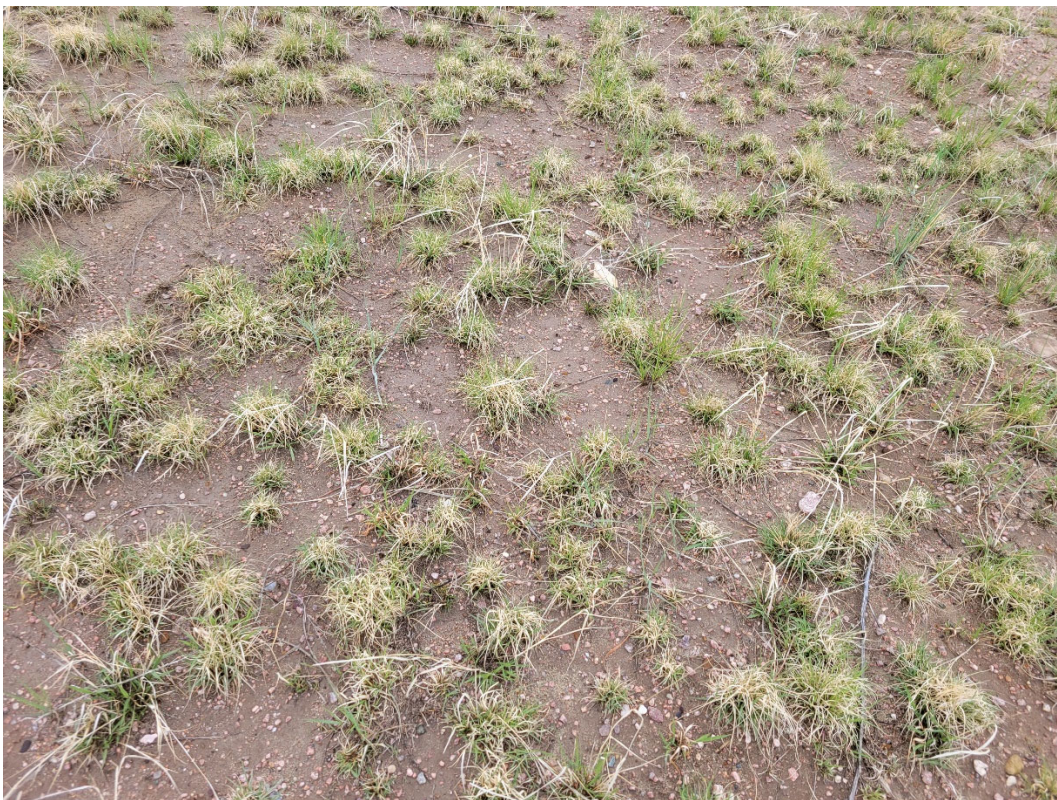
Photo 10. Closeup view of vegetation density in north mining area.

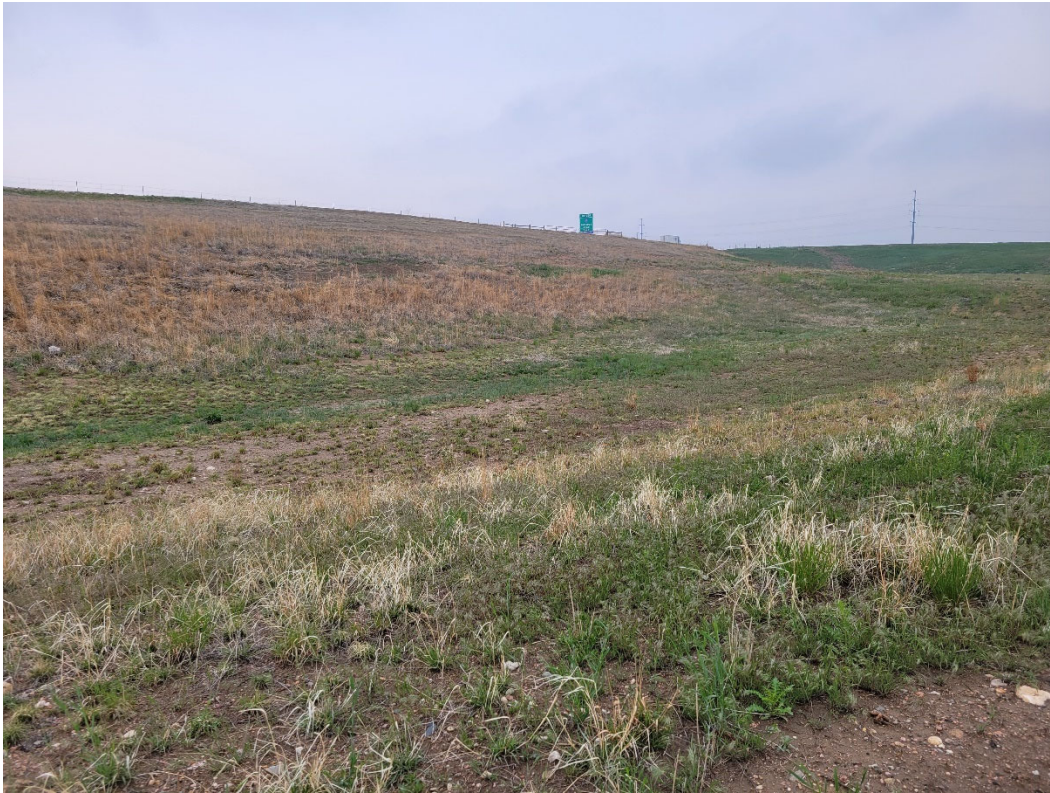
The north mining area was retopsoiled and seeded in the summer of 2020. Large patches of annual weeds, cheatgrass, kochia and some thistle, were noted in the north area. Patches of grass are sprouting in the former pit area and the slope along the frontage road is well vegetated to control erosion. In general, the annual weeds are outcompeting the native grasses in the north area, however, sprouts of grass were noted throughout and with proper weed control, the grasses will continue to fill in.

Photo 11. Looking at the western edge of the north mining area. Dense patches of annual weeds observed here. Vegetation has established on the hillside and controlling erosion.

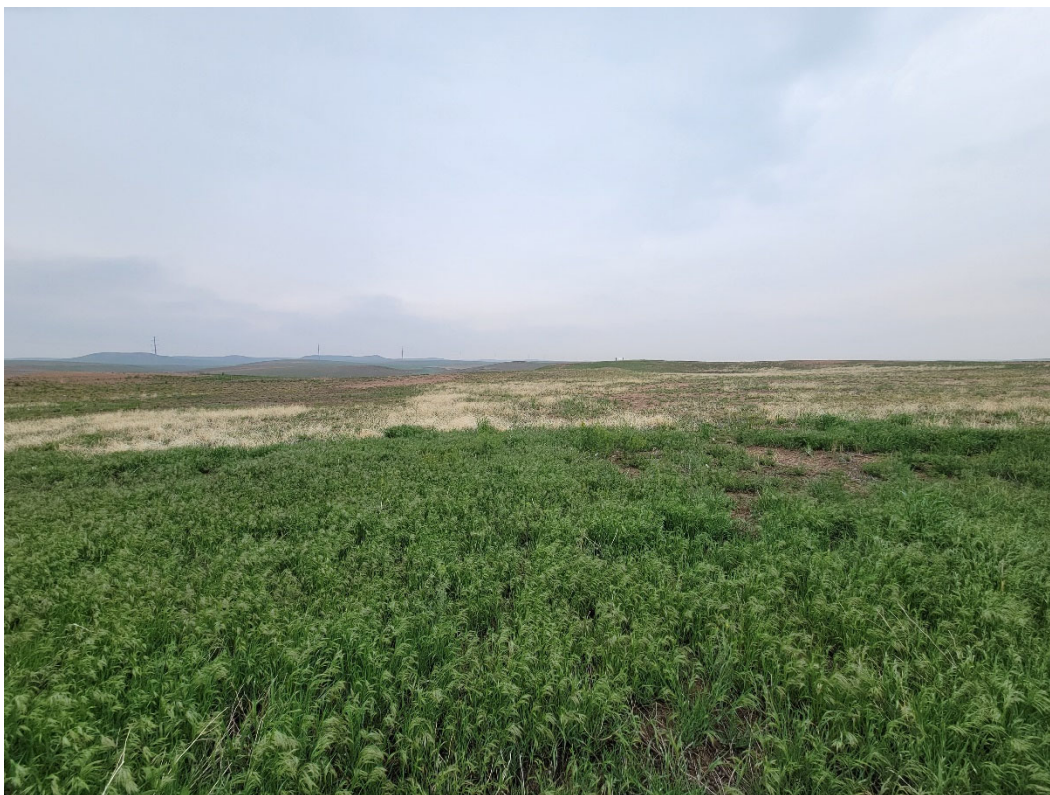
Photo 12. Large patches of annual weeds were observed in the north mining area.
