PERMIT INFORMATION

Permit Number: C1981033 Mine Name: Bear Mine Operator: N/A Operator Address: N/A	County: Gunnison Operation Type: Underground Permit Status: Revoked Ownership: Private				
	Operator Representative Present:				
	N/A				
Operator Representative Signature: (Field Issuance Only)

INSPECTION INFORMATION

Inspection Start Date: January 23, 2023 Inspection Start Time: 14:00 Inspection End Date: January 24, 2023 Inspection End Time: 12:00			Inspection Type: Coal Complete Inspection Inspection Reason: Normal I&E Program Weather: Clear		
Joint Inspection Agency: Joint Inspection Agency:		Joint	oint Inspection Contacts:		
None					
Post Inspection Agency:		Post	Post Inspection Contacts:		
None					
Inspector(s):	Inspector's Signature:		nature:	Signature Date:	
Leigh Simmons	#	Li		February 4, 2023

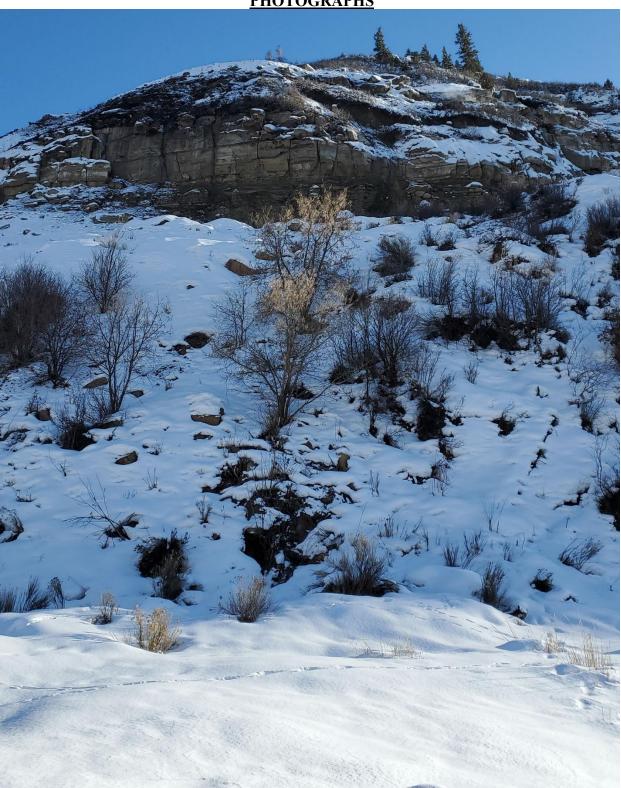
Figure 1: Slide area from below

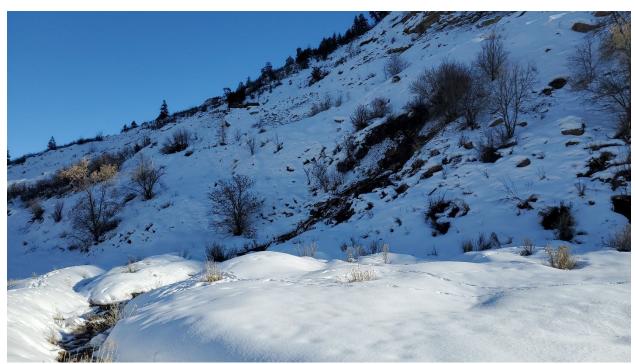
The groundwater seep was very obvious in the snowy surroundings, where the elevated temperature of the water kept the area free of snow.

Figure 2: Groundwater seep

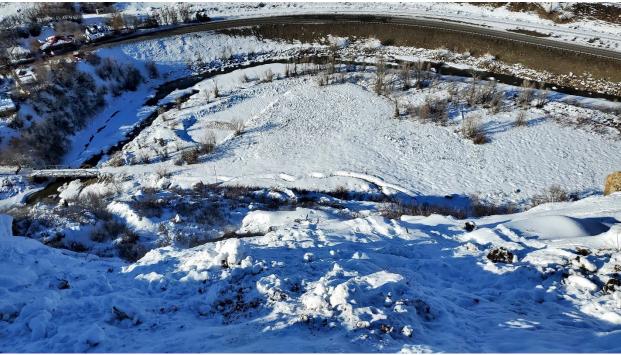
Figure 3: Overview of site from bench above slide area

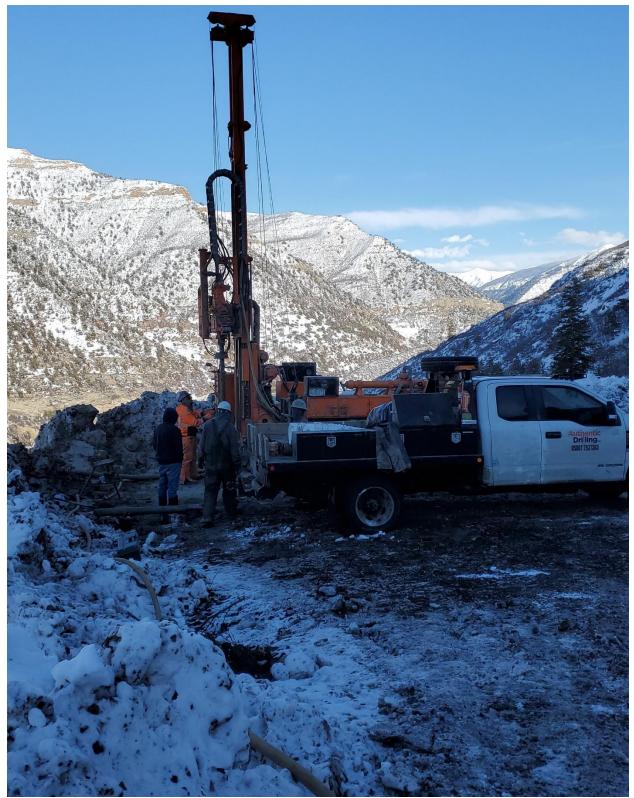
The drilling project on the bench above the slide area was still in progress. At the time of the inspection seven holes had been drilled using an air rotary drill, one core hole had been drilled (in an attempt to circumvent problems with circulation of drilling mud) and a final hole was being drilled in order to install an inclinometer.

Figure 4: Authentic Drilling drill rig installing inclinometer

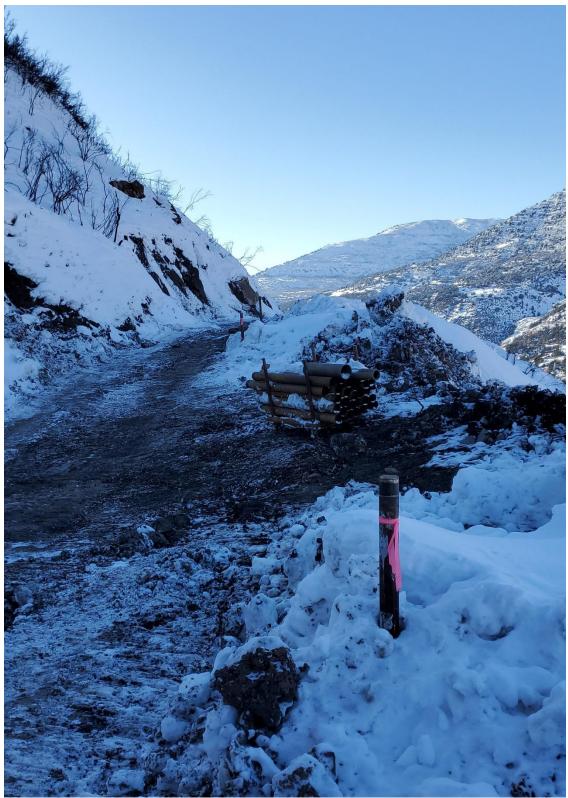
Figure 5: View along bench from east to west

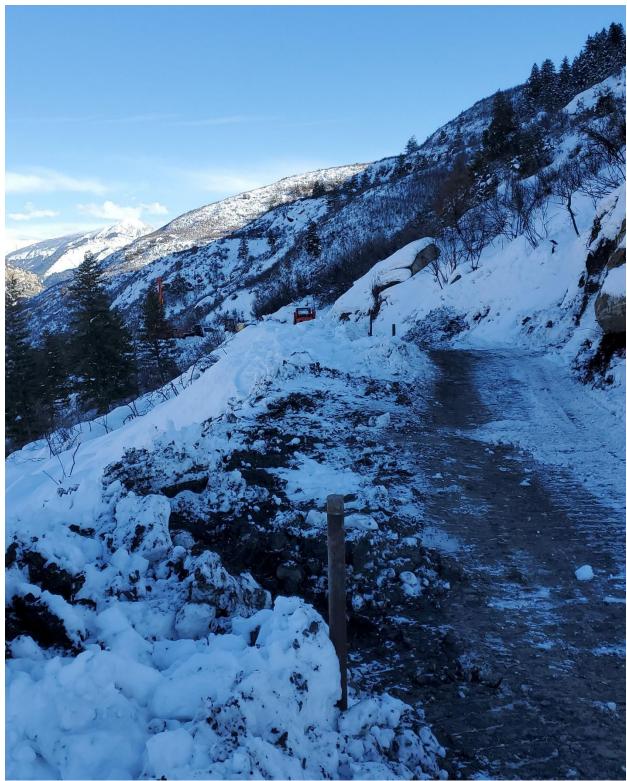
Figure 6: View along bench from west to east
