**MINERALS PROGRAM INSPECTION REPORT**  
**PHONE: (303) 866-3567**

<b>MINE NAME:</b> Climax Mine	<b>MINE/PROSPECTING ID#:</b> M-1977-493	<b>MINERAL:</b> Molybdenum	<b>COUNTY:</b> Lake, Summit
<b>INSPECTION TYPE:</b> Monitoring	<b>WEATHER:</b> Cloudy	<b>INSP. DATE:</b> June 6, 2023	<b>INSP. TIME:</b> 09:40
<b>OPERATOR:</b> Climax Molybdenum Company	<b>OPERATOR REPRESENTATIVE:</b> Alex Ungers	<b>TYPE OF OPERATION:</b> 112d-3 - Designated Mining Operation	
<b>REASON FOR INSPECTION:</b> Normal I&E Program	<b>BOND CALCULATION TYPE:</b> None	<b>BOND AMOUNT:</b> \$91,011,850.00	
<b>DATE OF COMPLAINT:</b> NA	<b>POST INSP. CONTACTS:</b> DRMS	<b>JOINT INSP. AGENCY:</b> None	
<b>INSPECTOR(S):</b> Amy Yeldell	<b>INSPECTOR'S SIGNATURE:</b>

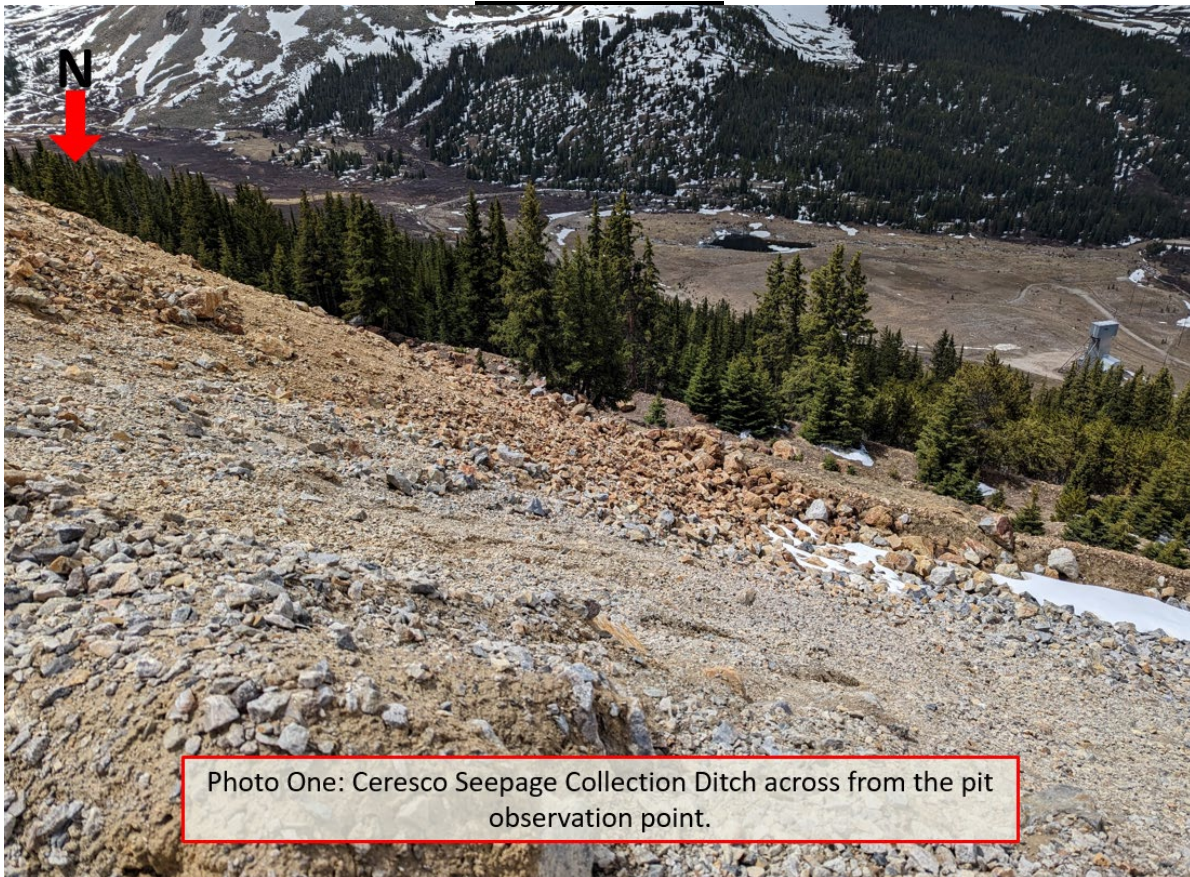
The Ceresco Seepage Collection Ditch is mostly melted free of snow, a few areas in the shadows still have snow cover (Photo One). Though the snow is melted in general the soils are still frozen and very limited seepage was observed. Overall the Ditch appeared to be in good shape and is anticipated to function properly once temperatures increase and seepage water is intercepted. Mr. Ungers indicated that the ditch is likely to get extended to the south-southeast to contain the rest of the stormwater from the switchback directly above the ditch (Photo Two). This would be a stormwater improvement. The goal is to remove the need for an outfall point for the east fork of the Arkansas River.

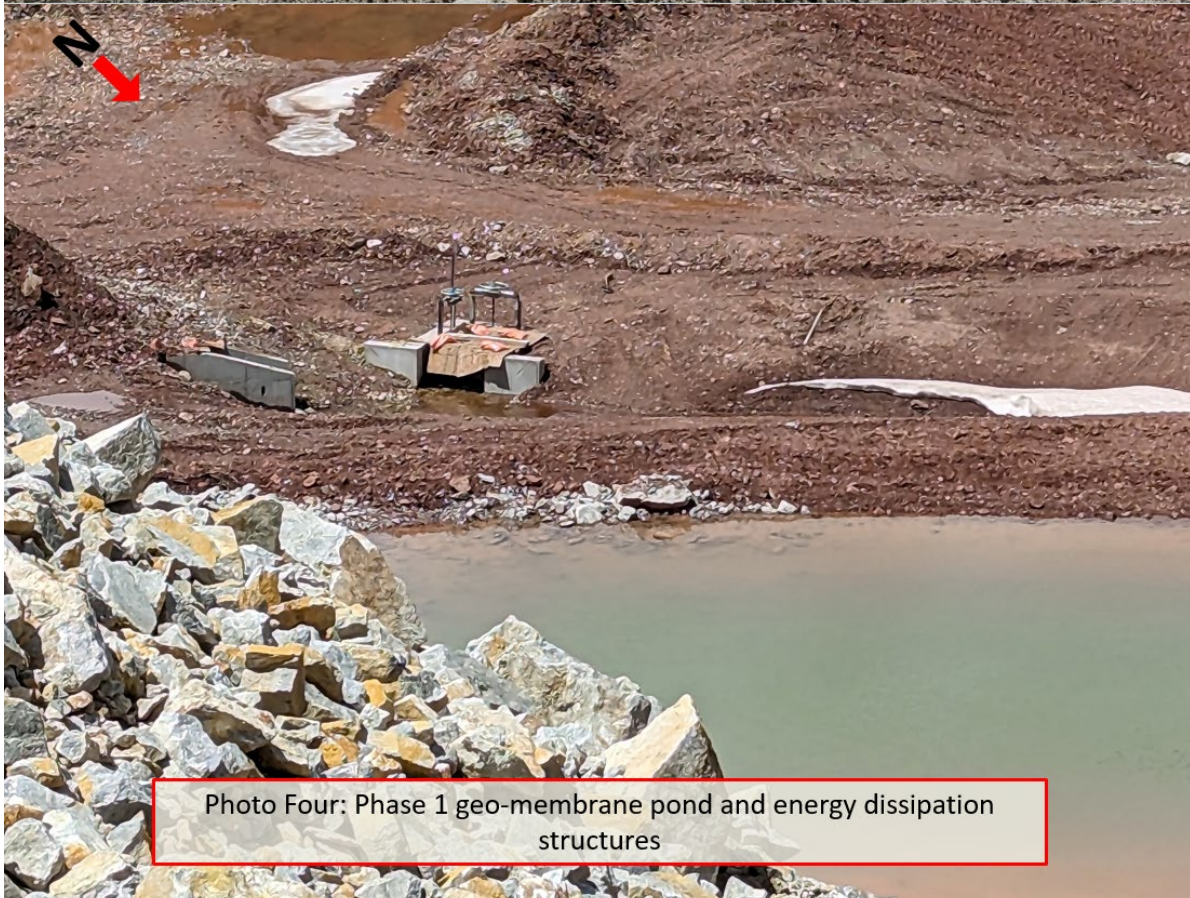
Atop the Underdrain System is the Primary Contact Water Collection System (CWCS). This feature will act as a French Drain, collecting surface waters which have infiltrated through the OSF and directing them into the Energy Dissipation Structure No.1. Contact water eventually gets taken to East Tailings Delivery Line (ETDL) which then gets treated prior to discharge. Secondary CWCS will also be installed as needed in addition to toe drains as material is placed in the OSF. The phase 1 geo-membrane lined pond was observed and held water at the time of the inspection (Photo Four).

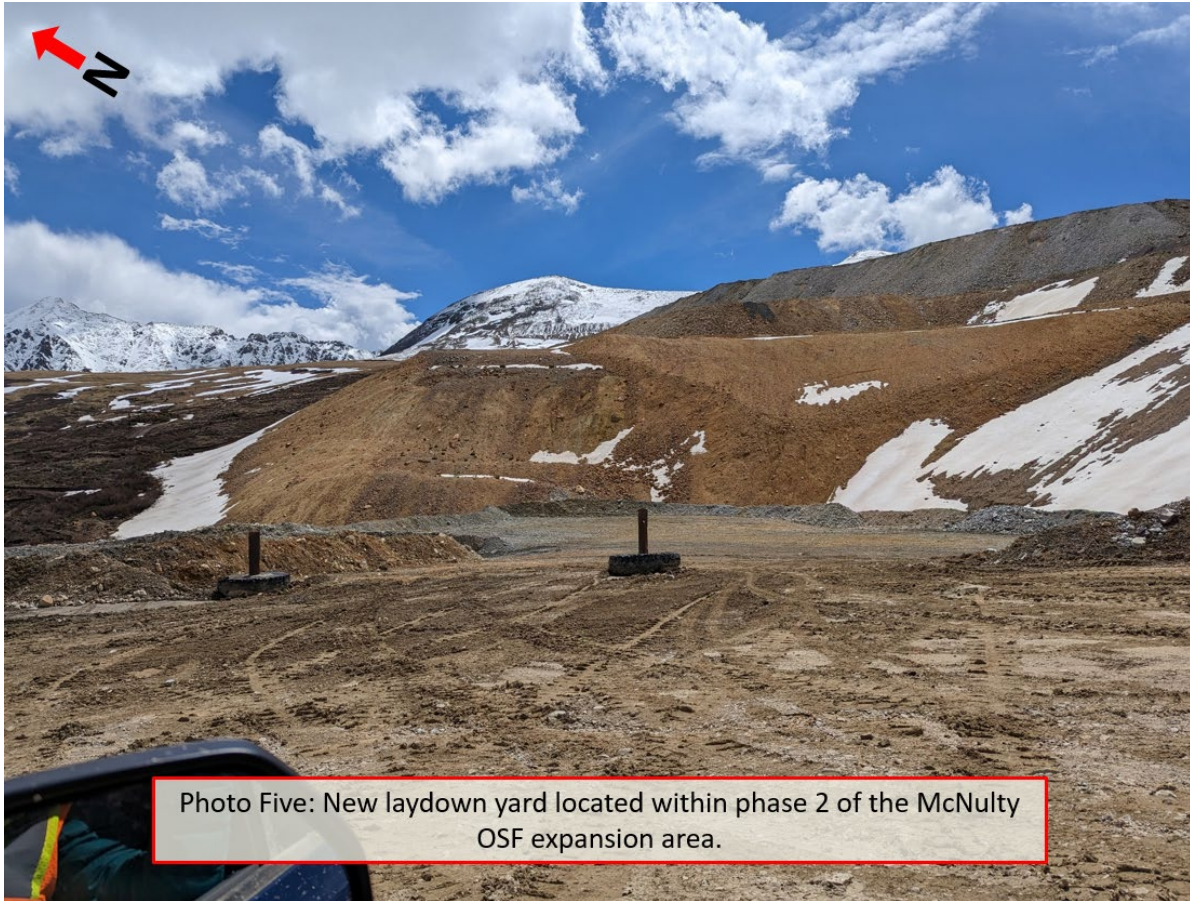
The phase 2 laydown yard has also recently been completed (Photo Five). The laydown yard is stabilized with rubble. Crews were mobilizing equipment at the time of the inspection. At this time no fuel or other similar support features have been placed in the laydown yard. The crews are mobilized to begin shredding/chipping trees in the Phase 2 area which have already been removed/knocked down. Crews will also begin stripping topsoil in the phase 2 expansion area (Photo Six).

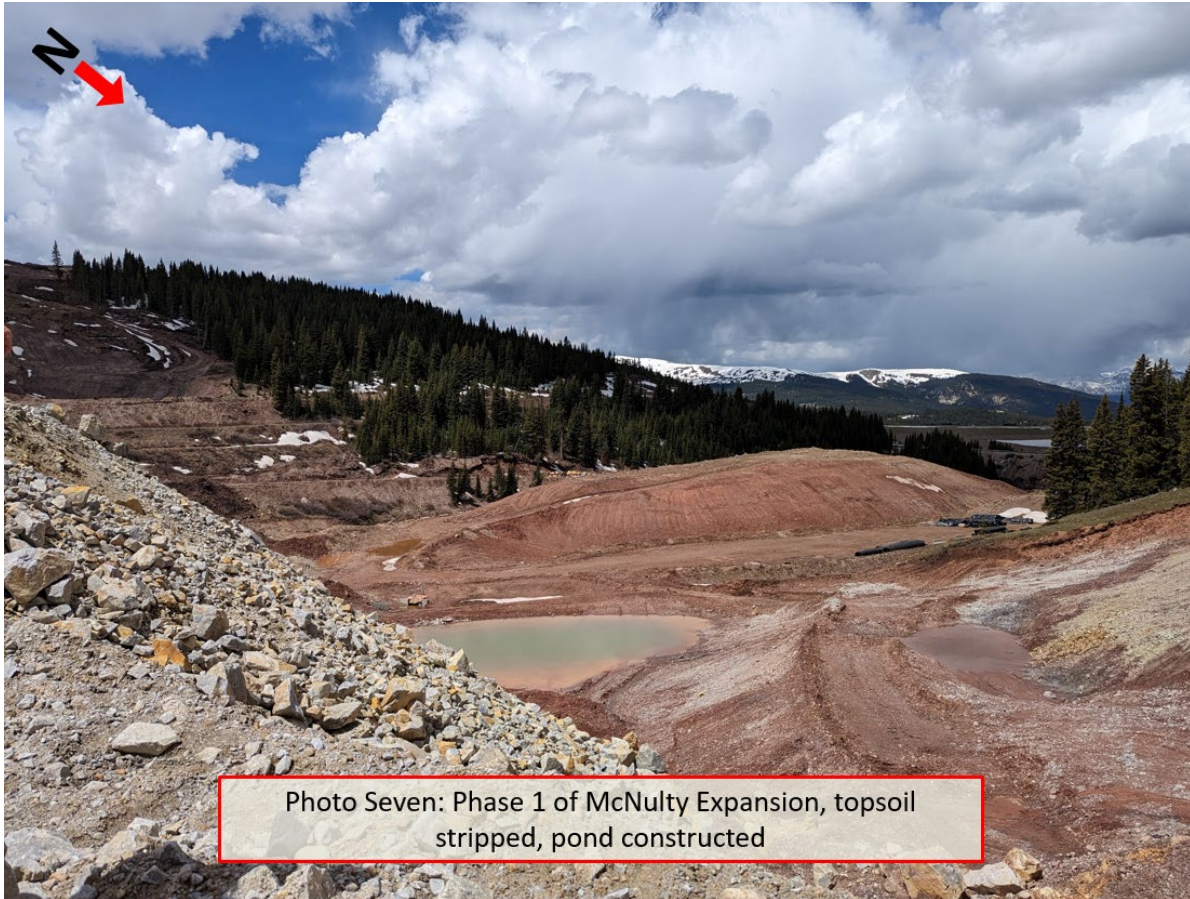
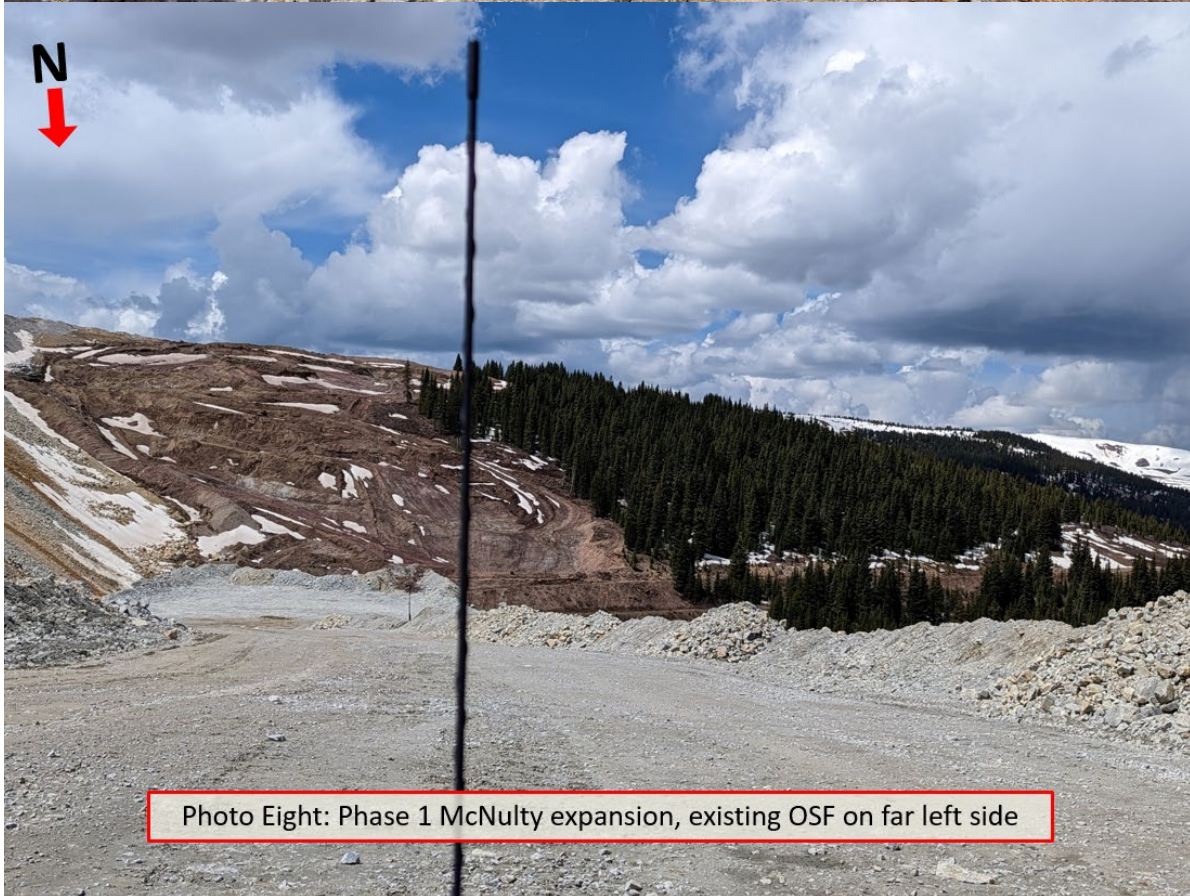
Phase 1 topsoil has been completely stripped (Photos Seven and Eight) and is approximate 400k CY located behind pond 1, and an additional 100K CY stored on the upper south ridge. Phase 2 stripping will commence soon and it is anticipated to generate at least 900k CY, though it's estimated that much more exists.

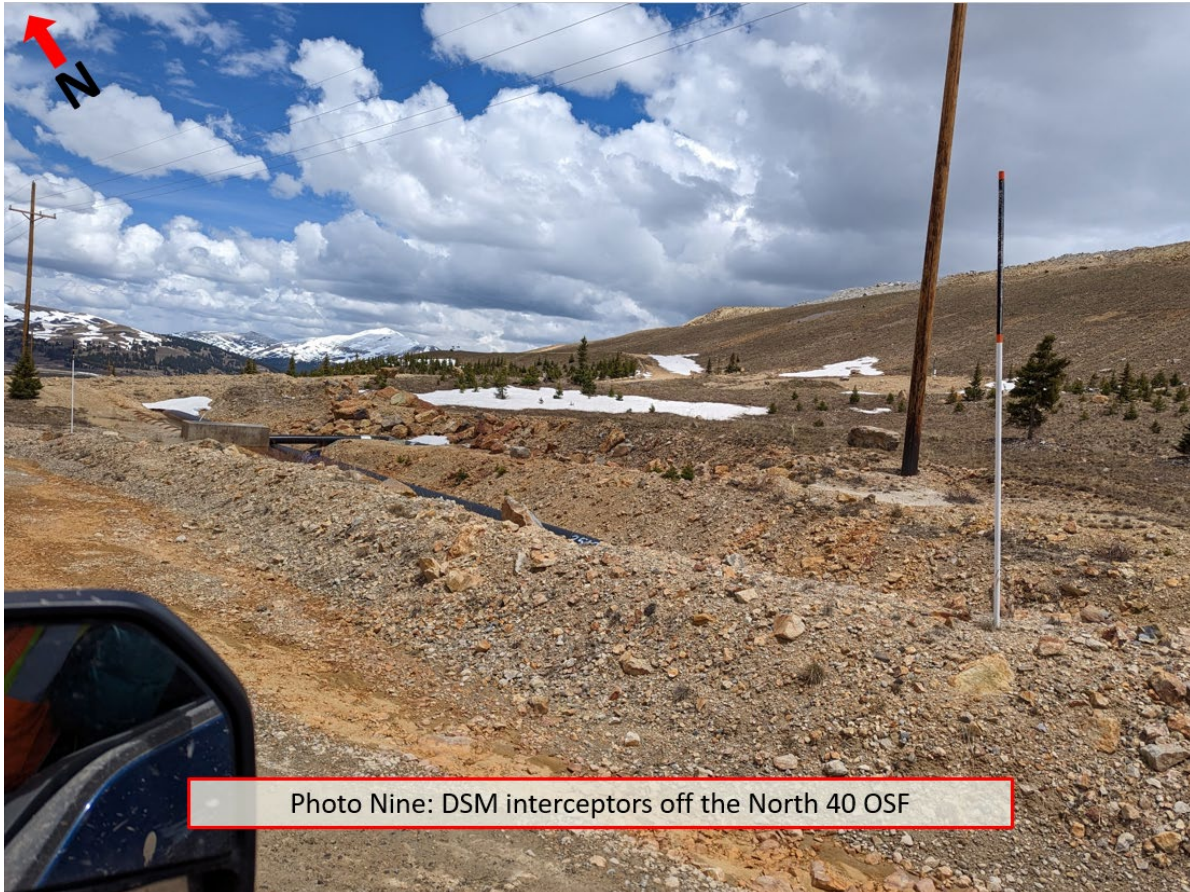
Lastly the Division inspected the North 40 OSF which contains mostly low-grade ore dump and historical waste rock. The reclaimed portions of the OSF remain stable. The toe drains go into DSM interceptors (the cement boxes) which direct contact water into the ETDL (concrete pipe) which diverts to the SDP (Photo Nine). Adjacent to the ETDL is the Tailings Delivery Line (TDL) is the black poly pie. Seepage from the north side channel is directed into the 10 mile (Photo Ten). Seepage out of the North 40 OSF was observed.
