**PERMIT INFORMATION**

<b>Permit Number:</b> C1981033 <b>Mine Name:</b> Bear Mine <b>Operator:</b> N/A <b>Operator Address:</b> N/A	<b>County:</b> Gunnison <b>Operation Type:</b> Underground <b>Permit Status:</b> Revoked <b>Ownership:</b> Private
	<b>Operator Representative Present:</b>  N/A
<b>Operator Representative Signature: (Field Issuance Only)</b>

<b>Inspection Start Date:</b> May 17, 2023 <b>Inspection Start Time:</b> 14:00 <b>Inspection End Date:</b> <b>Inspection End Time:</b>	<b>Inspection Type:</b> Coal Complete Inspection <b>Inspection Reason:</b> Normal I&E Program <b>Weather:</b> Clear
<b>Joint Inspection Agency:</b>  None	<b>Joint Inspection Contacts:</b>  
<b>Post Inspection Agency:</b>  None	<b>Post Inspection Contacts:</b>  
<b>Inspector(s):</b>  Leigh Simmons	<b>Inspector's Signature:</b>

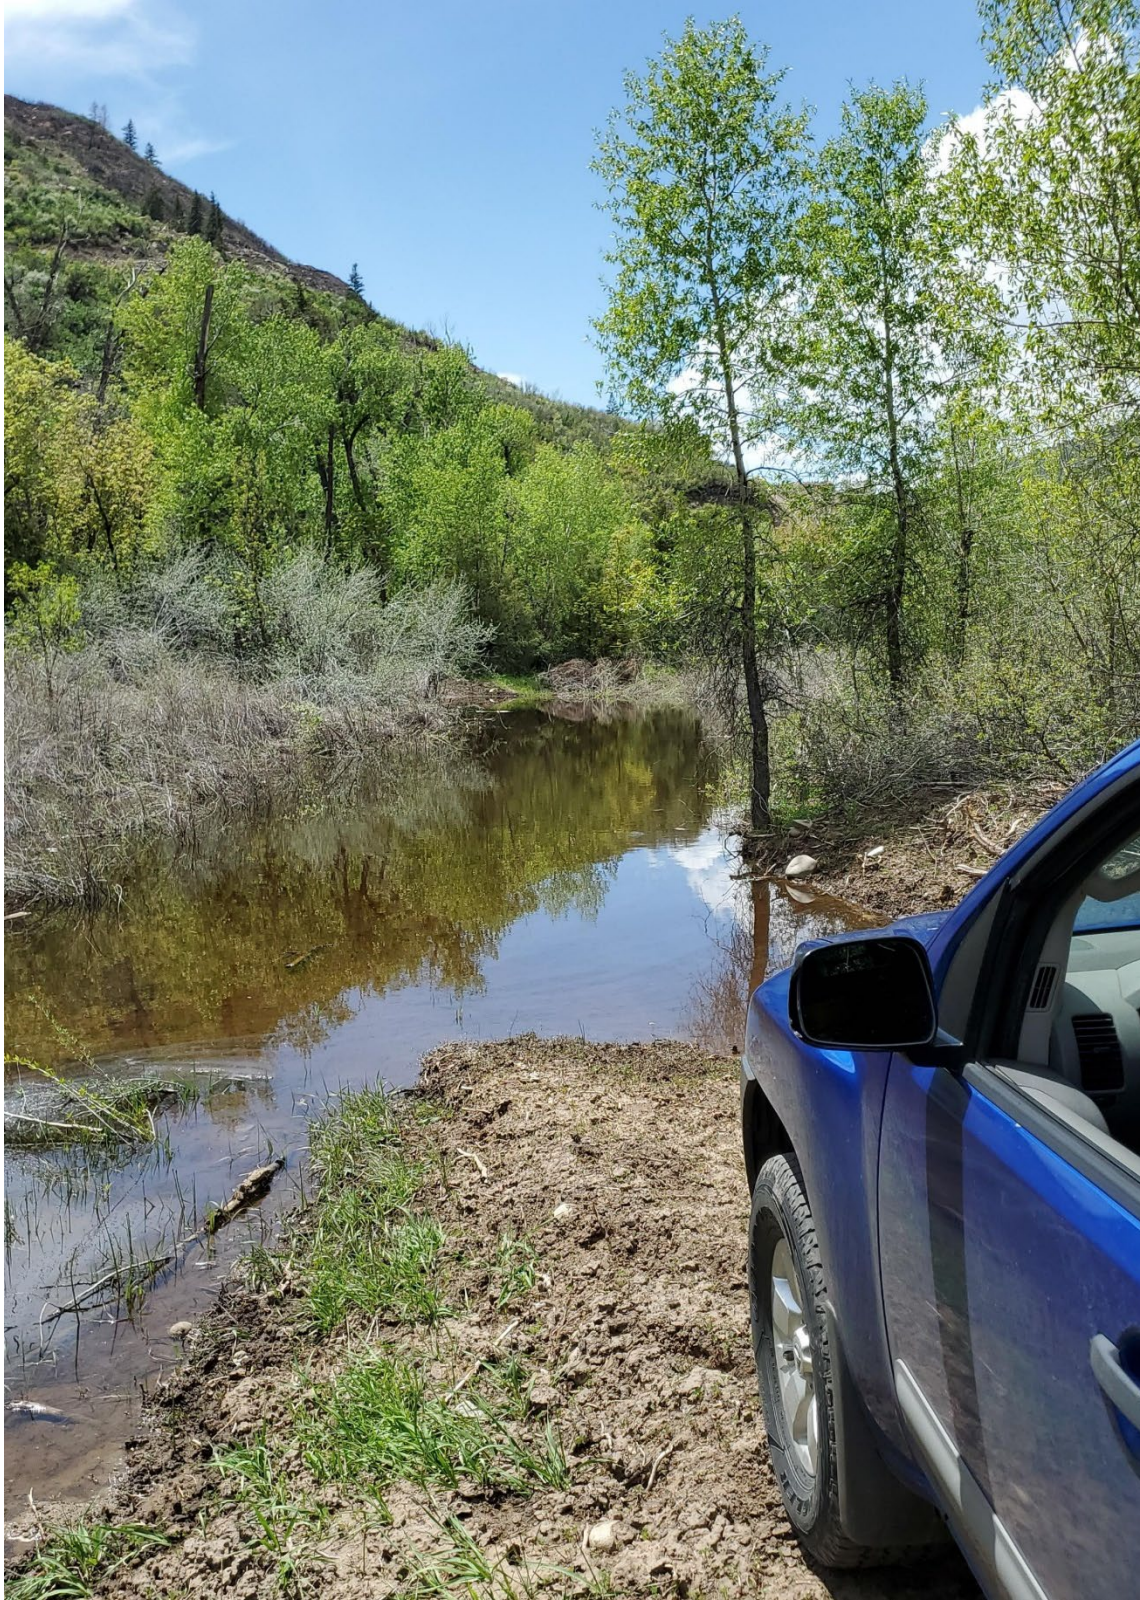
The temporary access road that had been constructed from the West Elk Mine in 2022 was flooded at a low spot, making it impassable. As the road gained height to the west it was clear of the flood water, but in very poor condition following the spring run-off as well as recent rain.

*Figure 6: Flooding on temporary access road from West Elk Mine*

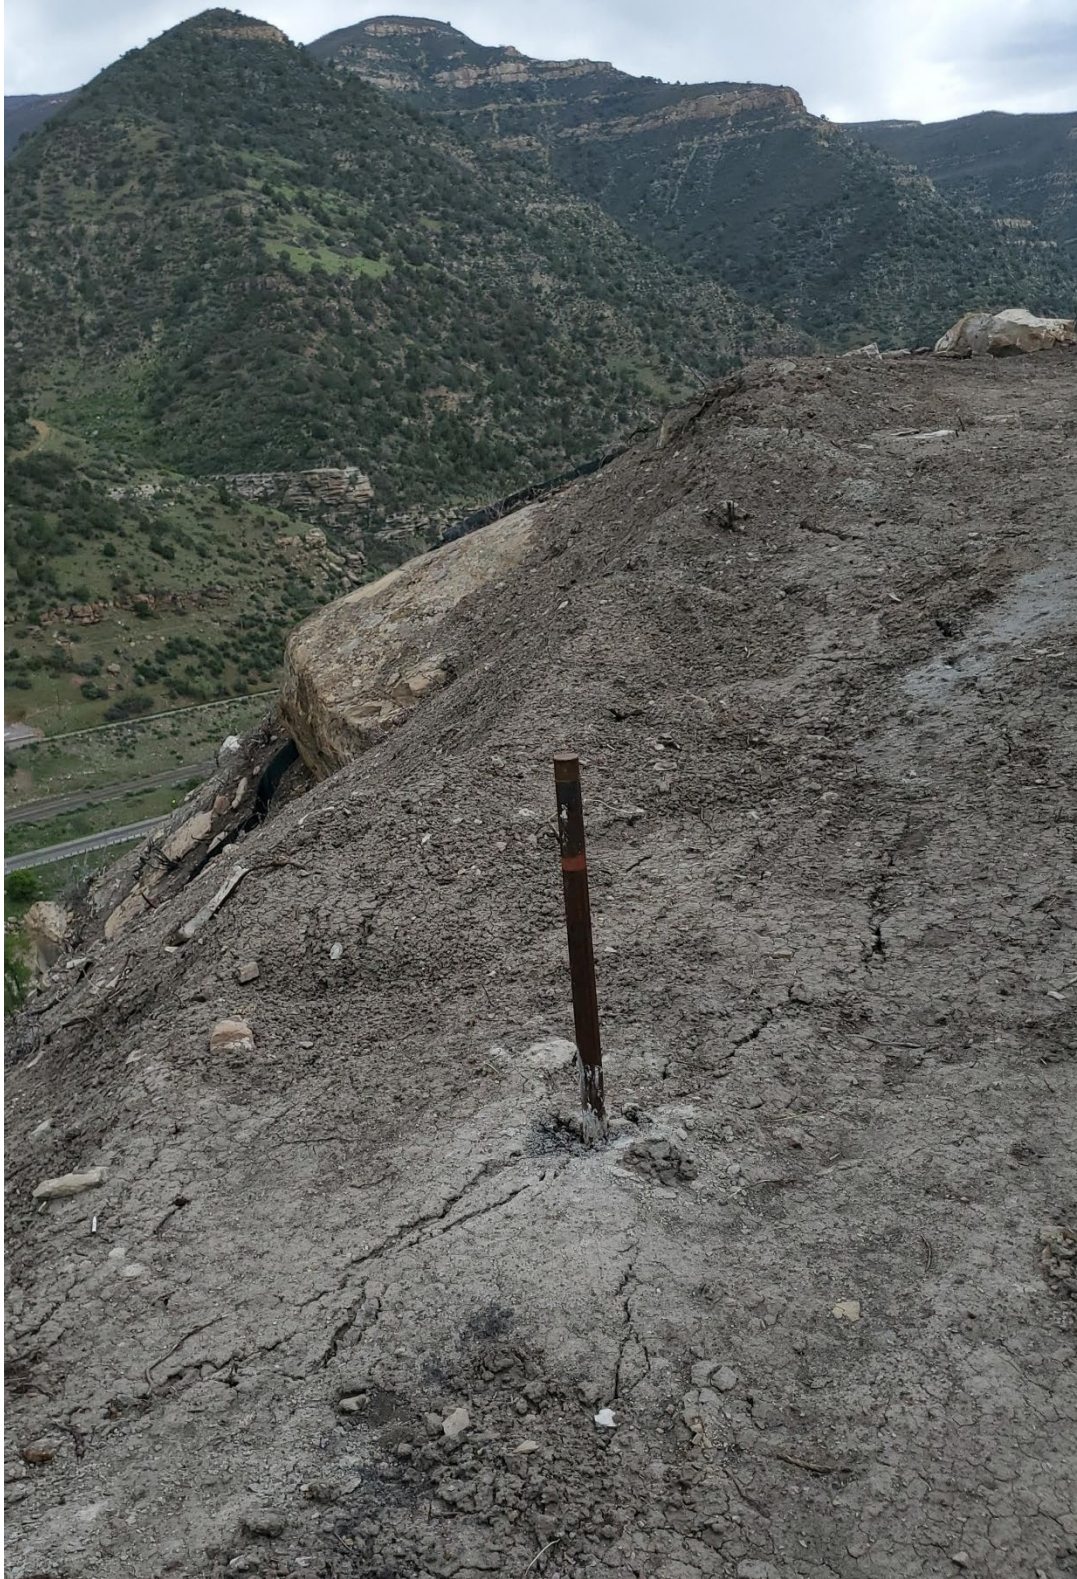
The pad constructed on top of the bench, and the road leading to it had eroded badly over the winter and spring. There were cracks and possible subsidence features visible on the pad, (see Figures 7-9).

*Figure 7: Cracking on benchtop pad (1 of 2)*

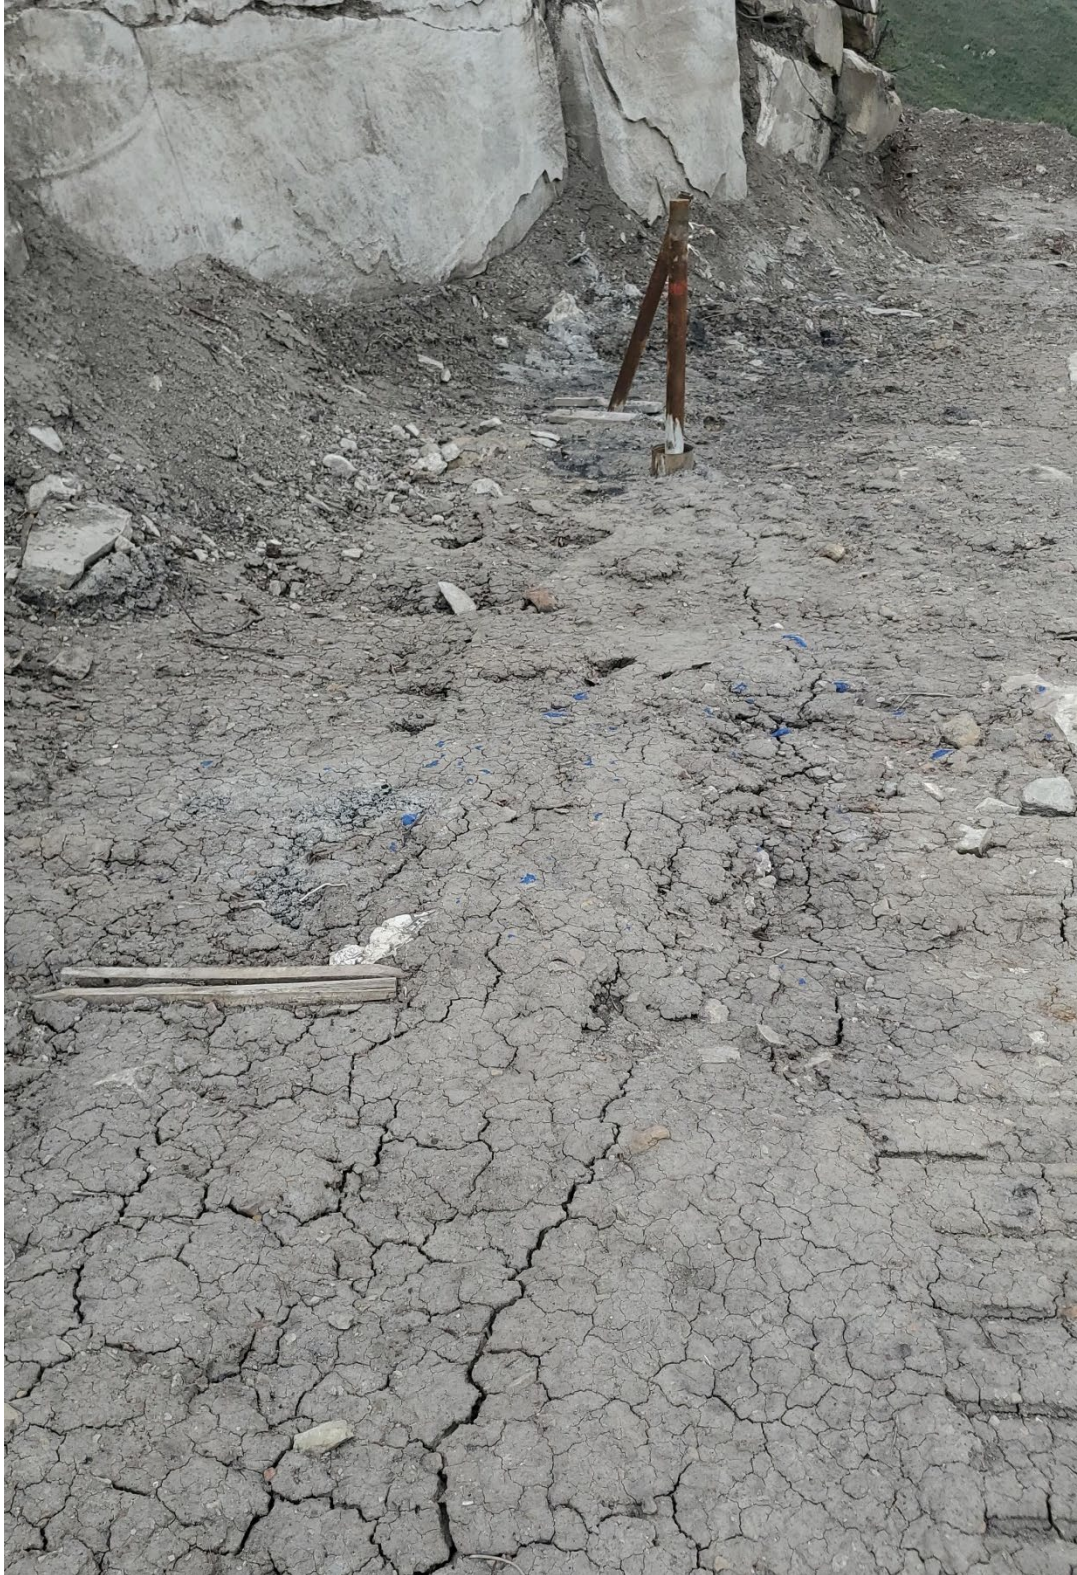
*Figure 8: Cracking on benchtop pad (2 of 2)*

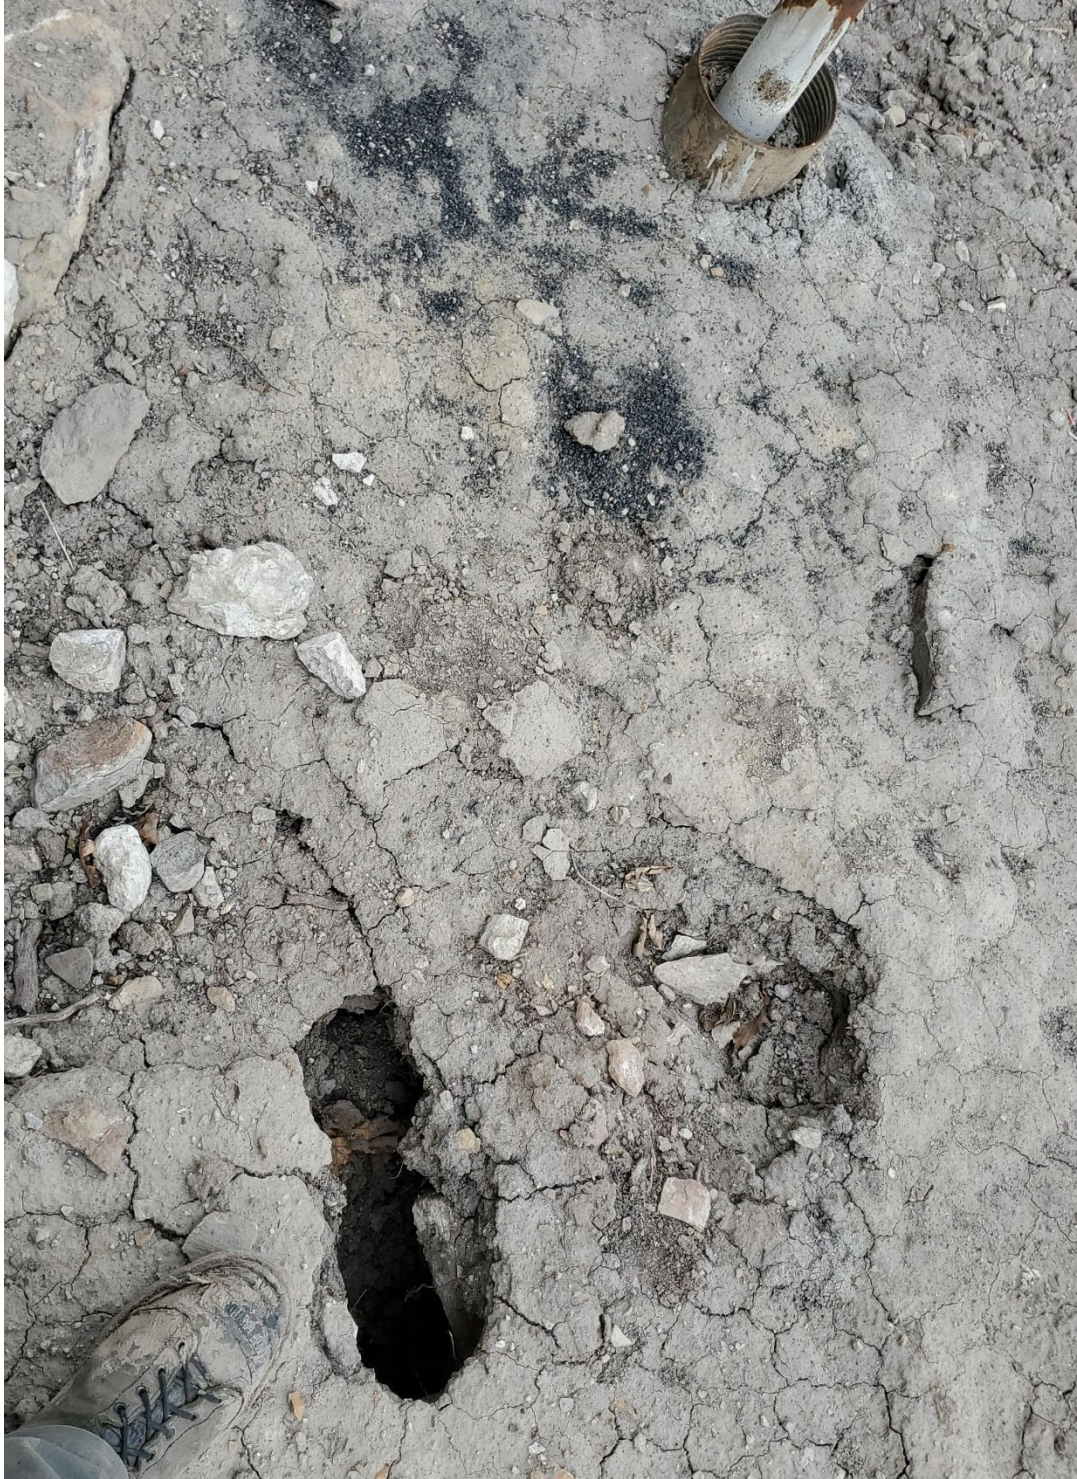
*Figure 9: Possible subsidence on benchtop pad*

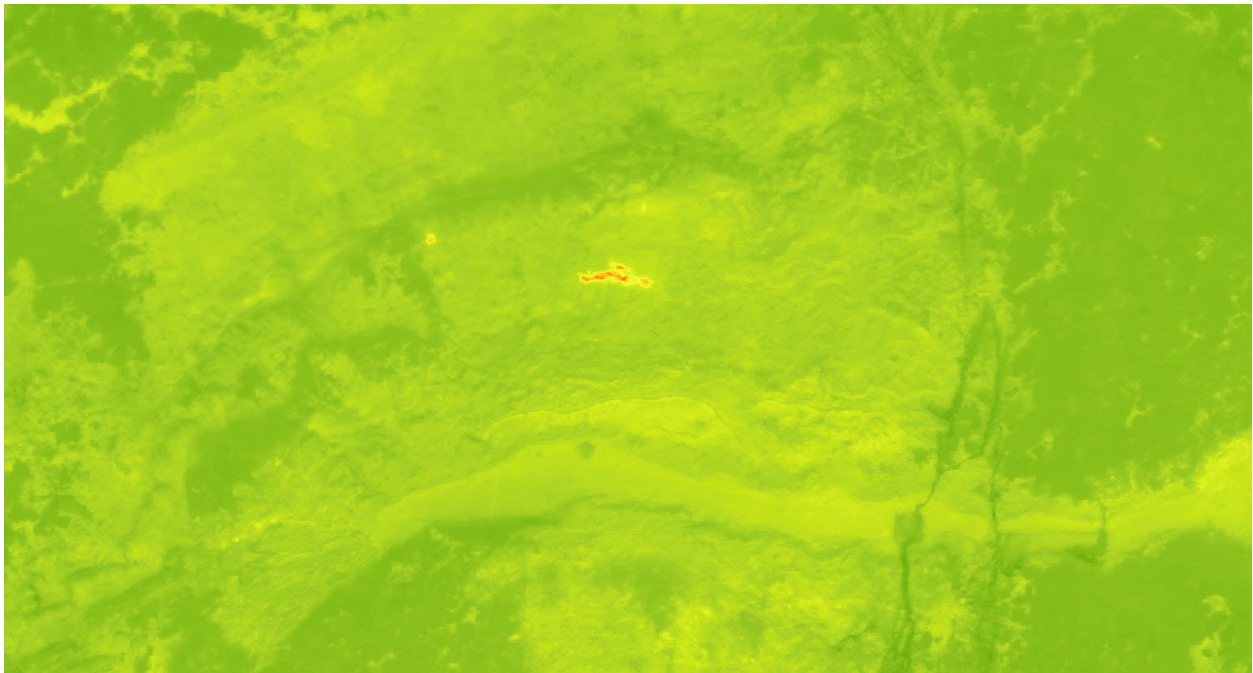
*Figure 12: IR reflectance raster over figure 11, showing highest relative temperatures (red)*

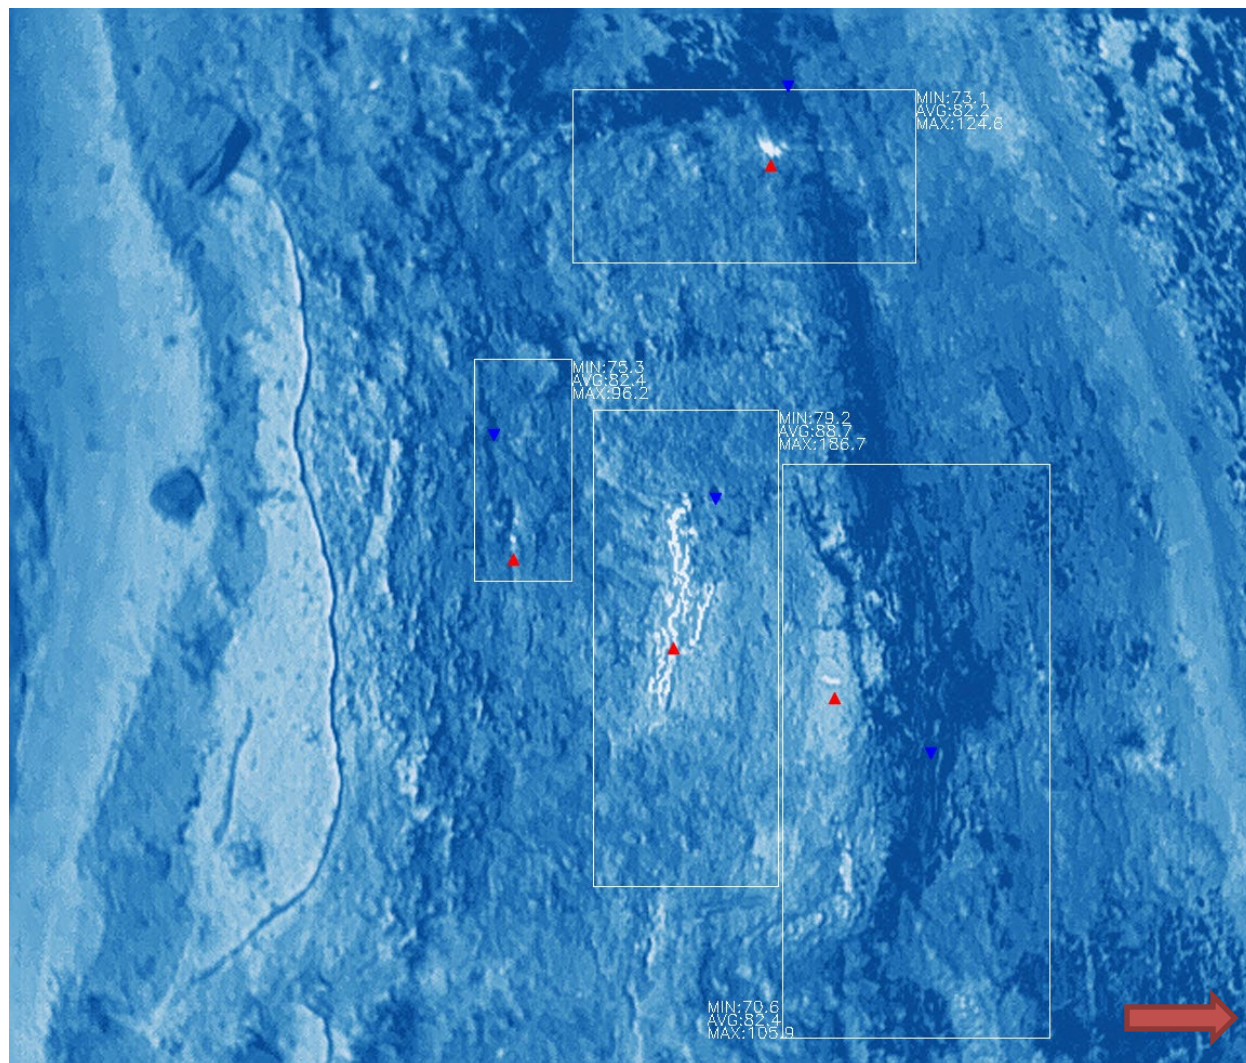
Although there appeared to be less smoke and steam issuing from the vents at the site, the drone data suggests that surface temperatures in May 2023 were similar to those measured in September 2022. The highest temperatures were measured at approximately the same location, from a collection of vents in the middle of the slope immediately below the pad (see Figures 16 and 17).

Figure 16: IRX\_0310.jpg, viewed using IR\_PCTool. The maximum temperature within each rectangle is shown with a red triangle. Temperature values in degrees Fahrenheit are given adjacent to the rectangle. The highest observed temperature was 186.7 F

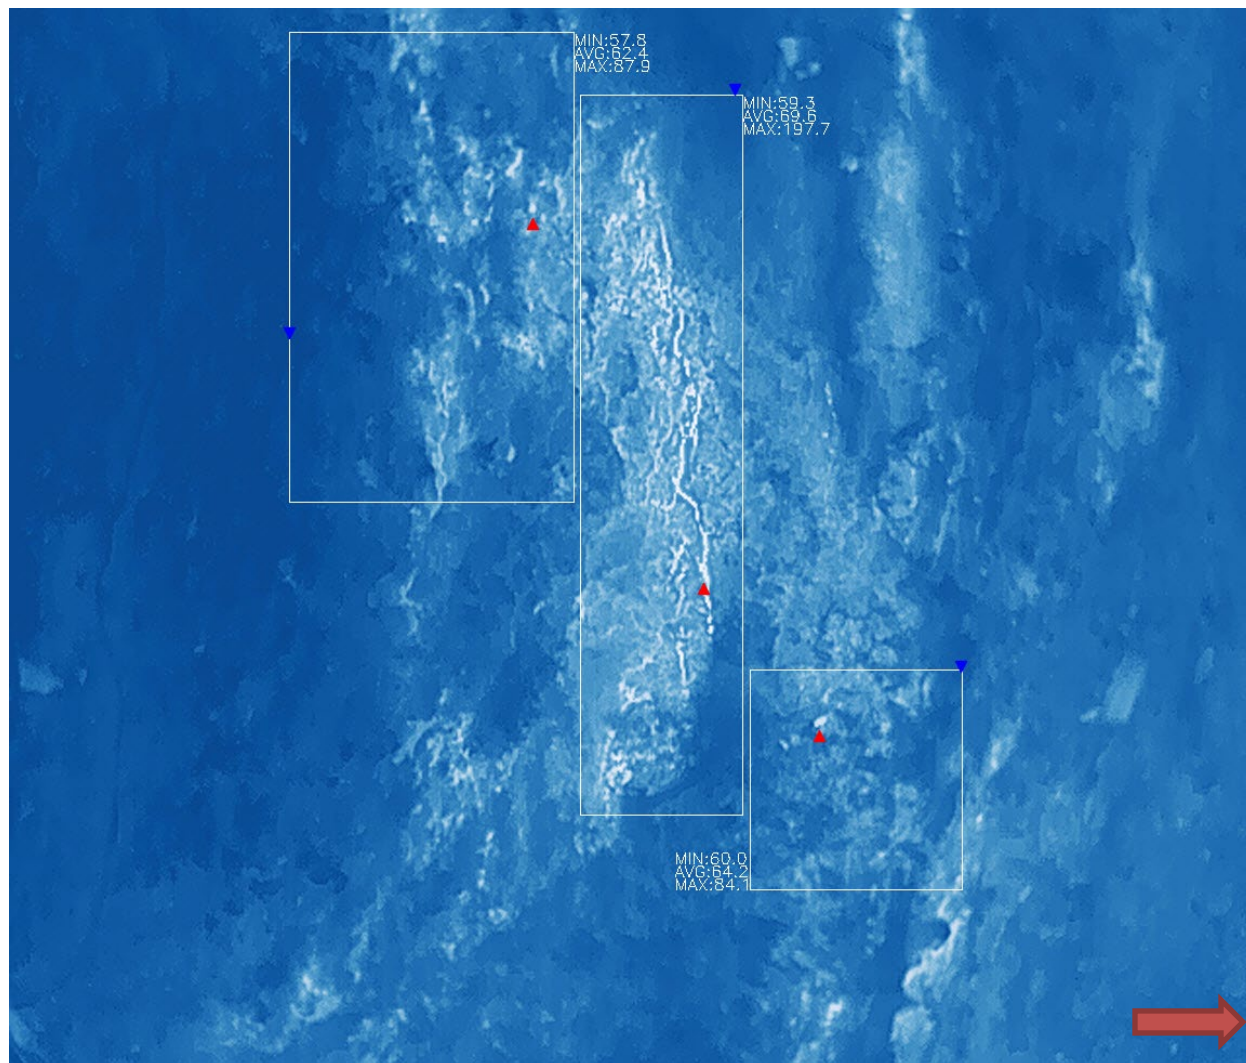
Figure 17: For comparison, IRX\_0422.jpg from September 2022. The image covers a slightly smaller area than Figure 16, but shows the same vent features. The highest observed temperature was 197.7 F, and was in a similar location.

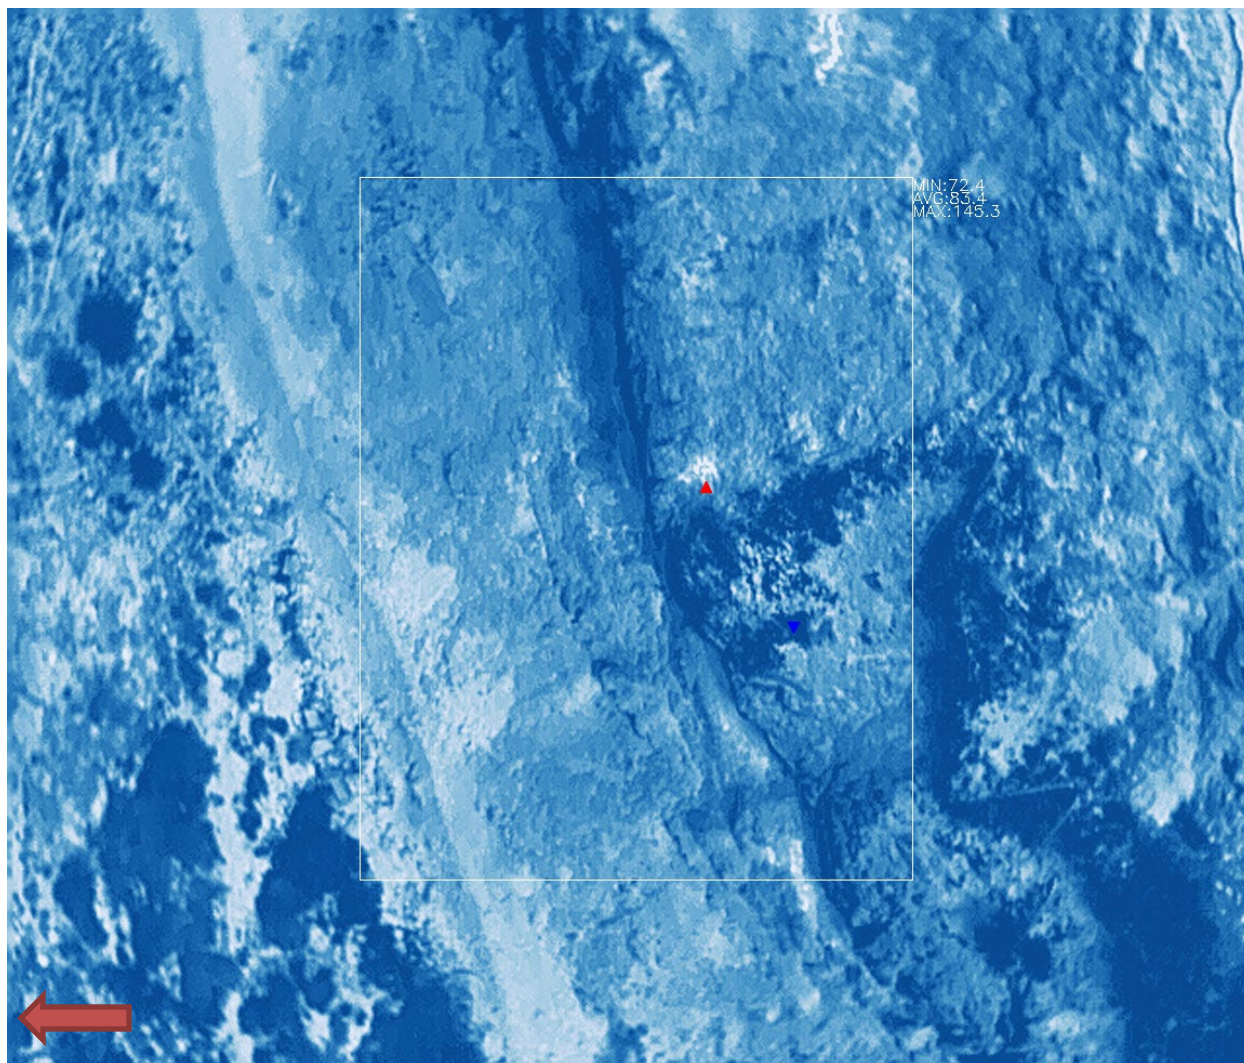
A second hotspot, slightly to the west of the first and lower on the slope, had increased measurably in temperature (from 98-110 °F, to 139-151 °F).

Figure 20: IRX\_0274.jpg, viewed using IR\_PCTool. The maximum temperature within the rectangle is shown with a red triangle. Temperature values in degrees Fahrenheit are given adjacent to the rectangle. The highest observed temperature in this area was 145.3 F

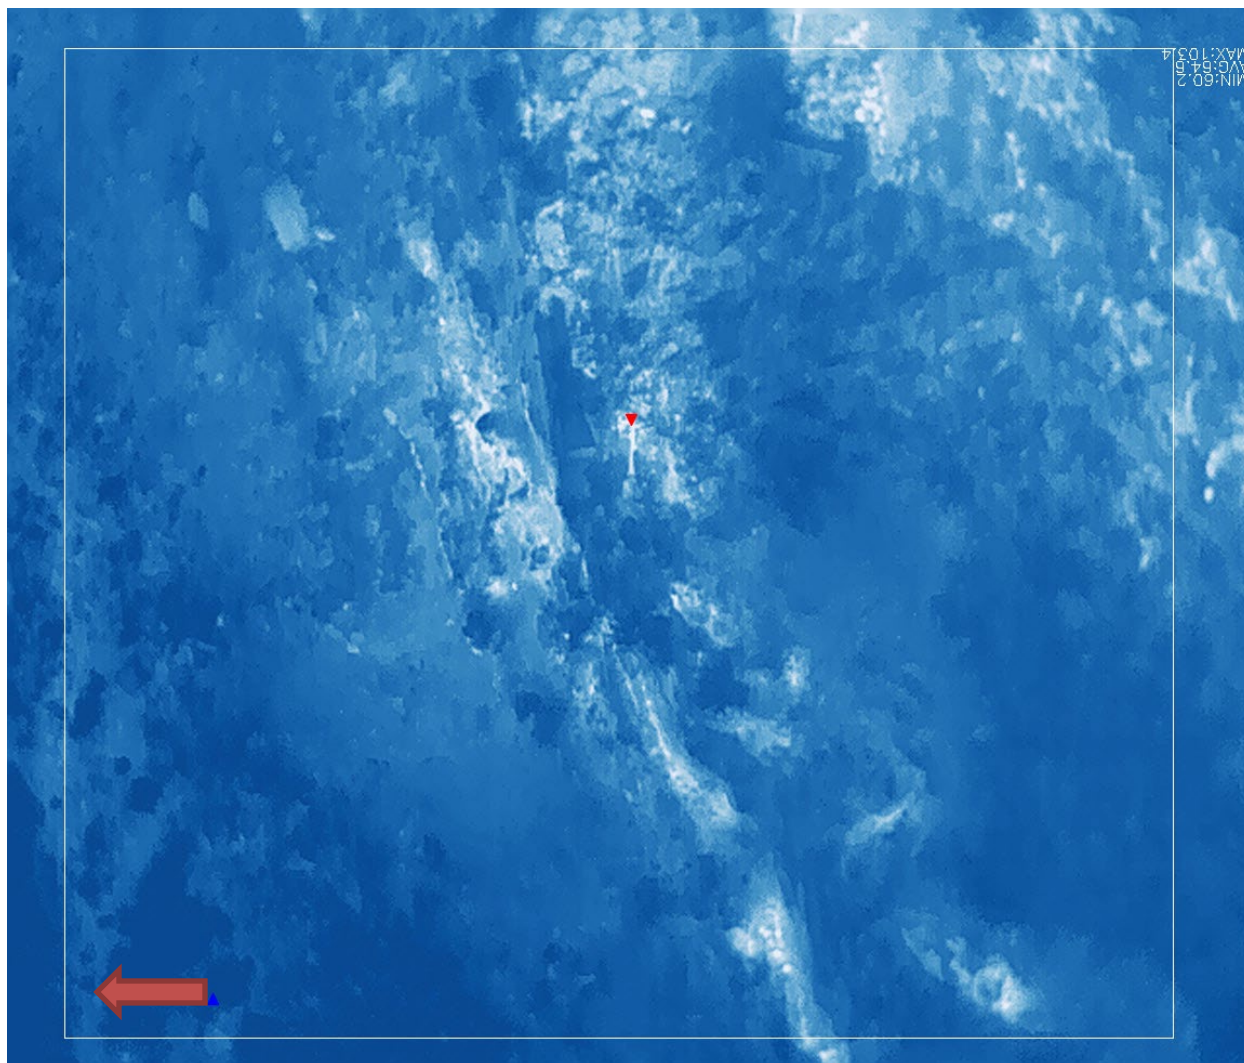
Figure 23: For comparison, IRX\_0384.jpg from September 2022. The image covers a slightly smaller area than Figure 20, but shows the same vent features. The highest observed temperature was 103.4 F, and was in a similar location.
