Western Sugar inspection report

MINERALS PROGRAM INSPECTION REPORT
PHONE: (303) 866-3567

MINE NAME: Western Sugar Reclamation Land Developme	MINE/PROSPECTING ID#: M-2010-049	MINERAL: Gravel and sand	COUNTY: Weld
INSPECTION TYPE: Monitoring	WEATHER: Clear	INSP. DATE: May 16, 2023	INSP. TIME: 10:15
OPERATOR: Varra Companies, Inc.	OPERATOR REPRESENTATIVE: Garrett Varra, Brad Janes	TYPE OF OPERATION: 112c - Construction Regular Operation	
REASON FOR INSPECTION: Normal I&E Program	BOND CALCULATION TYPE: None	BOND AMOUNT: \$309,000.00	
DATE OF COMPLAINT: NA	POST INSP. CONTACTS: None	JOINT INSP. AGENCY: None	
INSPECTOR(S): Robert Zuber, P.E. Michael Cunningham	INSPECTOR'S SIGNATURE:

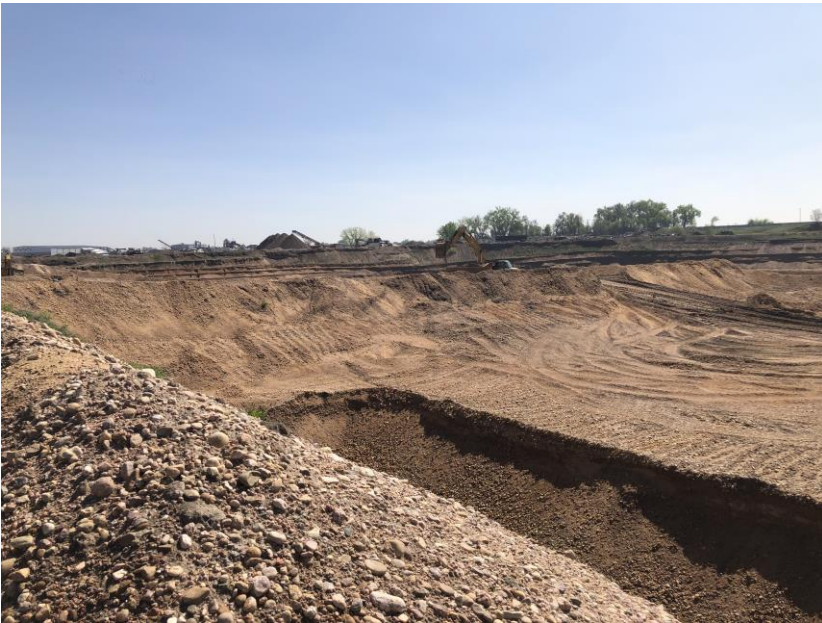
An active processing plant and product stockpiles were observed in the northeastern portion of the tract. The concrete batch plant remains in the southwest corner of the tract. An active mining pit, approximately 20 feet deep, encompasses a large portion of the tract and extends to the west side, almost to Tract B.

Tract A, extraction on west side

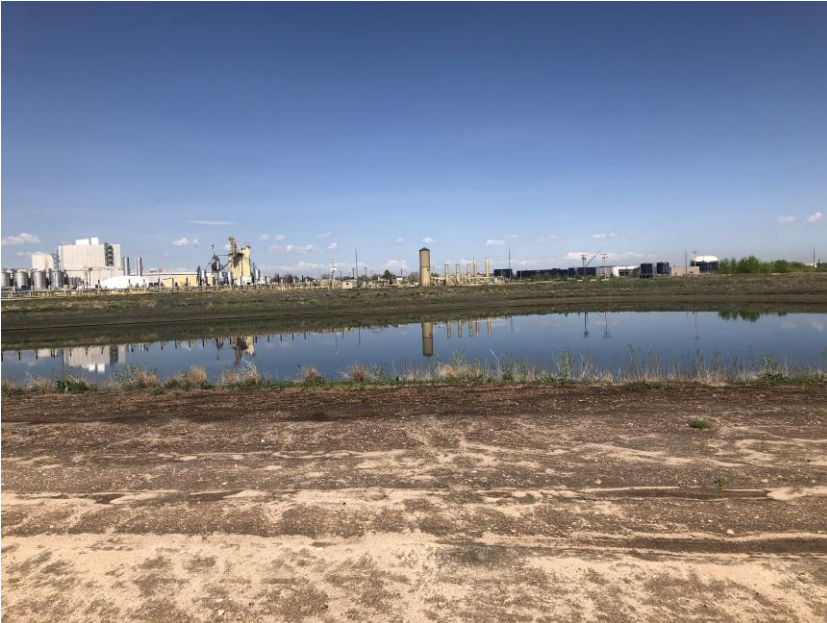
Mining excavation in Tract B is complete. Mr. Varra stated that the clay liner for the tract has been constructed and leak tested. (The Division has received the documentation of the leak test by the Division of Water Resources.) The reclaimed slopes appear to be 4H:1V or flatter and appeared stable. No erosion features were observed. The tract was partially filled with water, approximately 10 – 15 feet below the top of the reservoir slope. The slopes have not been topsoiled or seeded. Volunteer vegetation on the slopes is sparse.

Tract B, looking west

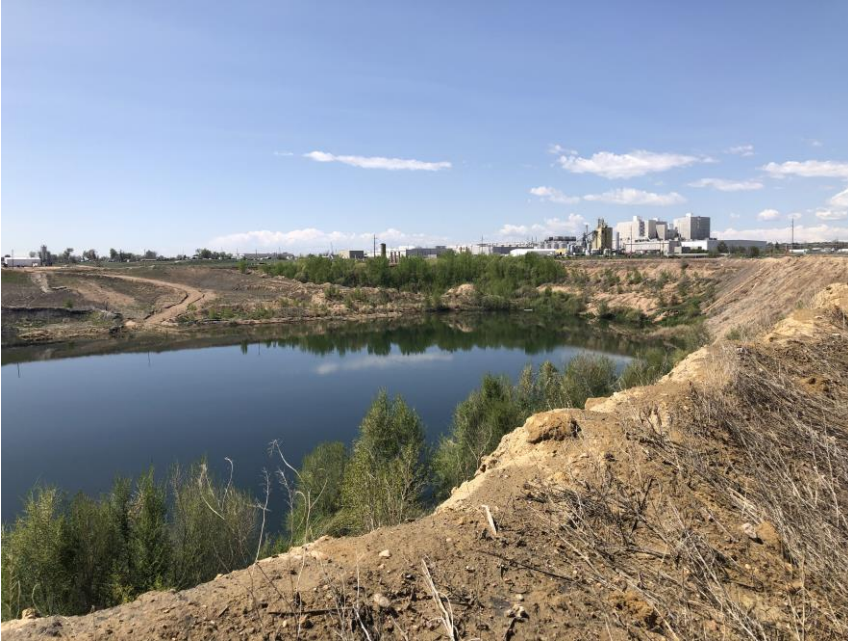
Mining excavation in Tract C is complete. Mr. Varra indicated that it is not certain if this tract will be filled or will become a reservoir. The slopes of the pit in this tract have not been graded and are very steep in some locations (much steeper than 3H:1V). The pit contained significant water, but it was at least ten feet from the top of bank.

Tract C, looking southwest

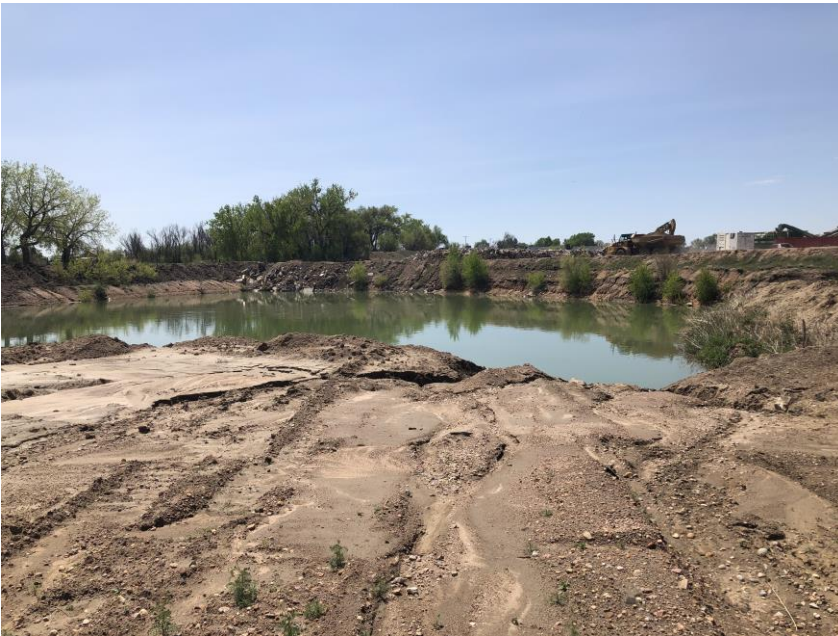
Mining excavation in Tract D is complete. Much of the tract has been backfilled with imported material. Varra Companies has submitted an inert fill notice in accordance with Rule 3.1.5(9) as part of the original permit application and also with the amendment approved in 2016 (AM-01). A small pit remains, and it contained exposed groundwater, approximately 15 feet below the top of the slope, at the time of the inspection.

Tract D

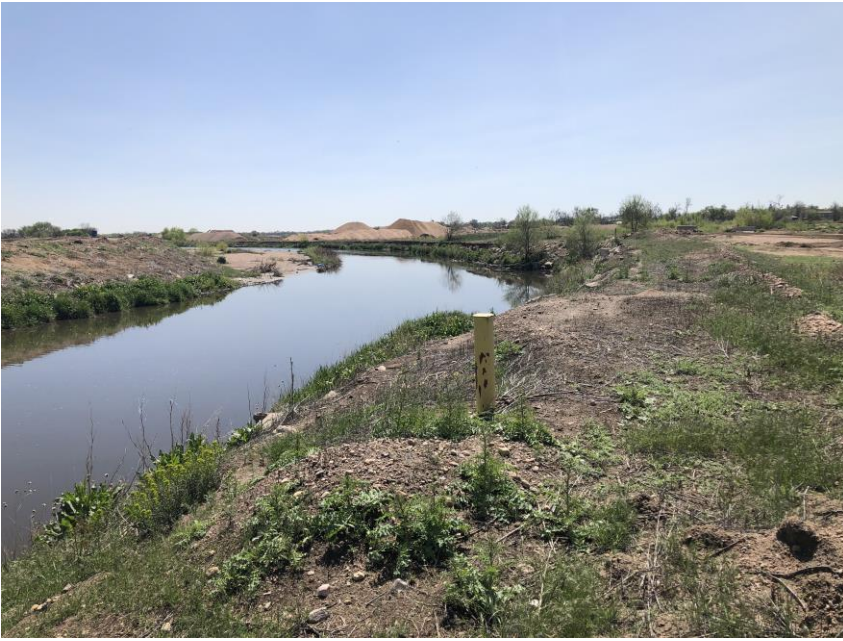
The banks of the Cache la Poudre River at the north end of the site are stable. The general site operation and layout was consistent with the approved permit. The permit boundaries are evident at the site. The entrance sign was not observed, as the site was accessed through another site, but in the previous Division inspection it was observed. Garrett Varra indicated that the sign remains in place.

Cache la Poudre River adjacent to Tract D

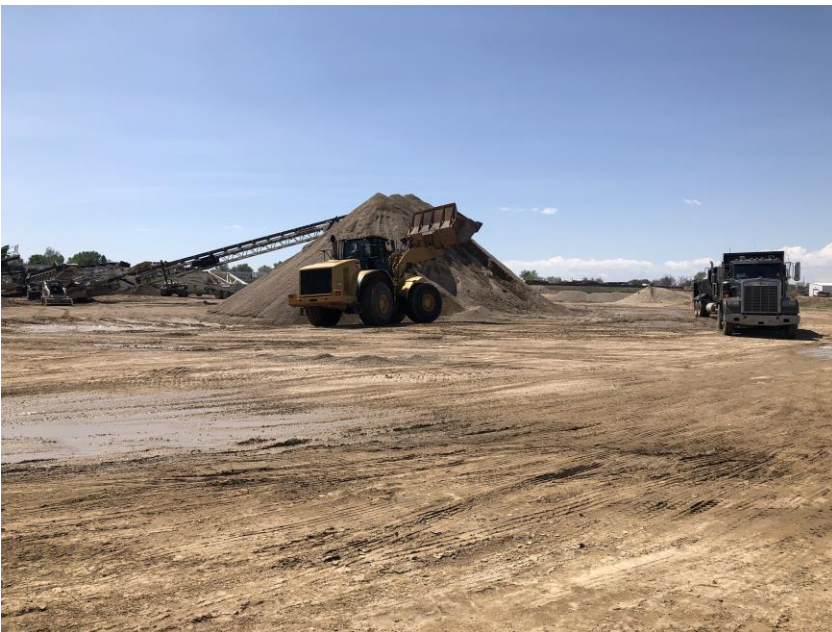
Tract A, processing on east side
