June 19, 2023  
Project No.: 19125

Holcim  
1687 Cole Boulevard, Suite 300  
Golden, CO 80401

Regarding: Daniels Sand Pit 2, Permit No. M-1973-007-SG  
Slope Stability Monthly Monitoring Report

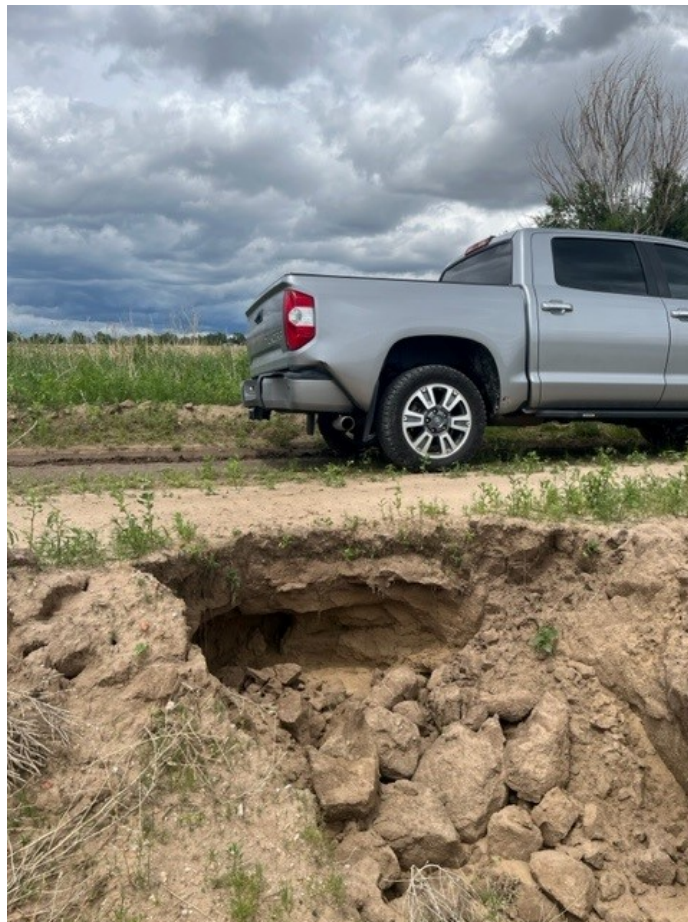
- 1) At four locations erosion gullies have developed on the berm top road and very near if not into the Fountain Ditch berm separating the Ditch from the Daniels Sand Pit. We recommend that berm be cared for and restored prior to Fountain Ditch's next flowing event. Site photographs are presented below.

Photo 1. Berm Road Undermined due to Slope's Erosion Gully

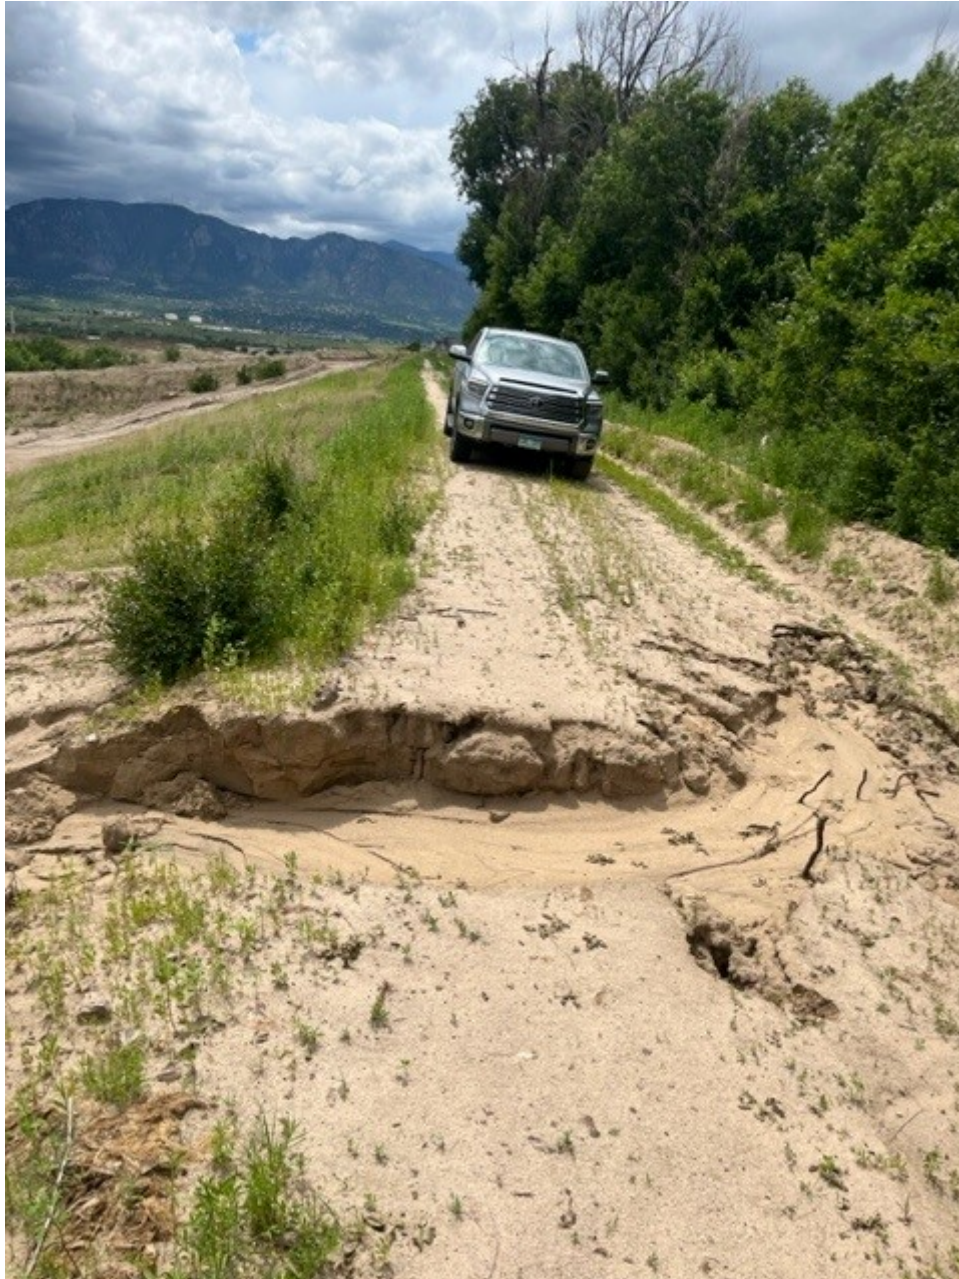
- 3) Weather: 60-70°, cloudy, winds 5 - 10 mph, heavy rain in previous days
- 4) Visual observation of the Fountain Mutual Ditch and ditch road:
  - a) Erosion gullies have formed across the ditch road. At one location the gully's depth and width has made the ditch road impassible for a stock 4x4 truck

Photo 2. Erosion Gully Traversing the Ditch Road.

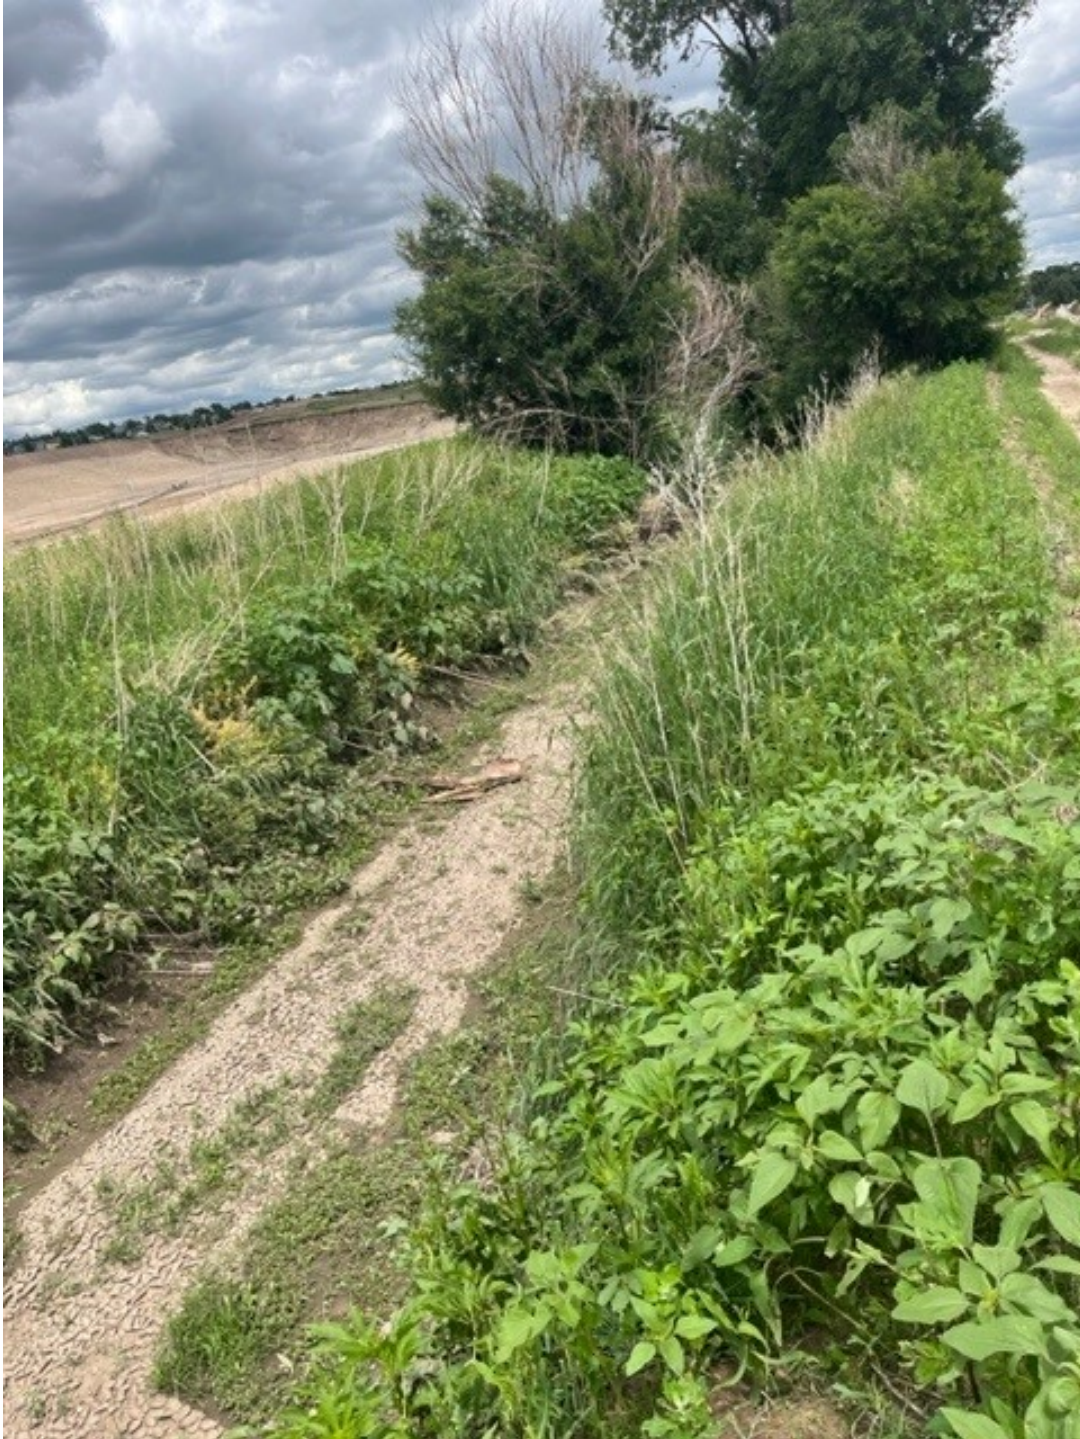
Photo 3. A Dry Fountain Mutual Ditch being separated from the ditch road on right by a berm.

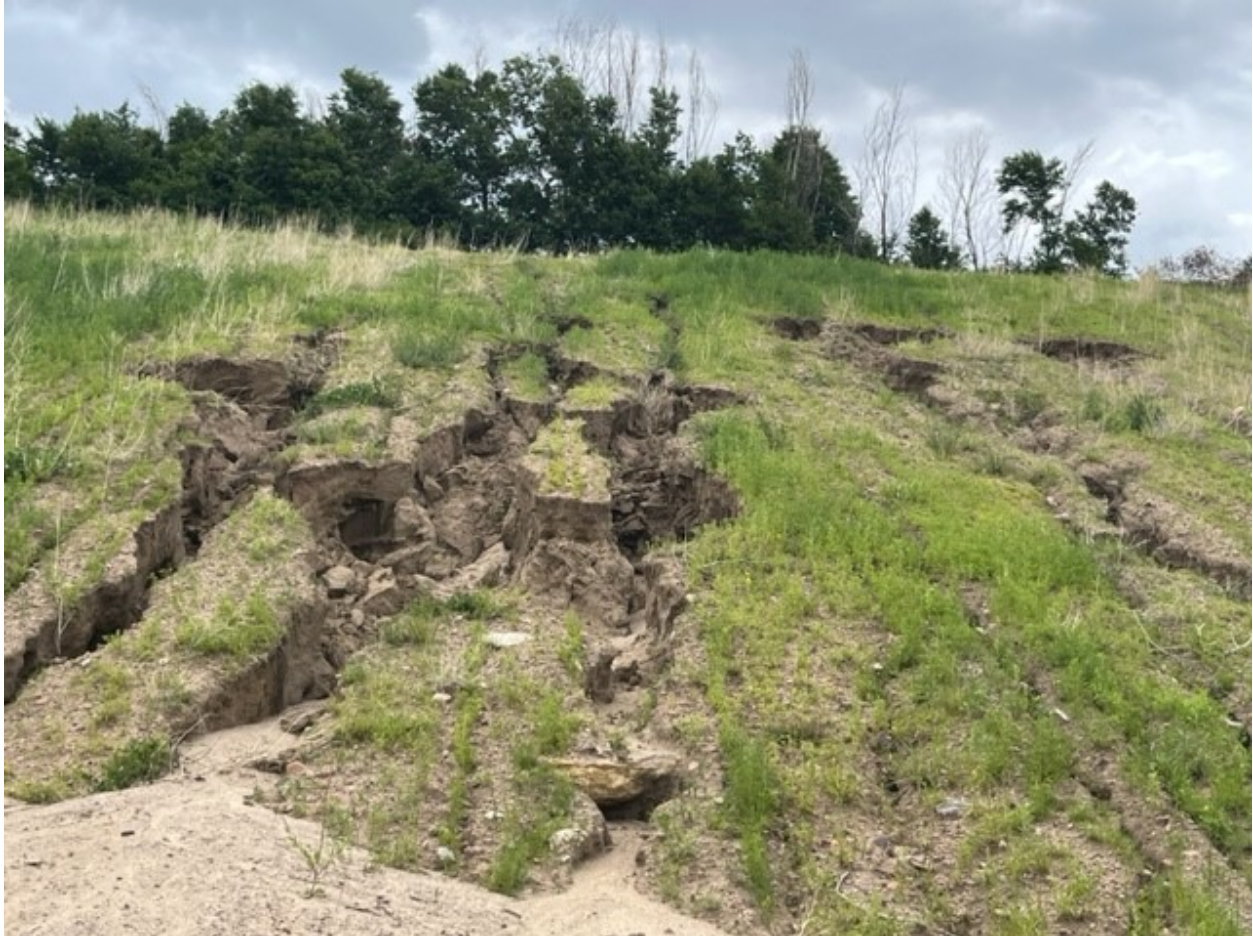
- 2) At several locations, erosion gullies have expanded in all three directions (longer up and down the slope, wider across the slope and deepening into the slope). We recommend those areas be reconstructed ASAP and that the areas be seeded per the reclamation plan. Photographs 4 & 5 below visually capture the expanded gullies over the last month.

Photo 4. Erosion gullies in central area of buttress in June

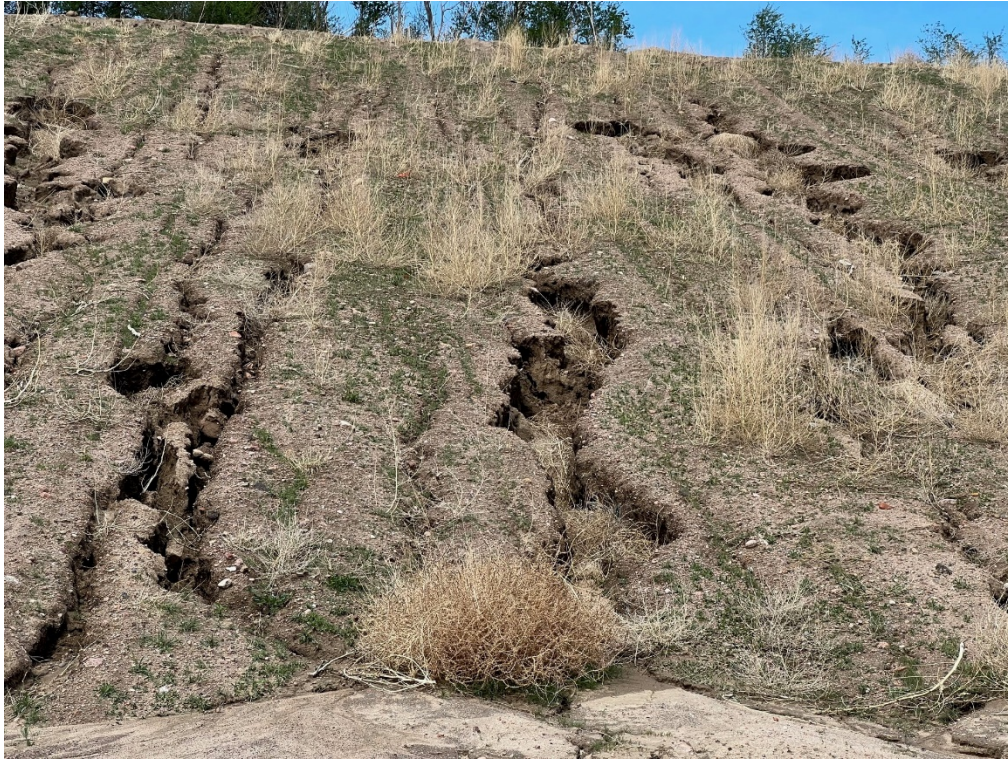
Photo 5. Erosion gullies in central area of buttress in May
