**MINERALS PROGRAM INSPECTION REPORT**  
**PHONE: (303) 866-3567**

<b>MINE NAME:</b> Russell Ranch Pit	<b>MINE/PROSPECTING ID#:</b> M-2006-008	<b>MINERAL:</b> Sand and gravel	<b>COUNTY:</b> Rio Blanco
<b>INSPECTION TYPE:</b> Monitoring	<b>WEATHER:</b> Cloudy	<b>INSP. DATE:</b> June 7, 2023	<b>INSP. TIME:</b> 10:30
<b>OPERATOR:</b> Russell Ranch General Partnership dba WR Aggregates	<b>OPERATOR REPRESENTATIVE:</b> Steve Baker	<b>TYPE OF OPERATION:</b> 110c - Construction Limited Impact	
<b>REASON FOR INSPECTION:</b> Normal I&E Program	<b>BOND CALCULATION TYPE:</b> Complete Bond	<b>BOND AMOUNT:</b> \$47,400.00	
<b>DATE OF COMPLAINT:</b> NA	<b>POST INSP. CONTACTS:</b> None	<b>JOINT INSP. AGENCY:</b> None	
<b>INSPECTOR(S):</b> Amy Yeldell Todd Jesse	<b>INSPECTOR'S SIGNATURE:</b>

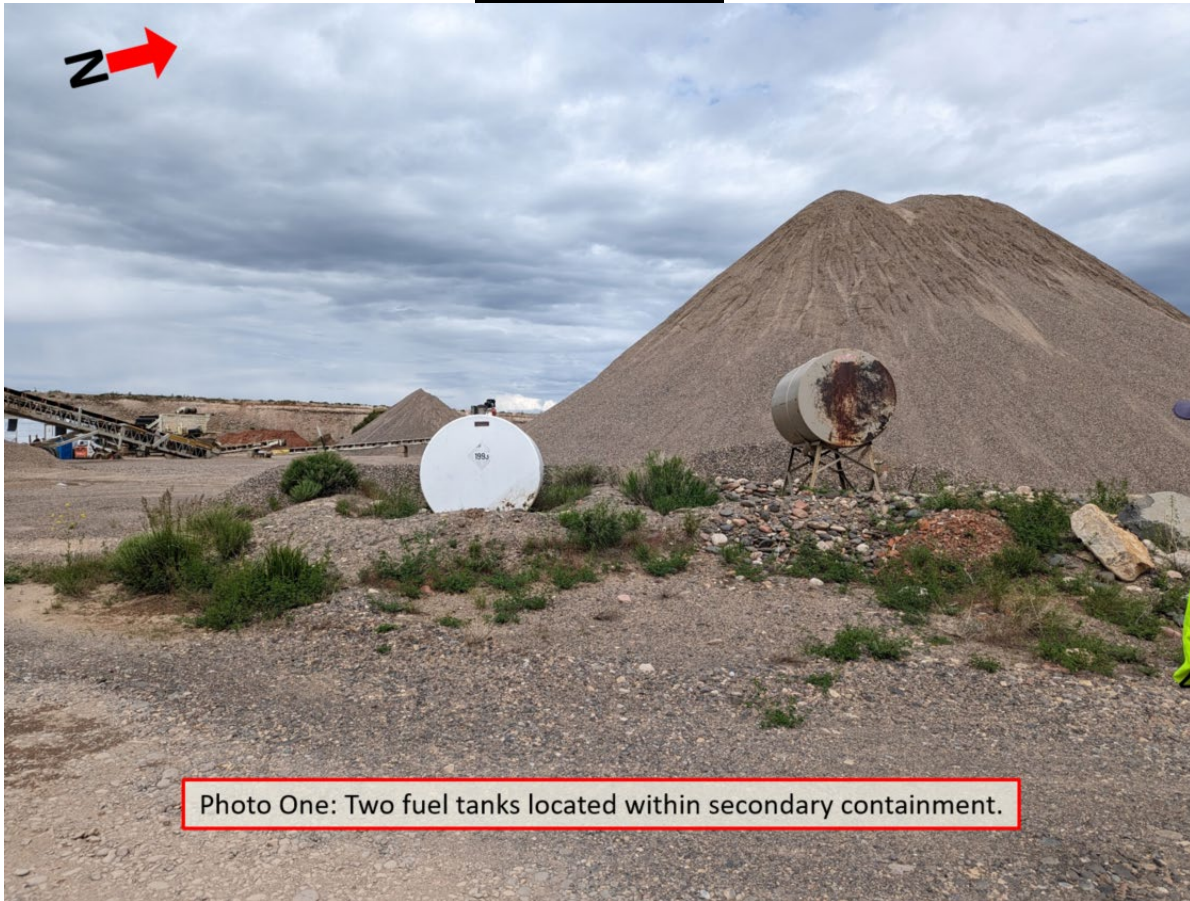
Two fuel tanks are stored near the scale. A clay lined earthen berm provides secondary containment (Photo One). No other hazardous or toxic materials were observed on site.

Photo One: Two fuel tanks located within secondary containment.

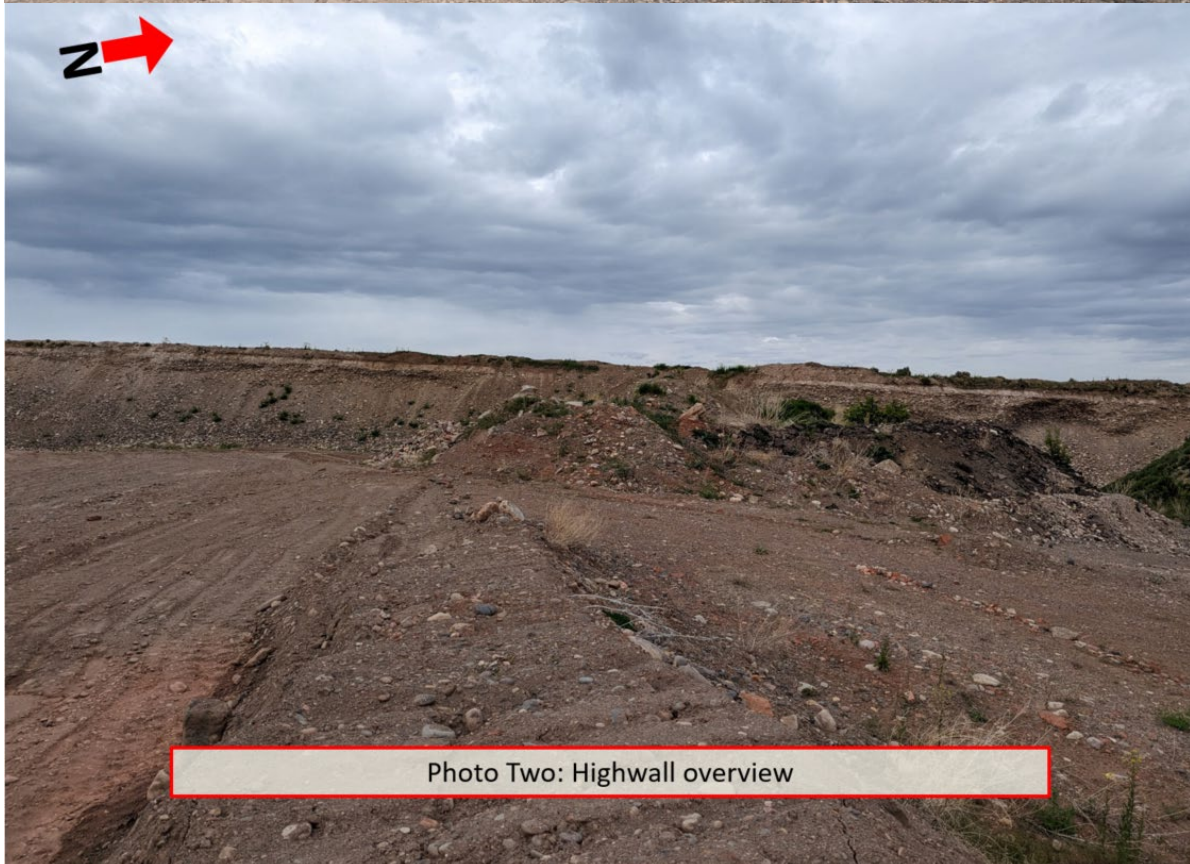
The pit is mined to an average depth of 25 feet with slopes at a 1.5H: 1V. The pit is mostly mined out, as slopes cannot be backfilled given the lack of overburden sourced from this site. Backfill material is not imported. The North and east highwalls currently are approximately 40 feet off of the permit boundary. The west side highwall abuts to the Strout-Amick Pit (M-1981-275) and the majority of the south highwall has been graded to a 5H: 1V and daylighted out to the access road below. This graded area is approximately 100 yds. long by 100 feet deep (Photos Two and Three).

Photo Two: Highwall overview

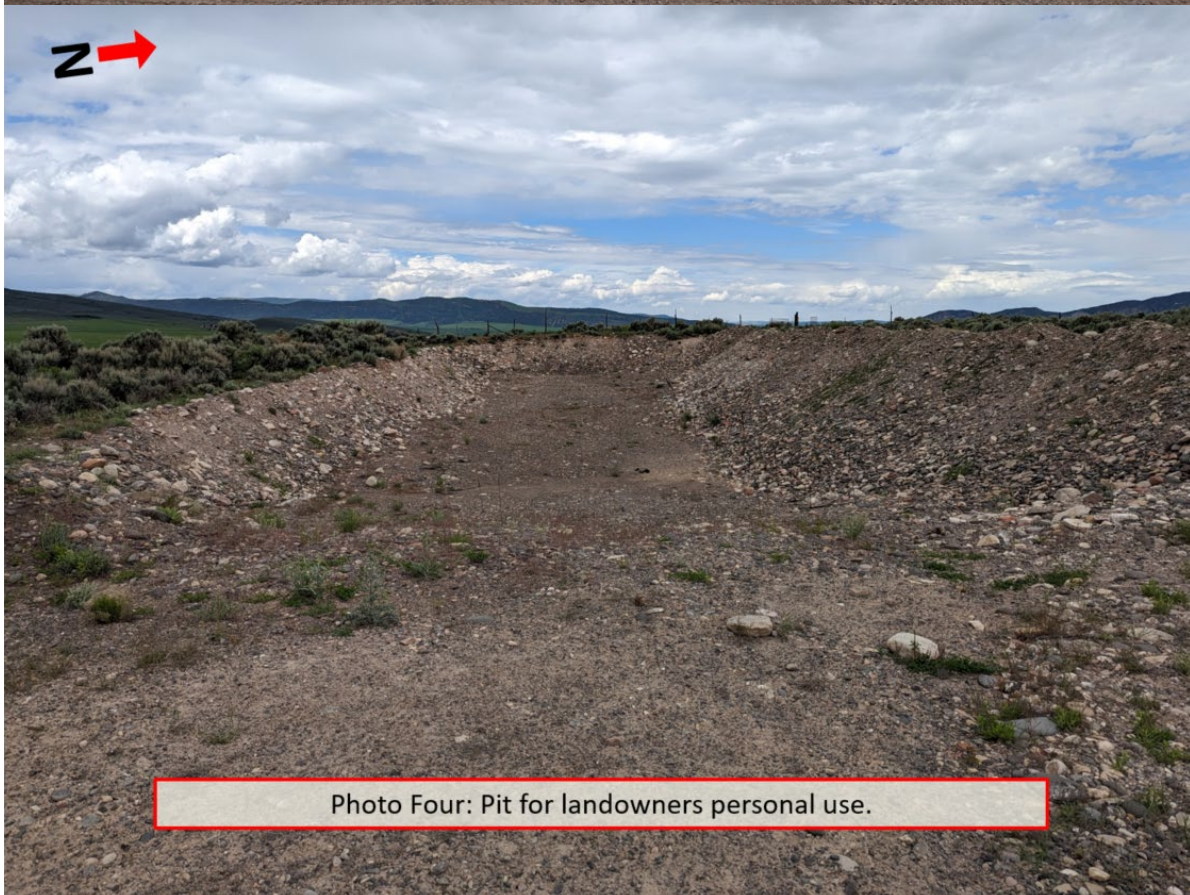
There is a small excavation southwest of the permit boundary. That is a pit used only by the landowner on the property (Photo Four).

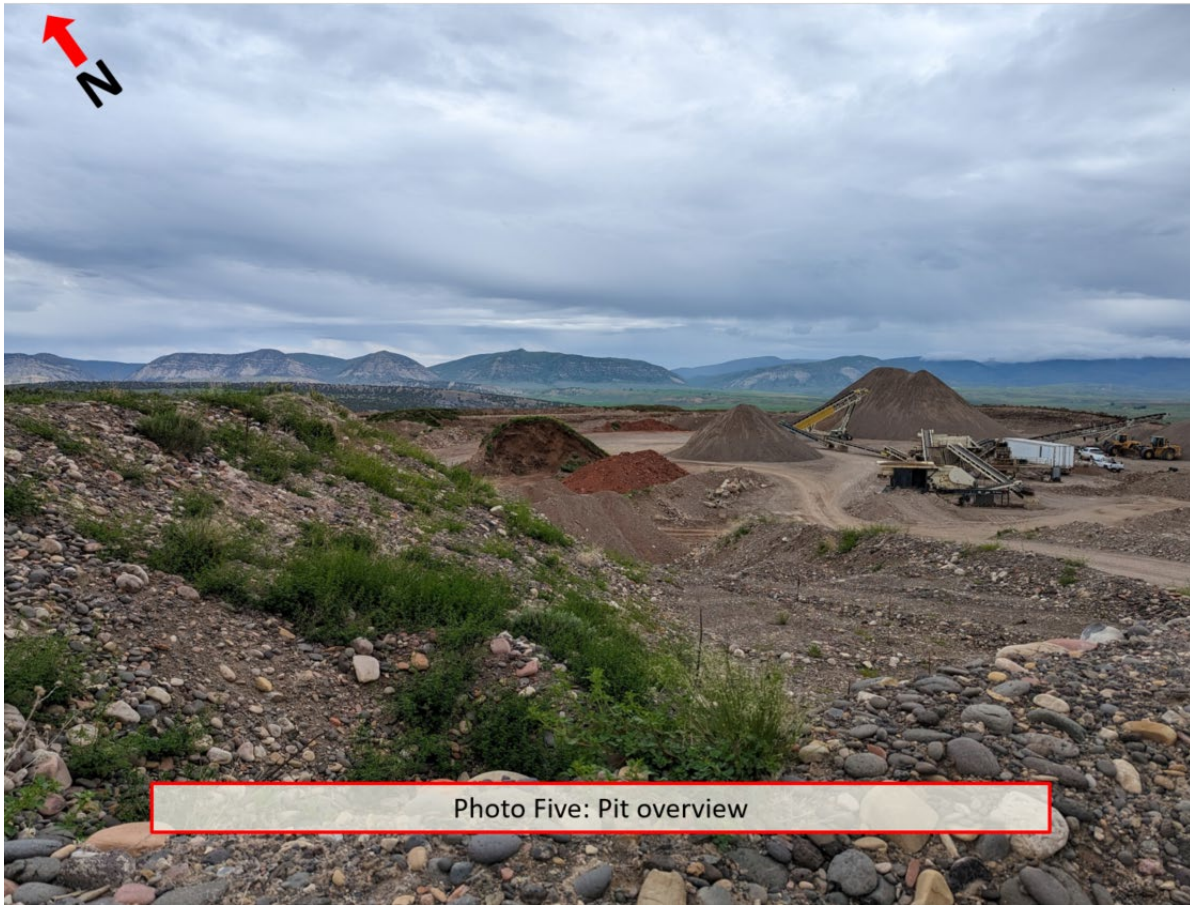
A crusher is located in the center of the pit. It was down for repairs at the time of the inspection (Photo Five). No washing, cement or asphalt production occurs at this site.

Photo Five: Pit overview

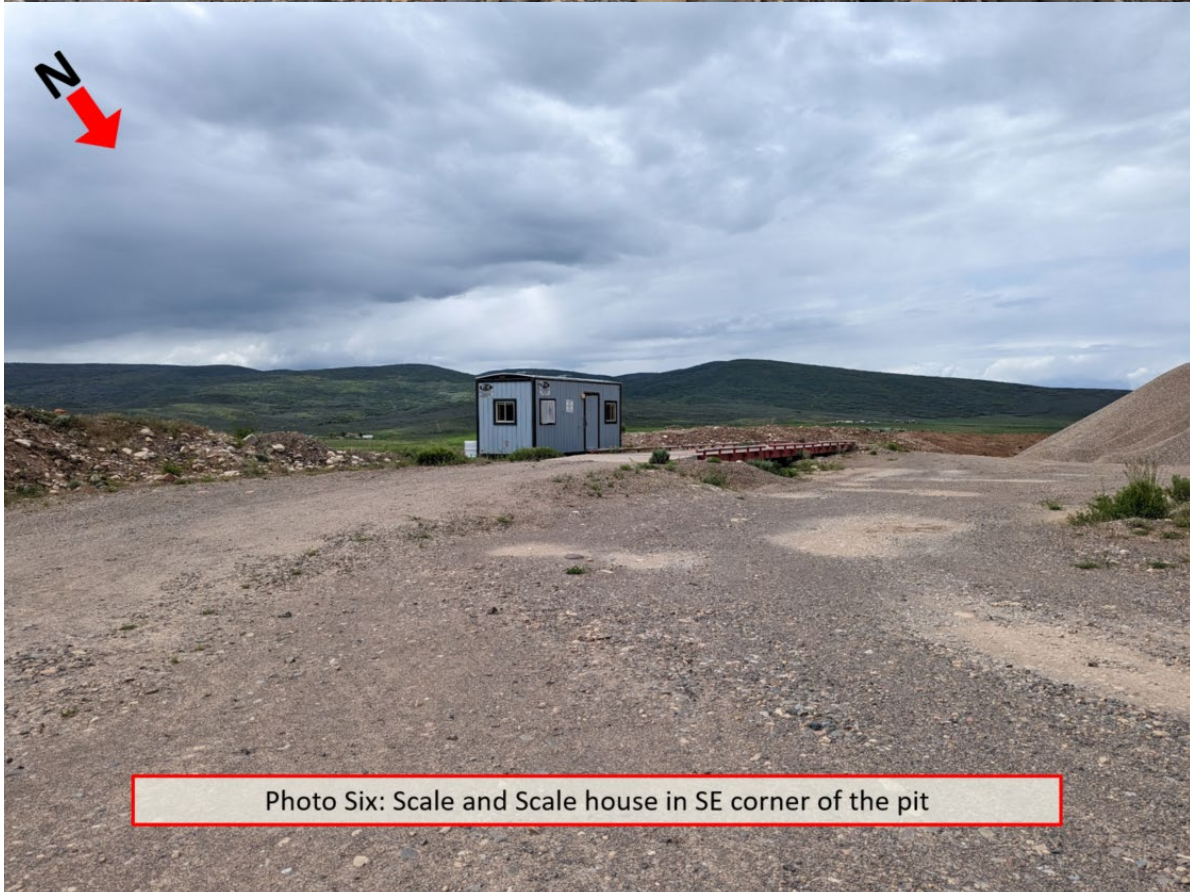
Scale and scale house are located on the southeast side of the pit (Photo Six).

Photo Six: Scale and Scale house in SE corner of the pit

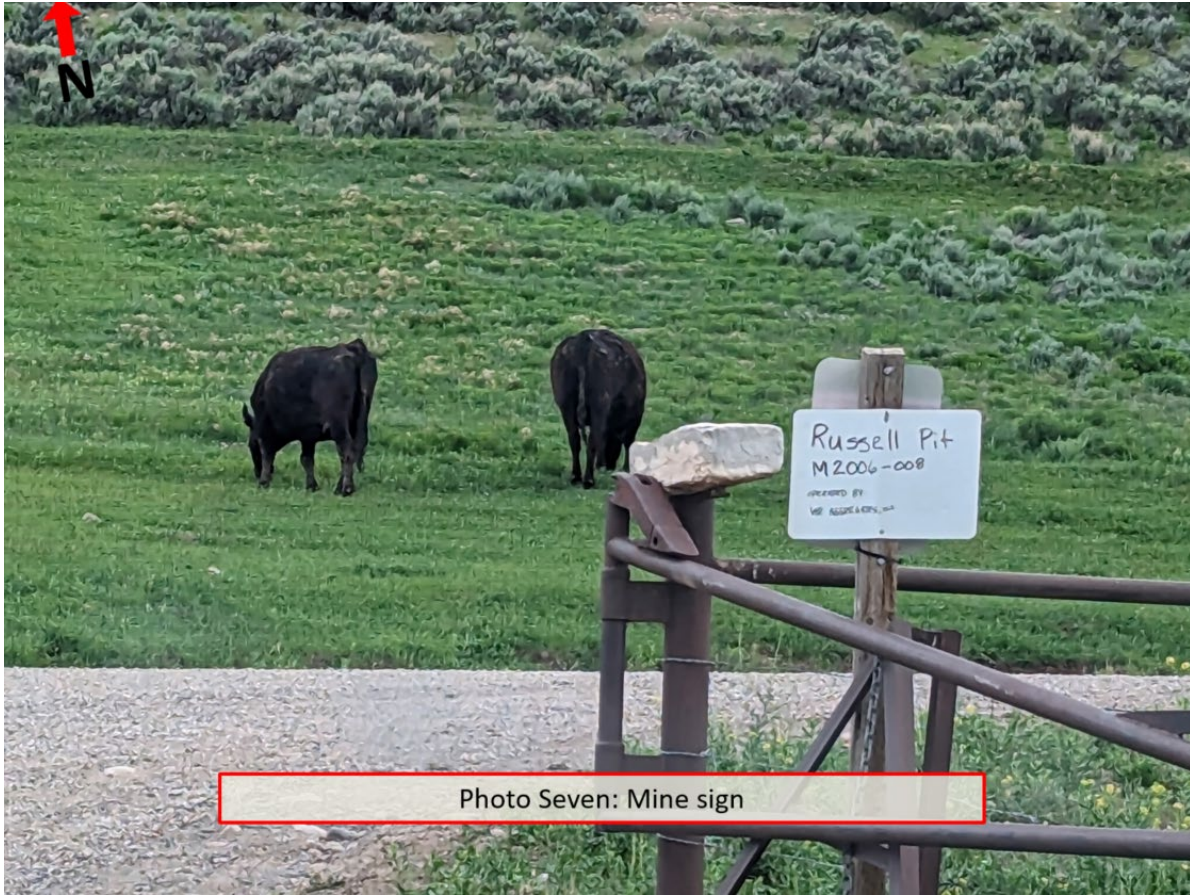
A mine sign was posted at the entrance to the mine site as required by Rule 3.1.12(1). The information depicted was slightly smudged and should be repaired/replaced. (Photo Seven).
