MINERALS PROGRAM INSPECTION REPORT
PHONE: (303) 866-3567

MINE NAME: Stout - Amick Pit	MINE/PROSPECTING ID#: M-1981-275	MINERAL: Sand and gravel	COUNTY: Rio Blanco
INSPECTION TYPE: Monitoring	WEATHER: Cloudy	INSP. DATE: June 7, 2023	INSP. TIME: 11:45
OPERATOR: Diana K. Watson	OPERATOR REPRESENTATIVE: Jim Watson	TYPE OF OPERATION: 112c - Construction Regular Operation	
REASON FOR INSPECTION: Normal I&E Program	BOND CALCULATION TYPE: None	BOND AMOUNT: \$68,521.00	
DATE OF COMPLAINT: NA	POST INSP. CONTACTS: None	JOINT INSP. AGENCY: None	
INSPECTOR(S): Amy Yeldell Todd Jesse	INSPECTOR'S SIGNATURE:

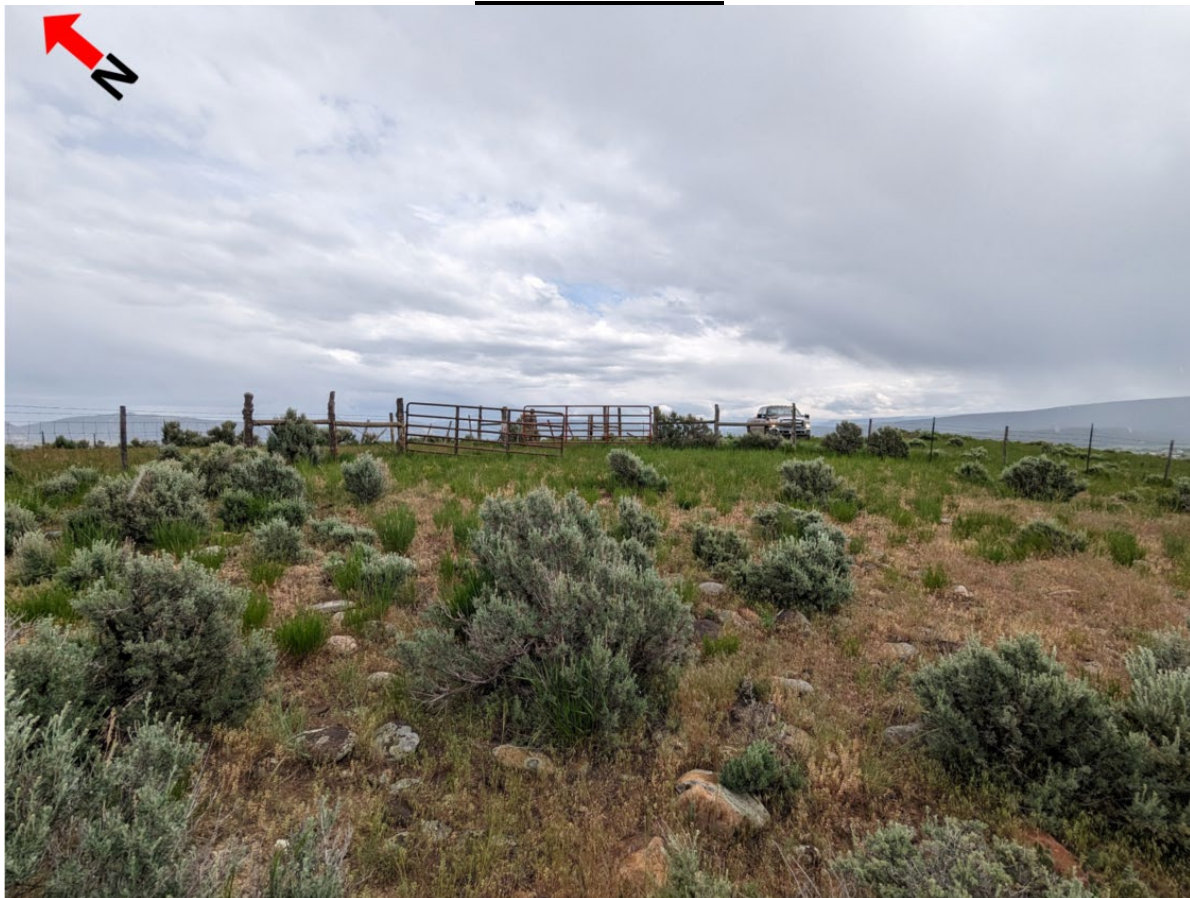
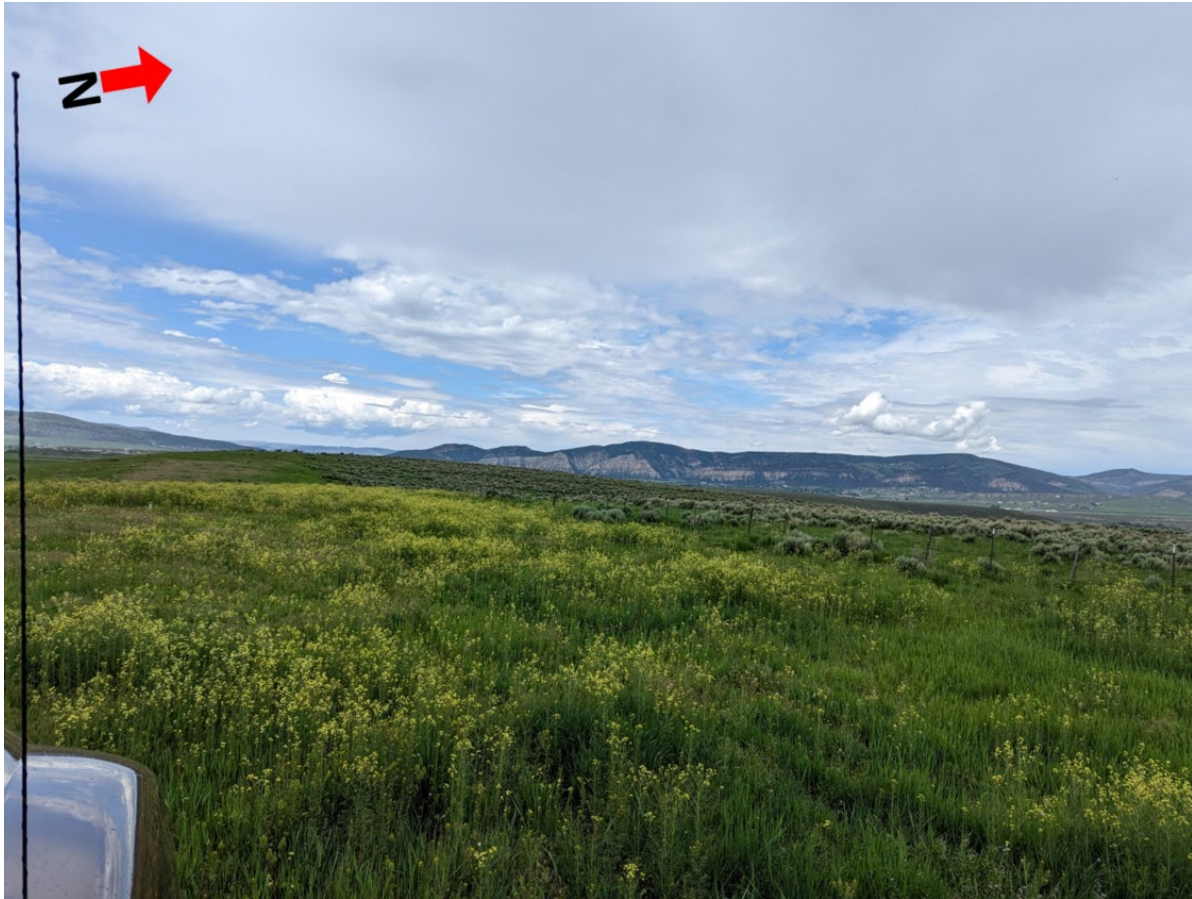
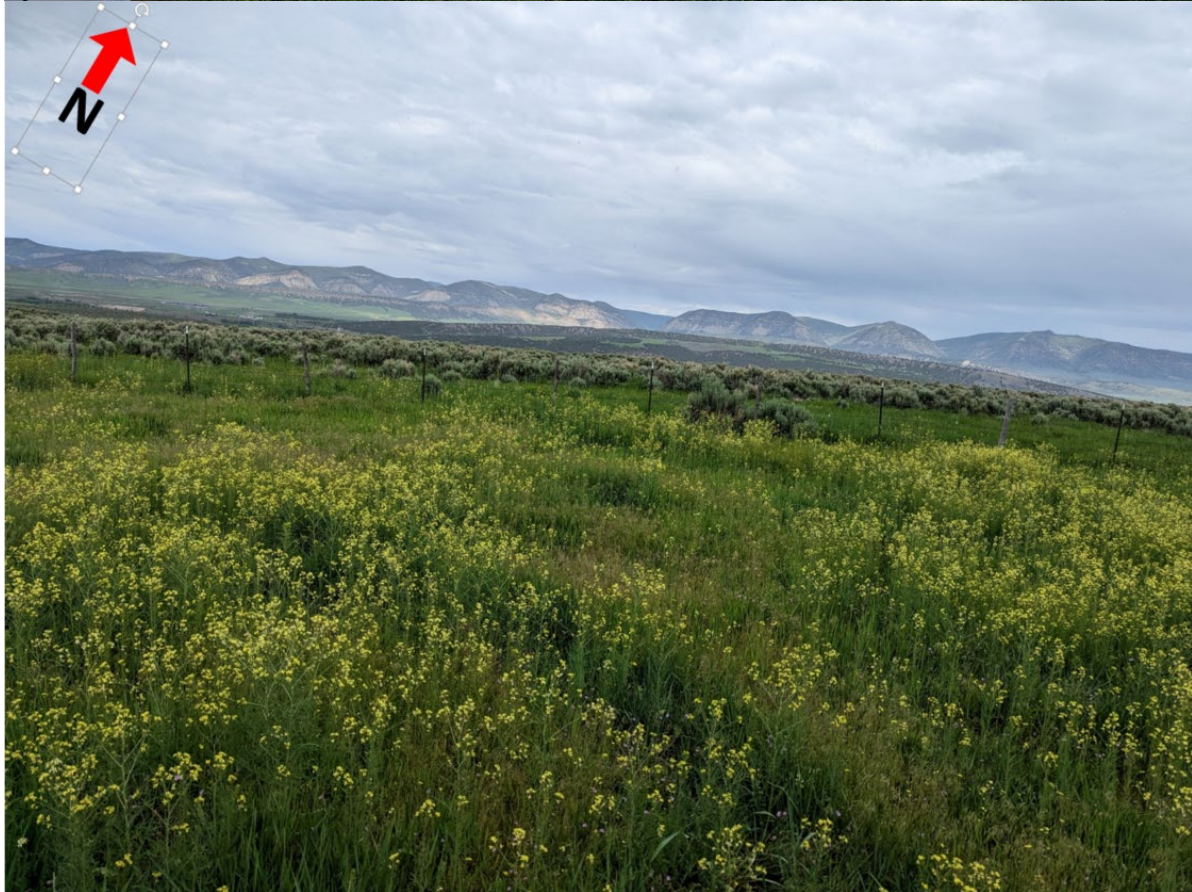
Mining at this site has not yet commenced. (Photos One-Three)

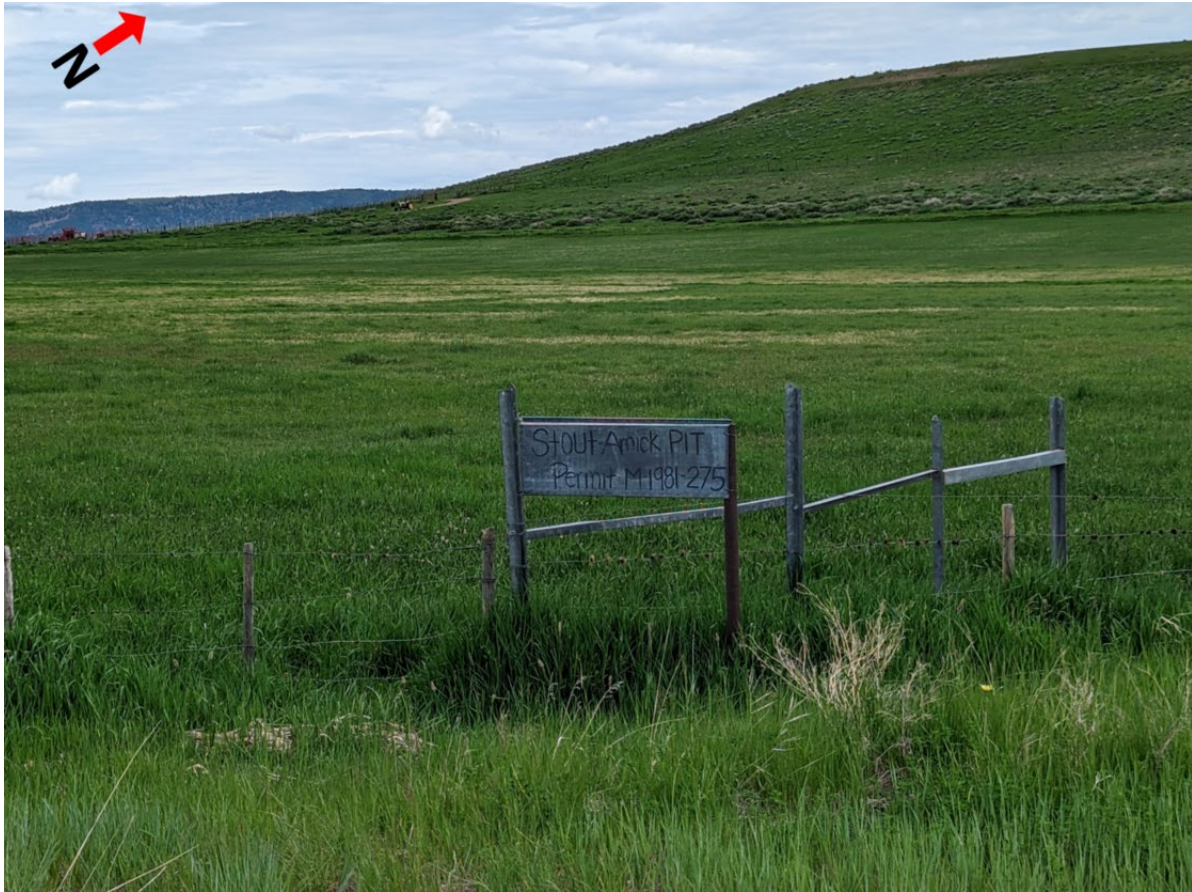
A mine sign was posted at the entrance to the mine site as required by Rule 3.1.12(1). The sign was of sufficient size (Photo Four).
