MINERALS PROGRAM INSPECTION REPORT

MINE NAME: The Shores	MINE/PROSPECTING ID#: M-1998-013	MINERAL: Sand and gravel	COUNTY: Weld
INSPECTION TYPE: Surety-Related Inspection	WEATHER: clear	INSP. DATE: June 15, 2023	INSP. TIME: 11:30
OPERATOR: Bestway Concrete Company	OPERATOR REPRESENTATIVE: Chris Oestreich	TYPE OF OPERATION: 112c - Construction Regular Operation

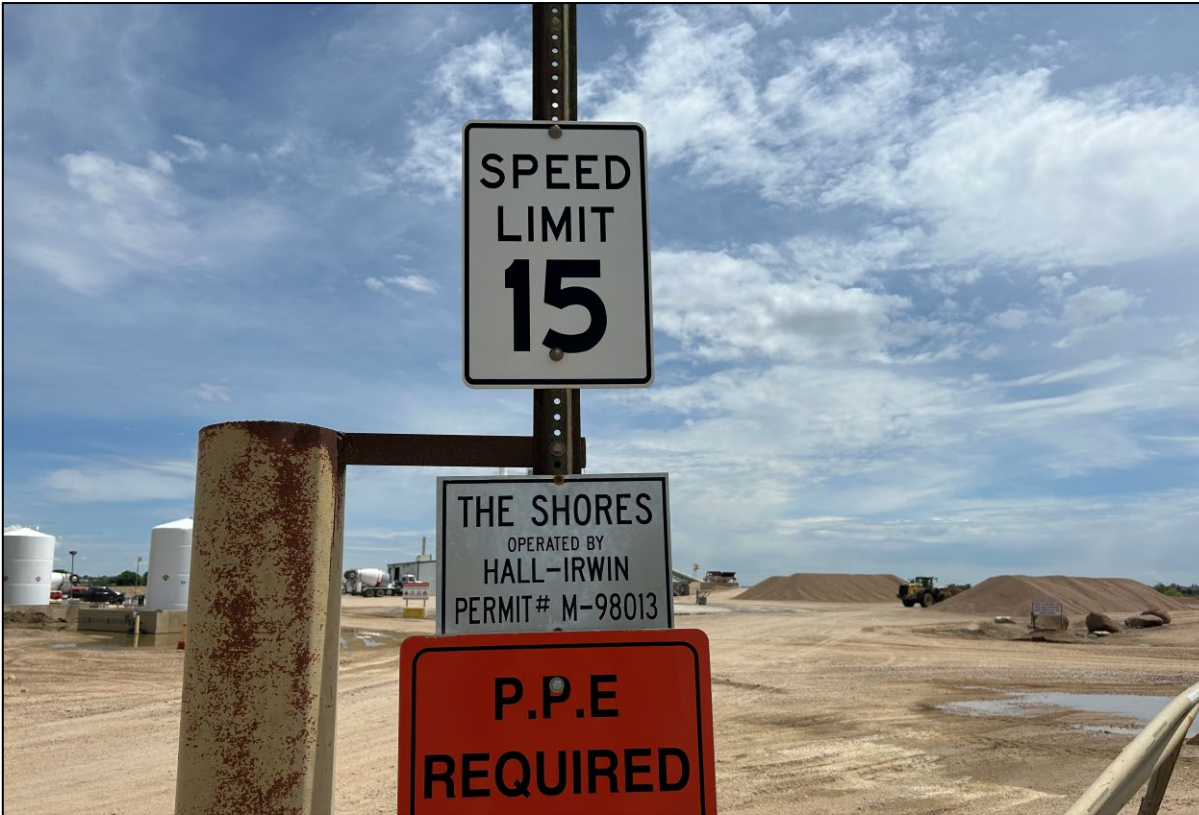
PROBLEM/POSSIBLE VIOLATION: Problem: The mine identification sign posted at the entrance of the mine site contains the wrong DRMS permit ID (see attached photo). This is a problem for failure to post a mine identification sign as required by Section 3.1.12(1) of the rule.

DRMS arrived on site at approximately 11:30 am, and noted that the permit number was incorrect on the site identification sign present at the site entrance. This has been noted as a problem and will need to be corrected by the corrective action date given above (7/31/23). DRMS also noted the continued presence of tamarisk and other noxious species with the permit that will need to be eradicated prior to release of the site.

Photo 1 – Sign with incorrect information at site entrance – this identification sign should be removed.

CORRECTIVE ACTIONS: The Operator shall, at the entrance of the mine site post a sign, which shall be clearly visible from the access road, with a minimum size equaling one hundred and eighty-seven (187) square inches, such as eleven (11) inches in height and seventeen (17) inches in width, with appropriate font size, with the following: the name of the Operator, a statement that a reclamation permit for the operation has been issued

by the Colorado Mined Land Reclamation Board; and the permit number. The operator shall submit photo documentation that a proper sign has been posted by the corrective action date.

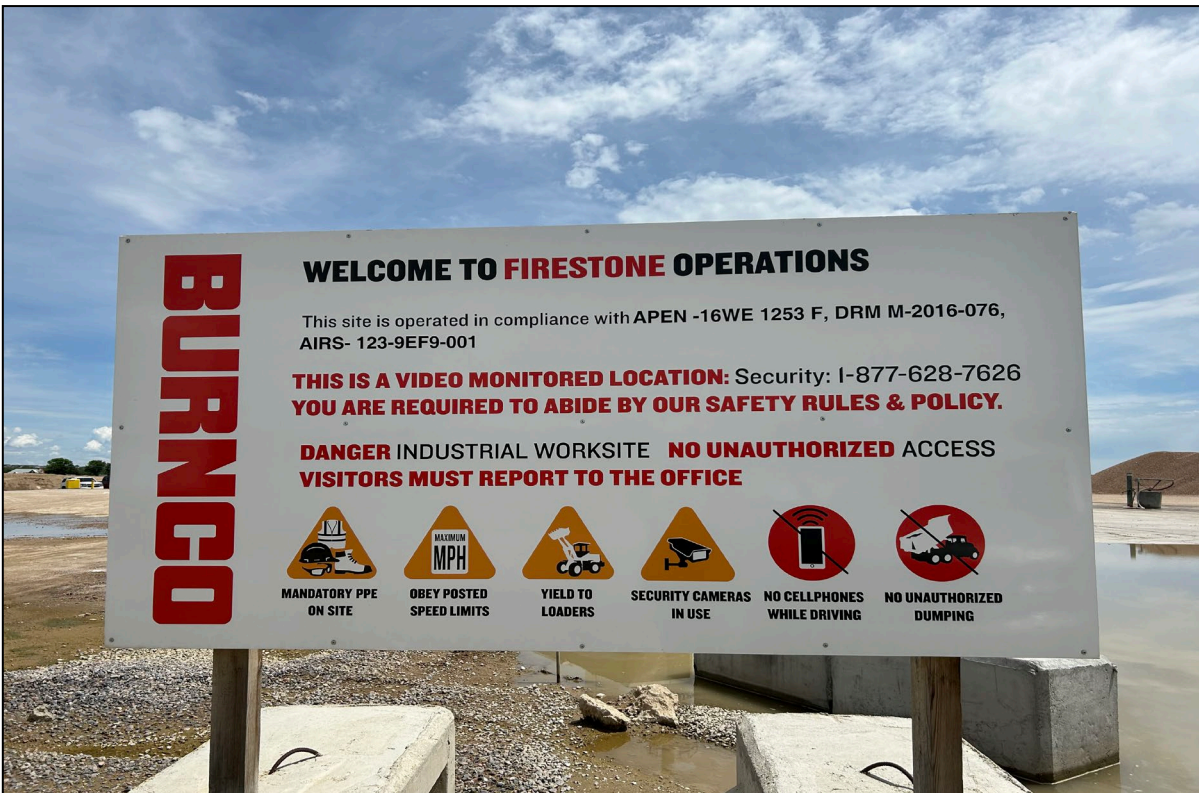
Photo 2 – Sign with incorrect information at site entrance – DRMS permit number needs to be corrected.

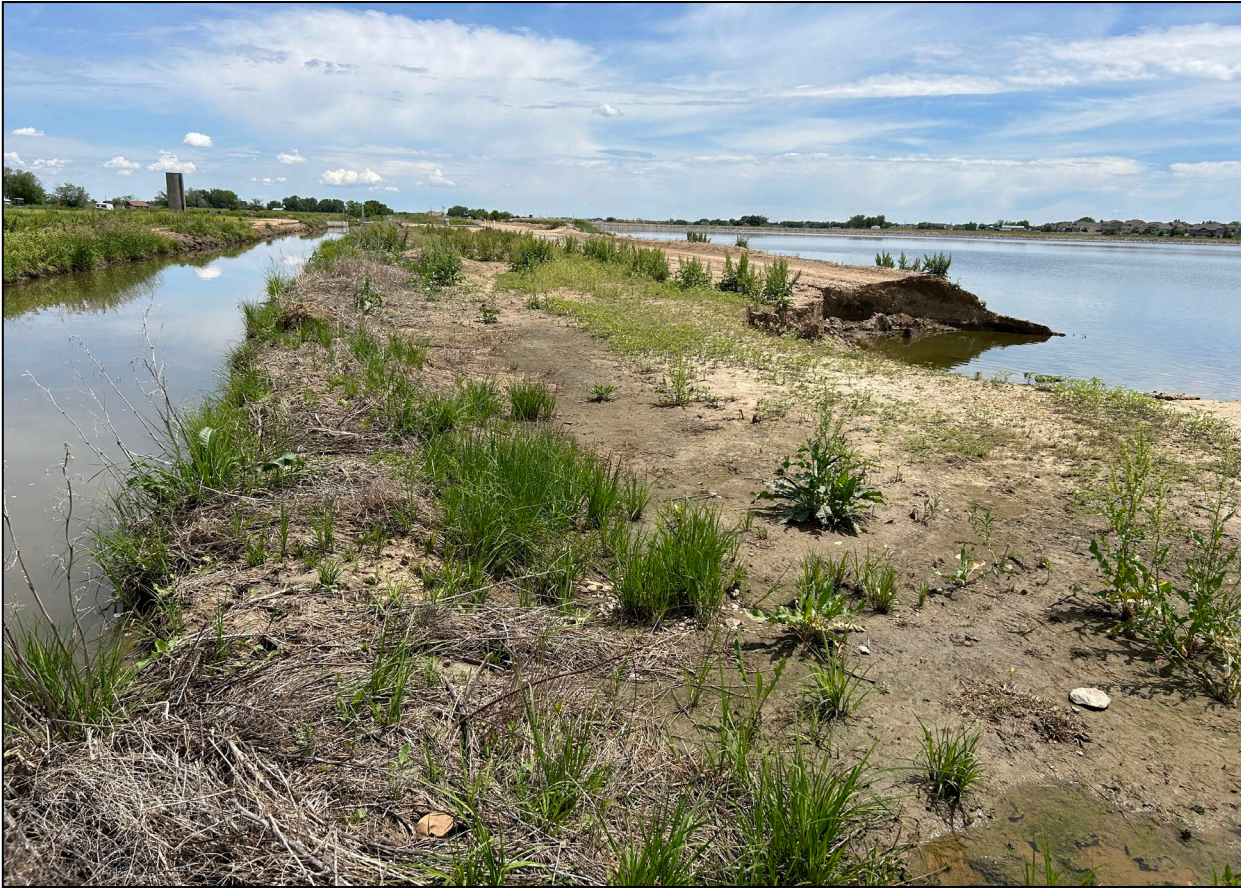
It was noted during the inspection that the extraordinary rainfall at the site earlier in the week has resulted in damage to the north side of pond C lined pit wall between the pit and the irrigation ditch. Overtopping of the ditch into pond C has resulted in damage to the pit wall as shown in the attached photos 3 and 4. This damage will need to be repaired as soon as possible as further erosion in this area will result in capture of the ditch into the pit. It is not known at this time if the approved slurry wall of this cell has been compromised.

Photo 3 – damage to north shore of Pond C due to overtopping of ditch into pond during recent heavy rains. This damage will need to be repaired as soon as possible so ditch is not captured by pit.

DRMS currently holds a \$3,439,500.00 reclamation bond for this site, which includes costs for installation of several of the existing and proposed slurry walls, therefore, no bond increase will be required for SO3 upon approval. However, DRMS expects that the existing damage to the pit slope noted will be carefully evaluated, and repaired, as soon as practically possible.

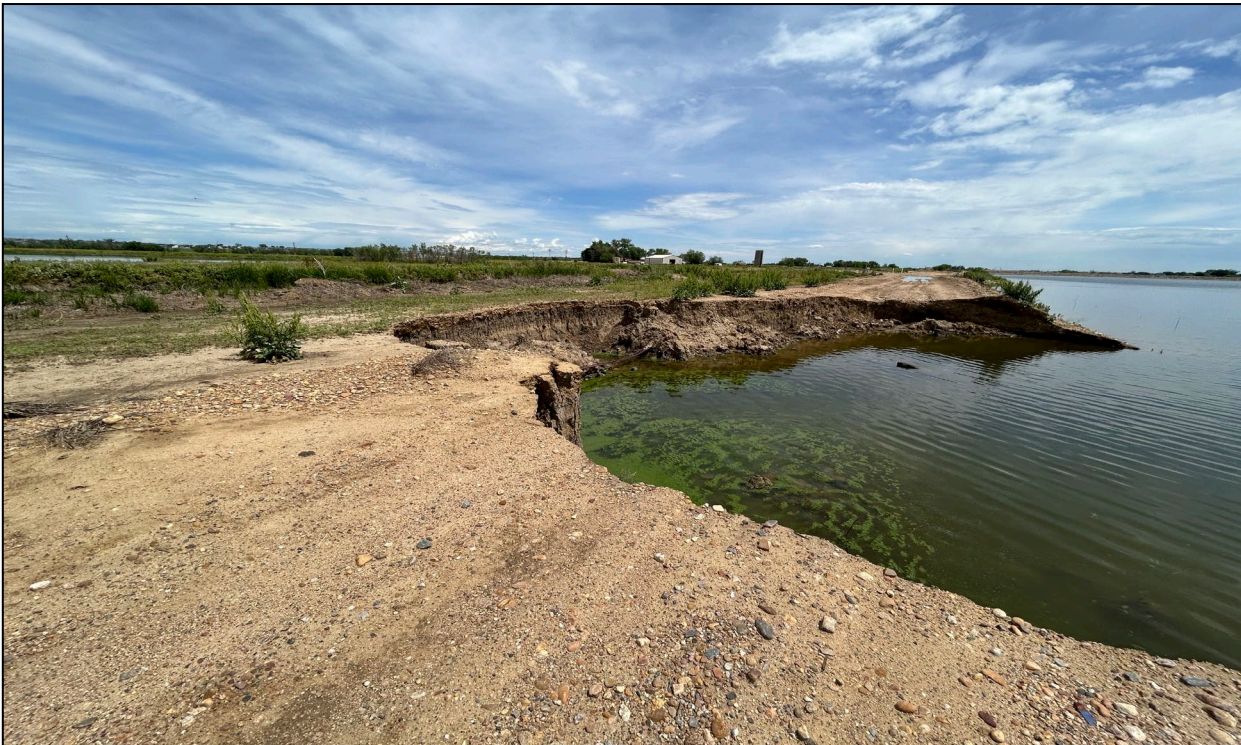
Photo 4 – damage to north shore of Pond C due to overtopping of ditch into pond during recent heavy rains. This damage will need to be repaired as soon as possible so ditch is not captured by pit.
