MINERALS PROGRAM INSPECTION REPORT
PHONE: (303) 866-3567

MINE NAME: Bernhardt Resource	MINE/PROSPECTING ID#: M-2002-120	MINERAL: Sand and gravel	COUNTY: Weld
INSPECTION TYPE: Surety-Related Inspection	WEATHER: Clear	INSP. DATE: June 15, 2023	INSP. TIME: 09:30
OPERATOR: BURNCO Colorado, LLC	OPERATOR REPRESENTATIVE: Daniel	TYPE OF OPERATION: 112c - Construction Regular Operation	
REASON FOR INSPECTION: Normal I&E Program	BOND CALCULATION TYPE: None	BOND AMOUNT: \$2,557,725.00	
DATE OF COMPLAINT: NA	POST INSP. CONTACTS: None	JOINT INSP. AGENCY: None	
INSPECTOR(S): Eric Scott	INSPECTOR'S SIGNATURE:

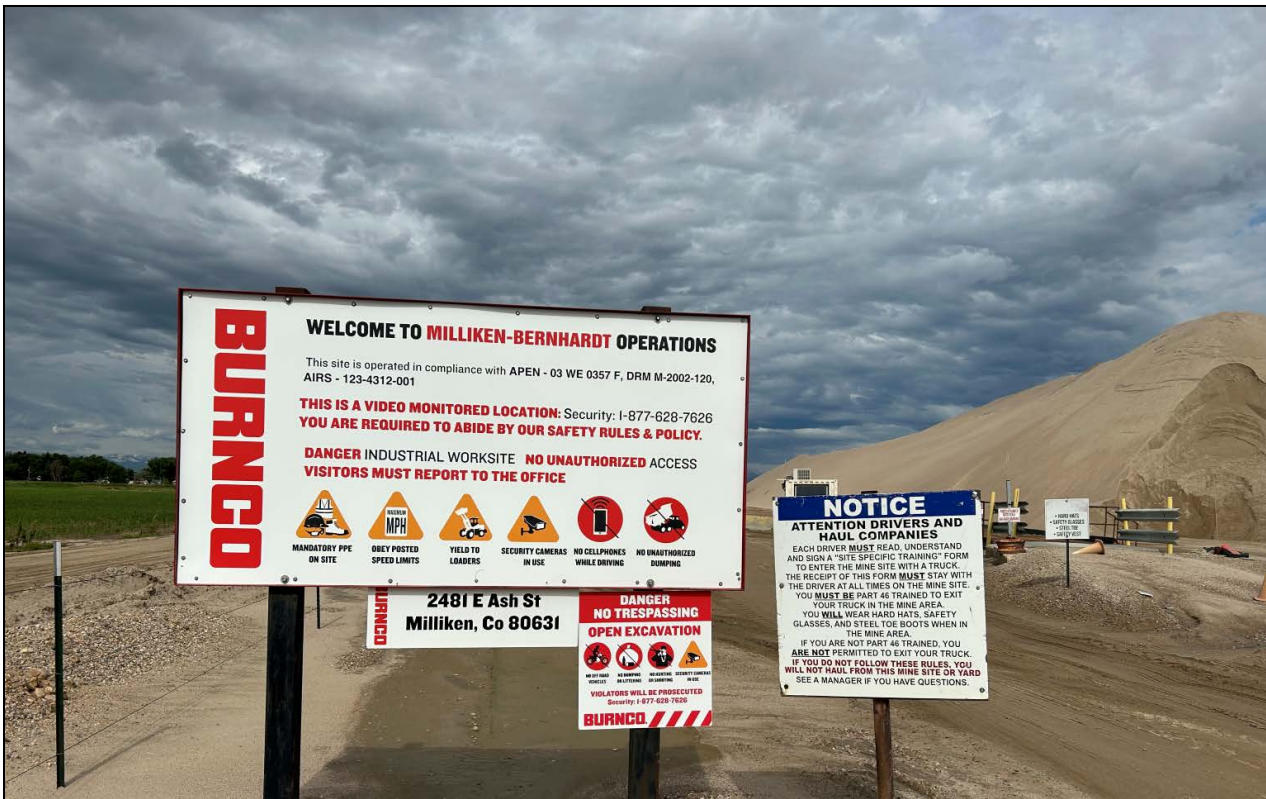
Photo 1 - Site identification sign at permit entrance

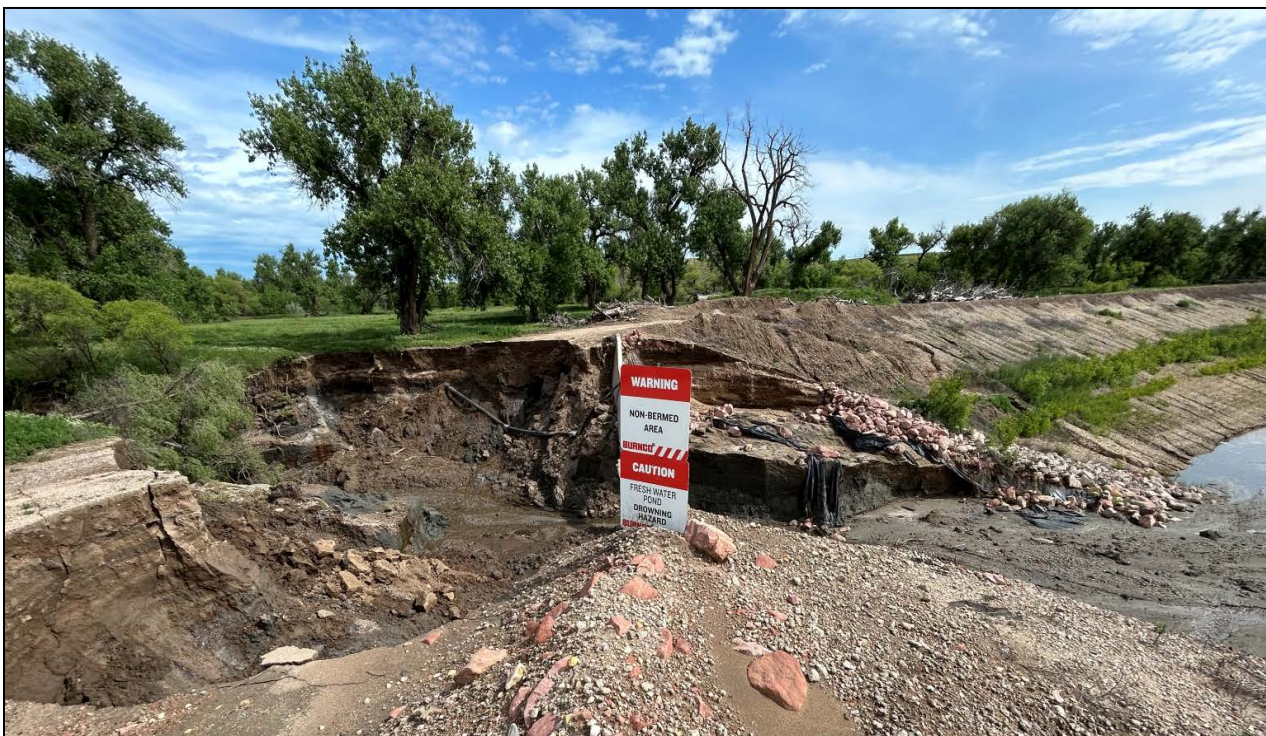
It was noted during the inspection that the extraordinary rainfall at the site earlier in the week has resulted in damage to the lined pit walls in all cells. The most severe damage was located in the northwest corner of cell 3, previously reclaimed as water storage. The cell 3 inlet/outlet structure has been destroyed by flood flow into the cell, and the cell totally breached in that area. The slurry wall in cell 3 will need to be repaired and recertified due to the pit breach. This may also be required for other mined and open cells. Damage to interior cell walls was noted in cells 2, 4 and 5. It is not known at this time if the slurry walls of these cells has been compromised, although it seems likely based on visual observations. Photos of damage observed have been attached to this report.

Photo 2 - Breach of cell wall and remnants of inlet/outlet structure in NW corner of cell 3.

DRMS currently holds a \$2,557,725.00 reclamation bond for this site, which includes costs for installation of the existing slurry walls, therefore, no bond increase will be required for SO2. However, DRMS expects that the existing damage to the open pit slopes will be carefully evaluated, and repaired, as soon as practically possible. DRMS noted that the permittee's consultant (Civil Resources) was present on-site at the time of this inspection to conduct a field survey of the conditions.

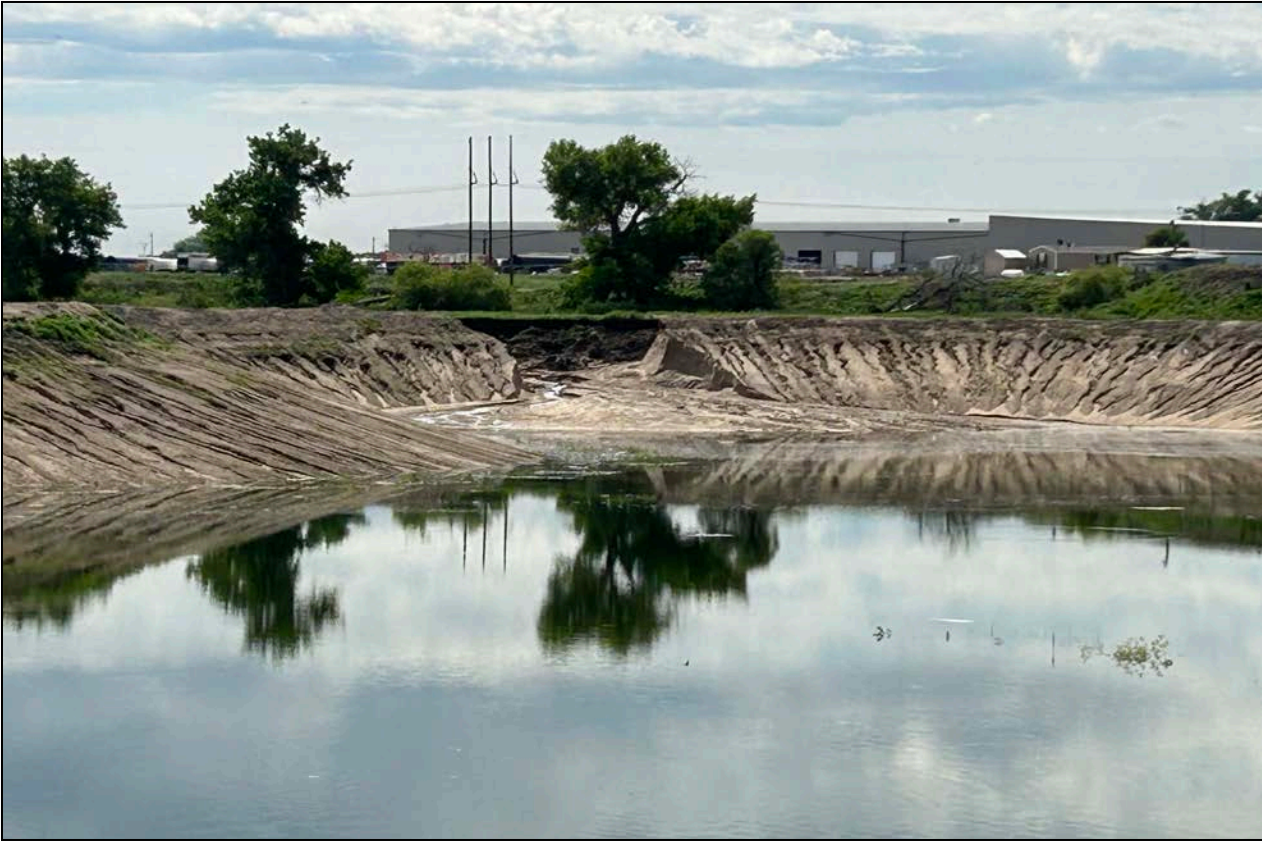
Photo 3 - Inflow damage to lined and reclaimed SE pit wall in cell 4. Similar damage was also present on SW side of pit.

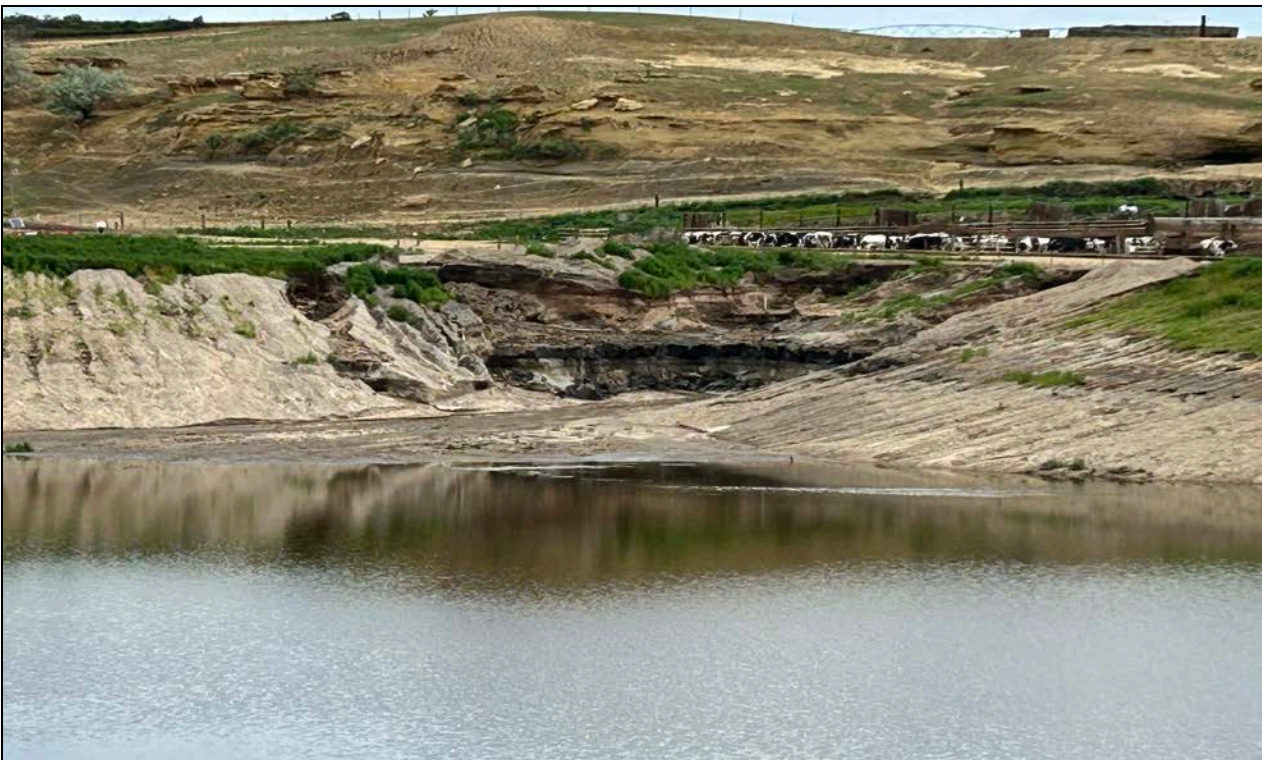
Photo 4 – Damage to NE corner of lined pit 5 cell wall adjacent to feed lot.

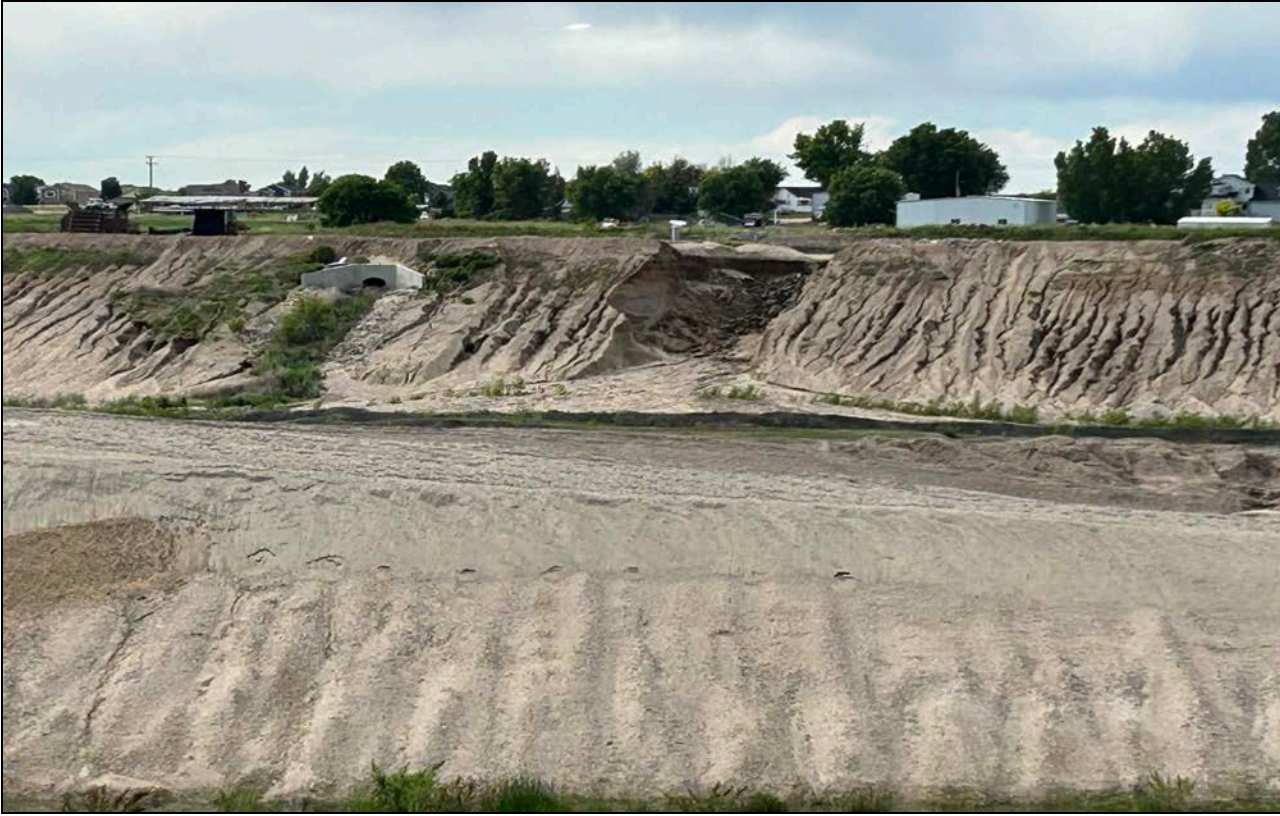
Photo 5 – Damage to south interior wall of lined cell 2 where current mining activity is taking place.
