## Sievers Pit, May 24, 2023 Inspection Report

**MINERALS PROGRAM INSPECTION REPORT**  
**PHONE: (303) 866-3567**

<b>MINE NAME:</b> Sievers Pit	<b>MINE/PROSPECTING ID#:</b> M-1977-098	<b>MINERAL:</b> Sand and gravel	<b>COUNTY:</b> Garfield
<b>INSPECTION TYPE:</b> Monitoring	<b>WEATHER:</b> Clear	<b>INSP. DATE:</b> May 24, 2023	<b>INSP. TIME:</b> 12:40
<b>OPERATOR:</b> Oldcastle SW Group, Inc. dba United Compas County	<b>OPERATOR REPRESENTATIVE:</b> Tyra Bartuska	<b>TYPE OF OPERATION:</b> 112c - Construction Regular Operation	
<b>REASON FOR INSPECTION:</b> Normal I&E Program	<b>BOND CALCULATION TYPE:</b>	<b>BOND AMOUNT:</b> \$794,357.00	
<b>DATE OF COMPLAINT:</b> NA	<b>POST INSP. CONTACTS:</b> County	<b>JOINT INSP. AGENCY:</b> County	
<b>INSPECTOR(S):</b> Clayton Wein Amy Yeldell	<b>INSPECTOR'S SIGNATURE:</b>

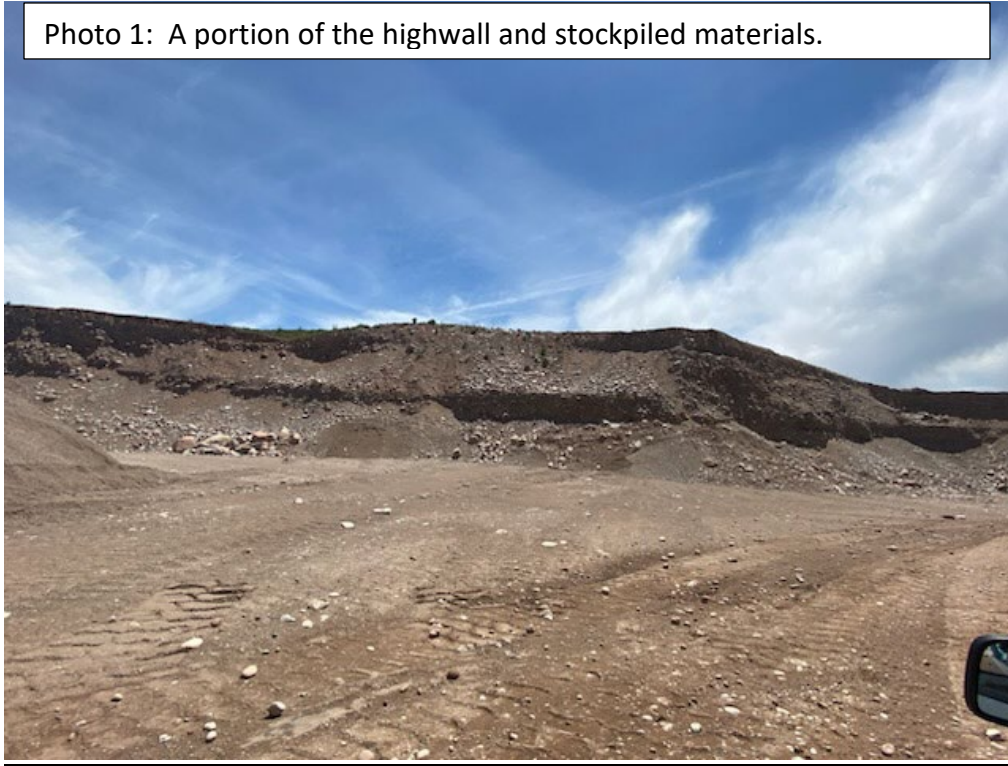
During the inspection mining activity was occurring in the southwestern portion of the site (Photo 1). The mining highwall was observed to be stable. The highwall was approximately 1,500 feet in length at the time of the inspection. The highwall was within the permitted boundary and no off-site impacts were observed. The mining plan is to finish mining the highwall to the south end of the permitted area and then move the mining operations to the eastern portion of the site. Material mined from the highwall was being processed through the crusher and sorted into material stockpiles. Several stockpiles were located throughout the floor of the mine pit (Photo 2). The stockpiles were well kept and organized. The plant at the bottom of the pit was active (Photo 3). Fuel stored at the site was located within secondary containment structures (Photo 4). There were no indications of spilled fluids or contaminated soils.

Photo 1: A portion of the highwall and stockpiled materials.

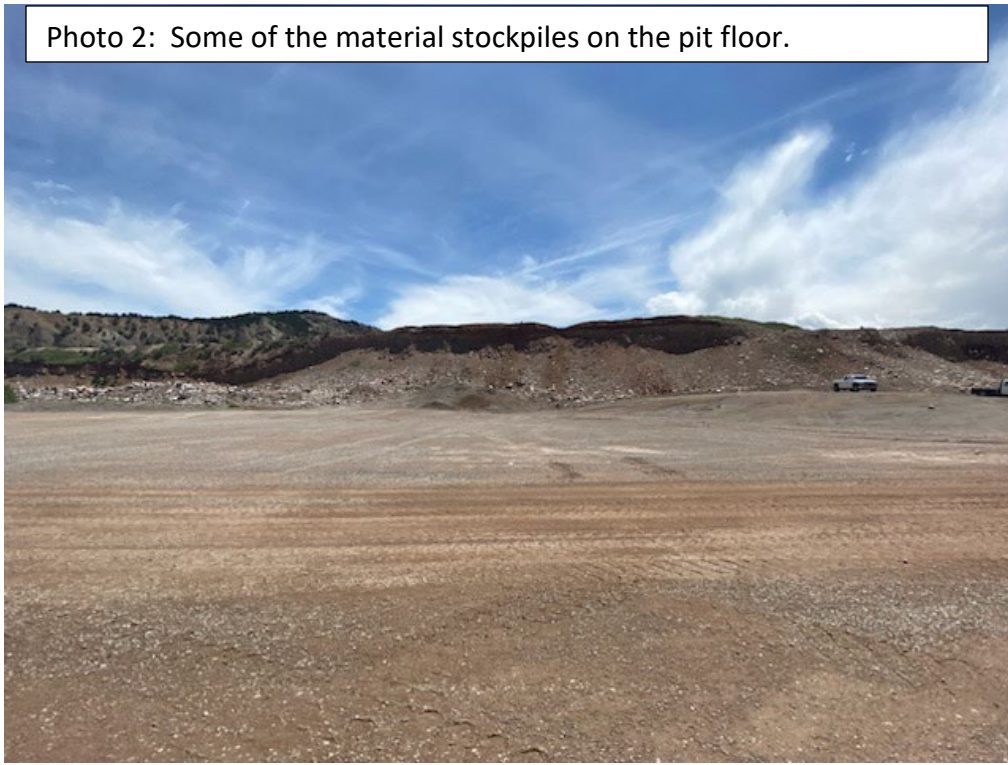
Photo 2: Some of the material stockpiles on the pit floor.

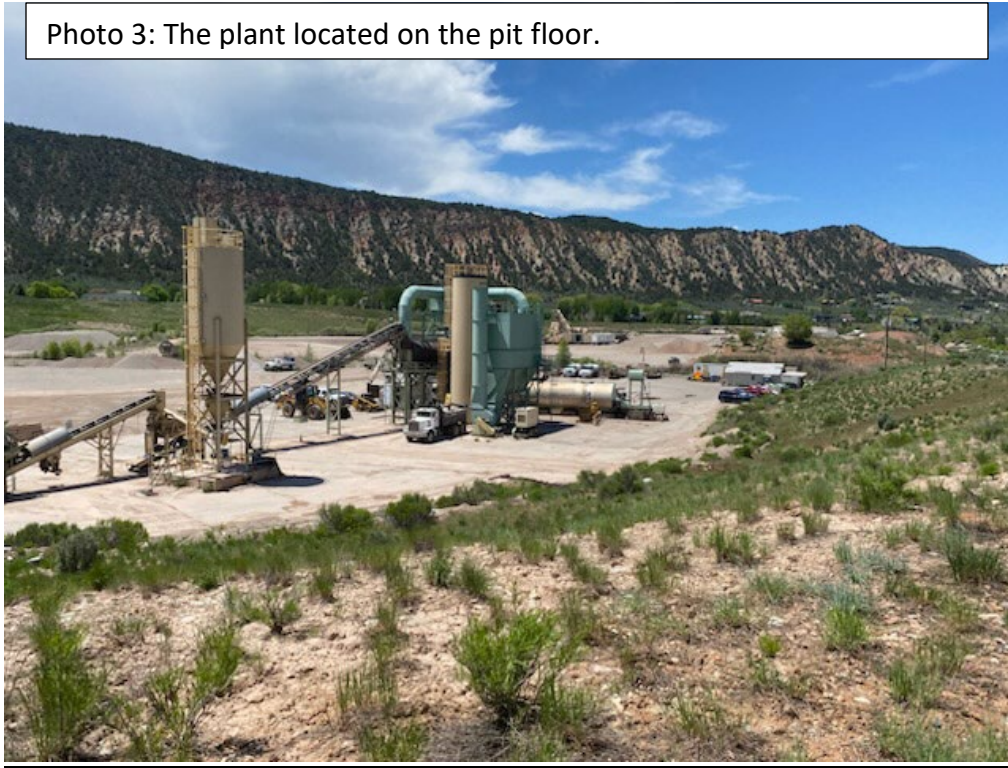
Photo 3: The plant located on the pit floor.

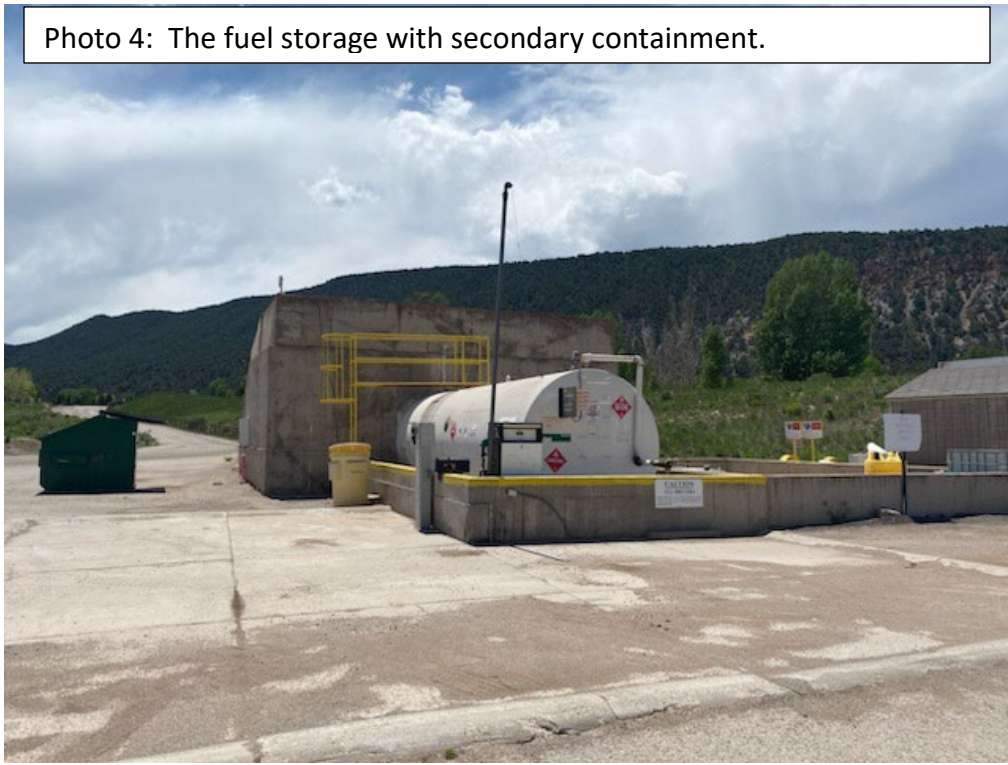
Photo 4: The fuel storage with secondary containment.

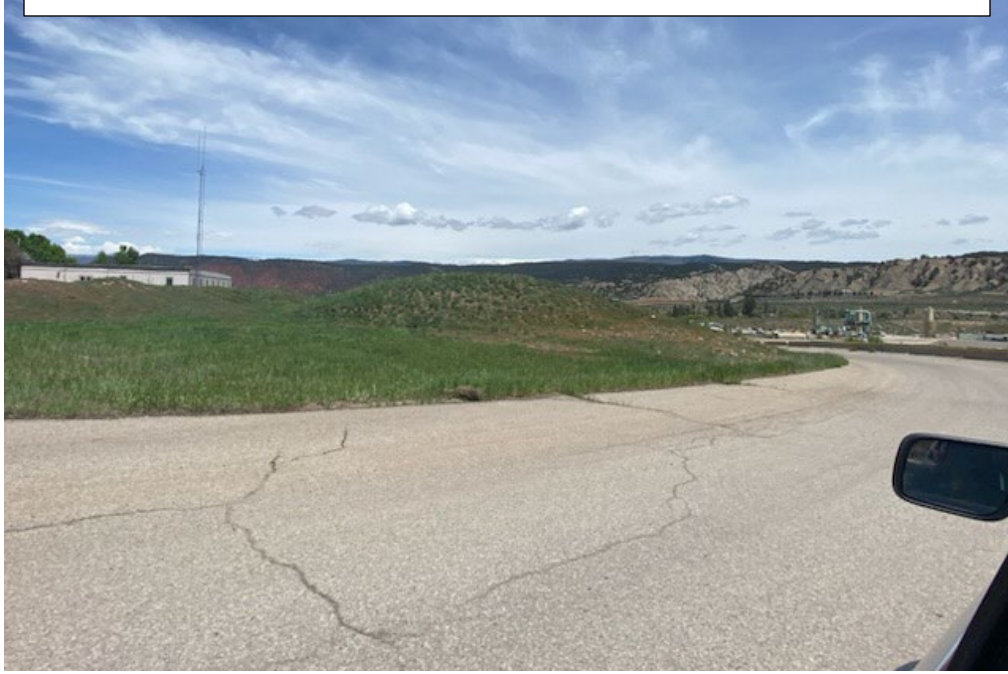
Stockpiled topsoil was stable with vegetative cover (Photo 5). There were no erosional features or loss of topsoil resource observed.

Photo 5: One of the topsoil stockpiles located on the western portion of the mine site.

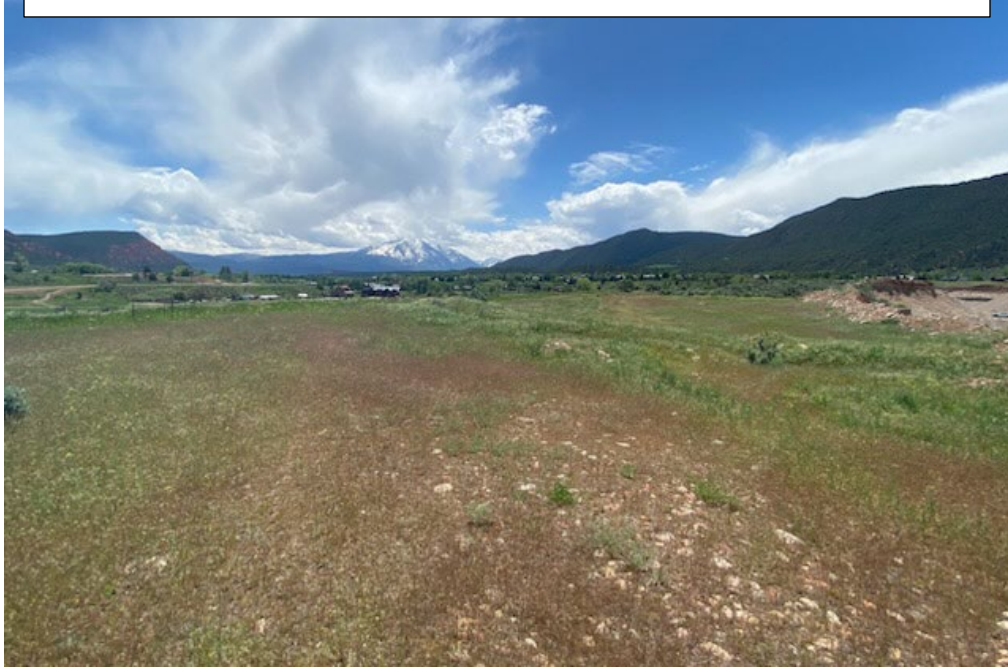
During the inspection the eastern berm and western berm were vegetated and stable (Photos 6 and 7). Minimal amounts of weeds were identified. Hounds Tong and Scotch Thistle have been sprayed for at the site in previous seasons. Weed control has been implemented at the site in accordance with the mining permit. There were no concerns identified. The Division recommends continuing to follow the approved weed control plan.

Photo 6: A southern portion of the permit area visited during the inspection. There were no indications of weed infestation.

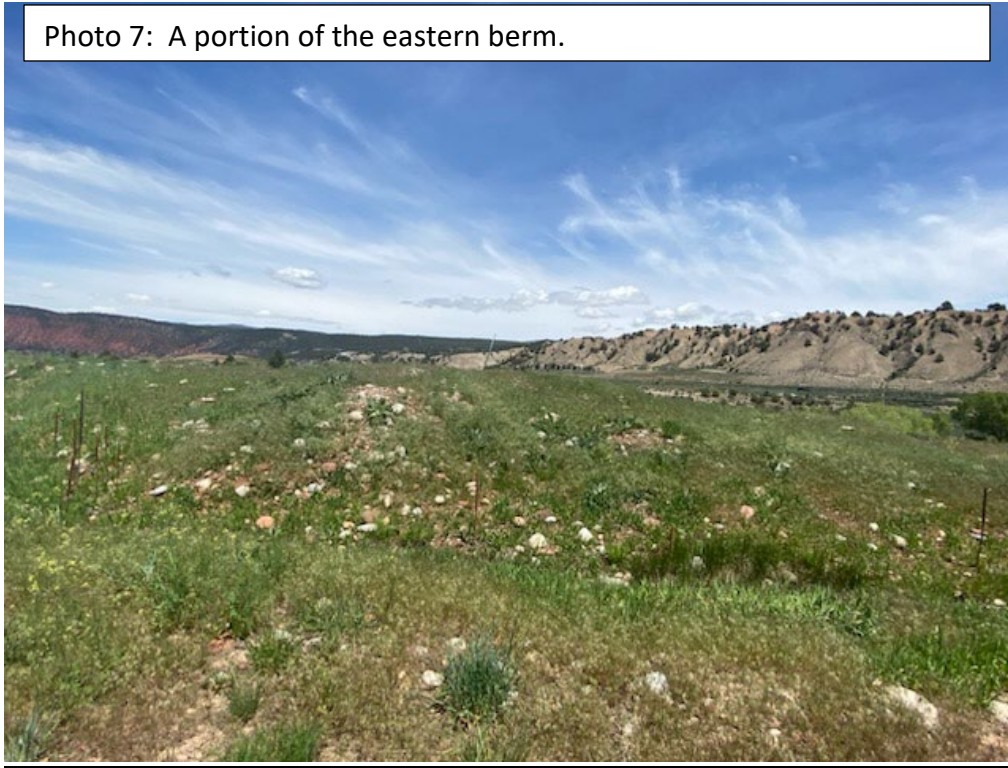
Photo 7: A portion of the eastern berm.
