MINERALS PROGRAM INSPECTION REPORT
PHONE: (303) 866-3567

| MINE NAME: Everhart Pit | MINE/PROSPECTING ID#: M-1997-081 | MINERAL: Gravel | COUNTY: Pueblo |
| INSPECTION TYPE: Monitoring | WEATHER: Clear | INSP. DATE: May 17, 2023 | INSP. TIME: 11:45 |

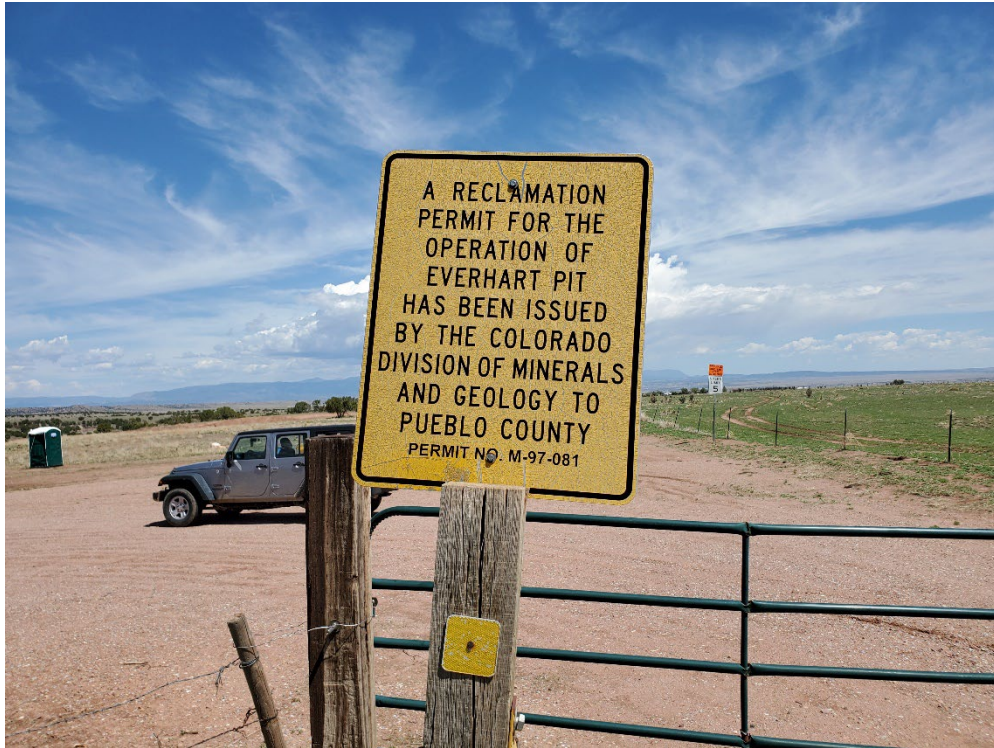
A mine sign in compliance with Rule 3.1.12(1) was observed at the entrance of the site (Photo 1: Map 2).

Photo 1: Mine sign posted at the entrance to the site.

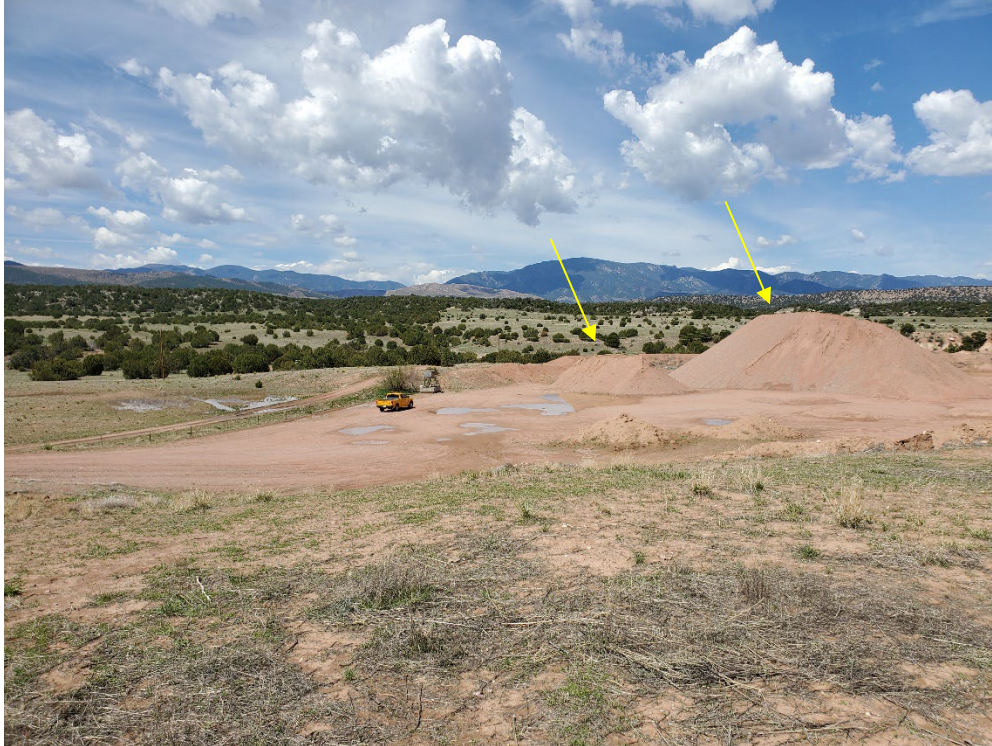
The areas that have undergone reclamation in photos 3, 4, and 32 and that are outlined by the blue polygons in Map 3 have established vegetative cover and appear stable, other than the erosion noted above. The

Photo 3: Looking south-west at the southwest corner of the site. The arrows point to the main product stockpiles currently onsite.

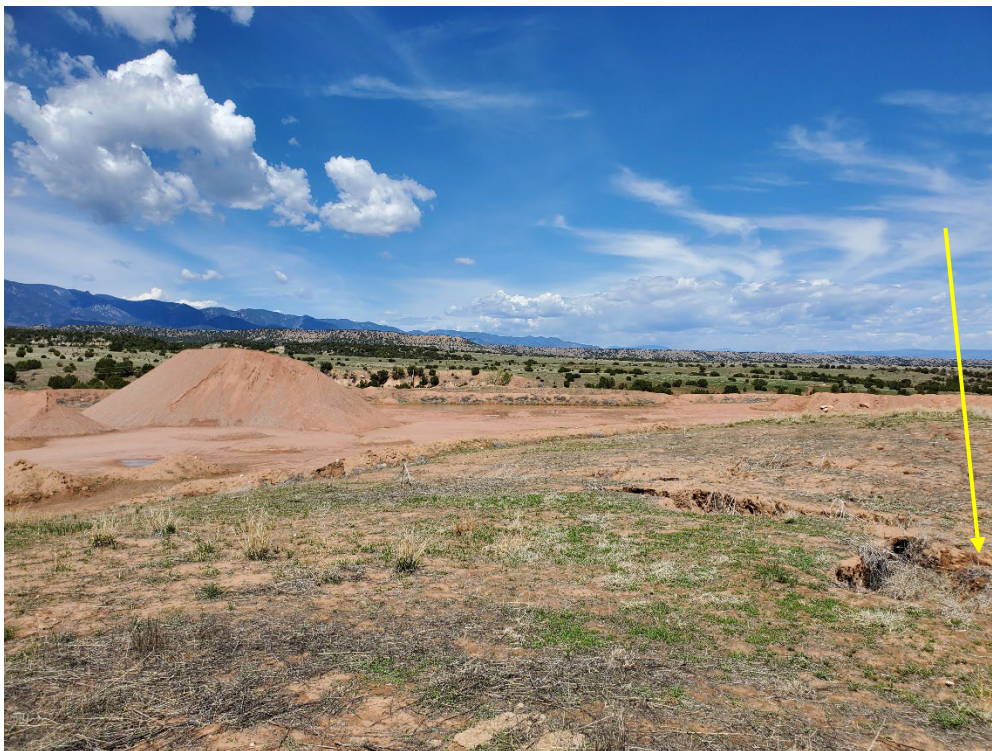
PROBLEM: Erosion gullies and ruts were observed on-site. This is a problem at this time for failure to protect the affected land from erosion pursuant to C.R.S. 34-32.5-116 (4) (j).

A problem was cited above for the presence of erosion gullies and ruts. In the eastern perimeter of the pit, an excessive erosion gully has formed that cuts east and north into the elevated land to the east of the active pit (Photos 3-8; Map 2). The Operator stated that they will have equipment at the pit within a few weeks of the inspection that will be used to repair the erosion gully and the damage to the eastern perimeter (Photo 7) using the small stockpiles of test material (Photos 46 and 74). The Operator will need to provide photo evidence to the Division that the erosion has been repaired and the land has been stabilized by the corrective action date.

Photo 4: Looking north-west from the land to the east of the active pit. The arrow shows where the erosion gully bends to the west.

CORRECTIVE ACTIONS: The Operator shall provide photo documentation to the Division verifying erosion gullies and ruts have been repaired, and that the site has have been reconstructed and stabilized to prevent erosion damage by the corrective action date.

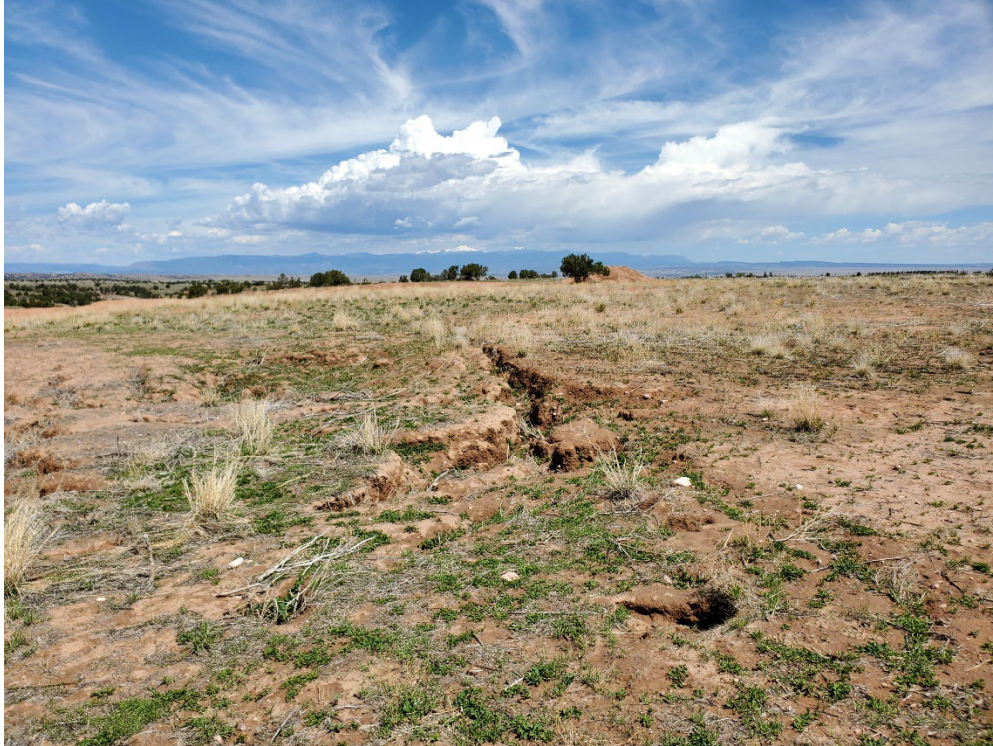
Photo 5: Looking north at the portion of the erosion gully that goes northward.

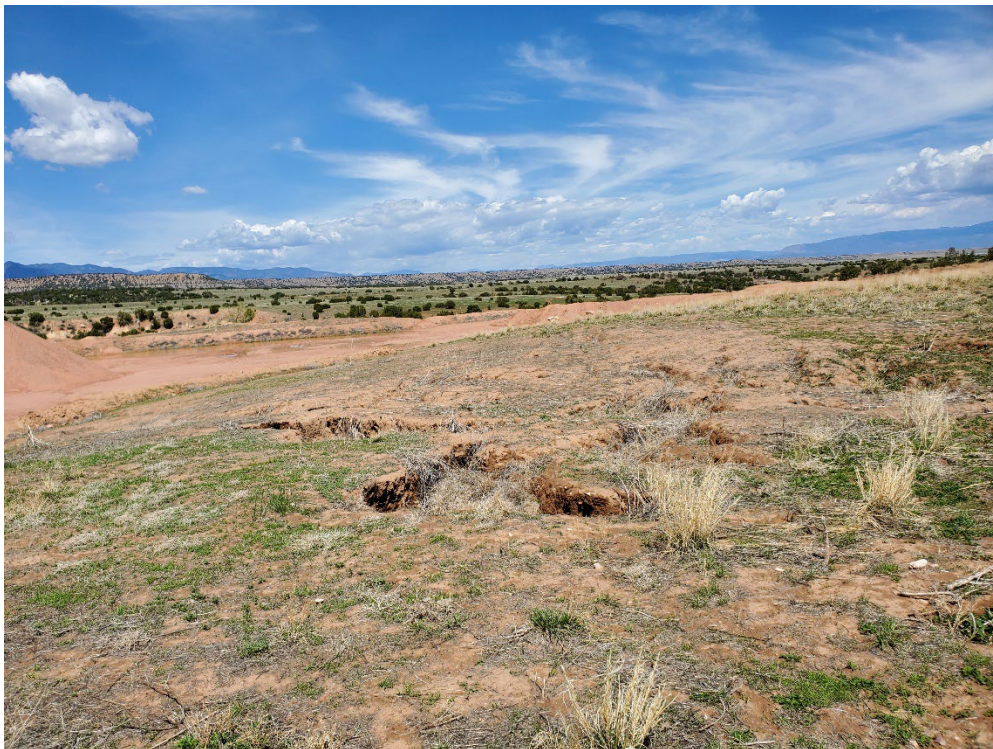
Photo 6: Erosion gully pictured in photos 4 and 5.

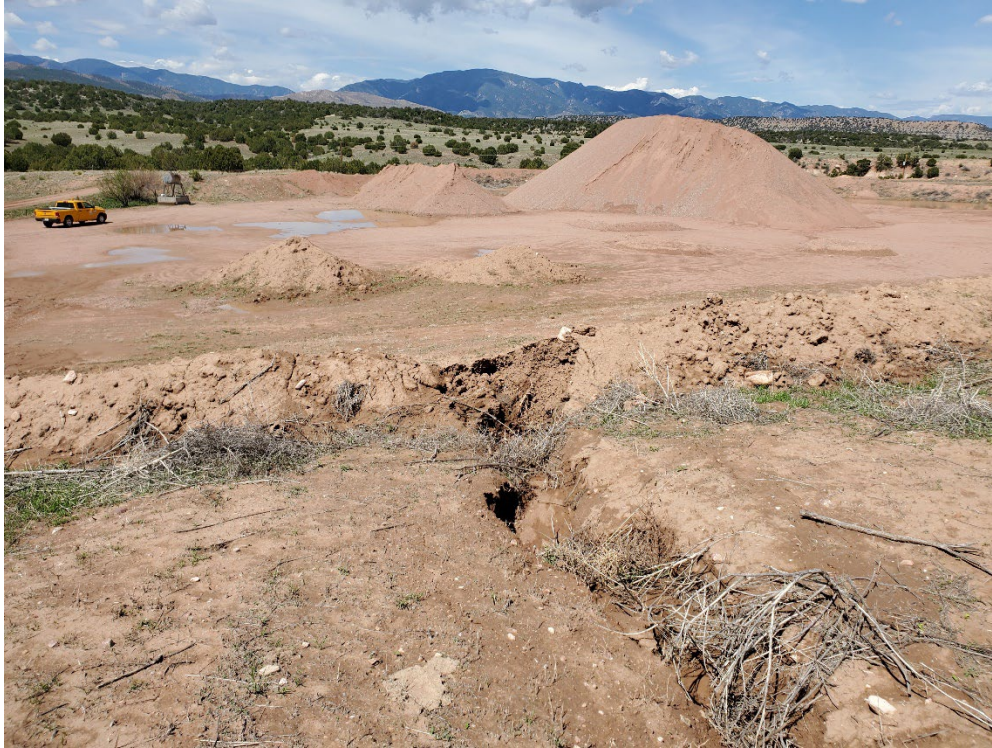
Photo 7: Looking west at where the erosion gully has caused erosion in the pit's perimeter berm.

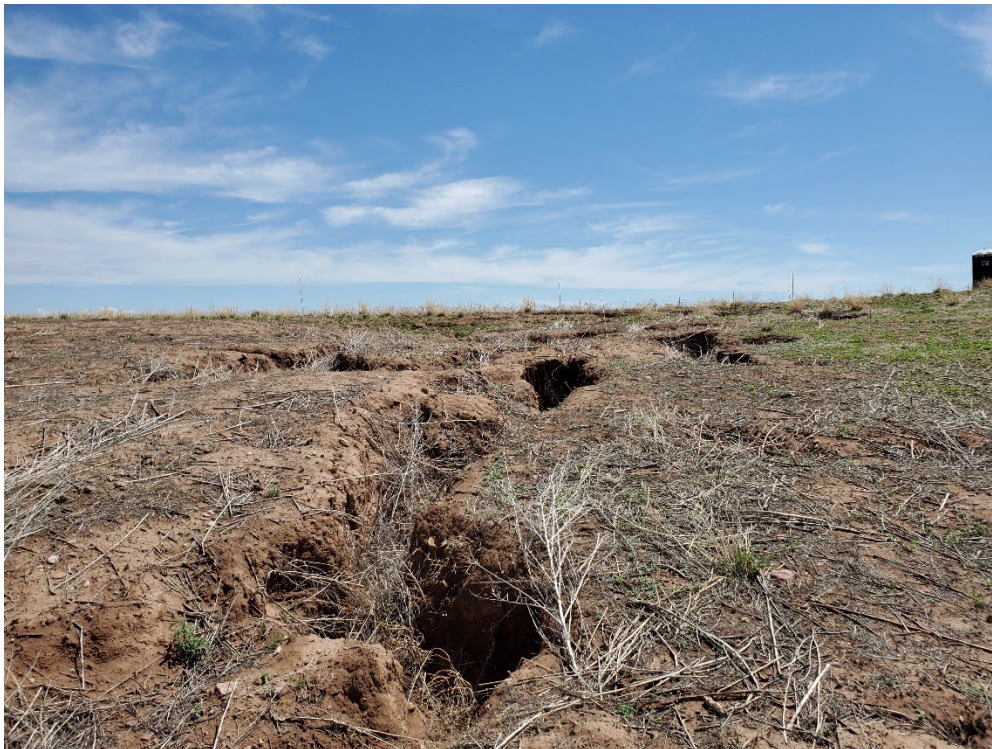
Photo 8: Looking east from the eastern pit berm across the erosion gully.

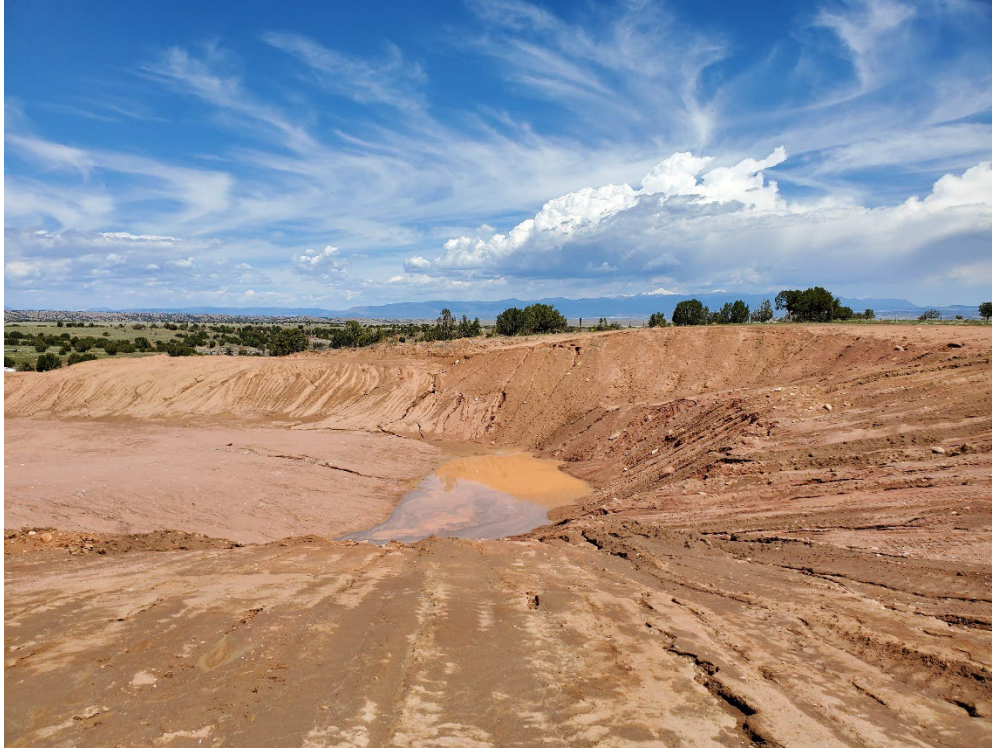
Standing water was observed throughout the pit, primarily in the south-western corner and in the north-eastern corner (Photos 9, 10, 25, 26, 30, 31, 38, 40-42, and 46). The area has seen a high accumulation of precipitation within the weeks leading up to the inspection, causing the site to have small ponds throughout. The ponds are relatively shallow, but combined they cover a significant amount of surface area. The Operator stated that this area is generally very dry, and water infiltrates within 72 hours, however they have undergone many days with continued rainfall and were expecting more over the next few days.

Photo 9: Looking north at the most recent disturbance in the north-east portion of the active pit.

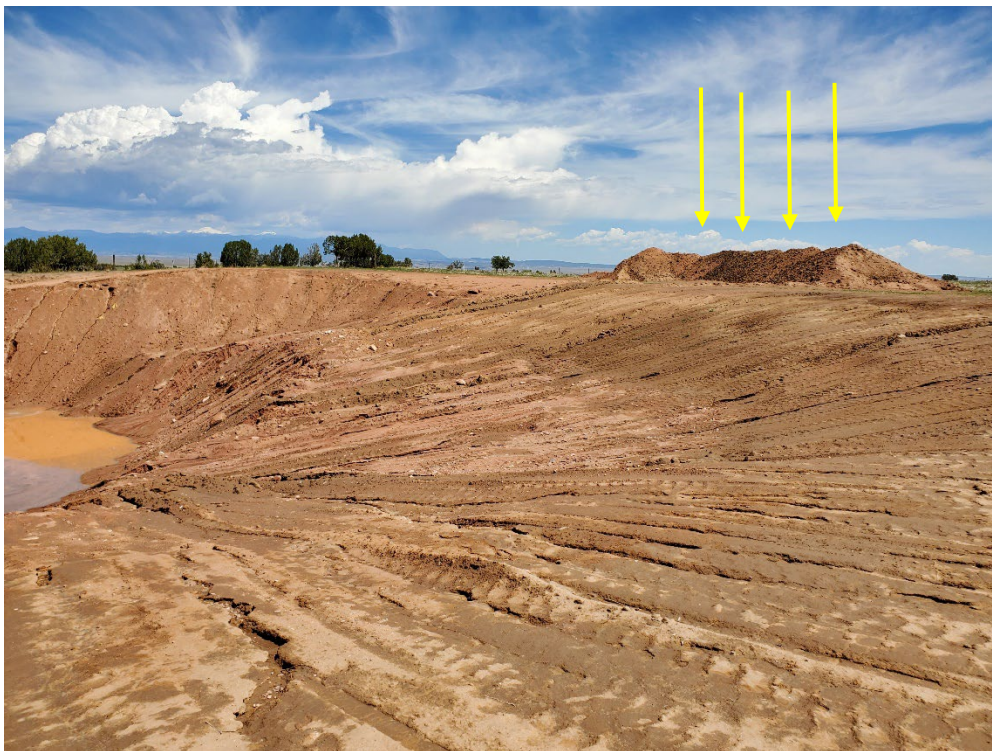
A new topsoil pile was observed to the east of the north-eastern corner of the active pit (Photos 10, 11, 14, and 17: Maps 2 and 3). The topsoil stockpile appears stable at this time, but does not have an established vegetative cover. The Division reminds the Operator that per the approved reclamation plan, the topsoil stockpiles shall be preserved with the same seed mixture used for reclamation throughout the site. In addition to the reclamation plan, Rule 3.1.9(3) states that The Board may require immediate planting of an annual and/or perennial on topsoil stockpiles for the purpose of stabilization.

Photo 10: Looking north-east at the most recent disturbance in the north-east portion of the active pit. The arrow points to the current topsoil stockpile (located at Inspection Point A on Map 3).

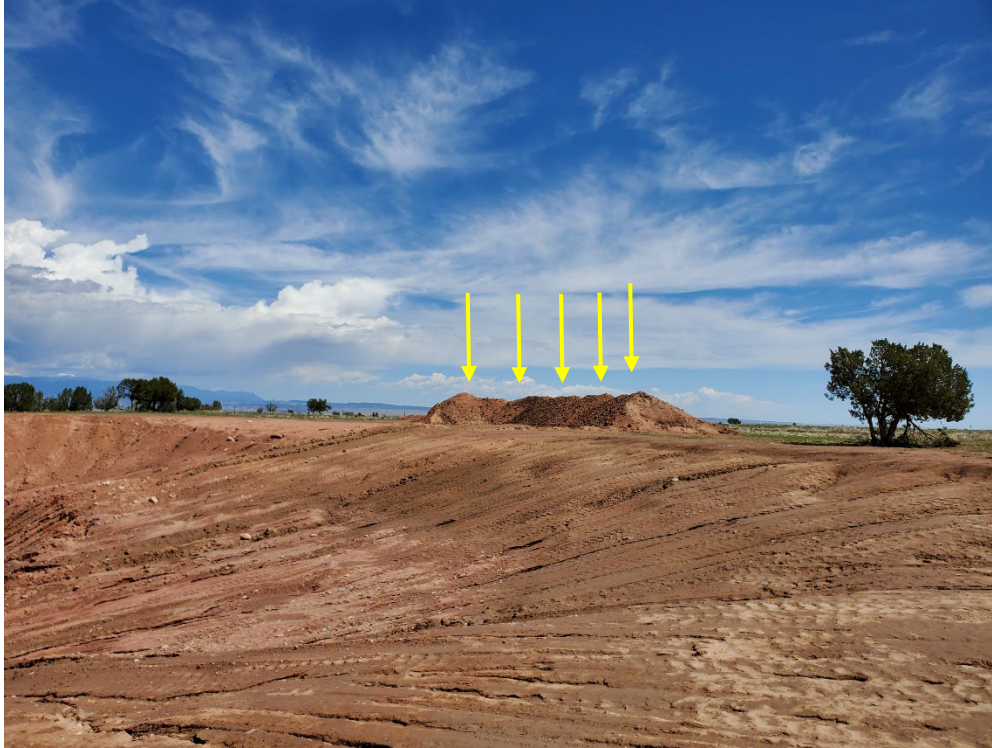
Photo 11: Looking north-east at the most recent disturbance in the north-east portion of the active pit. The arrow points to the current topsoil stockpile (located at Inspection Point A on Map 3).

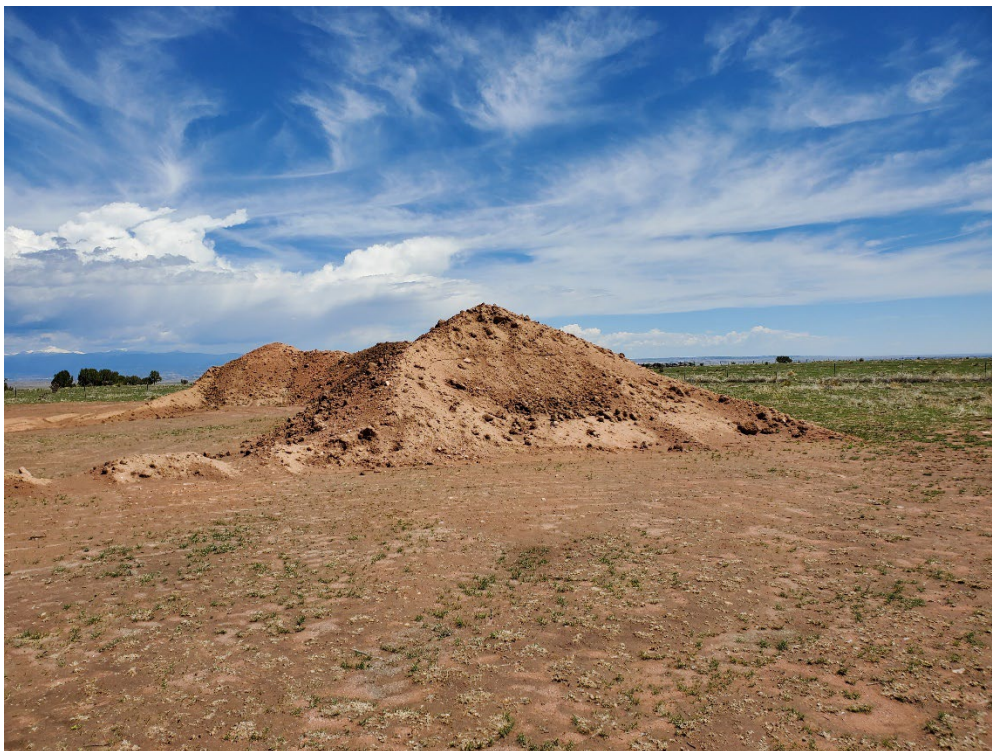
Photo 14: Looking north at the recently placed topsoil pile (located at Inspection Point A on Map 3).

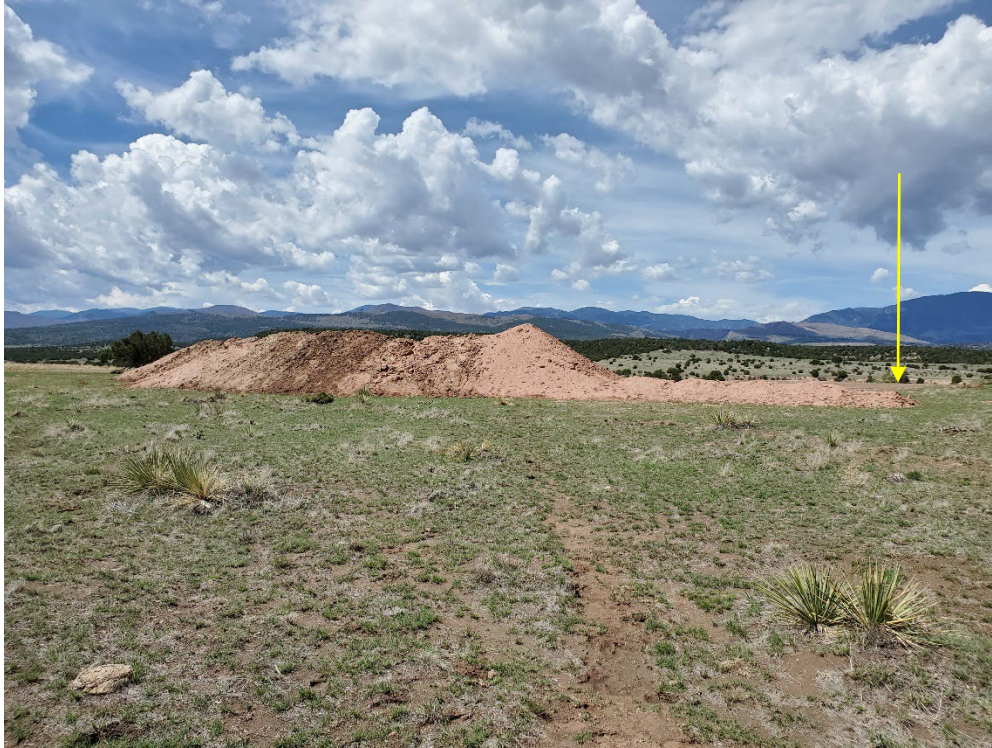
Photo 17: Looking at the recent disturbance from the corner fence post (arrow indicating approximate location of Inspection Point A on Map 3).

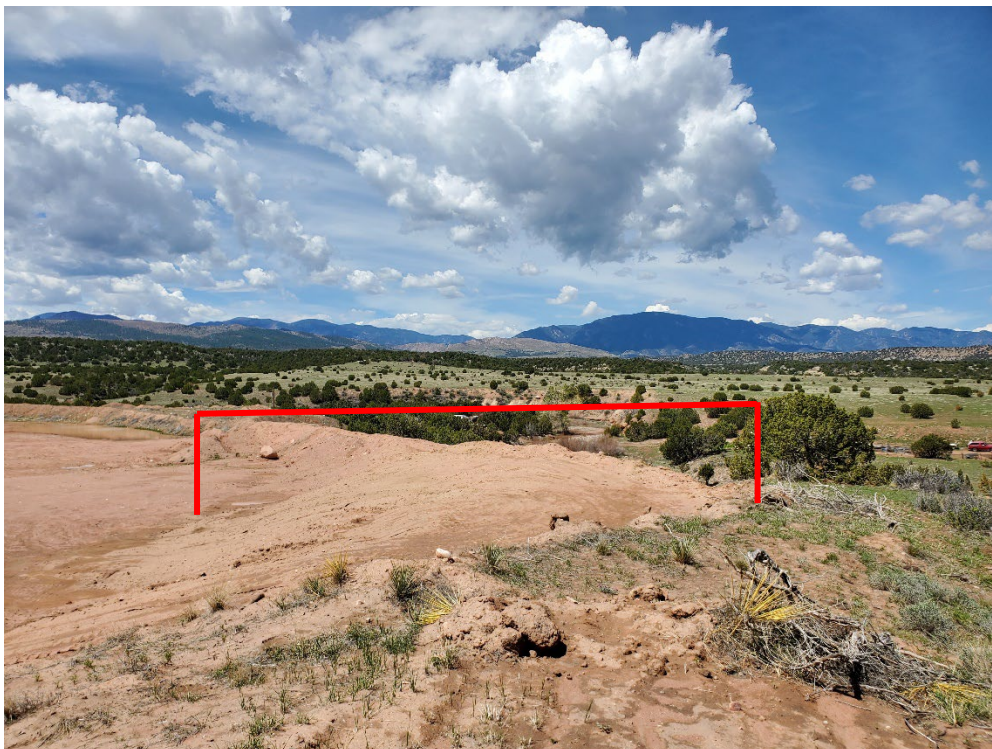
PROBLEM: The Operator has committed to maintaining 150 - 200 foot buffer zone with undisturbed vegetative cover between the mining operations and Red Creek. The south-facing side of the buffer zone that was repaired as a problem abatement to the 2019 DRMS inspection remains un-vegetated.

Photo 20: Looking south-west across the pit at the re-established buffer area from the DRMS 2019 inspection problem abatement.

CORRECTIVE ACTIONS: Please provide the Division with evidence that the Operator has taken measures to establish vegetative cover on this south-facing slope to stabilize the buffer zone pursuant to Rule 3.1.6(3) by the corrective action date.

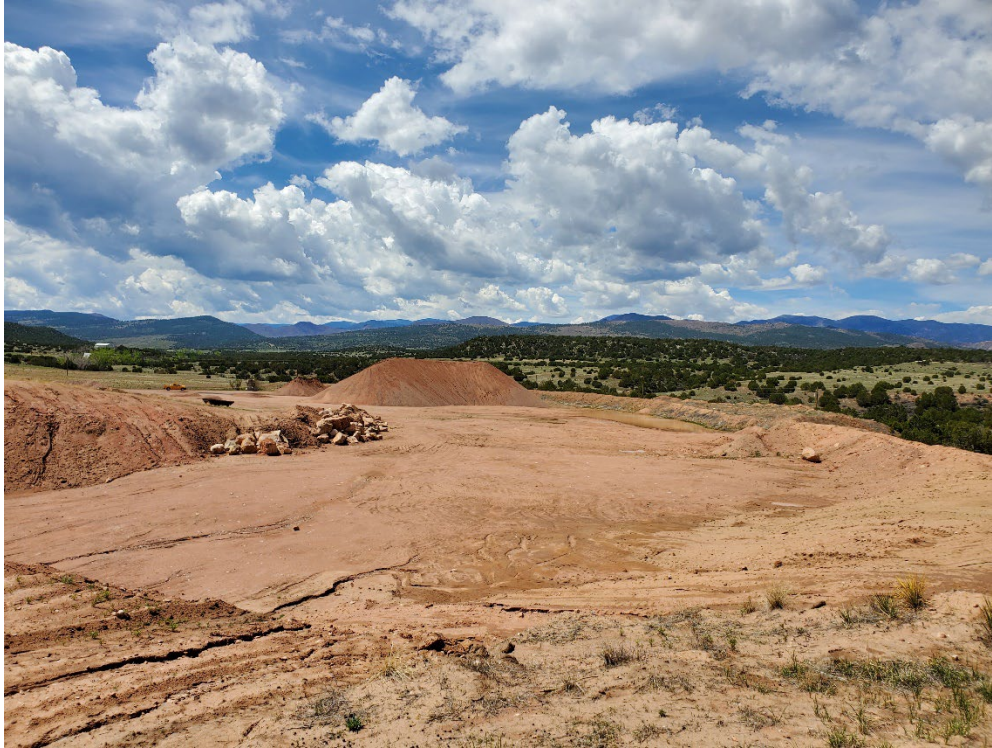
Photo 21: Looking south-west across the pit from the north-eastern disturbance. Along the northern boundary the slopes have been returned to 3H:1V.

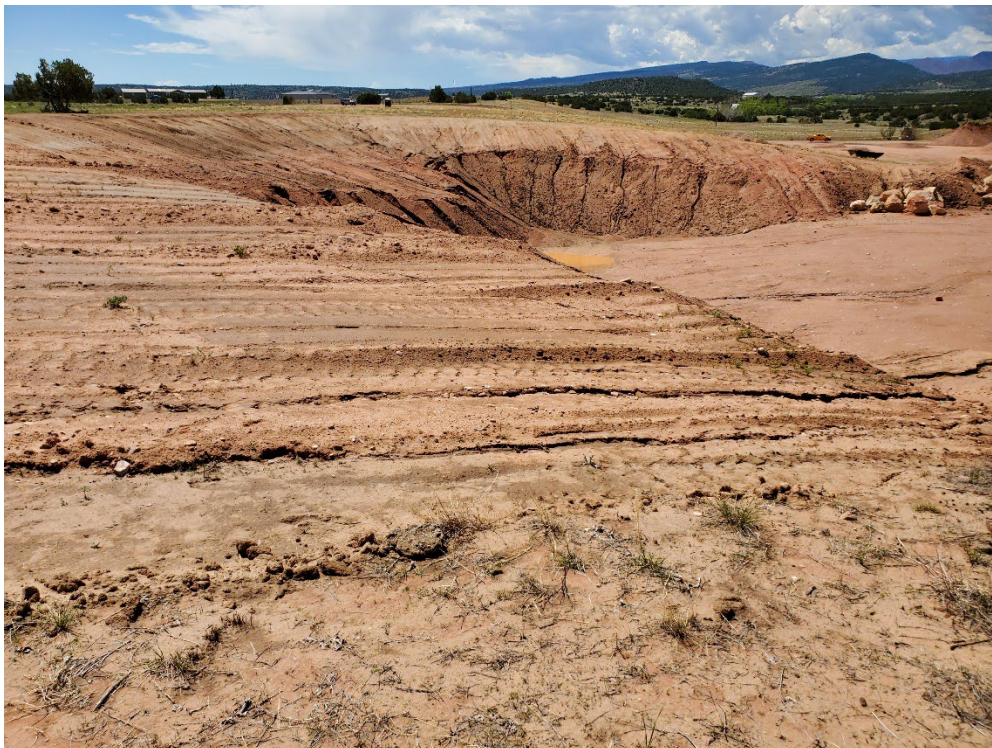
Photo 22: Looking southwest across the recently disturbed pit area where small erosional rills have formed.

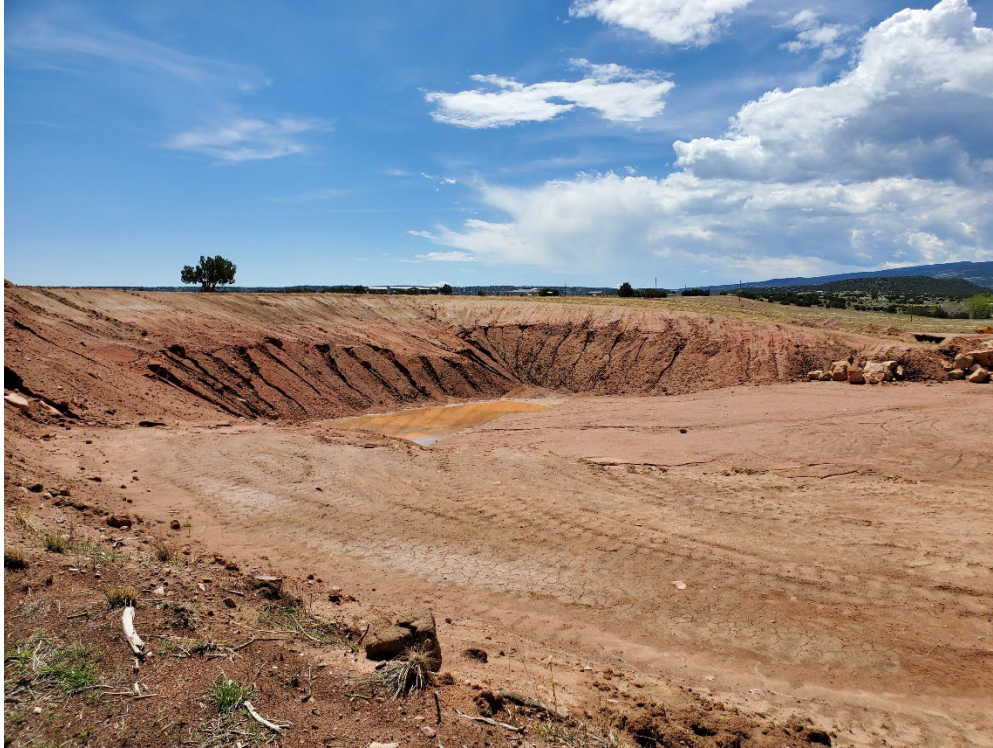
Photo 23: Looking southwest across the recently disturbed pit area where small erosional rills have formed.

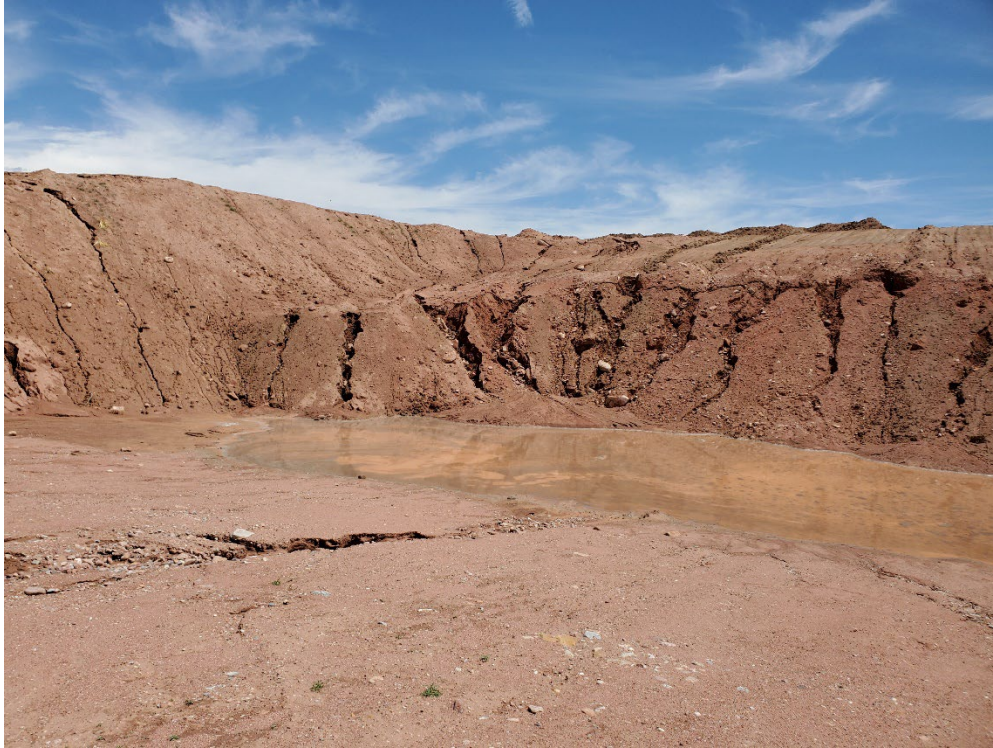
The recently disturbed area in the north-eastern corner of the pit appears to have been mined at a depth of approximately 19 feet (Figure 1). There is an accumulation of water at the base of the slopes in this area (Photos 25 and 26) The Operator's mining plan states that they planned to mine at a depth between 10 and 15 feet to avoid the possibility of encountering groundwater. **A problem was cited** for mining at a deeper depth than what is approved in the current mining plan. Please submit a Technical Revision to update the mining plan if the Operator intends to mine deeper than what is currently approved. If this is the plan, please also provide an explanation of how the mining operations will be conducted in a manner to avoid encountering the groundwater table.

Photo 25: Looking north-east at the slopes in the newly disturbed area. The bottom portions of the slopes have undergone more erosion than the upper slope.

CORRECTIVE ACTIONS: The operator shall submit a Technical Revision, with the required \$216 revision fee, to update and clarify the current approved mine plan to reflect existing and proposed activities by the corrective action date.

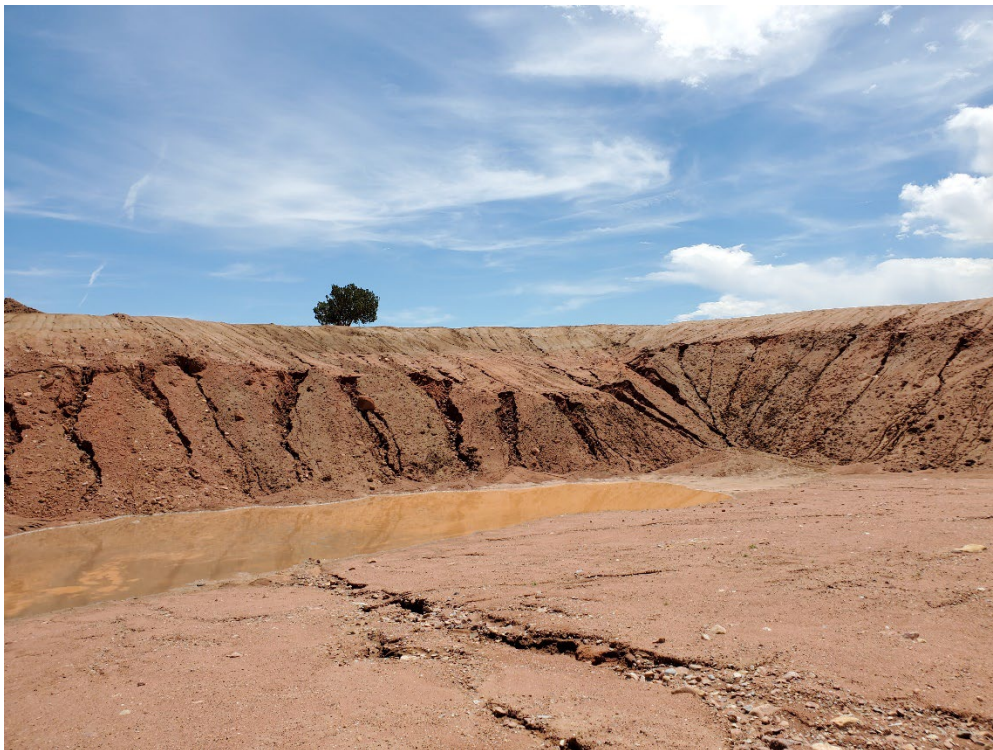
Photo 26: Looking south-east at the slopes in the newly disturbed area. The bottom portions of the slopes have undergone more erosion than the upper slope.

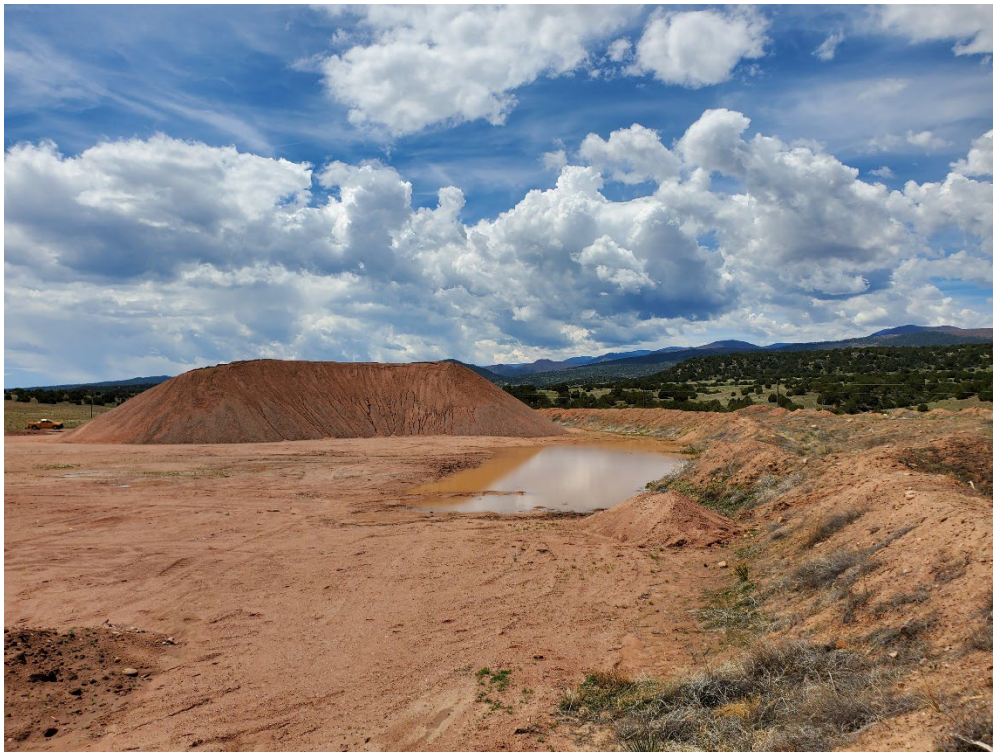
The other perimeter berms on the north and west side nearest Red Creek (Photos 30, 34-36, and 40) are also stable and are constructed in a way that allows water and run-off to flow into the pit as well. As a reminder, any areas that are within 150-200 feet of Red Creek need to maintain an undisturbed vegetative cover that will remain unaffected by additional mining activities.

Photo 30: Looking west along the northern border of the pit.

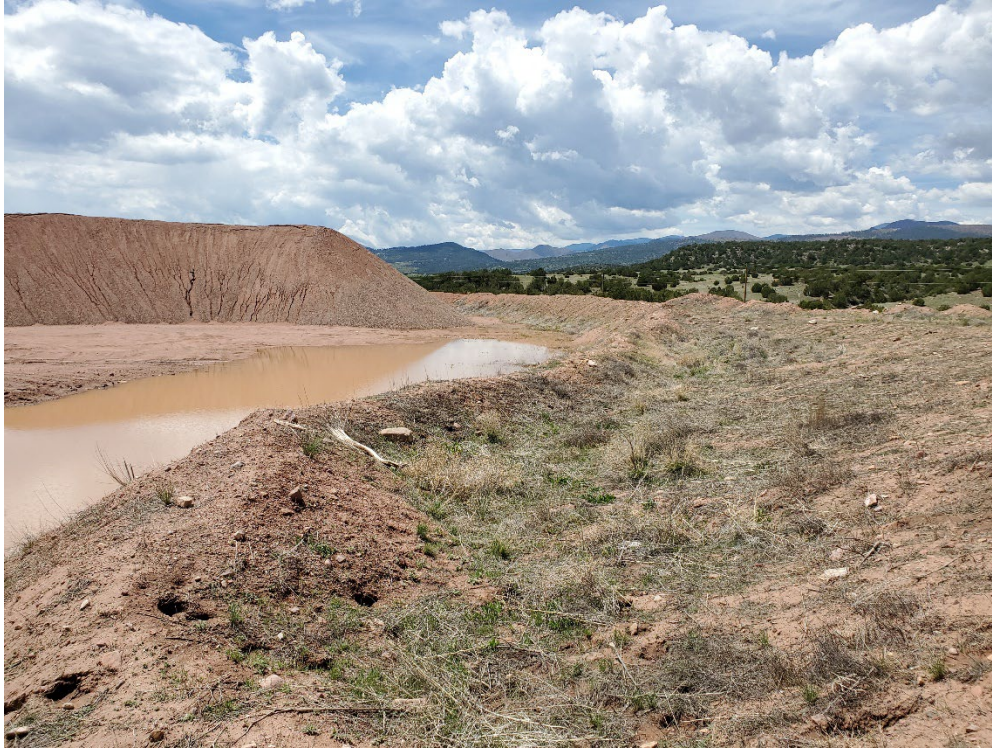
Photo 31: Looking south-west along the western berms surrounding the pit. The area to the right in frame has been graded, topsoiled, and seeded and has been reclaimed for a few years.

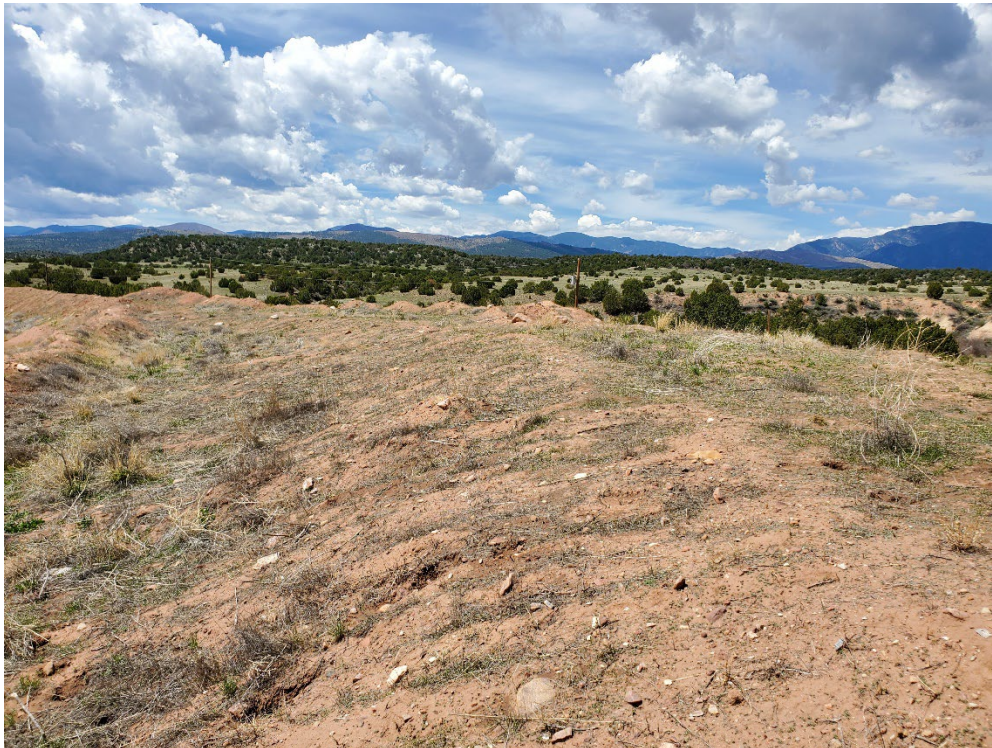
Photo 32: Looking west along the area that has been graded, top-soiled, and seeded and has been reclaimed for a few years.

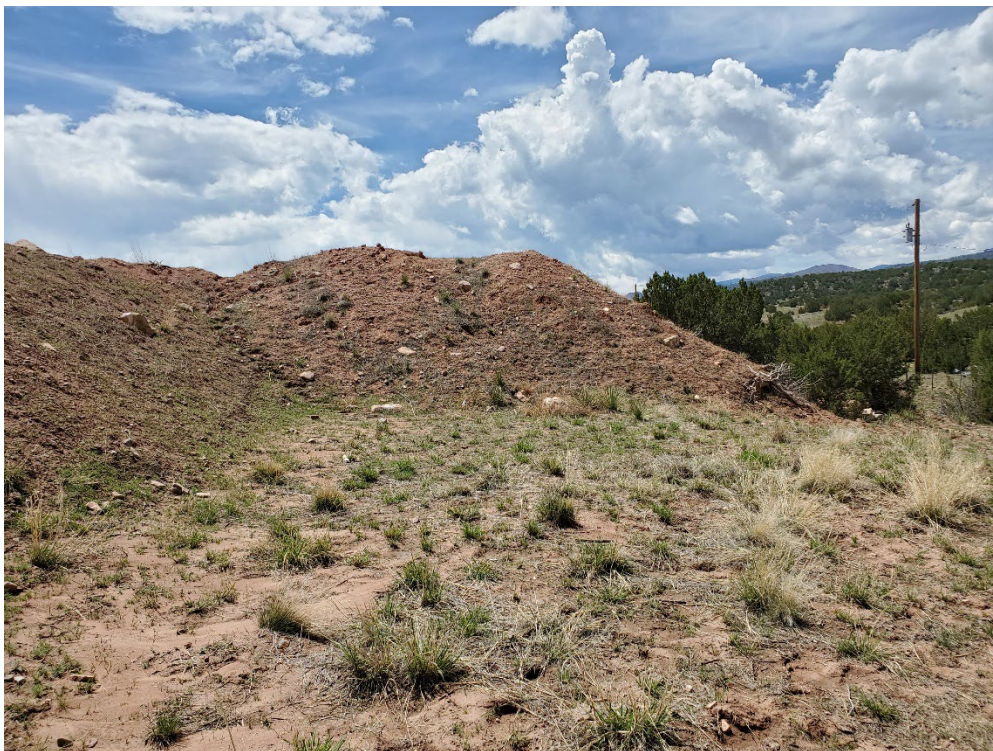
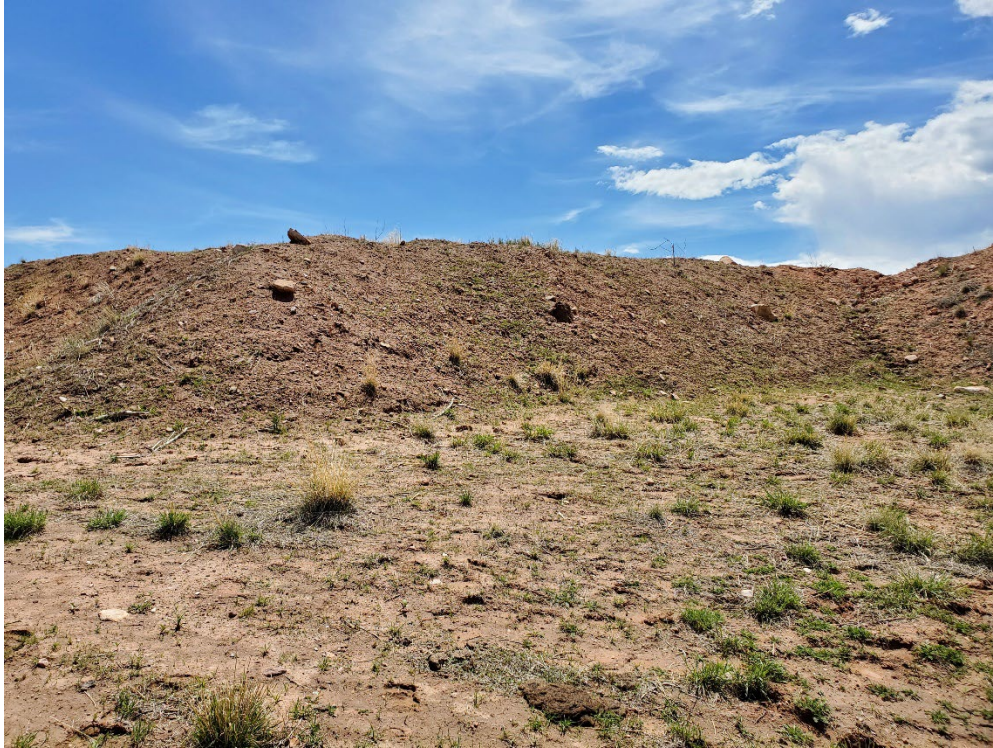
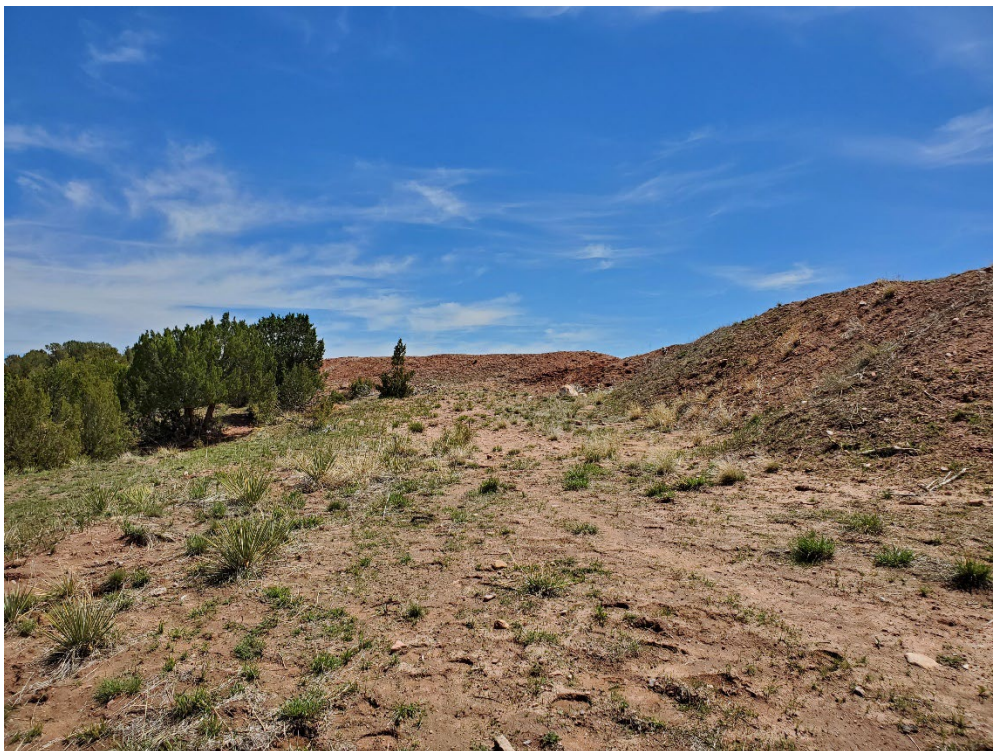
Photo 34: Looking south from behind the north-western-most corner of the pit's perimeter berm.

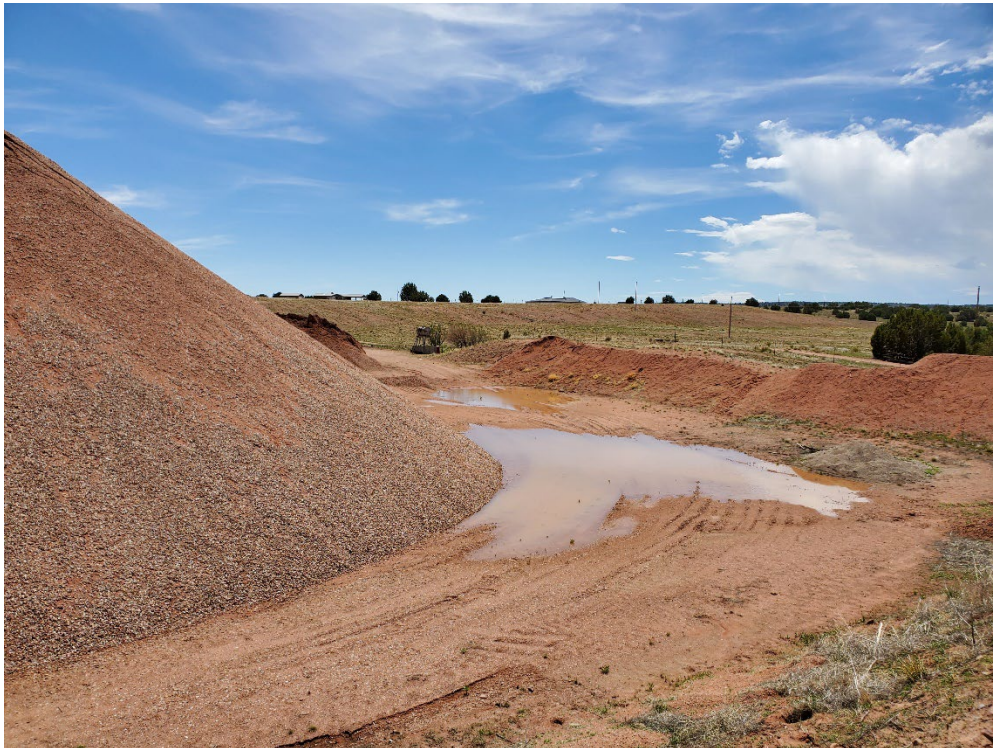
Photo 38: Looking south at the south-western-most edge of the active pit area.

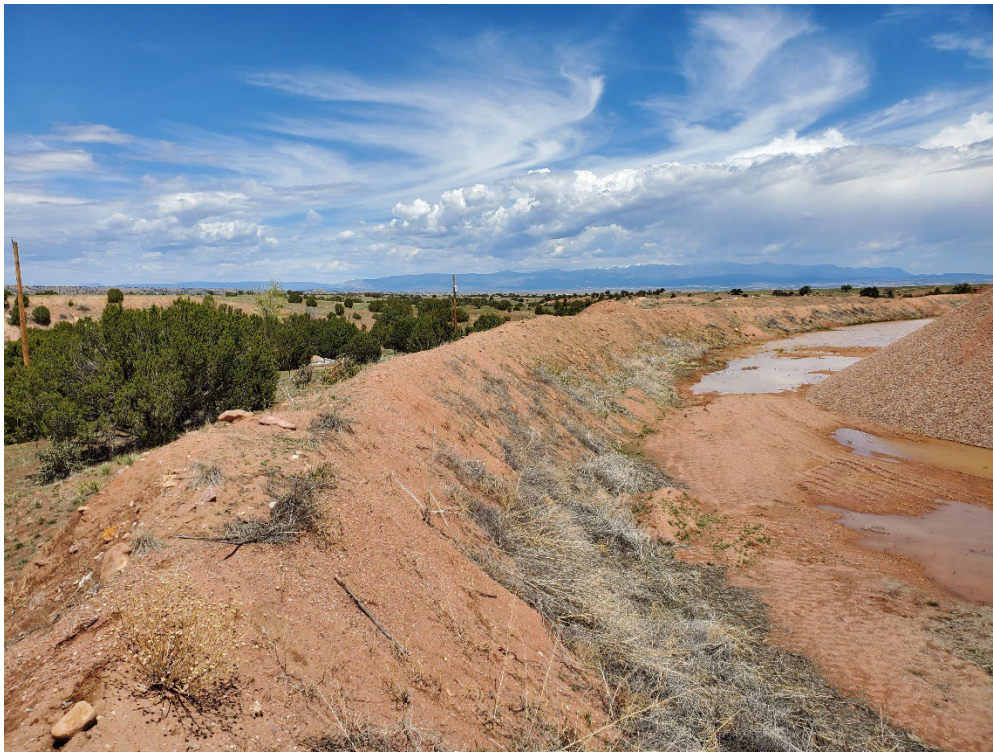
Photo 40: Looking north-west at the western perimeter berm from the south-western-most edge of the active pit area.

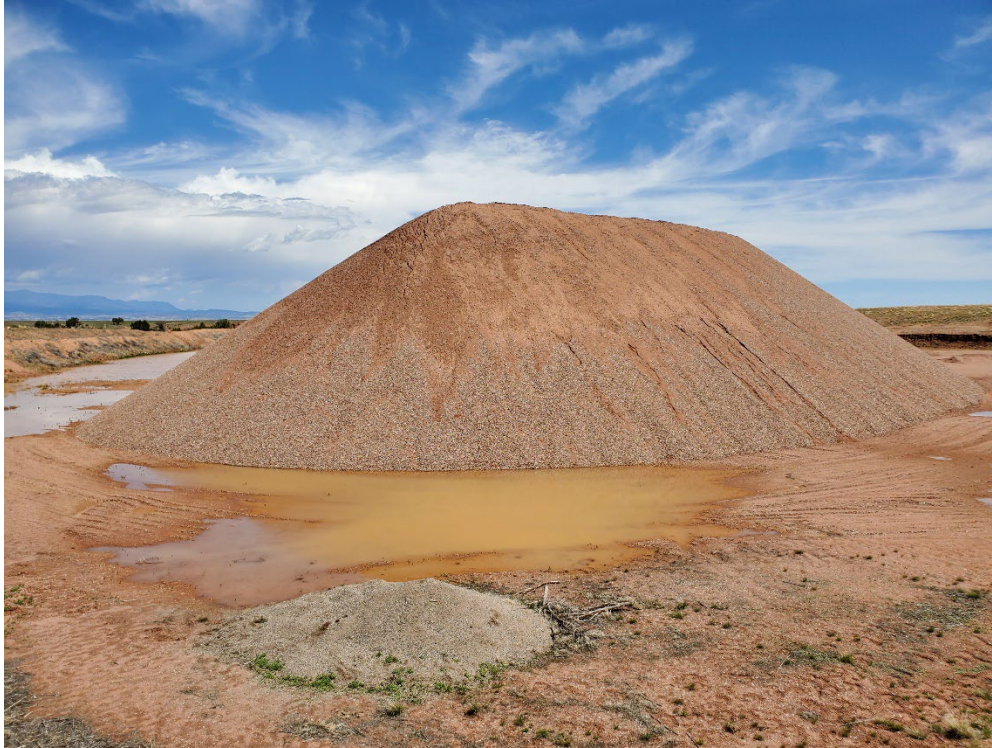
Photo 41: Looking north-east at the large product stockpile in the south-west corner of the active pit.

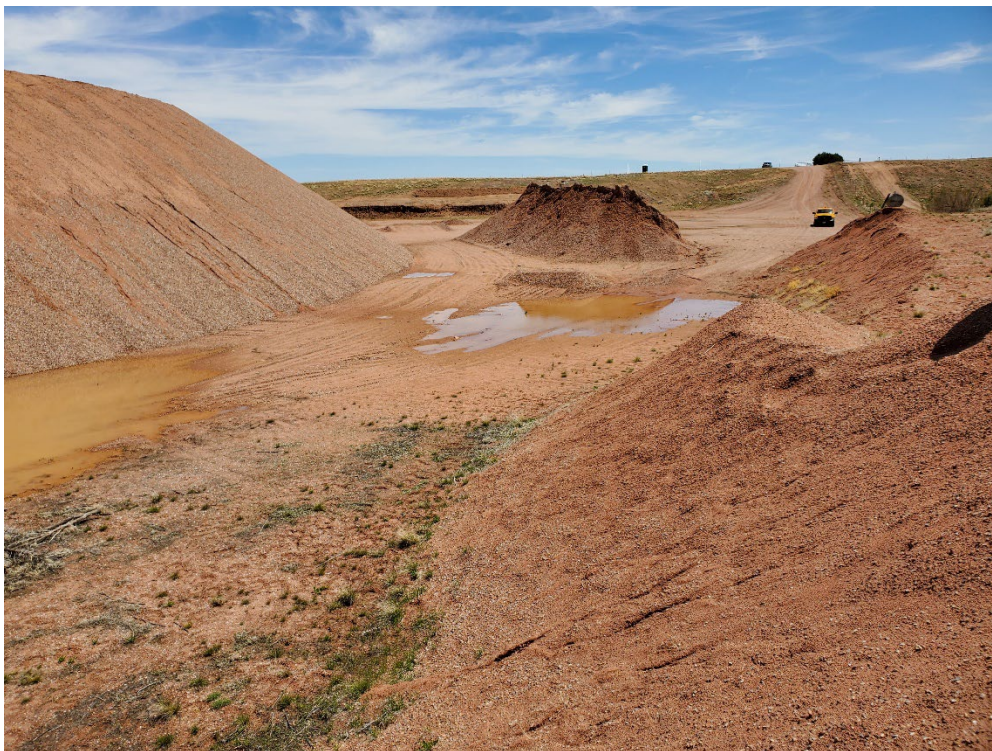
Photo 42: Looking east across the southern perimeter berm from the south-western-most edge of the active pit area.
