MINERALS PROGRAM INSPECTION REPORT
PHONE: (303) 866-3567

| MINE NAME: Everhart Pit | MINE/PROSPECTING ID#: M-1997-081 | MINERAL: Gravel | COUNTY: Pueblo |
| INSPECTION TYPE: Monitoring | WEATHER: Clear | INSP. DATE: May 17, 2023 | INSP. TIME: 11:45 |

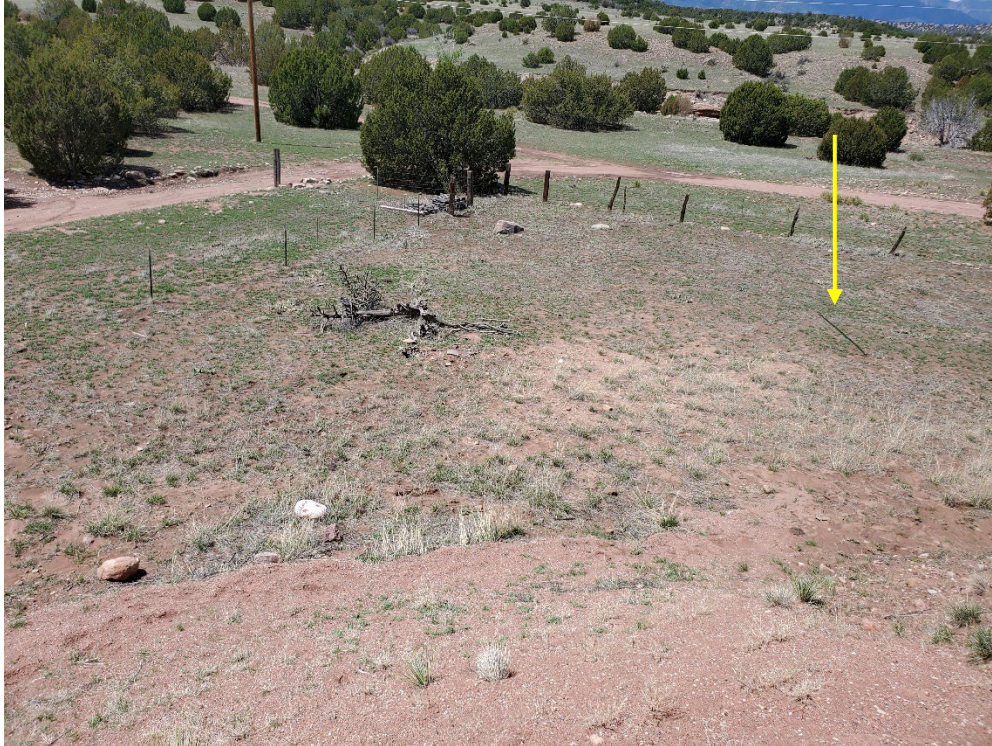
PROBLEM: The affected area boundary markers are missing or incorrectly placed. This is a problem for failure to maintain boundary markers around the affected area as required by Section 3.1.12(2) of the rule.

A problem was cited above for failure to maintain boundary markers around the affected area per Rule 3.1.12(2). The Operator stated there is a boundary marker in the south-western corner of the site, and upon review of the inspection photos a T-post was located (Photo 43). However, all other affected land boundary markers were missing. Additionally, the Division requests that the Operators install markers indicating the 150-200 foot buffer zone between the mining operation and Red Creek and/or indicate the location of this buffer on the next annual report map.

Photo 43: Looking south-west at the south-west corner of the fence surrounding the active pit area. The yellow arrow points to what the Operator believes is the south-western affected boundary marker.

CORRECTIVE ACTIONS: The Operator shall conduct a survey and replace the boundary markers in the correct location(s). The Operator shall provide proof to the Division that this has been done by the corrective action date.

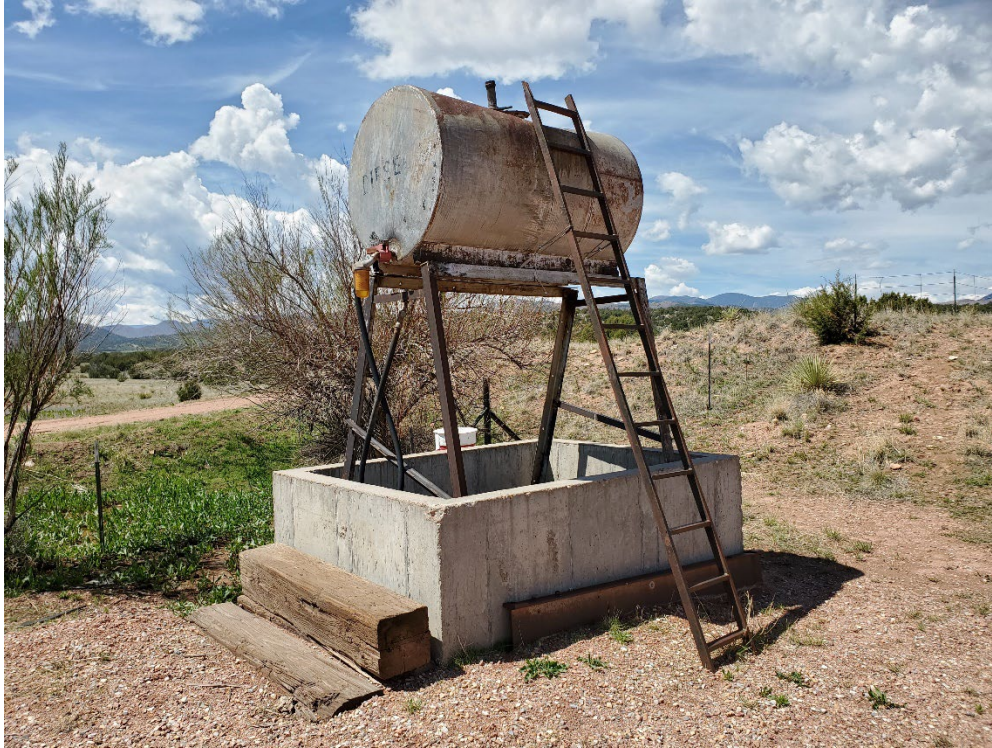
A fuel storage container was observed along the southern border within the active pit (Photo 45). No spills or leaks were observed and the concrete berm appears to be in good condition. A containment berm surrounds the base of the fuel tank to prevent any possible contamination of the underlying sediment and of the hydrologic balance if a leak were to occur.

Photo 45: Looking south at the fuel tank stored onsite.

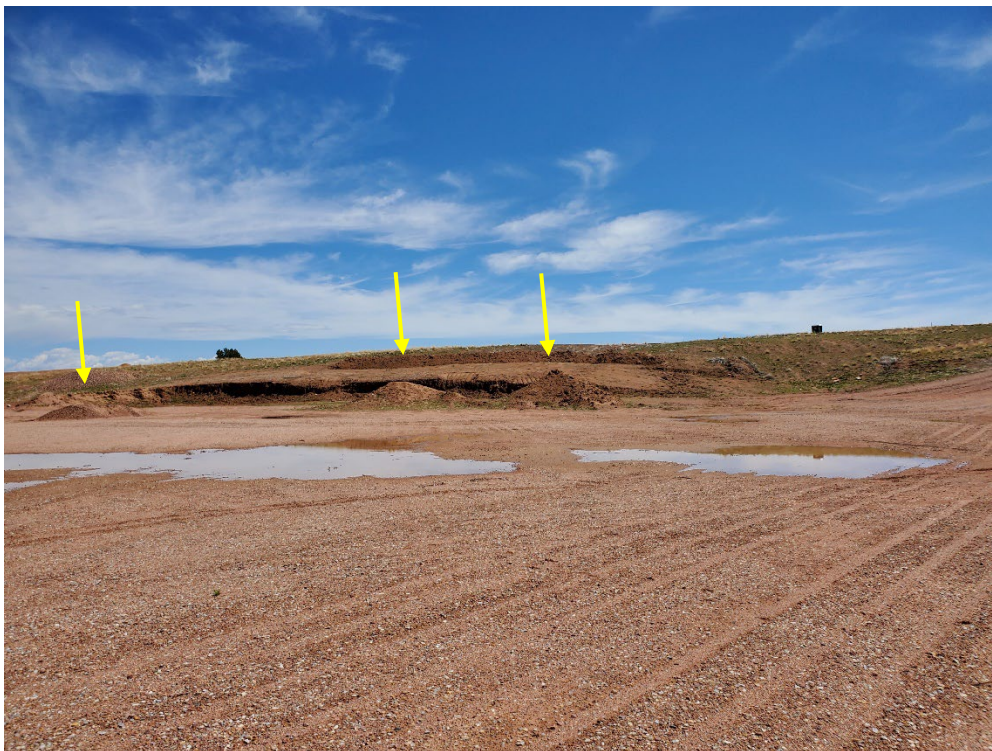
Standing water was observed throughout the pit, primarily in the south-western corner and in the north-eastern corner (Photos 9, 10, 25, 26, 30, 31, 38, 40-42, and 46). The area has seen a high accumulation of precipitation within the weeks leading up to the inspection, causing the site to have small ponds throughout. The ponds are relatively shallow, but combined they cover a significant amount of surface area. The Operator stated that this area is generally very dry, and water infiltrates within 72 hours, however they have undergone many days with continued rainfall and were expecting more over the next few days.

Photo 46: Looking north-east at the small test-pile stockpiles (yellow arrows) that will be used to fix the erosion in the eastern perimeter of the active pit and to slope the edges of the eastern perimeter.

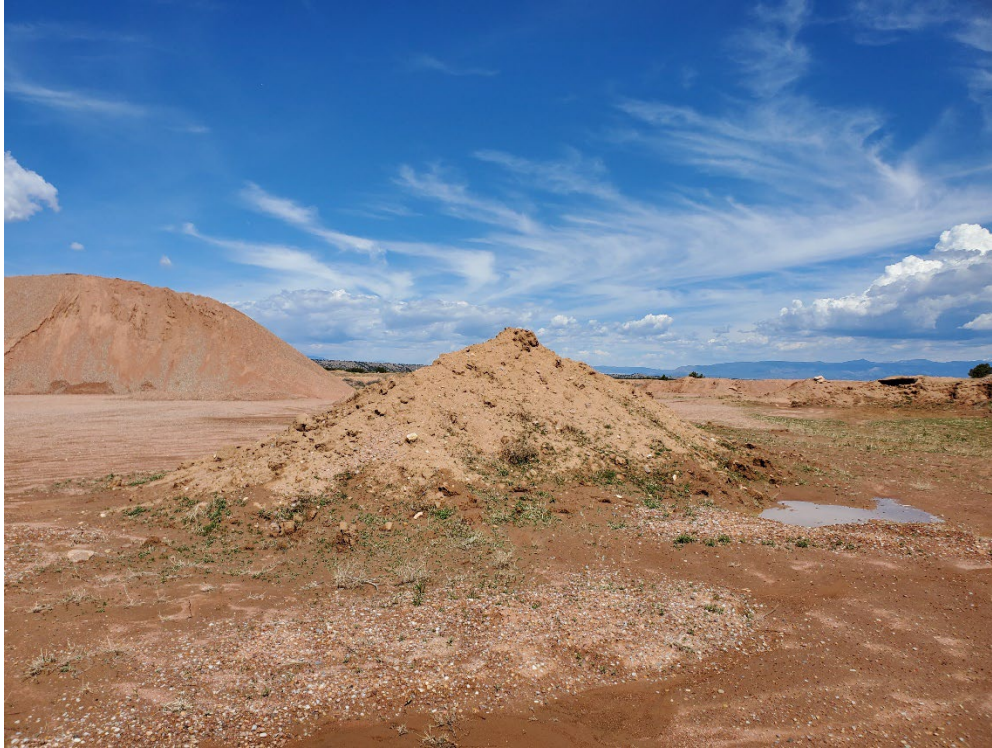
Photo 47: Looking north at one of the small test-pile stockpiles that will be used to fix the erosion in the eastern perimeter of the active pit and to slope the edges of the eastern perimeter.

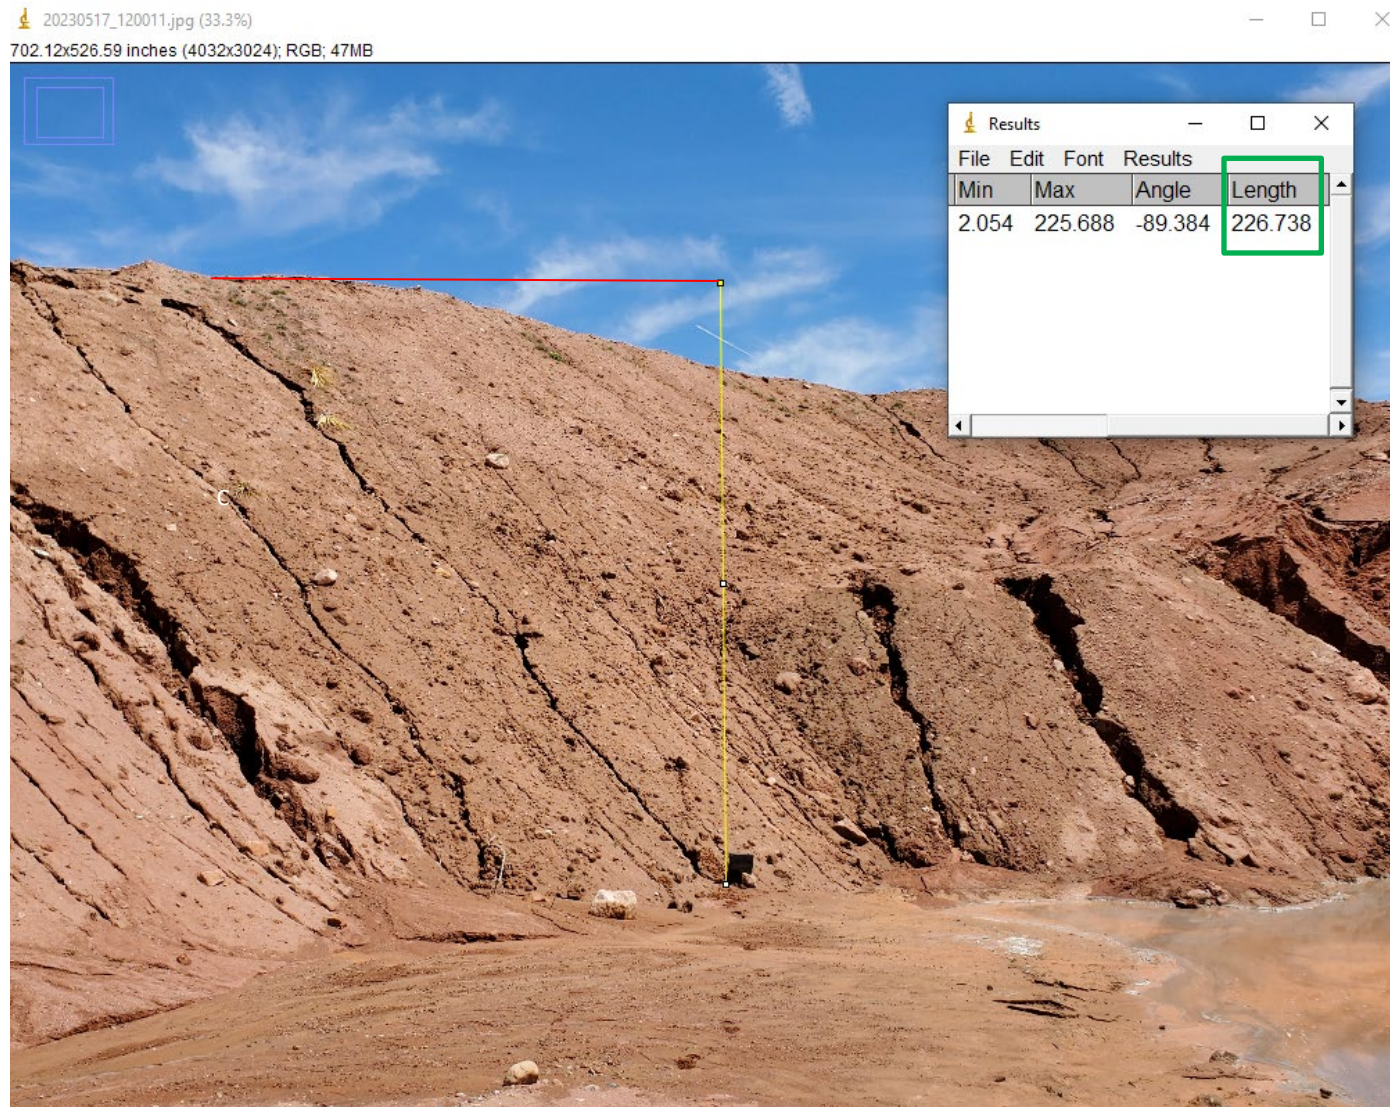
PROBLEM: The Operator has mined at a depth deeper than what is approved in their mining plan. The current mine plan needs to be updated and clarified pursuant to C.R.S. 34-32.5-112 (1)(c)(VI). The Operator must provide sufficient information to describe or identify how the operator intends to conduct the operation.

The recently disturbed area in the north-eastern corner of the pit appears to have been mined at a depth of approximately 19 feet (Figure 1). There is an accumulation of water at the base of the slopes in this area (Photos 25 and 26) The Operator's mining plan states that they planned to mine at a depth between 10 and 15 feet to avoid the possibility of encountering groundwater. **A problem was cited** for mining at a deeper depth than what is approved in the current mining plan. Please submit a Technical Revision to update the mining plan if the Operator intends to mine deeper than what is currently approved. If this is the plan, please also provide an explanation of how the mining operations will be conducted in a manner to avoid encountering the groundwater table.

Figure 1: Recent disturbance in the north-eastern corner of the active pit. The height of the pit was estimated at approximately 19ft (226.74 inches) using ImageJ software and an 11.75" tall binder as a scale.

CORRECTIVE ACTIONS: The operator shall submit a Technical Revision, with the required \$216 revision fee, to update and clarify the current approved mine plan to reflect existing and proposed activities by the corrective action date.
