## Inspection Report, Raindance Reservoir #2 (M-2021-049)

**MINERALS PROGRAM INSPECTION REPORT**  
**PHONE: (303) 866-3567**

<b>MINE NAME:</b> Raindance Reservoir #2	<b>MINE/PROSPECTING ID#:</b> M-2021-049	<b>MINERAL:</b> Borrow material for construction and clay (general)	<b>COUNTY:</b> Weld
<b>INSPECTION TYPE:</b> Monitoring	<b>WEATHER:</b> Raining	<b>INSP. DATE:</b> June 13, 2023	<b>INSP. TIME:</b> 09:00
<b>OPERATOR:</b> Vima Partners, LLC	<b>OPERATOR REPRESENTATIVE:</b> Garrett Scallon and Derek Patterson	<b>TYPE OF OPERATION:</b> 112c - Construction Regular Operation	
<b>REASON FOR INSPECTION:</b> Normal I&E Program / Preoperation Inspection	<b>BOND CALCULATION TYPE:</b> Complete Bond	<b>BOND AMOUNT:</b> \$1,191,782.00	
<b>DATE OF COMPLAINT:</b> NA	<b>POST INSP. CONTACTS:</b> None	<b>JOINT INSP. AGENCY:</b> None	
<b>INSPECTOR(S):</b> Hunter Ridley Michael Cunningham	<b>INSPECTOR'S SIGNATURE:</b>

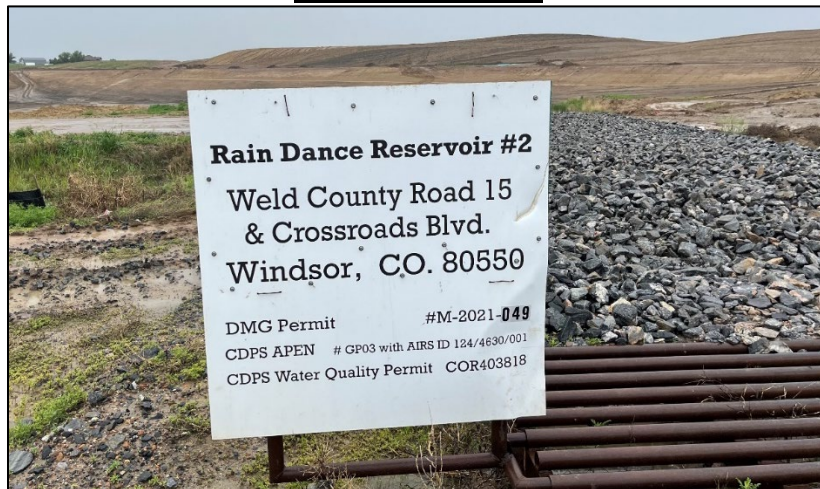
The mine identification sign and affected area boundary markers are in place and in compliance with Rule 3.1.12. The sign is located at the entrance of the site and the permit number has been updated and corrected since the last inspection (Photo 1). The perimeter has been marked with posts and pink flags to delineate the current permit boundary. Flag markers are present on the western boundary of the pit to show the proposed permit boundary expansion. Notice signs, pursuant to Rule 1.6.2(1)(b), were not posted at the site for AM01. The Division requested that these be posted at the site as soon as possible. The Division received confirmation that signage was posted on June 17, 2023 (Photos 13-15).

**Photo 1: An appropriate mine sign is posted at the entrance to the site.**

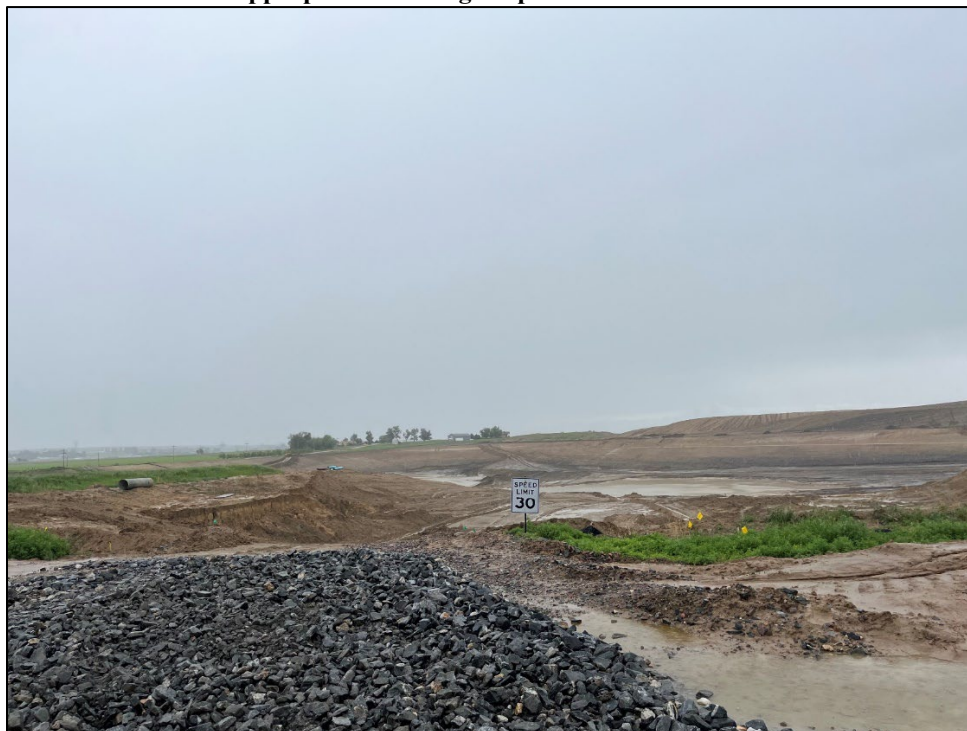
A majority of the reservoir has been excavated and graded to the appropriate 3H: 1V slopes (Photo 2). The northeastern corner remains to be fully excavated. With the approval of AM01, a pump station will also be installed in this corner of the site. The site representative stated that current plans see excavation complete in the summer/fall of 2023 with full reservoir function and final reclamation beginning in the spring of 2024.

**Photo 2: View southeast from the site entrance showing a partially excavated reservoir footprint.**

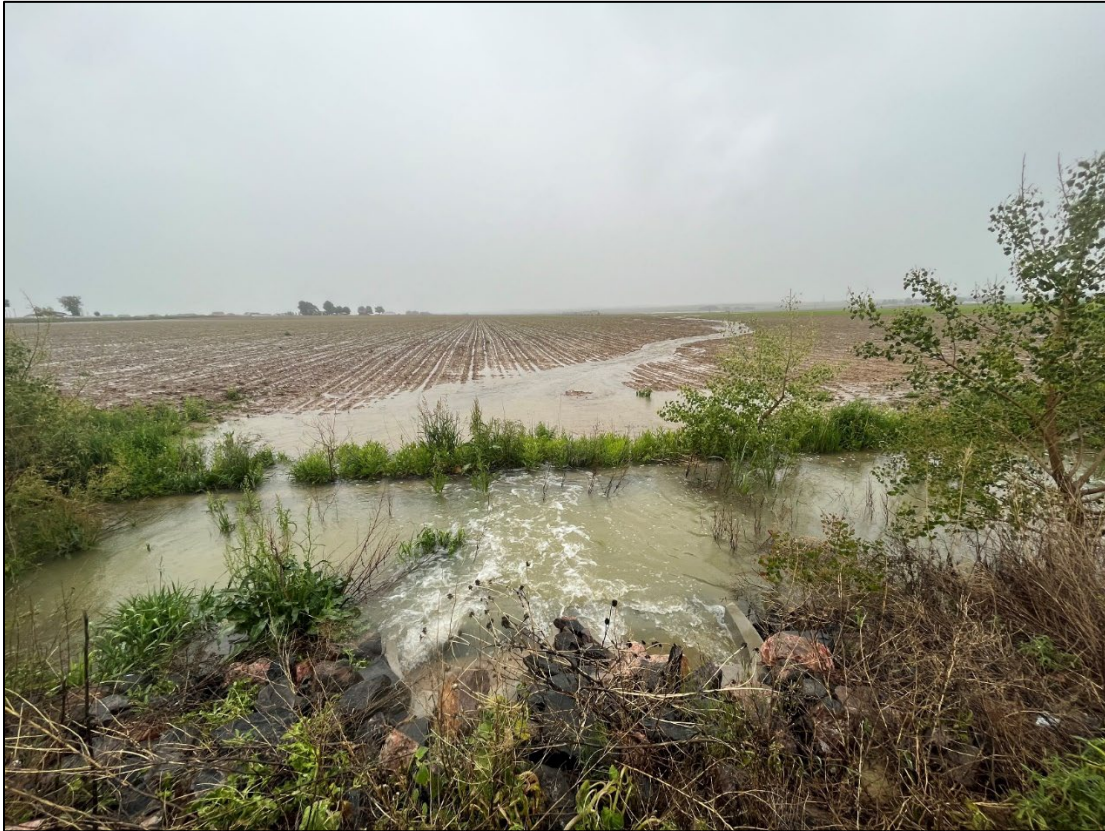
Weld County has experienced significant rain events in recent months. Any impounded water at the site is currently being pumped to an outfall structure which lies on the eastern side of WCR15 (Photos 3-5). Sediment ponds located within the reservoir basin were currently overtopped with water (Photo 4). Water from this site no longer reports to the two ponds located on the eastern side of WCR15 (Photos 6 and 7).

**Photo 3: View east of the outfall structure currently being used to discharge impounded storm water from the site, recent extraordinary rain events have caused overflow and erosion of adjacent agricultural fields in this area.**

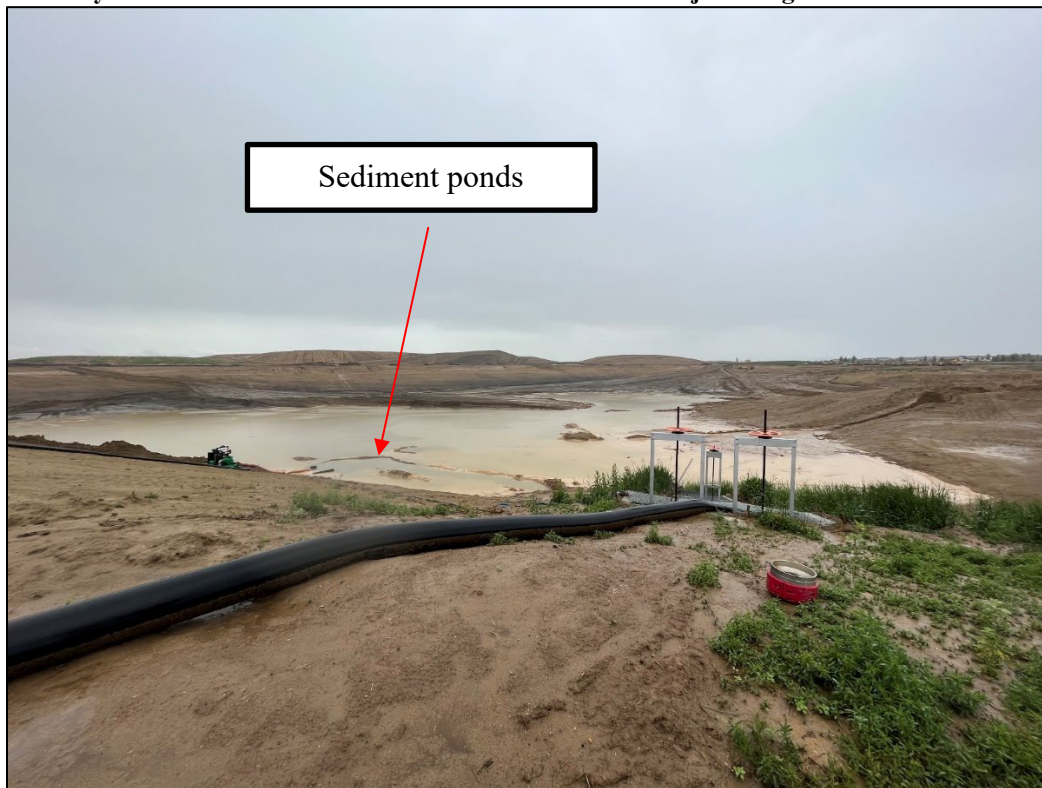
**Photo 4: View northwest of the pump station used to discharge impounded water under WCR15 and to an outfall structure. The sediment pond system within the reservoir is visible, though currently covered with water.**

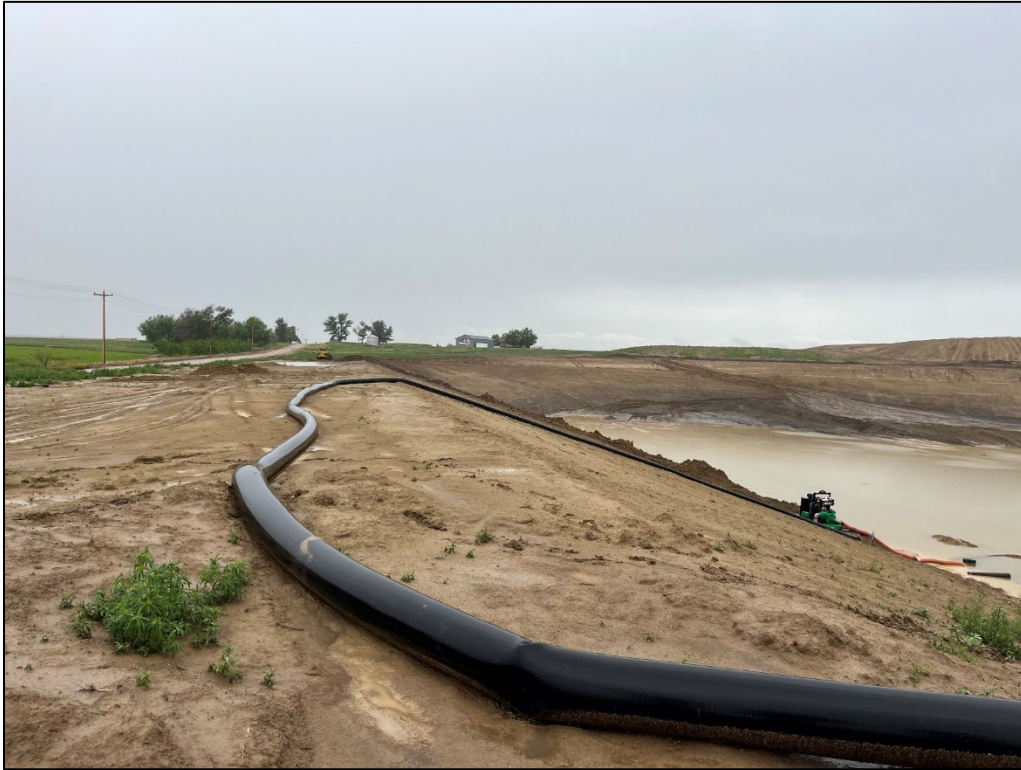
**Photo 5: Pump and generator which is part of the pump system which discharges impounded storm water into an outfall structure. A small, temporary access route has been cut into the eastern slope to allow access to the generator in wet and muddy conditions.**

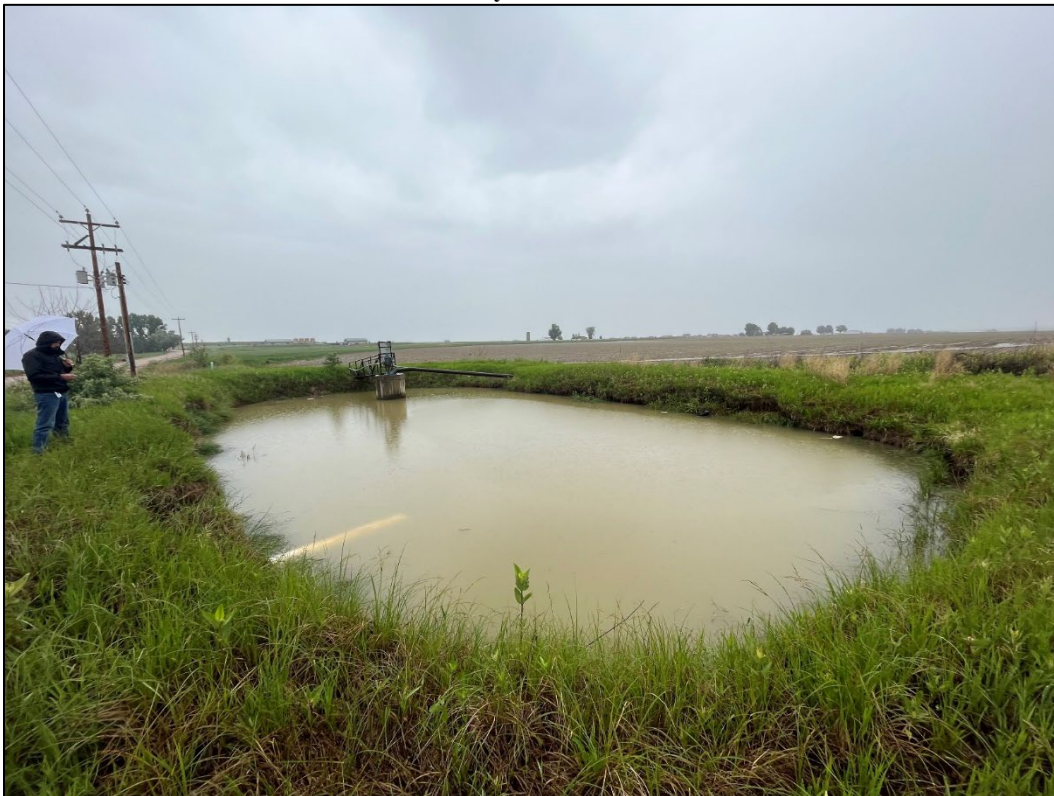
**Photo 6: One of two ponds which lie to the east of WCR15, water from the mine site no longer reports to these ponds.**

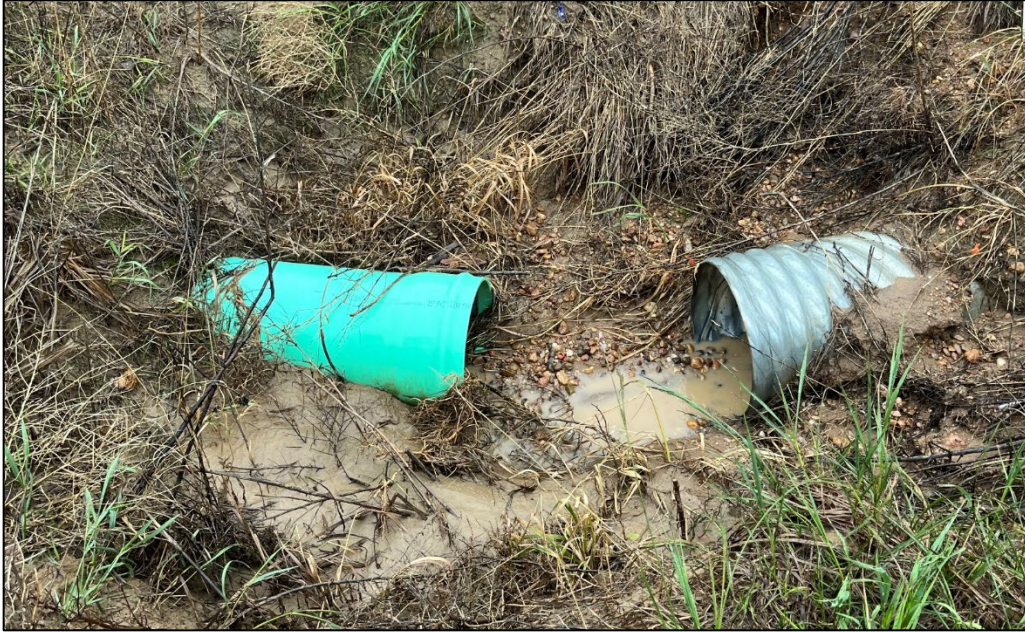
**Photo 7: Only water from the ditch along WCR15 is reporting to the two ponds which lie across WCR15.**

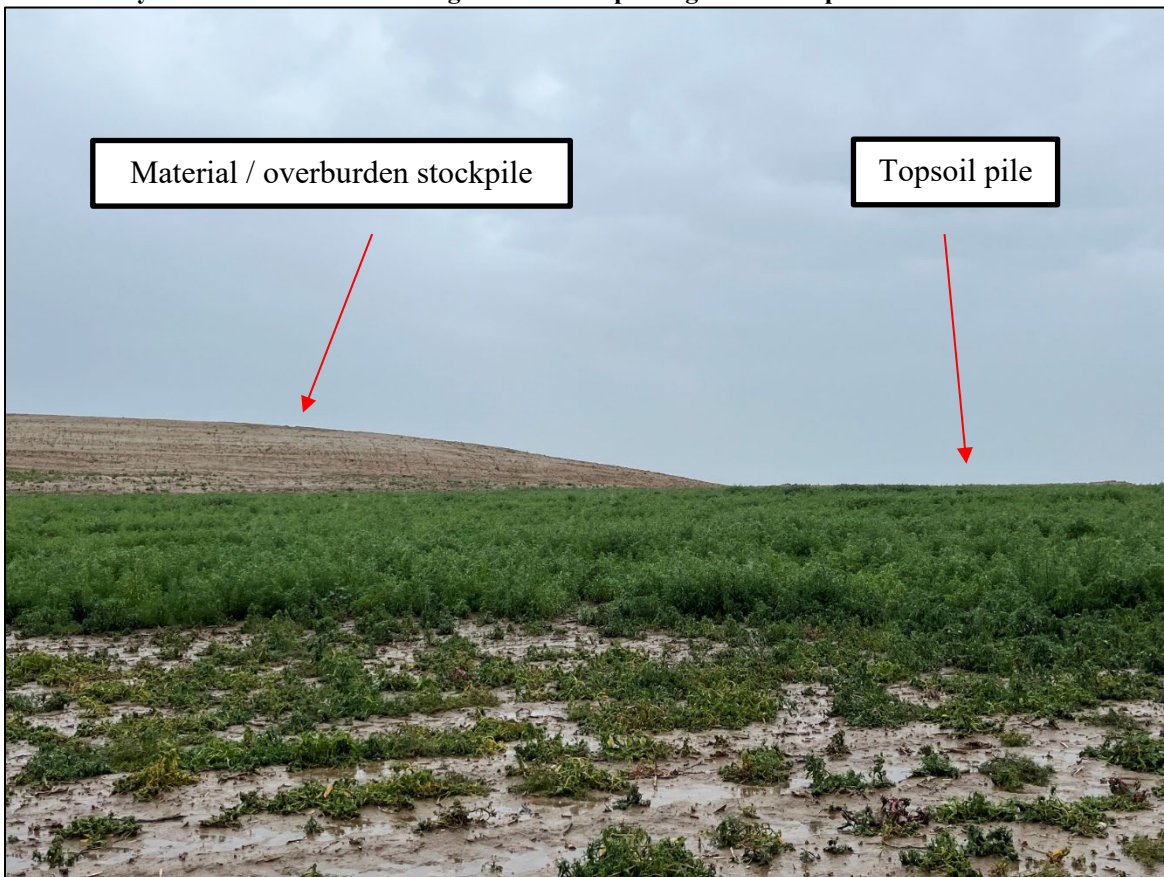
There are two topsoil stockpiles located around the mine site (Photos 8 and 12). The site representative stated that the topsoil pile to the northwest was being sold, while the topsoil stockpiled to the southeast is being stored for use in final reclamation. Please ensure that all topsoil piles are appropriately vegetated in the Spring/Fall season to promote stabilization and prevent erosion as stated in the mine plan and as required by Rule 3.1.9.

**Photo 8: View north along the southern boundary of the pit. An overburden pile is visible to the west and a topsoil pile (partially obscured) is located to the east.**

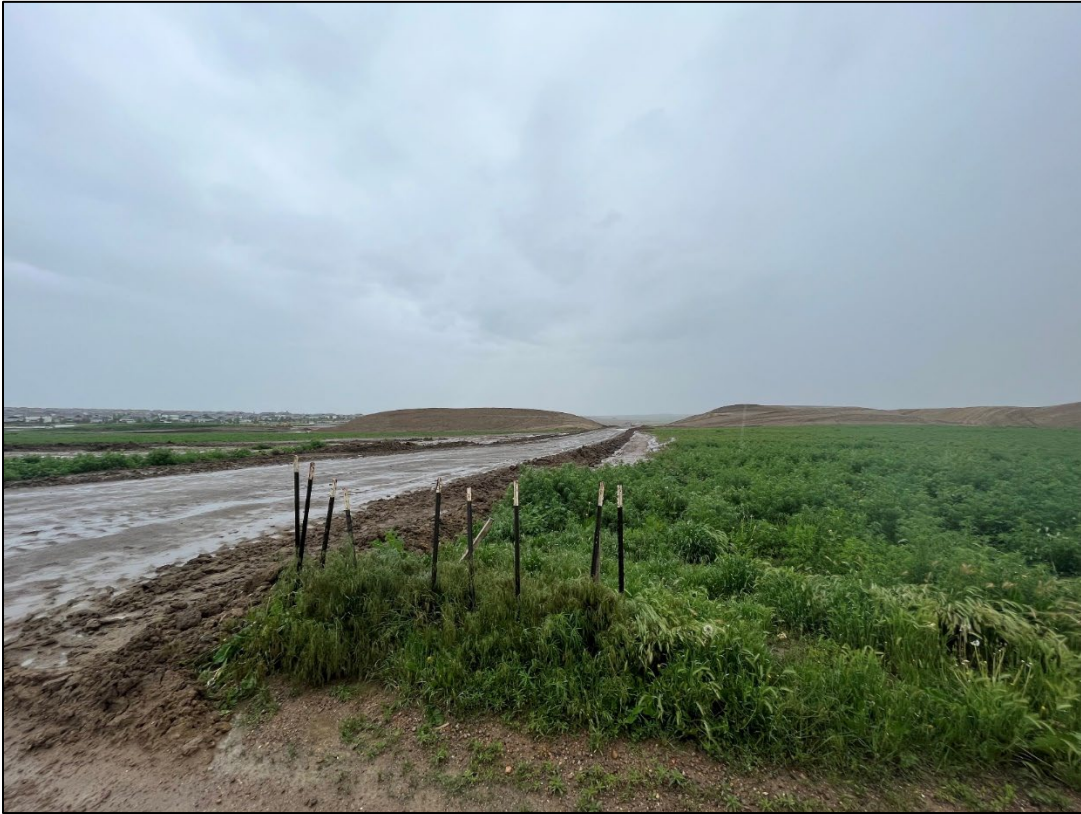
The operator has constructed three access roads on the parcel to the west of the mine site. These roads are traversed by scrapers which transport material sold to the adjacent parcel owner directly from the mine site to the adjacent parcel (Photos 9-11). This material is being utilized by the purchasing landowner to create a privacy berm.

**Photo 9: View east of an access road cut between the existing overburden pile. The access road is currently being utilized to transport material from the site to the western adjacent field. This material was purchased by the western adjacent parcel owner.**

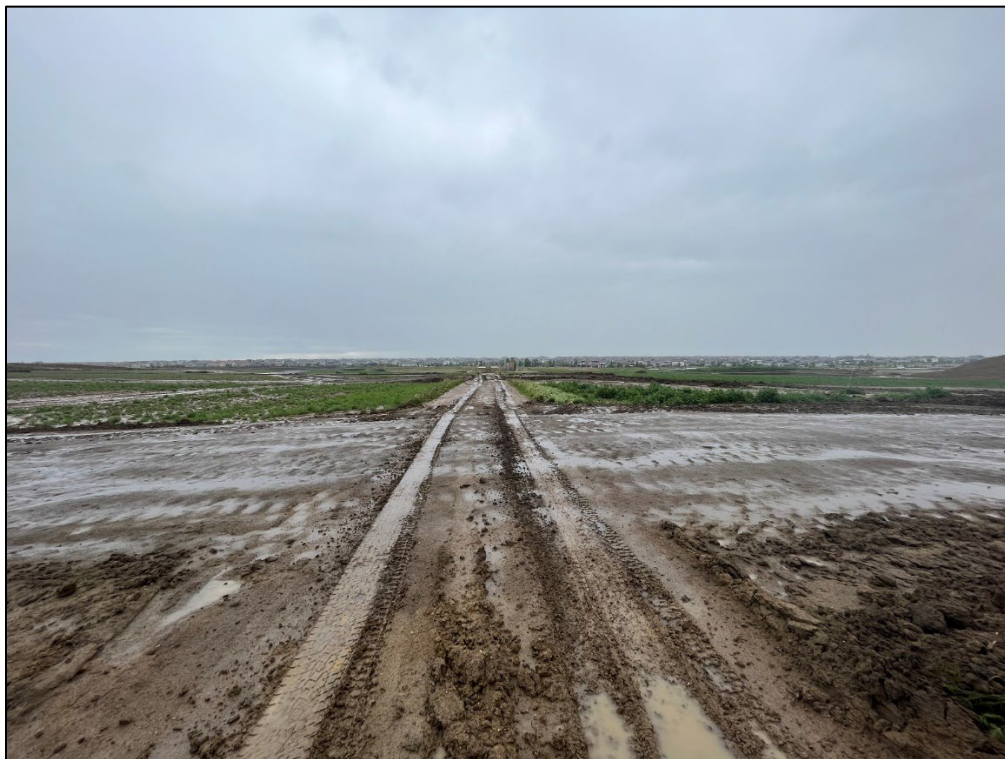
**Photo 10: View north of a previously existing private road, which the newly built access road crosses perpendicular to. The current permit boundary for the mine site lies approximately 250 feet to the east of this currently existing private road.**

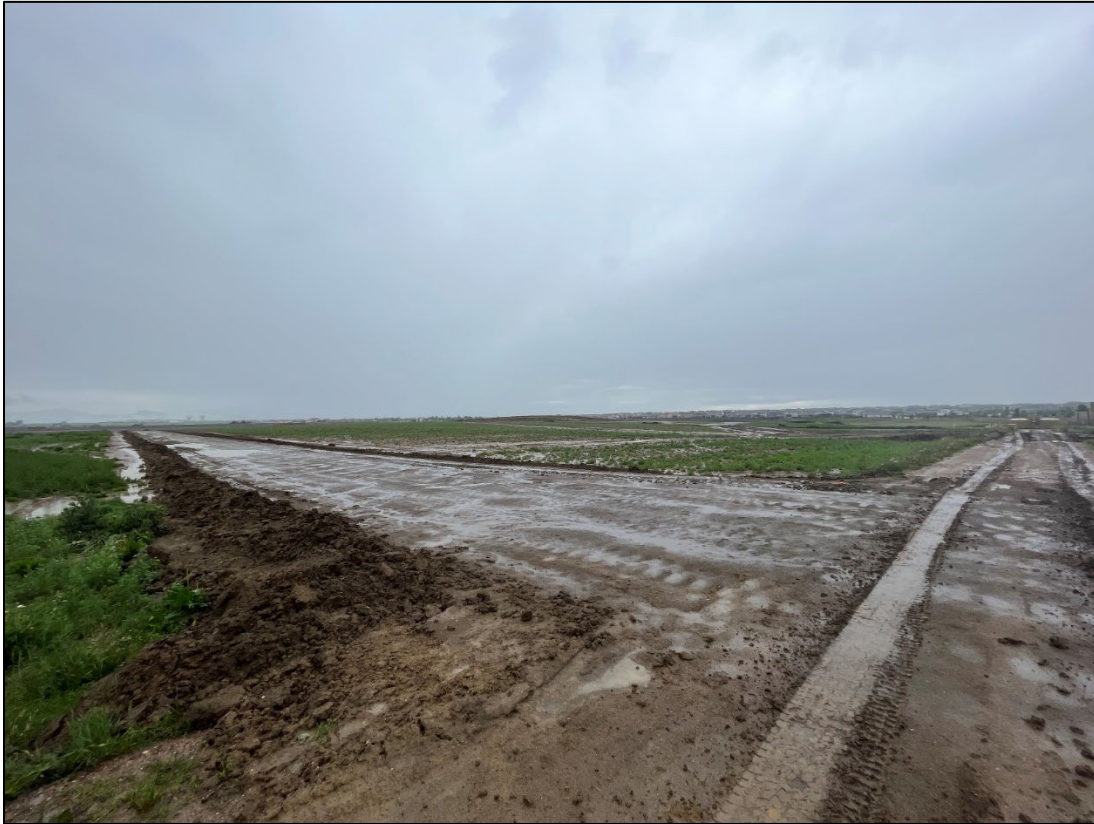
**Photo 11:** View northwest of the western adjacent parcel onto which the newly built access road extends. Two additional roads have been built in this adjacent parcel to regulate the traffic of scrapers to and from the mine site.

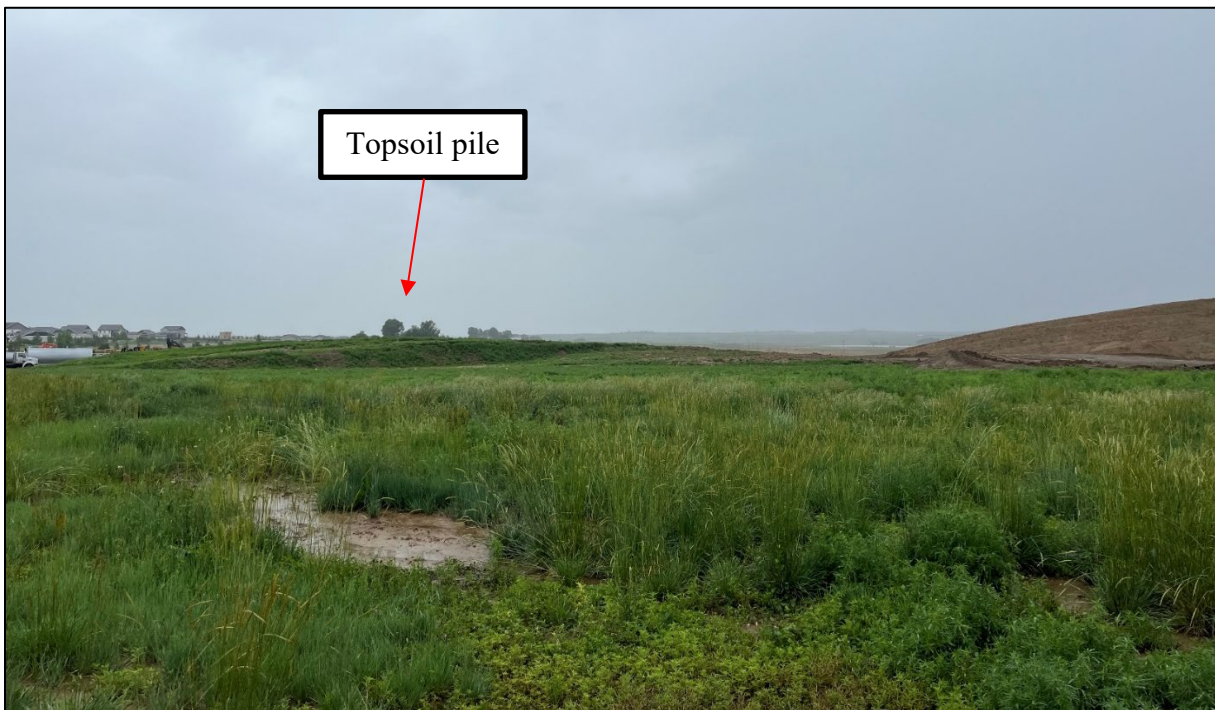
**Photo 12:** View east from the western boundary of the pit, the topsoil pile to be removed/sold is visible.

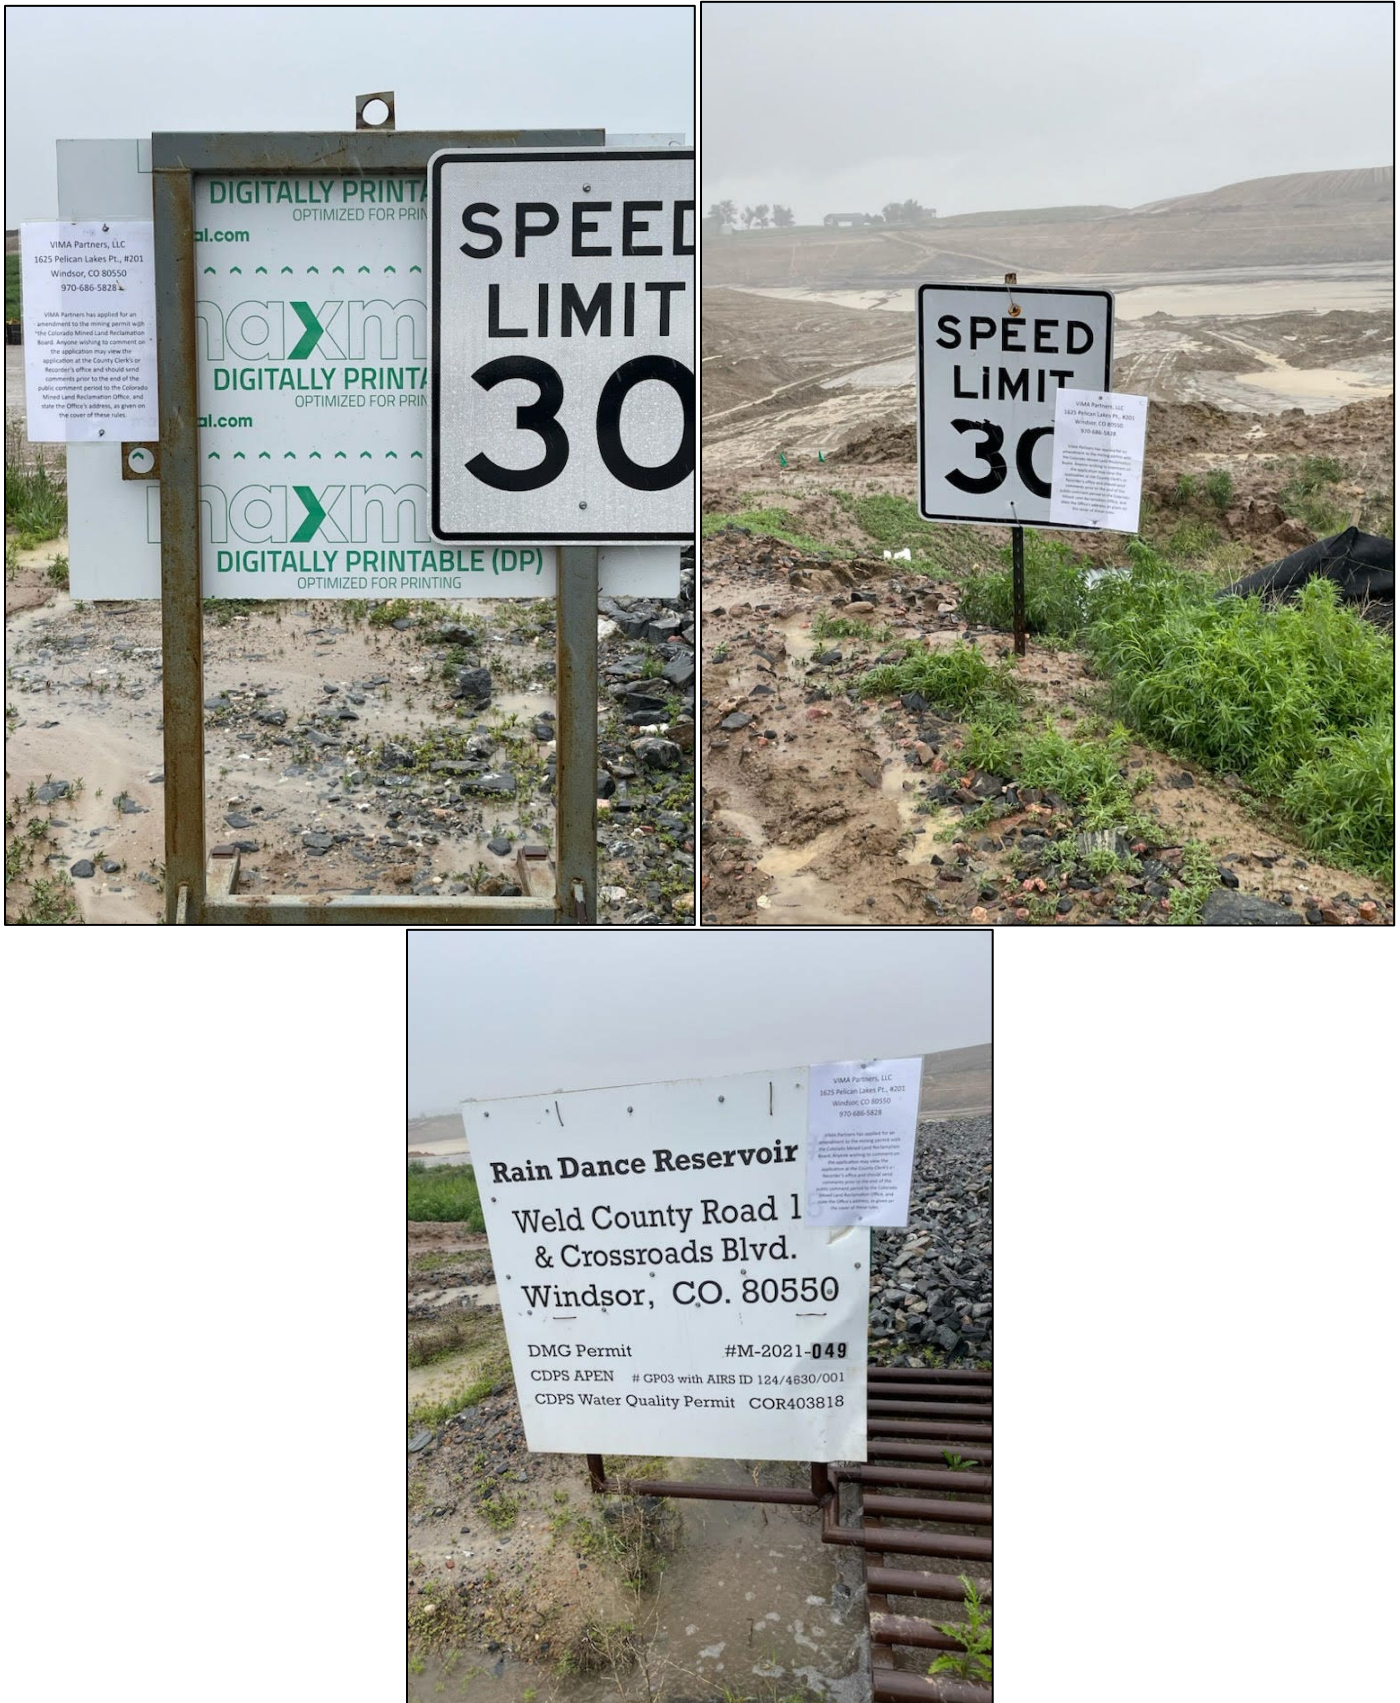
Photos 13 – 15: Amendment notice signage has been posted.
