Corrective Action Due, Gardner Pit, M-1979-034

RE: Gardner Gravel Pit, Permit No. M-1979-034, Unresolved Problem(s) Noted in a Past Inspection Report

MINERALS PROGRAM INSPECTION REPORT PHONE: (303) 866-3567

MINE NAME:		MINE/PROSPECTING ID#:	MINERAL:	COUNTY:
Gardner Gravel Pit		M-1979-034	Sand and gravel	Routt
INSPECTION TYPE:		WEATHER: Snowing	INSP. DATE:	INSP. TIME:
Monitoring			March 31, 2023	09:00
OPERATOR:		OPERATOR REPRESENTATIVE:	TYPE OF OPERATION:	
General Operating Company		Zach Gomez	112c - Construction Regular Operation	
REASON FOR INSPECTION:		BOND CALCULATION TYPE:	BOND AMOUNT:	
Normal I&E Program		Partial	\$130,932.00	
DATE OF COMPLAINT:		POST INSP. CONTACTS:	JOINT INSP. AGENCY:	
NA		None	None	
INSPECTOR(S):	INSPECTOR'S SIGNATURE:		SIGNATURE DATE:	
Hunter Ridley	1.7	5	April 11, 2023	
Michael Cunningham		re Ridley		
	Tranco	e (verage

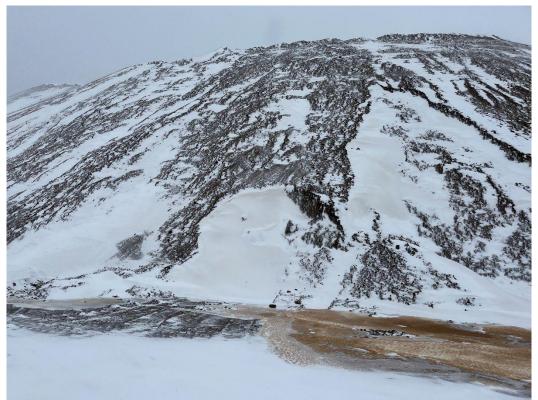
Photo 6: View north of the excavated hillside and haul road from the upper processing portion of the pit.
