**NEW ELK MINE  
Permit No. C-1981-012**

**QUARTERLY COAL WASTE BANK INSPECTION REPORT  
June 22, 2023**

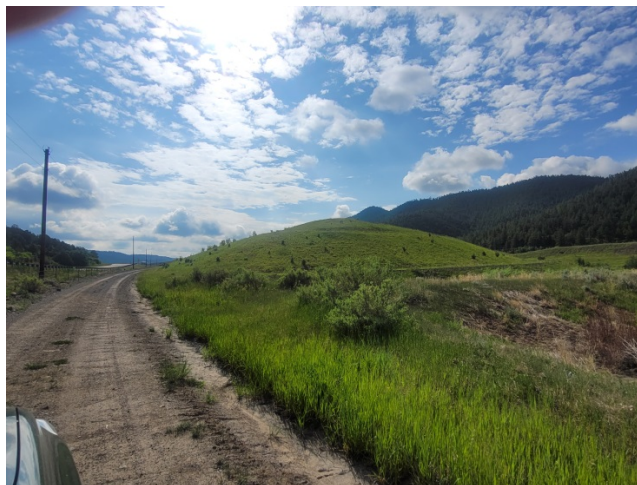
Overall the disposal area is in good condition.

**North Facing Side of DWDA #1**

None at this time.

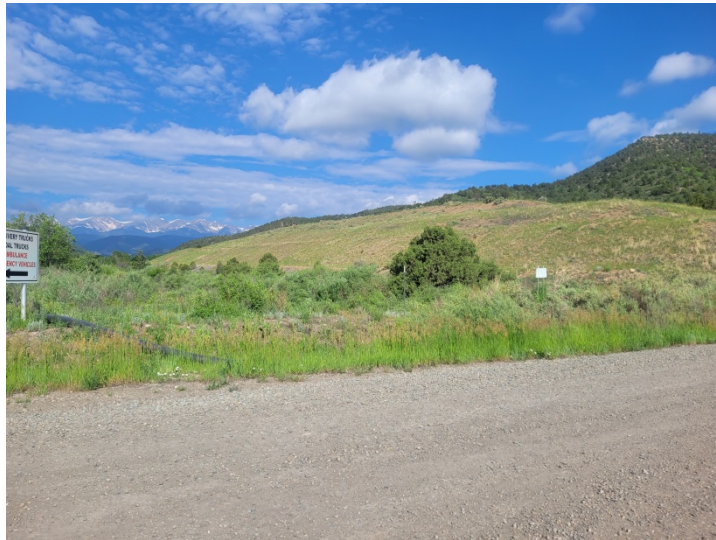
**South Facing Side of DWDA #1**

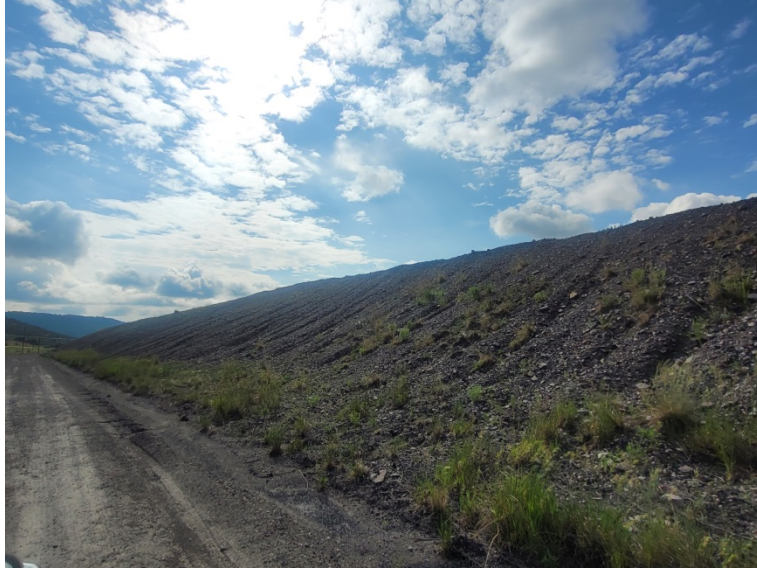
Surface and out slopes of the pile were inspected for visible signs of potential failure or instability. There was some surface erosion but not enough to make the area unstable. In all no signs of failure or instability were observed.

Overall the disposal area is in good condition. The sign with the name of the area was recently replaced.

**North Facing Side of the DWDA #2**

The Rills are being monitored and have not gotten any bigger and there is no sediment loading. Operator is evaluating either reclamation of the area or permitting alternative uses of the land north of the Purgatoire River and south of Highway 12. The sump at the end of the area was being cleaned as annual maintenance.

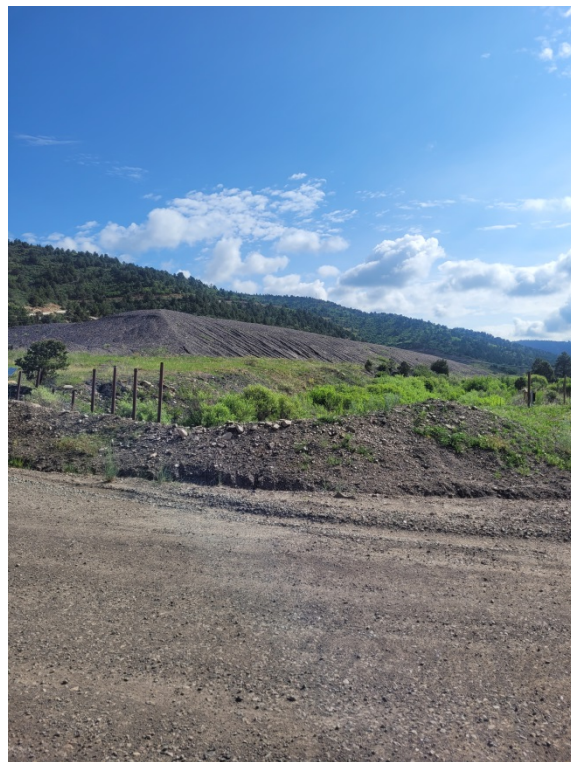
**South Facing Side of the DWDA #2**

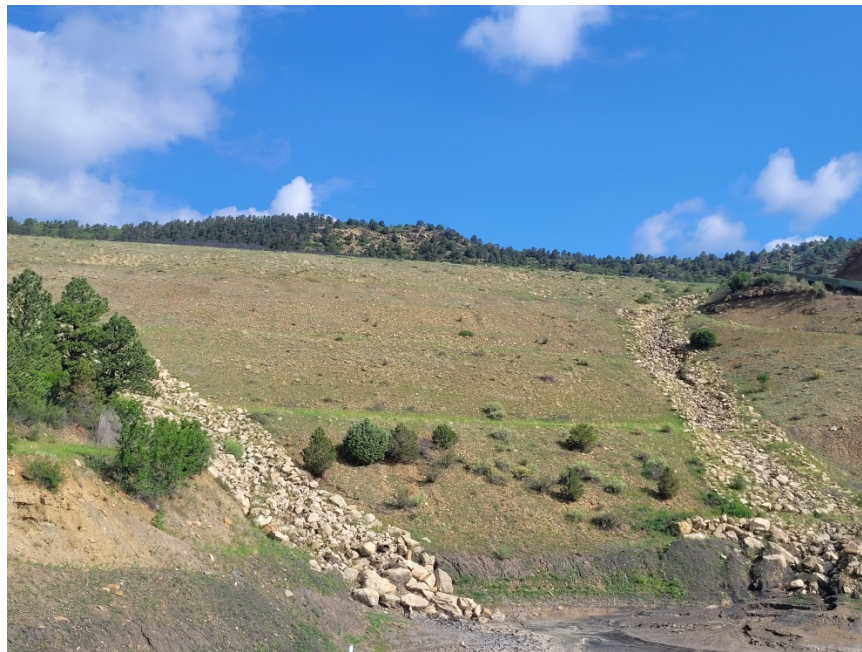
Overall the site is in good condition.

**Face of Refuse Disposal Area**

None required at this time.
