**LORENCITO CANYON MINE**  
**Permit No. C-1996-084**

**INSPECTION OF EXCESS SPOIL-FILLS 7, 8, & 9**  
**June 22, 2023**

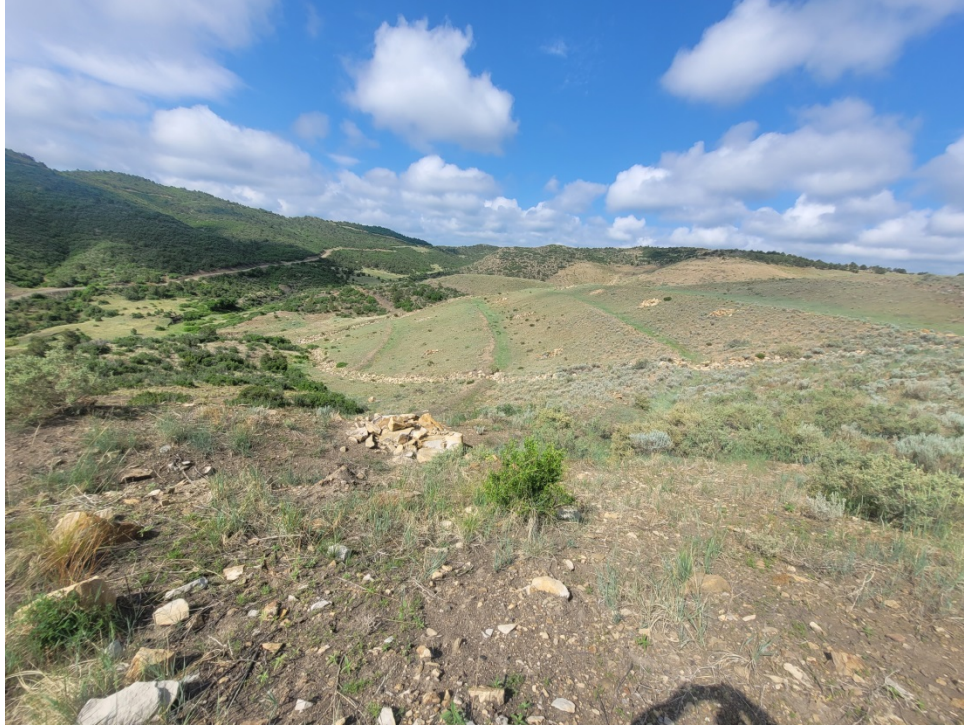
**Fill #7**

East armored down drain needs to be monitored and might need a spot that is washed out to be re-armored. All else looks good.

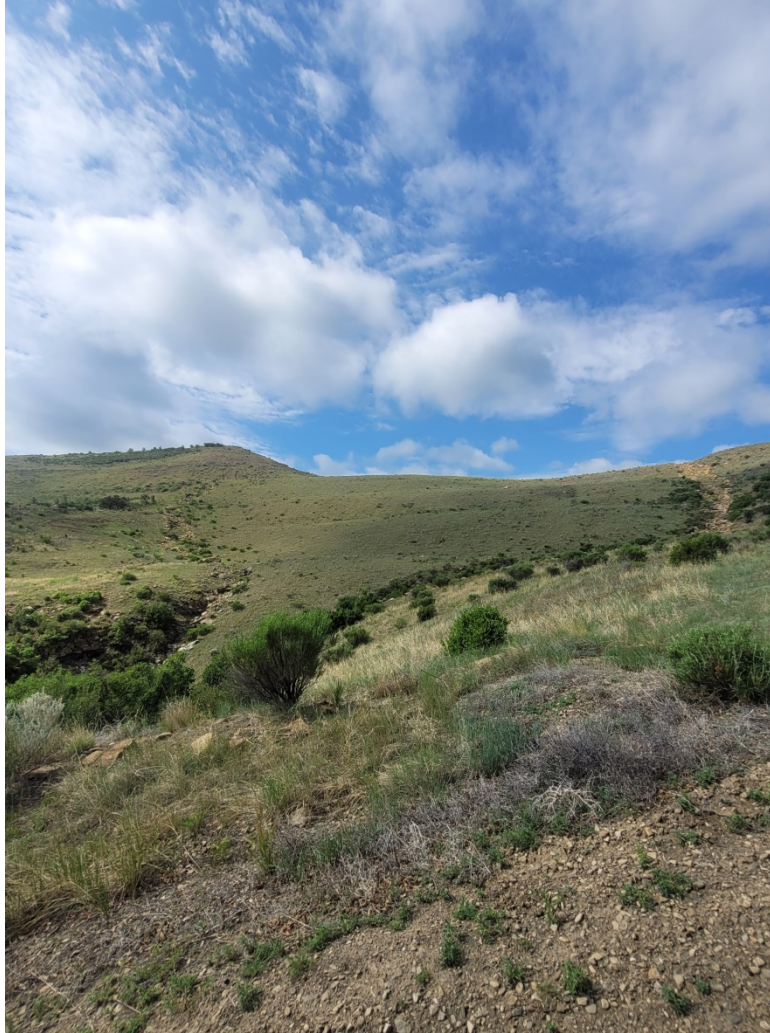
**Fill #8**

Lower portion of East down drain needs to be monitored and may need additional rock in bare spots. All else is in good condition.

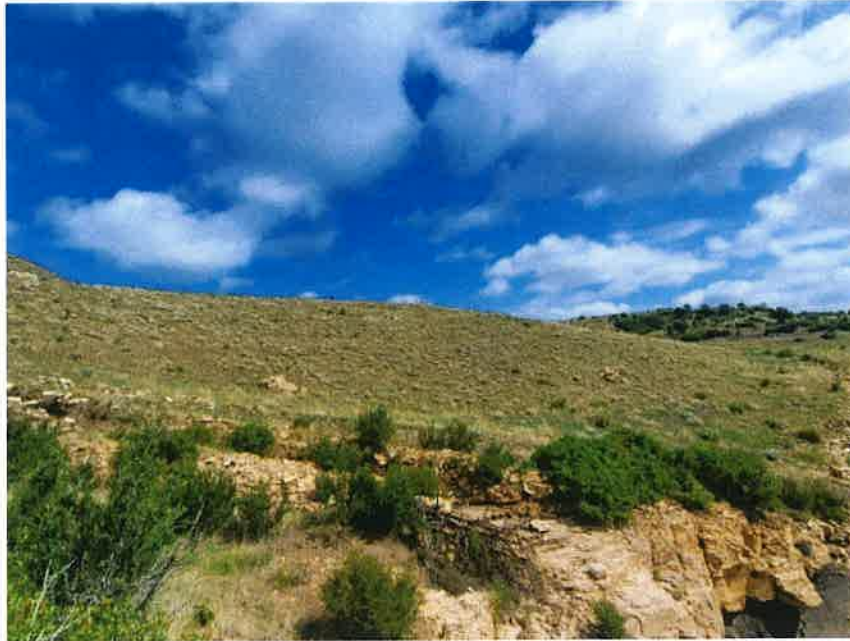
Fill #9

Overall the site is in good condition.
